Client:	Lincolnshire County Council		
Job Title:	Burgh le Marsh Windmill: repairs		
Drawing Title:	4 th floor internal walling repairs		
Scale:	NTS @ A3	Drawn By:	PEO
		Date:	November 2023
Job Number:	6700/3	Drawing Number:	5

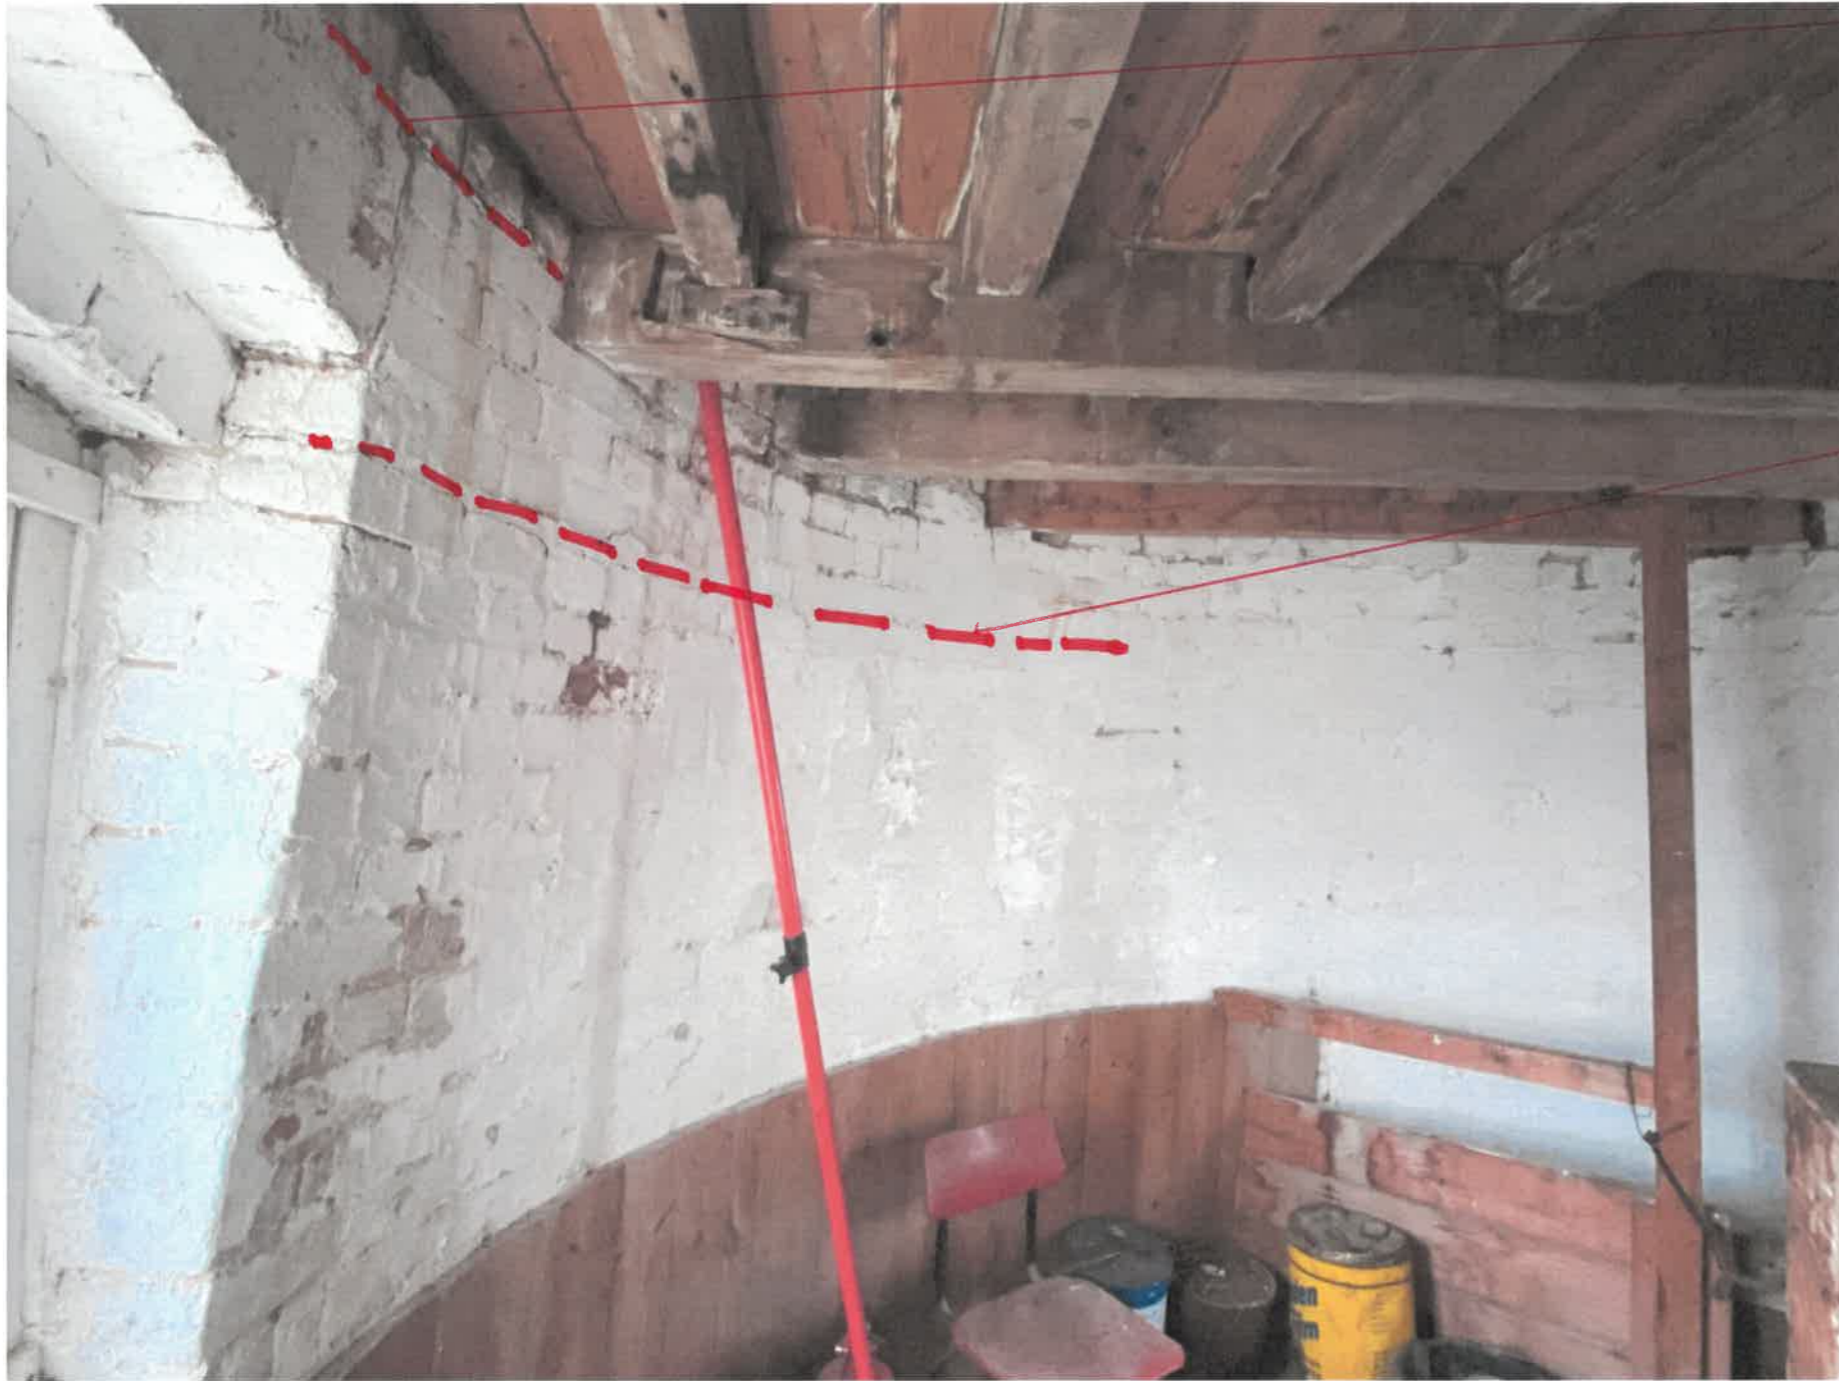
View looking south, window E4 on left

Item 10.16 rake out the cracked bed joint south of window E4 3no courses below the ceiling joist bearings provisional 3500mm length on wall arc, pack with hydraulic lime mortar NHL5 and point up to surface, brush up when set

Item 10.17 Window E4 head: cut out bed joint above the south jamb in 3rd course above window head springing level, insert stitch 500mm long as specification in item 10.8
