### **Design and Access Statement**

Re: Doors, sidelight and toplight replacement to 2 Chepstow House, Chester

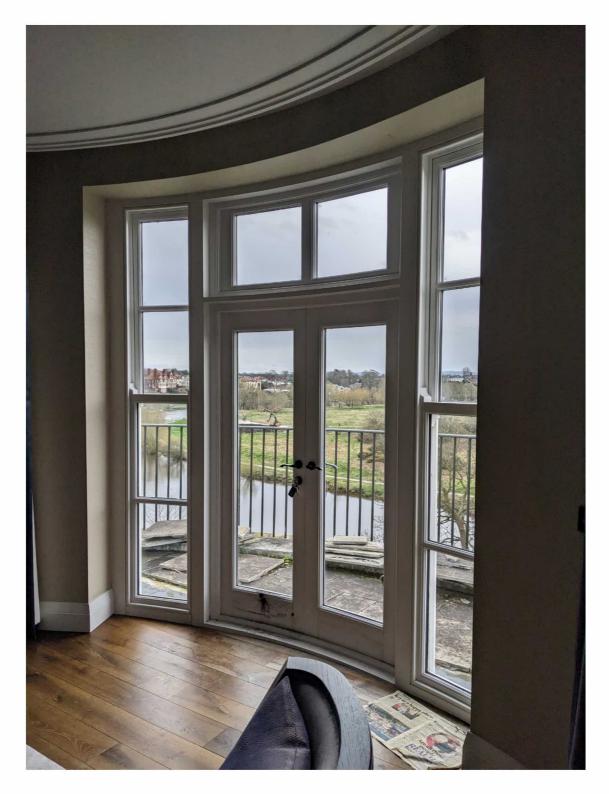
# Water damage to existing doors and frame.

Doors and frames are softwood and are of poor quality. They are only 7 years old and shouldn't be in this condition after such as short period of time

Carefully remove existing doors and dispose of.

Supply and fit new hardwood doors, toplights and sidelights with a like for like design with existing.

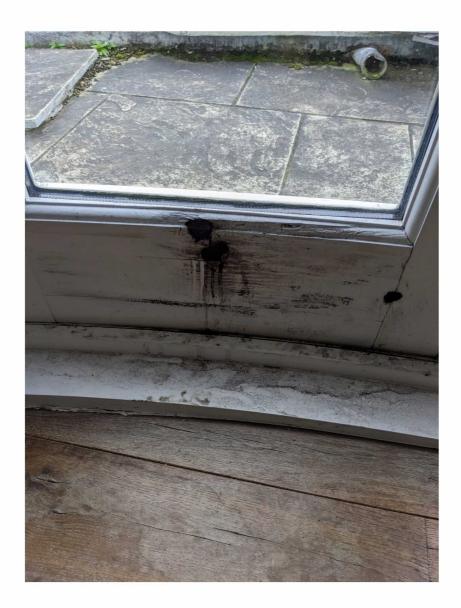
## Poor design

No upstand from balcony aand inadequate tanking membrane causing water to ingress into property. Promenade tiles that were fitted onto balcony sit higher than the wooden cill causing it to be permanently sat in water

Form upstand and tank balcony to prevent water ingress into the property.
