Shellfield Road

### Boundary Treatments

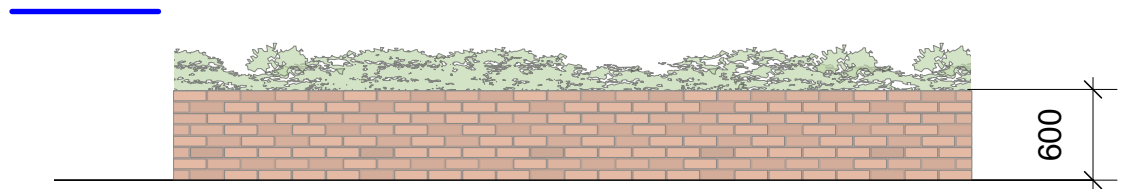
600mm high existing Low Brick Wall - With hedge behind - Along Shellfield Road

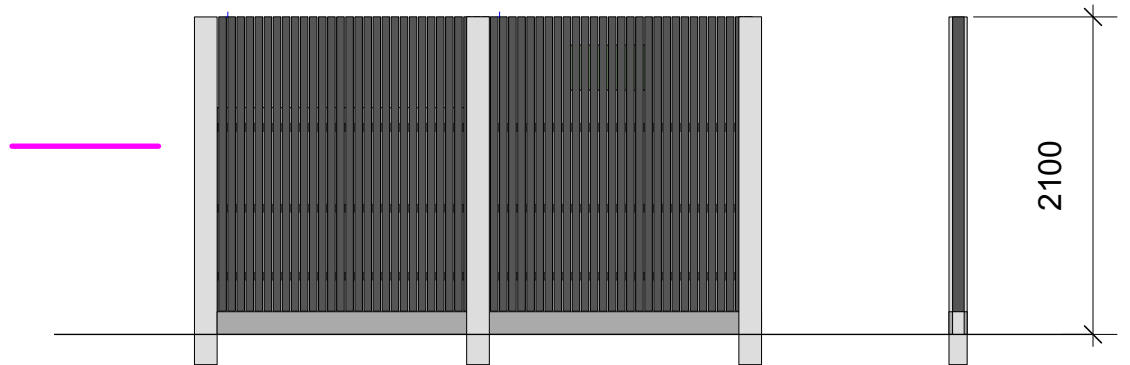
2100mm high timber fencing and concrete fence posts - Stained black

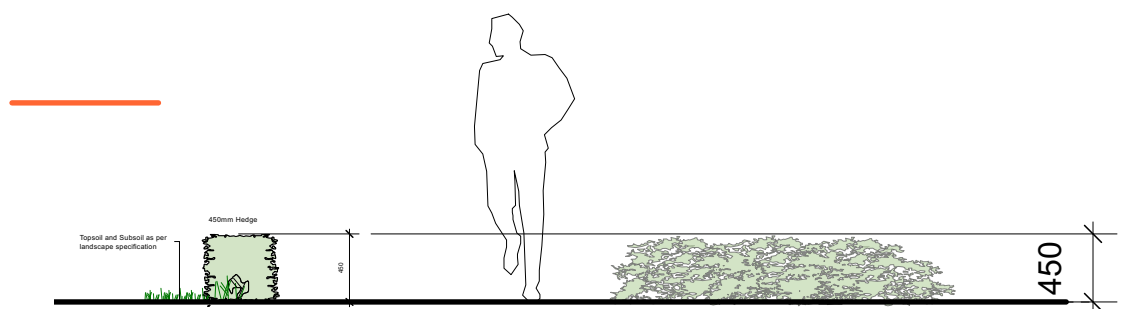
450mm high Low hedge
