Project:						
son+Partners				Mid-Tier South Western Railways Projects					
				Title: Surbiton Station					
				Demolition Downside					
				South Elevation					
				Scale:	Date:	Drawn:	Checked:	Approved:	
				1:50 @ A1	08/03/24	SSIL	JBB	RR	
				Status:	Status:				
				Planning Submission					
	SSIL	JBB	RR	Drawing Number: Revision:					
	Drawn	Check	Approv	1019-WWP-SUR-00-GA-A-3001 B01					
Converse Williamson / Dorthorn

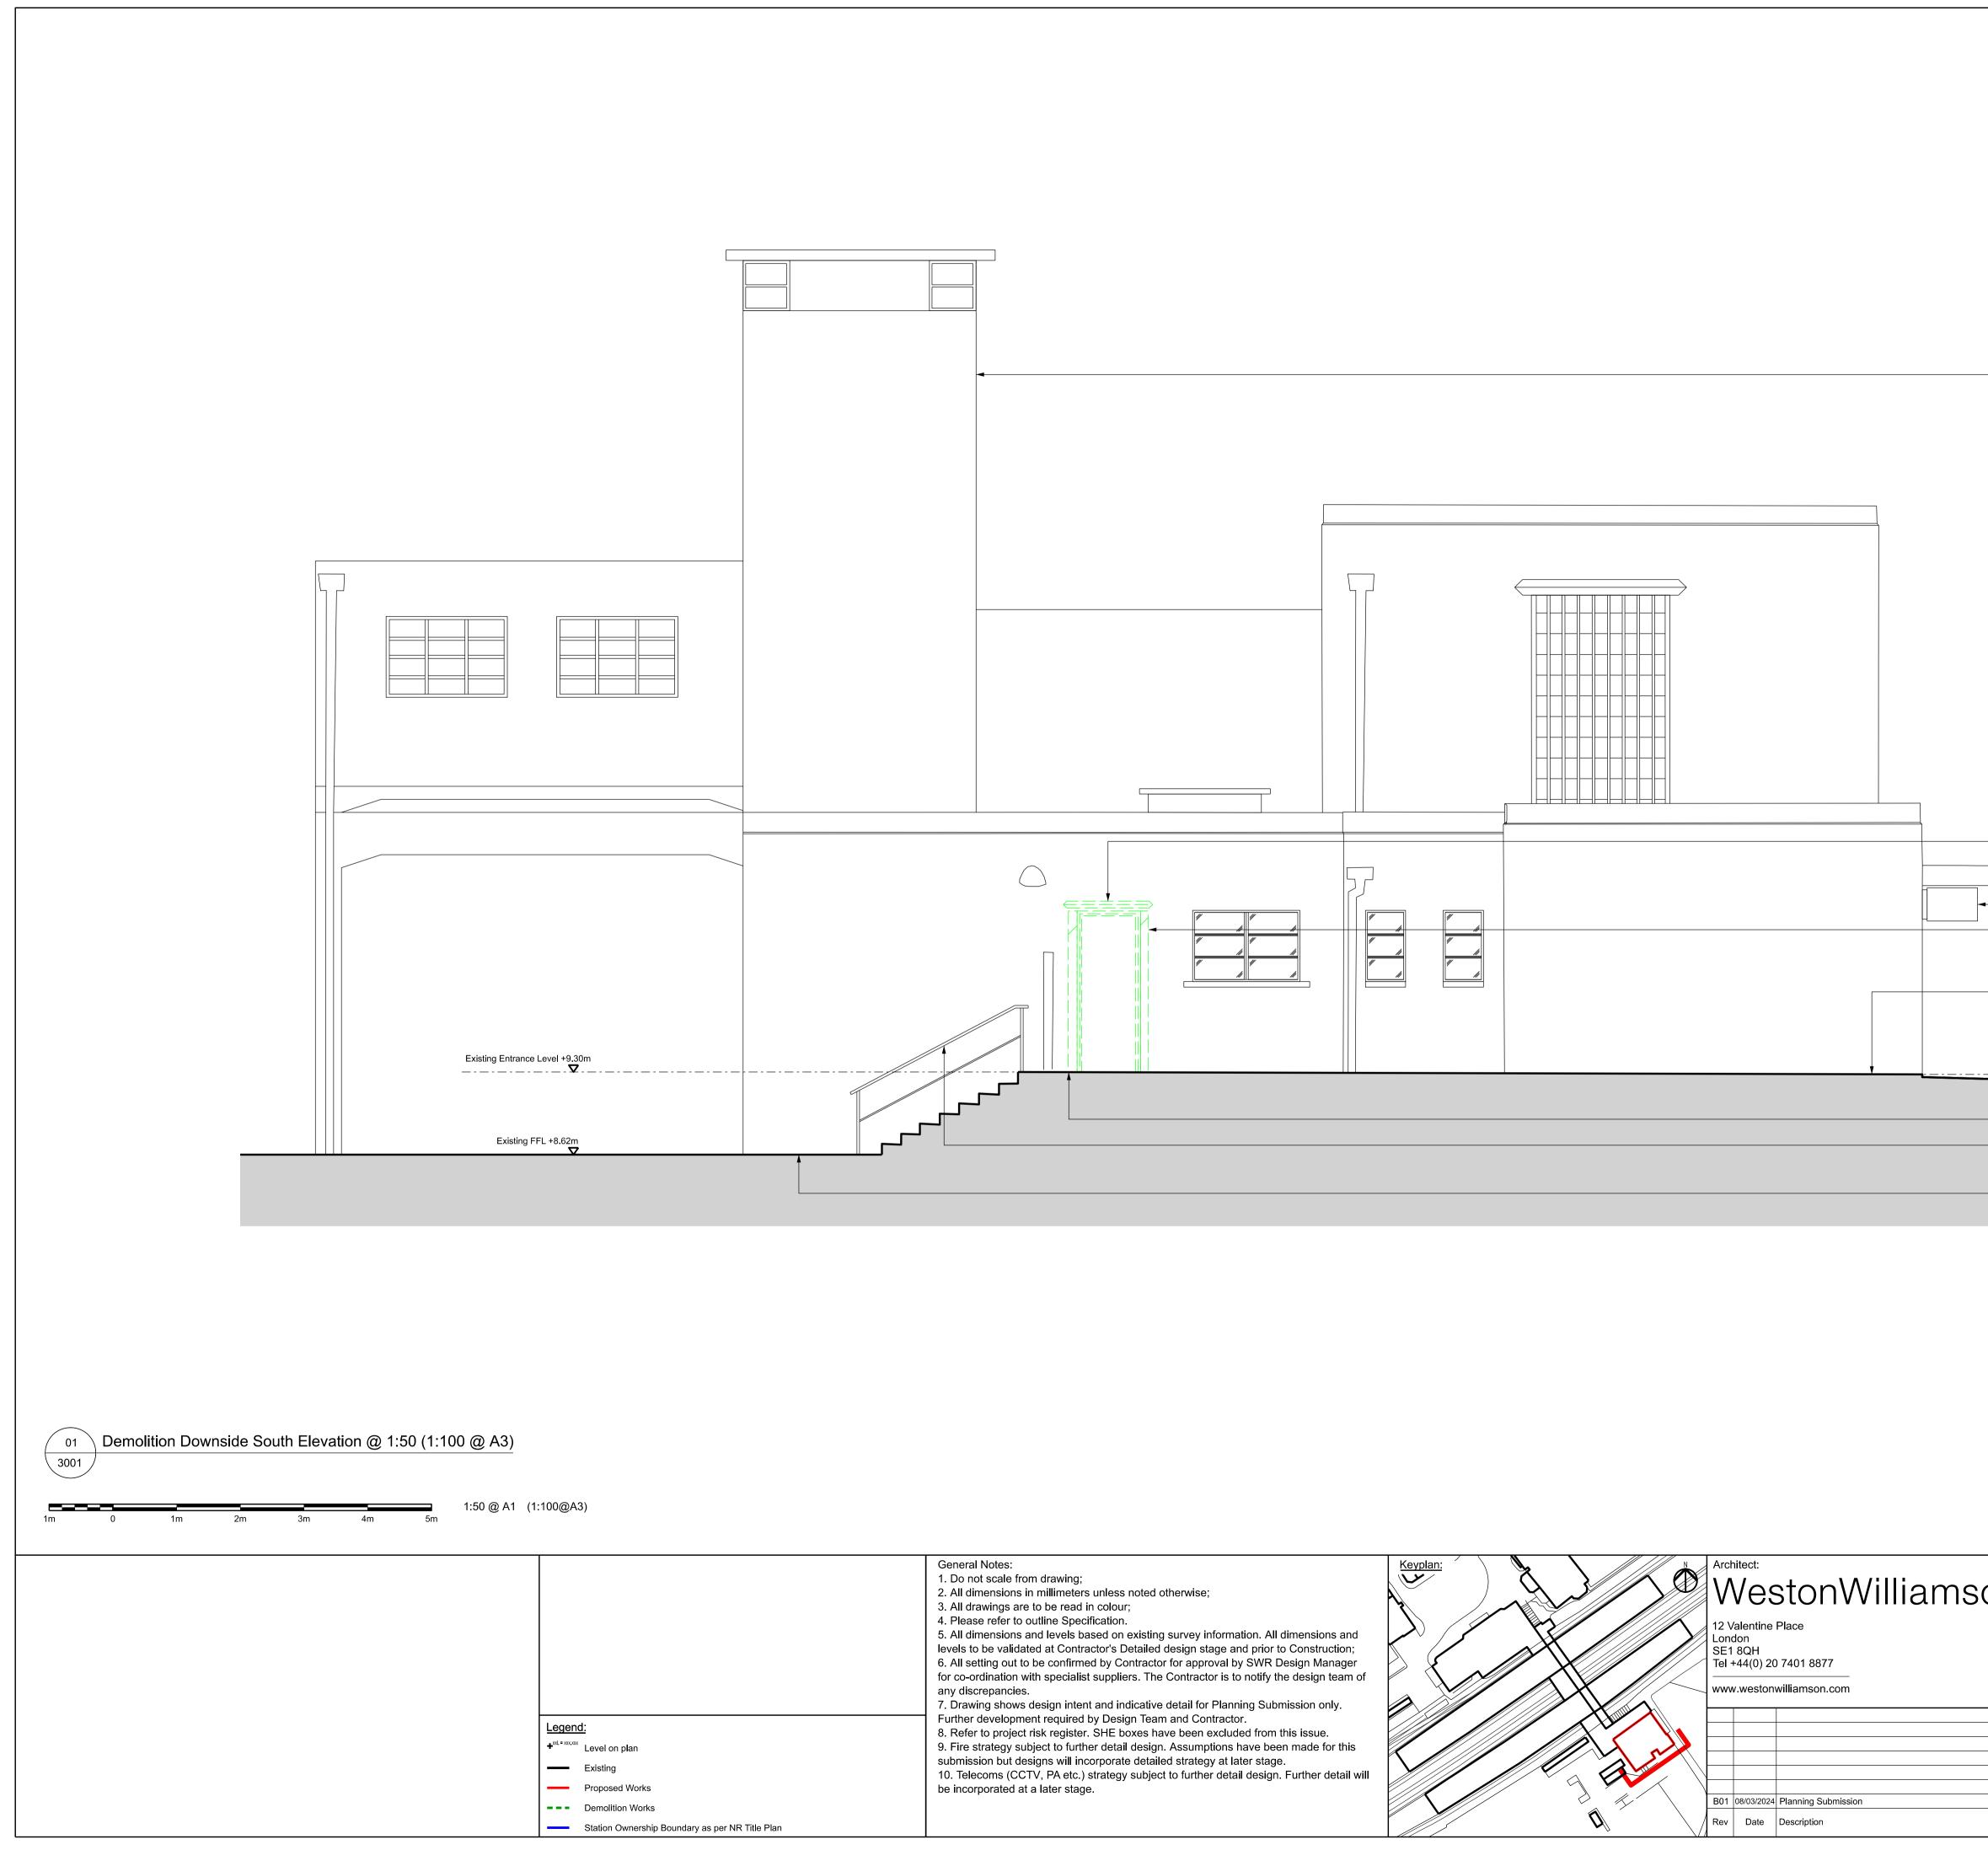
Existing lift shaft

Removal of existing canopy above door Existing overhead canopy Existing Station Cars sign DEM-10 Removal of the existing unoriginal door Existing pedestrian route to BOH areas Existing FFL +9.88m __ - **又** - __ Existing Tactile paving to be removed Existing contrast handrail to steps Existing Tactile paving
