Retained Heritage Features

Client	Scale
Andrew Street Construction Limited	1:250 @ A1

# Andrew Street, Compstall Retained Heritage Features

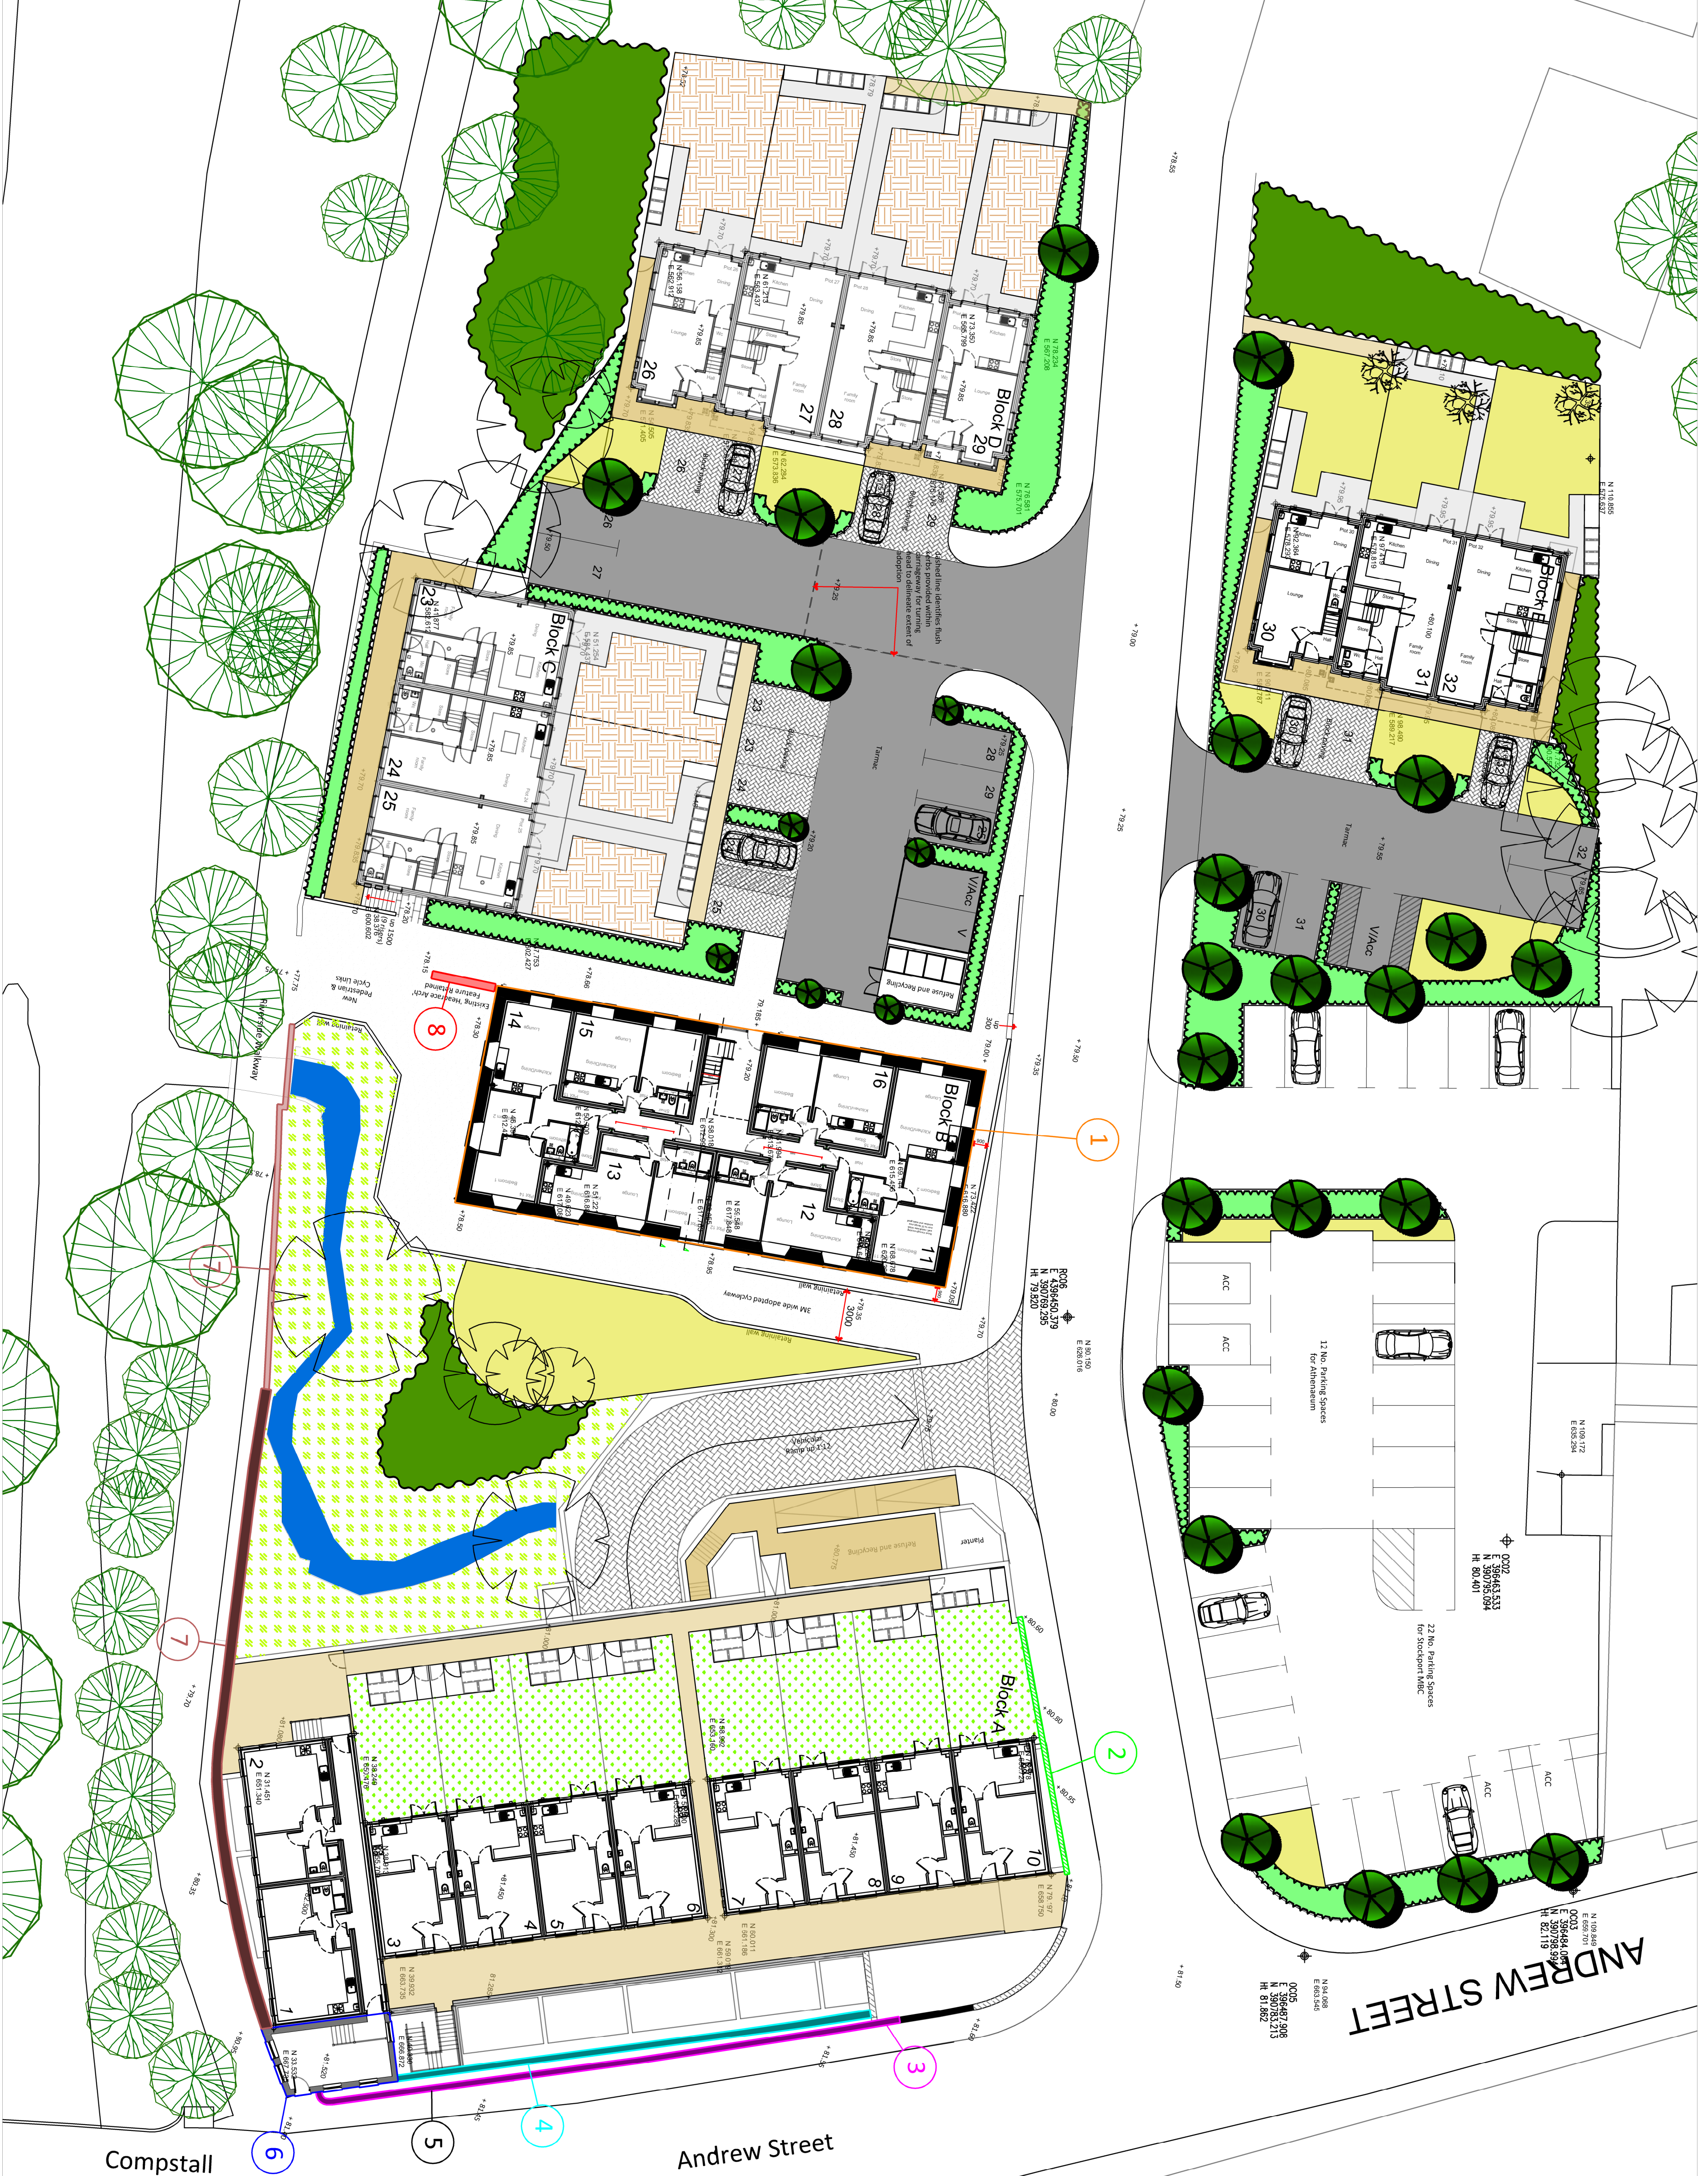
Retained Heritage Features

- 1. Industrial mill building.
- 2. Archway to west of access road to be rebuilt to original form.
- 3. Existing stone boundary wall to be retained.
- 4. Rear wall from previous mill building to be rebuilt to previous state.

- 5. Existing railings to be retained in part due to visibility splay at access.

- 6. Stone Lodge building to be retained and refurbished with access to Block A.

- 7. Riverside walkway boundary wall to be retained.
- 8. Head race arch to be retained and refurbished.
