Design and Access Statement

The Proposed Redevelopment

**Rainford Reservoir
Higher Lane
Rainford
St. Helens,
WA11 8NF**

Date: 2nd January 2024

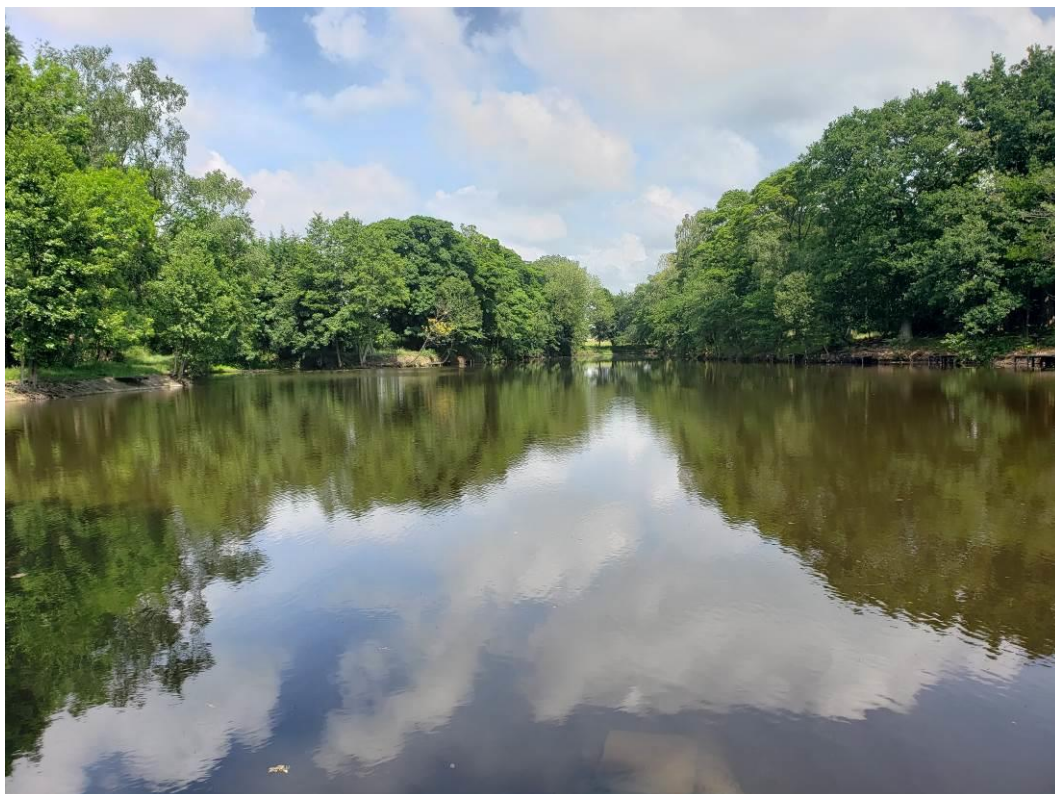
Photograph 7 – Existing Reservoir

- 2.2.1. The existing reservoir is to be reduced in capacity taking it to below the 10,000m³ threshold, at which point it will no longer be legally classified as a reservoir. In doing so the existing dam wall will no longer be retaining the water and as such will cease to perform any structural function.
- 2.2.2. The reduction in volume will be implemented from the south end of the reservoir pushing the bank 38m towards the north.
- 2.2.3. The resulting backfilled section will then be dressed and seeded to form a semi- wetland meadow area.

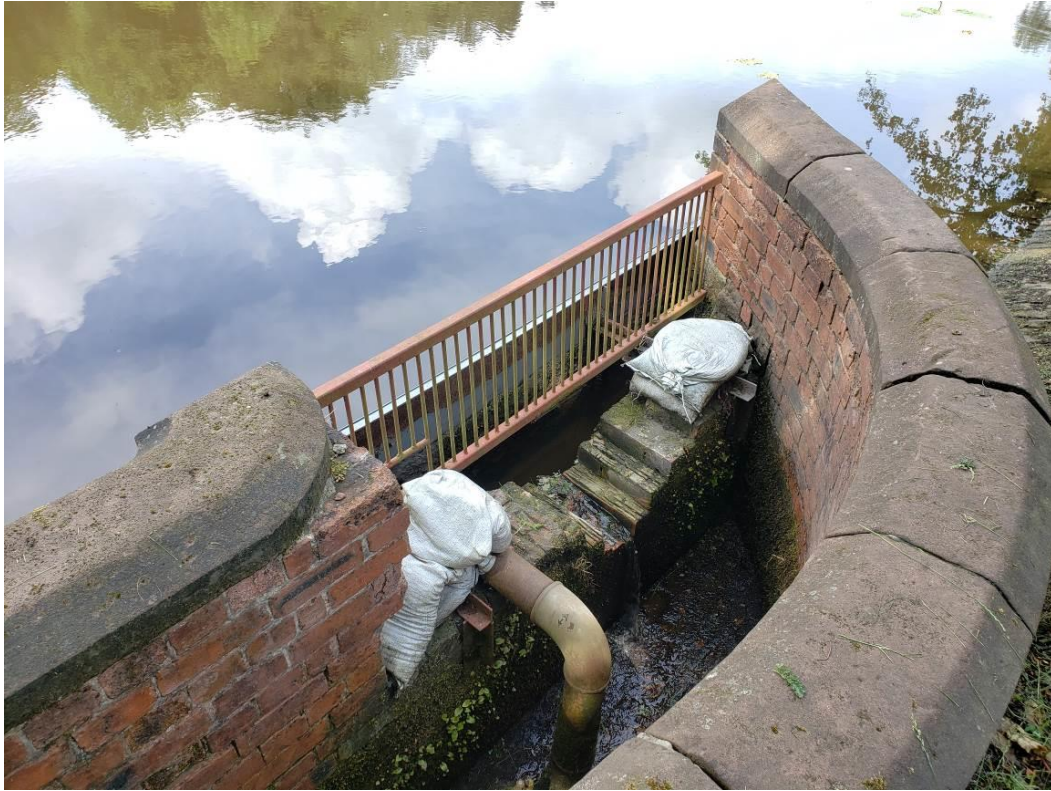
Photograph 8– Existing dam overflow weir

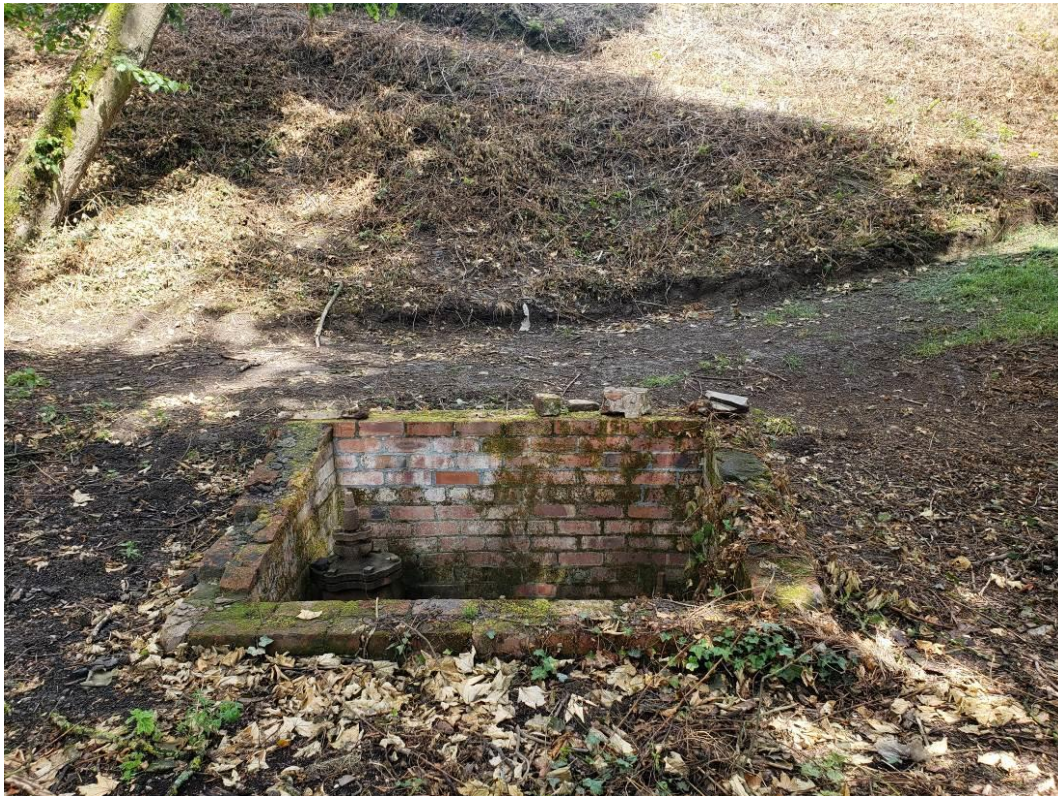
Photograph 9 – Redundant infrastructure confirming brownfield use

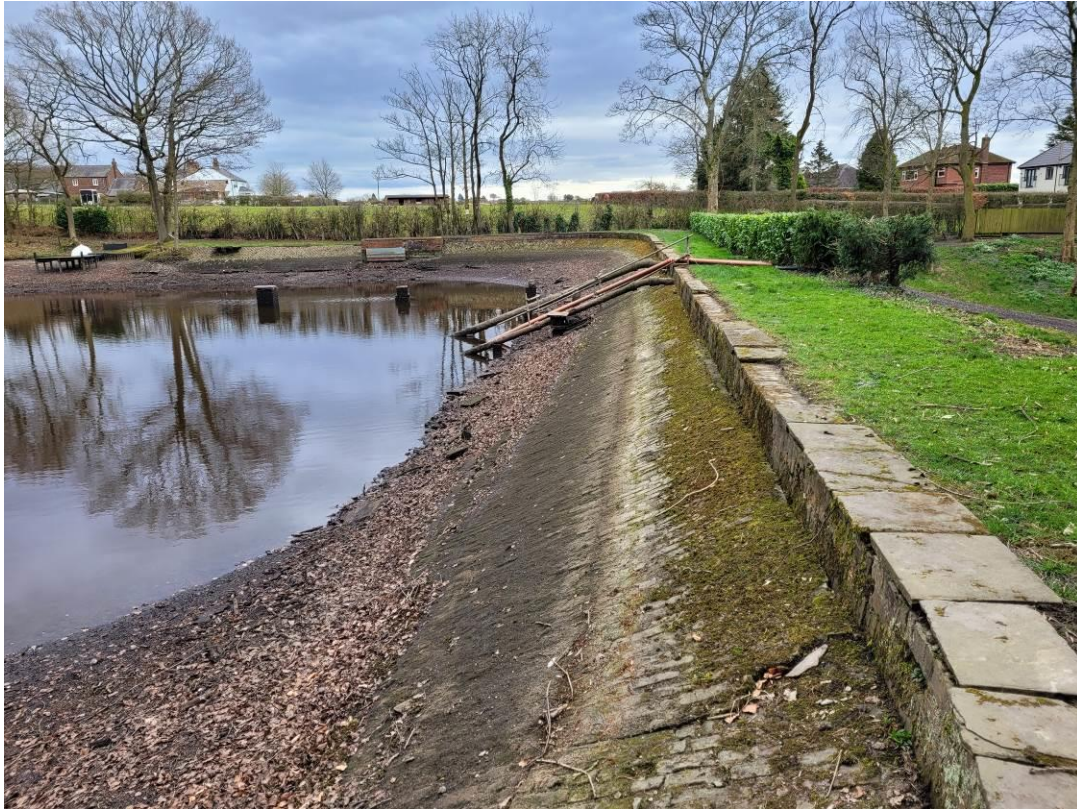
Photograph 10 – Extent of brick-built dam structure (water level temporarily reduced during routine maintenance)

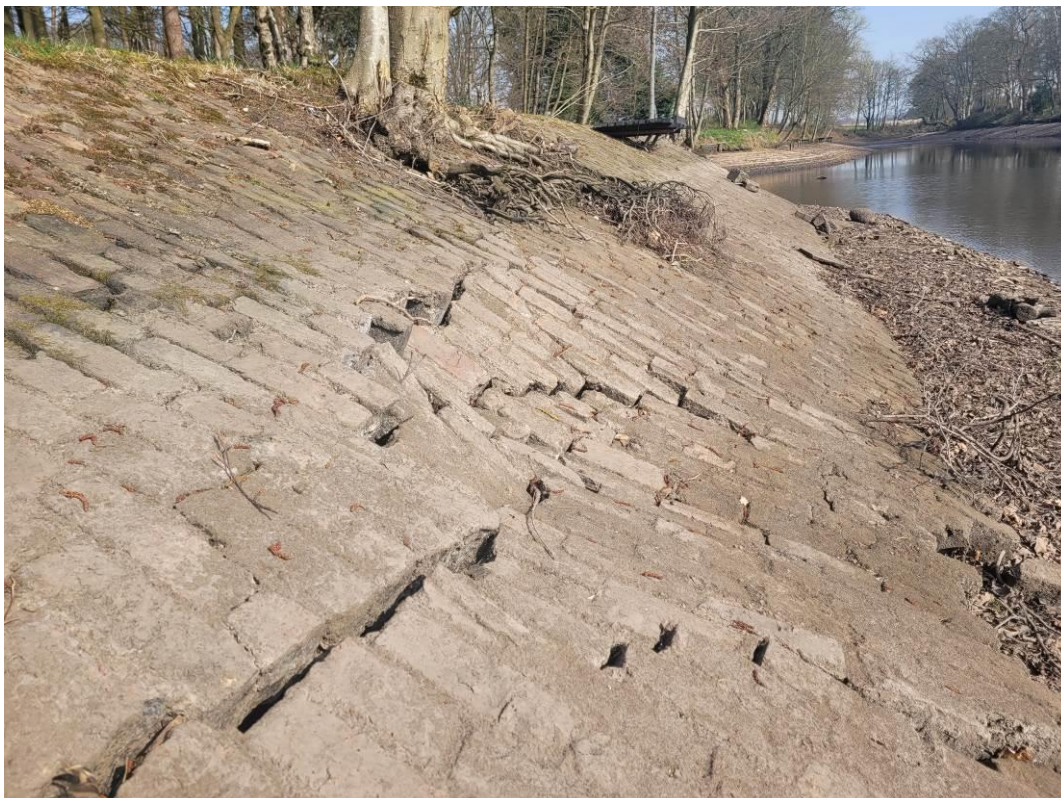
Photograph 11 – Cracking to dam structure caused as a result of extensive root damage and lack of maintenance.

- 1.3.1. The site currently forms both a car park and a private commercial fishing lake formally used as a reservoir servicing the glass industry as a means of providing the water for a local sand washing plant formally situated on what is now the Sand Wash Industrial Estate in Rainford to the south of the site. Prior to this, historic maps indicate the site was part of a clay brickworks.
- 1.3.2. The applicant commissioned a structural report on the reservoir and south dam wall on 11th August 2017. This report highlights both the need for immediate and future repairs to and around the dam itself.
- 1.3.3. The primary purpose of this development is to implement measures to mitigate against the risks posed by the presently dilapidated dam structure and the damage caused by tree roots to the associated culverted watercourse.

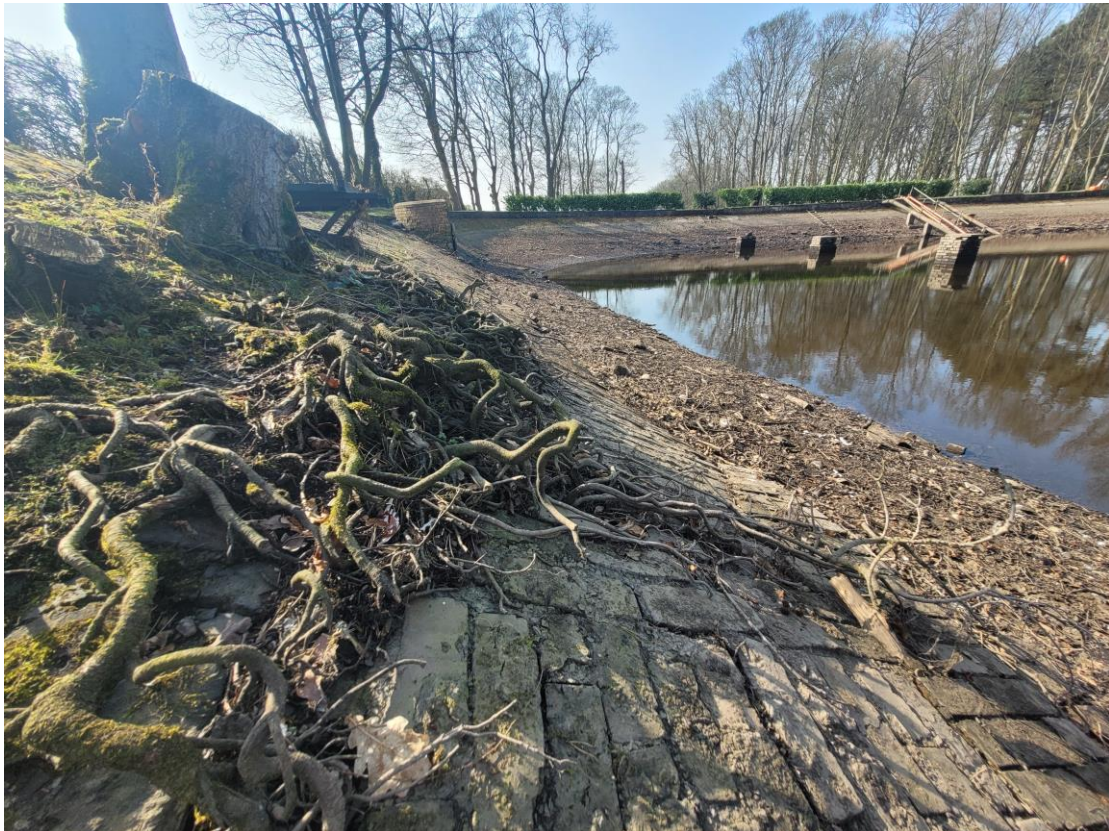
Photograph 12 – Extensive root over-growth and damage along dam structure
