Arboricultural impact appraisal and method statement

Grandpont House, Abingdon Road, Oxford, Oxfordshire OX1 4LD

15th March 2024
17115-AIA4-CA

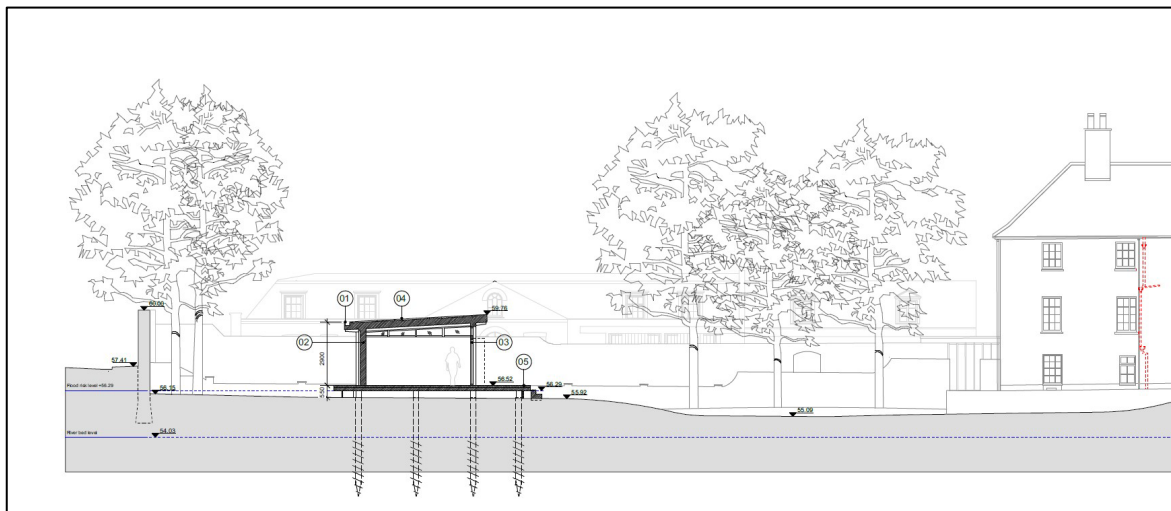
Extract from plan GH(20)A16-Proposed Boat House Section

The above cross section demonstrates that the existing ground levels within the RPAs of trees T9, T10 and T11 will not be altered, and that the new floor will be above the existing ground level. Please refer to the all the submitted plans for full details.

These trees may be affected by the installation of the new boathouse. It is proposed to build the new structure with a suspended floor support by screw piles, which means that it can be built without any significant excavation into the soil and RPA beneath the floor. This is shown by the yellow highlighting on the plan. This construction solution is within the advice set out in BS 5837 (7.2 and 7.5) and would be appropriate in this situation. It is unlikely that this encroachment will have any significant adverse impact on the trees because it is only a very small proportion of its RPA compared to the area that will remain undisturbed. All of the area around the new structure will be covered with ground protection during the construction phase to ensure no damage occurs to the RPA.

In summary, if the guidance set out in SGN 3 *Ground protection*, SGN 7 *Excavating in RPAs*, and SGN 10 *Installing structures in RPAs* is followed, we believe that the proposed works can be implemented without any long-term detrimental impact on the health of these trees, and therefore local character.
