Arboricultural Consultancy for Prestige

Insured	Mrs Yvonne Olive Walters	Address	Woodstock, COTTESMORE ROAD, ASHWELL, Oakham, RUTLAND, LE15 7LJ		
Client	Subsidence Management Services	Contact	Scott Rue	Claim No.	IFS-PRE-SUB-22-0104778
ES Ref	SA-253349	Consultant	Kirk Thompson	Contact No.	0330 380 1036
Report Date	22/06/2023

Scope of Report: To survey the property and determine significant vegetation contributing to subsidence damage, make recommendation for remedial action and assess initial mitigation and recovery prospects. The survey does not make an assessment for decay or hazard evaluation.

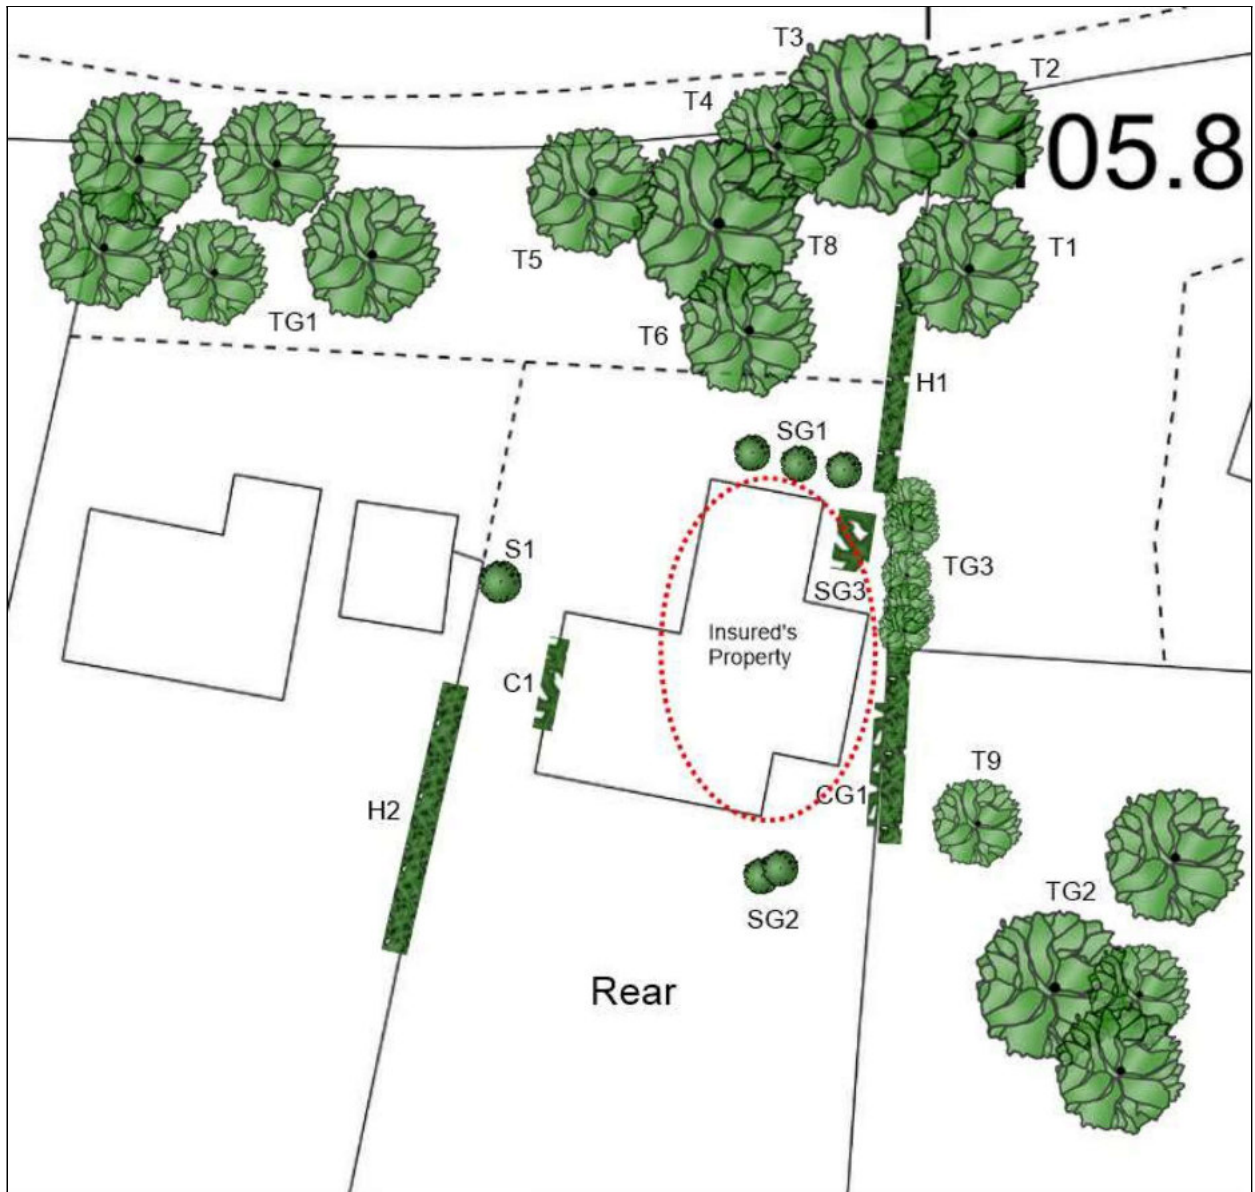
7. Site Plan

Please note that this plan is not to scale. OS Licence No. 100043218

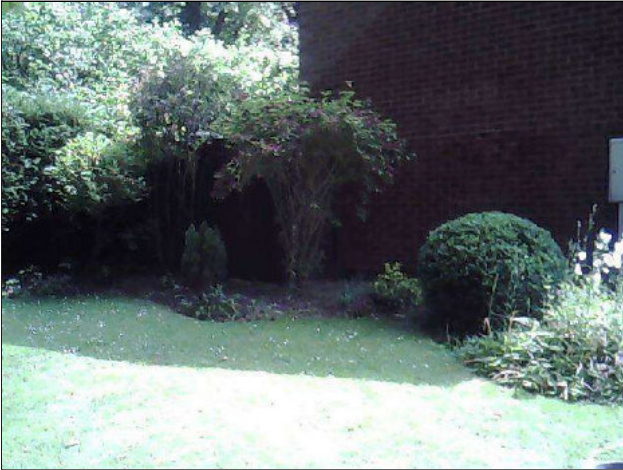
SG1 - Mixed species shrubs

SG1	Mixed species shrubs	1	2	1.4	C - Insured	Action to avoid future risk	Maintain at broadly current dimensions by way of regular pruning. Box, Wiegela and Rose
SG2	Mixed species shrubs	1	1.7	3	C - Insured	Action to avoid future risk	Maintain at broadly current dimensions by way of regular pruning. Philadelphia and Pyracantha

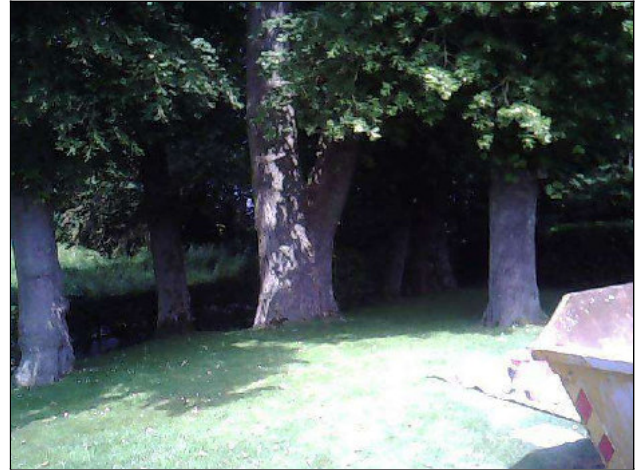
With due regards to species profile, size and proximity, T3 & T8 (Poplar) are considered the dominant features proximate to the focal area(s) of movement and accordingly, where vegetation is confirmed as being causal, we have identified them as the primary cause of the current subsidence damage.

The size and proximity of the above vegetation is consistent with the advised location of damage and it is our opinion, on balance of probability, that roots from the above vegetation will be in proximity to the footings of the insured property.

T8 - Poplar

Consequently, we have advocated the complete removal of T3 & T8 (Poplar) as it will offer the most certain arboricultural solution likely to restore long-term stability.

Tree No.	Species	Age Cat	Approx. Height (m)	Distance to Building (m) *	Ownership	Action	Requirement
T3	Poplar	3	28	16.8	C - Insured	Remove	Remove close to ground level; do not treat stump due to translocation risk. Where such a risk exists, we advise that any emergent regrowth is removed annually.
T8	Poplar	3	28	11	C - Insured	Remove	Remove close to ground level; do not treat stump due to translocation risk. Where such a risk exists, we advise that any emergent regrowth is removed annually.

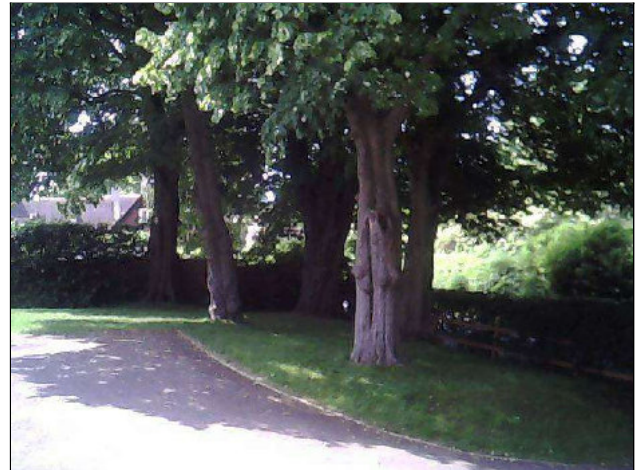
TG1 - Lime

TG1	Lime	3	22	18.5	A - Third Party	Action to avoid future risk	Maintain at broadly current dimensions by way of regular pruning.

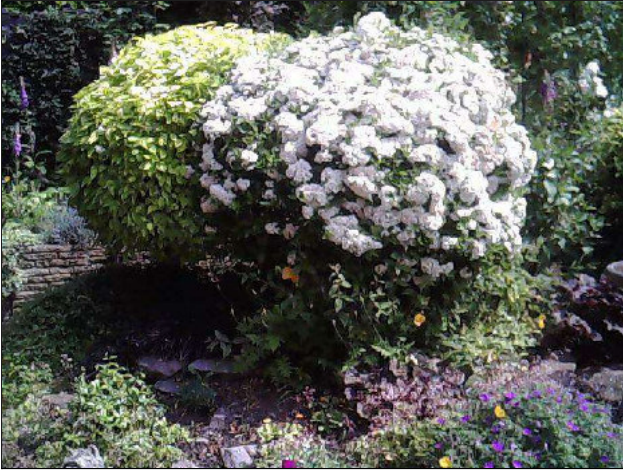
SG2 - Mixed species shrubs

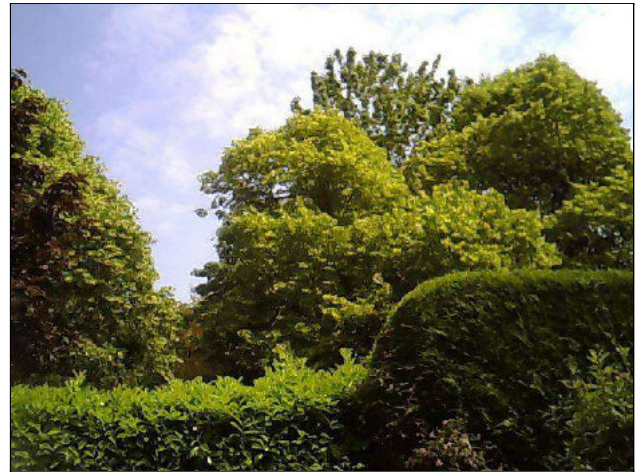
TG2 - Mixed species group

TG2	Mixed species group	1	16	14	A - Third Party	Action to avoid future risk	Maintain those trees within recognised influencing distance of the property (based on species, size and proximity) at, or below current dimensions by way of regular pruning so as to effectively mitigate subsidence risk. Any pruning undertaken should be in accordance with BRE IP7/06 and repeated on a 3-year (max) basis to be deemed as effective. Lime and Maple
TG3	Apple	1	4	2	A - Third Party	Action to avoid future risk	Remove section of group to achieve a minimum clearance of 6m to the insured property; do not treat stumps due to translocation risk. Where such a risk exists, we advise that any emergent regrowth is removed annually. Maintain retained section thereafter at broadly current dimensions by way of regular pruning.
Age Cat: 1 = Younger than property; 2 = Similar age to the property; 3 = Significantly older than property

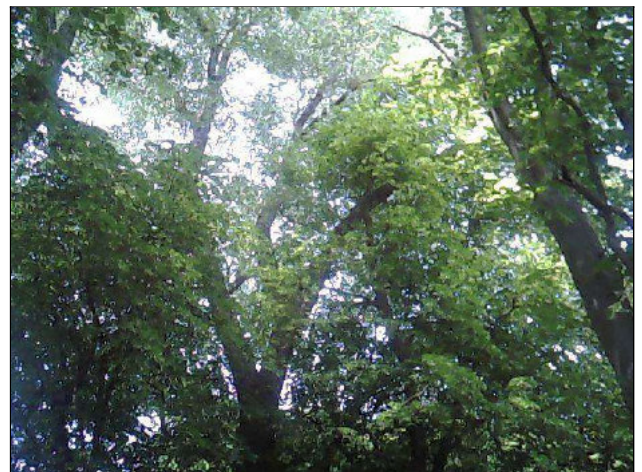
T3 - Poplar

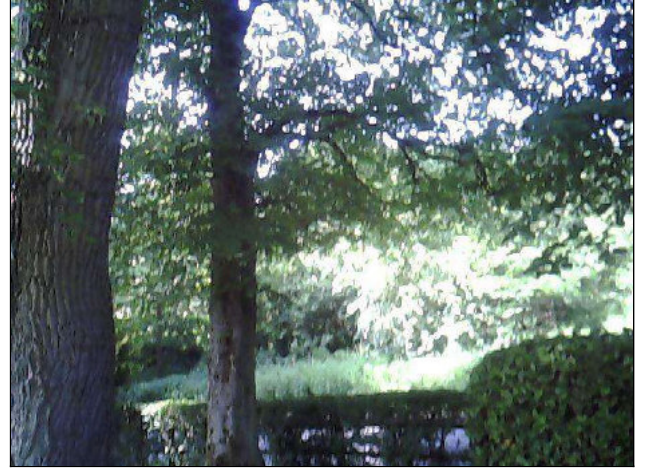
T5 - Lime

T5	Lime	3	21	14.5	C - Insured	Action to avoid future risk	Crown reduce overall canopy by 30% (minimum) to achieve a crown volume reduction in line with BRE IP7/06. Maintain at reduced dimensions by re-pruning back to points of previous reduction on a 3 year (max)cycle.
T6	Lime	3	21	11.5	C - Insured	Action to avoid future risk	Crown reduce overall canopy by 30% (minimum) to achieve a crown volume reduction in line with BRE IP7/06. Maintain at reduced dimensions by re-pruning back to points of previous reduction on a 3 year (max)cycle.
T7	Lime	3	19	11.5	C - Insured	Action to avoid future risk	Crown reduce overall canopy by 30% (minimum) to achieve a crown volume reduction in line with BRE IP7/06. Maintain at reduced dimensions by re-pruning back to points of previous reduction on a 3 year (max)cycle.
T9	Maple (Norway)	1	10	8	A - Third Party	Action to avoid future risk	Do not allow to exceed current dimensions by way of regular pruning.
