Arboricultural Survey to BS5837:2012

**18 Motspur Park,
New Malden,
Kingston Upon Thames,
KT3 6PL**

30 January 2024

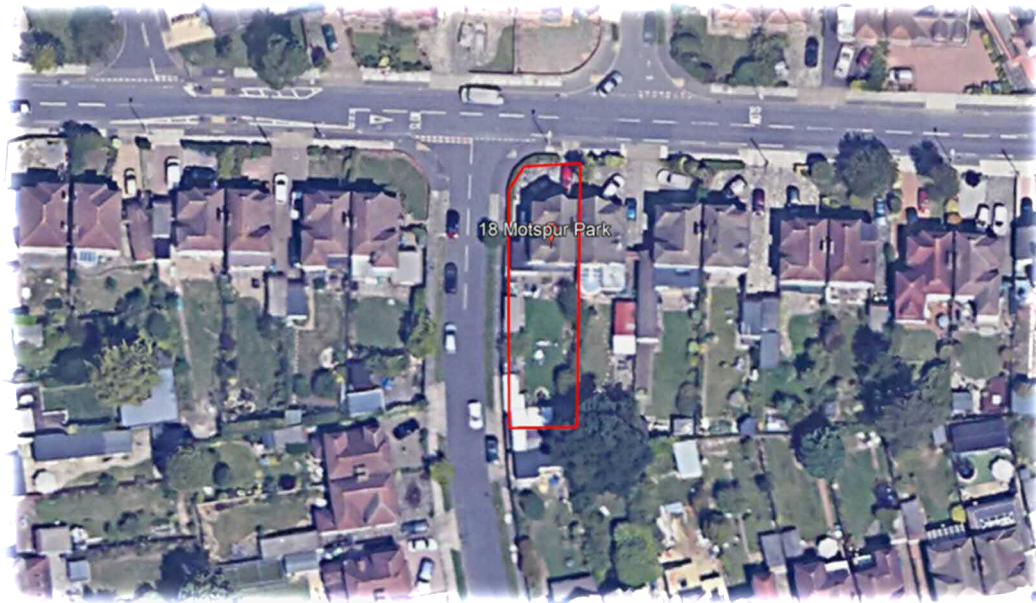
Figure 2: Aerial Image of site with approximate red line boundary (Google Earth)

Site is set in a residential area, sites aspect is general north to south, the rear garden being to the south of the house.

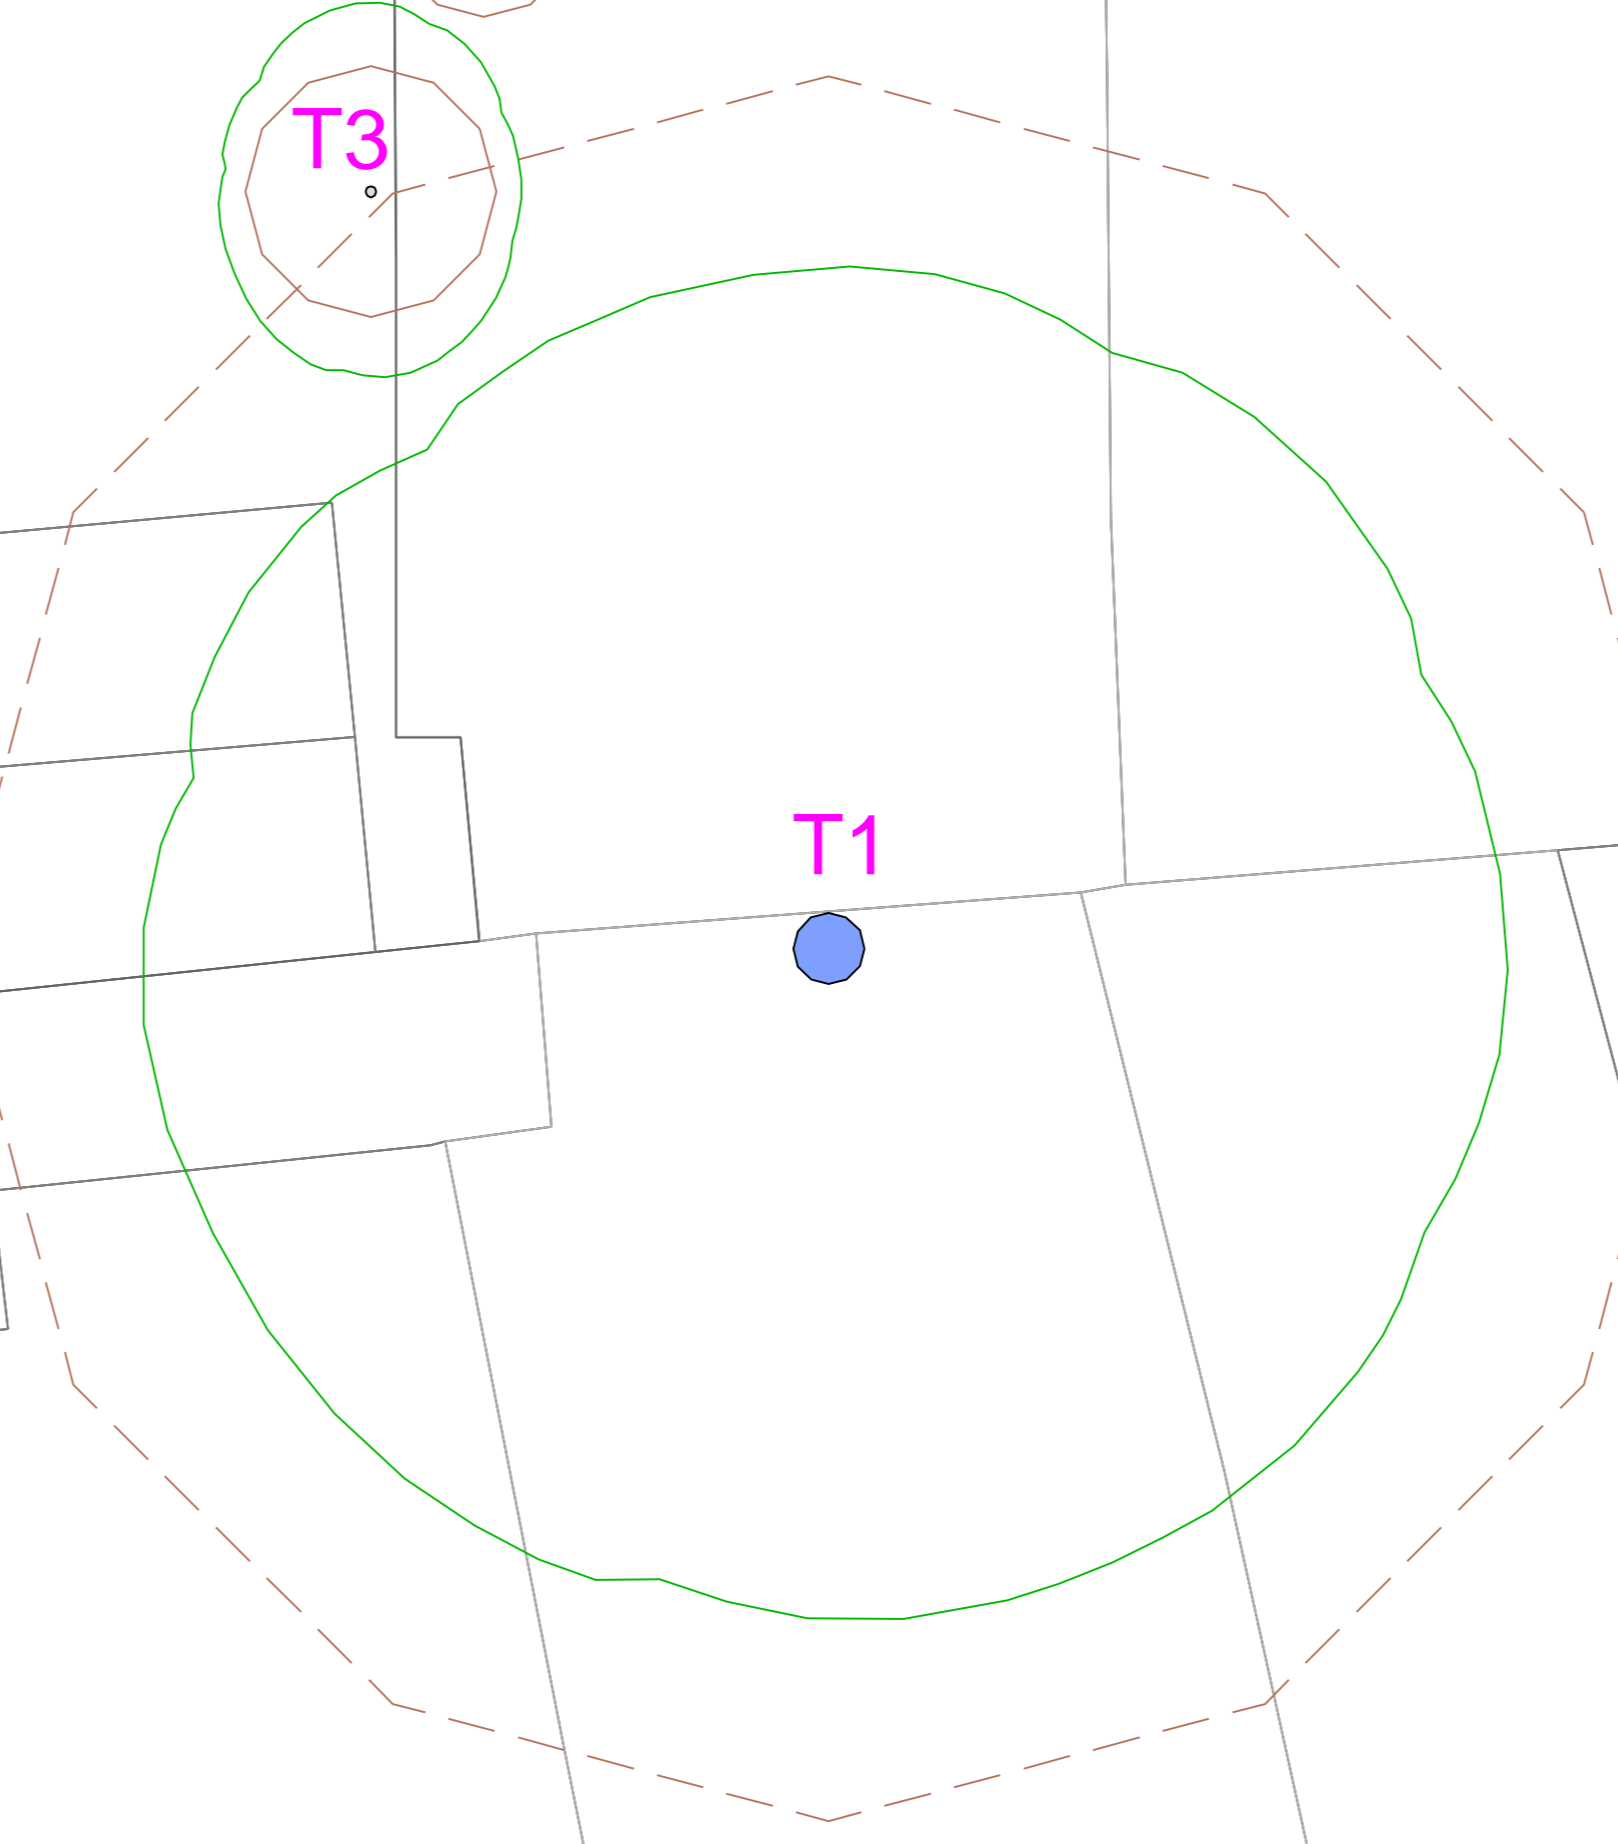
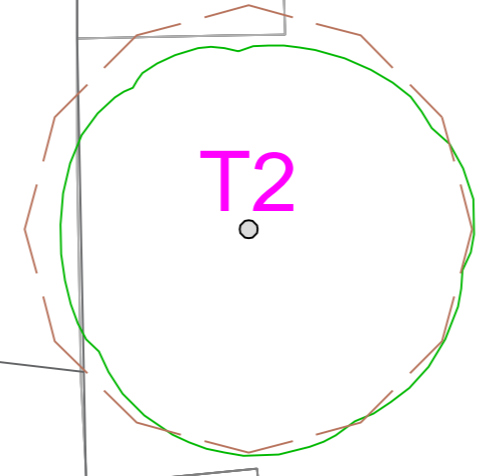
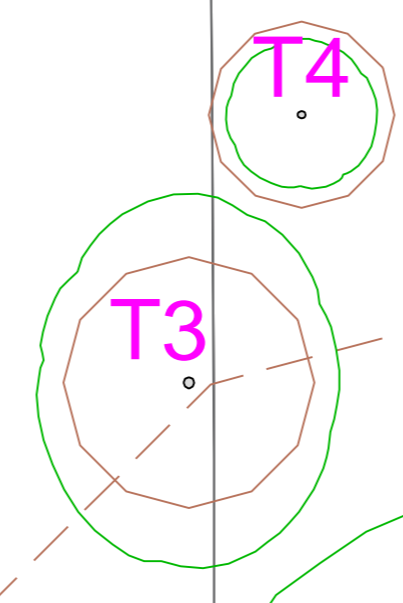
Root Protection Area
 In order to avoid damage to the roots or rooting environment of retained trees, the Root Protection Area (RPA) should be plotted around each of the category 'A, B and 'C' trees. This is a minimum area in m² which should be left undisturbed around each retained tree.
 The RPA is calculated using the British Standard BS 5837:2012 'Trees in relation to design, demolition and construction - Recommendations'.
 The calculated RPA is capped to 70m², which is the equivalent to a circle with a radius of 15m. Where there appears to be restrictions to root growth the root protection area is reshaped to more accurately reflect the likely distribution of the roots.

Tree Survey Report
 Please refer to Arbtch Consulting Ltd Tree Survey Report and Tree Schedule for full details on all surveyed trees, hedgerows and major shrub groups.
 All trees were surveyed and categorised in accordance with the guidance as set out in the British Standard BS5837:2012 Tree in relation to design, demolition and construction.
 Recommendations:
 We make the following recommendation to ensure that no conditions relating to arboriculture are attached to any planning consent secured - obtain and arboricultural report to include:
 a) An arboricultural impact assessment (AIA);
 b) An arboricultural method statement (AMS); and
 c) A tree protection plan (TPP)

At this stage we have not made an assessment on the proposed scheme, therefore, we make the following recommendation to ensure that there are no irrevocable issues to the proposed retained trees and so that no conditions relating to arboriculture are attached to any planning consent secured; obtain an arboricultural report to include:

- a) An arboricultural impact assessment (AIA).
- b) An arboricultural method statement (AMS).
- c) A tree protection plan drawing (TPP).
