Planning Support Document

Proposed Works

To accompany the Listed Building Application
for the and upgrading/improvement works to
Brookside House

Hurstbourne Tarrant
Hants
SP11 0AE

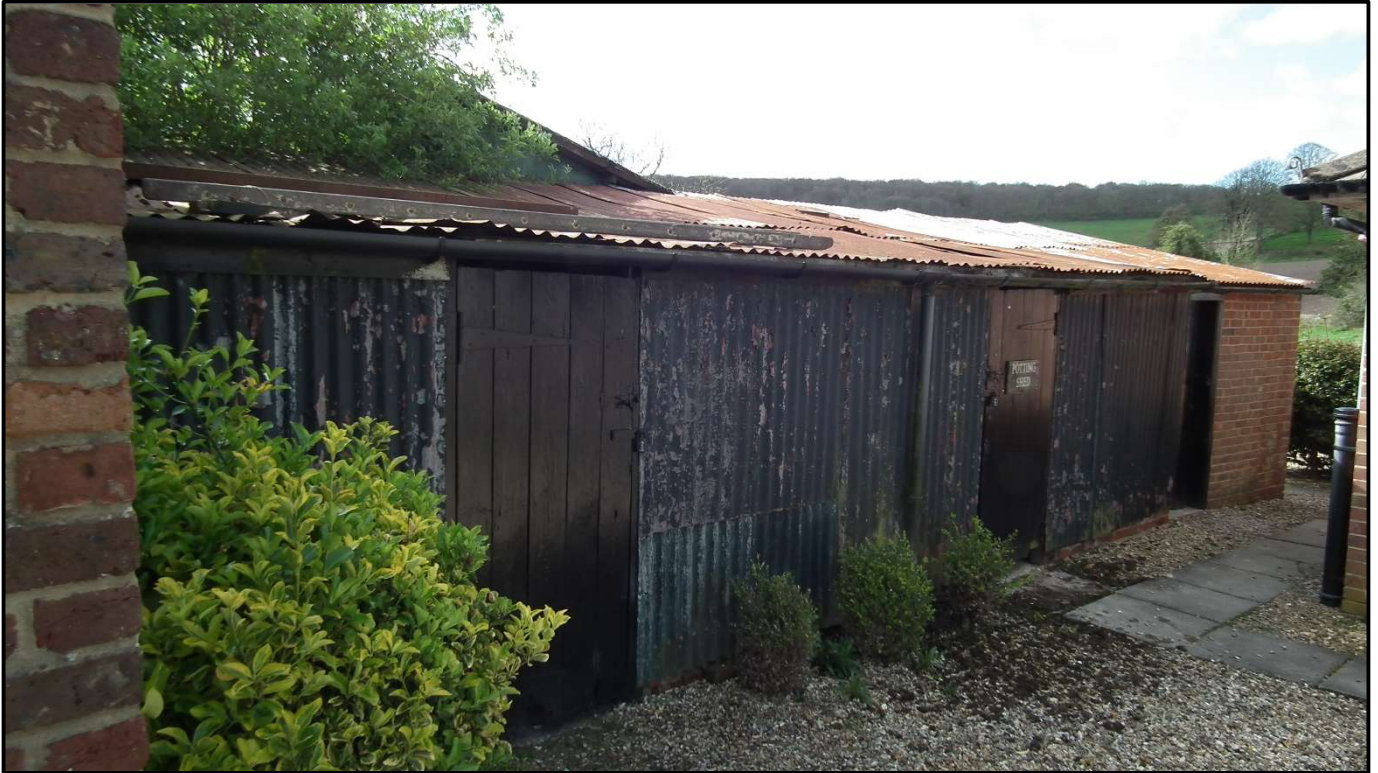
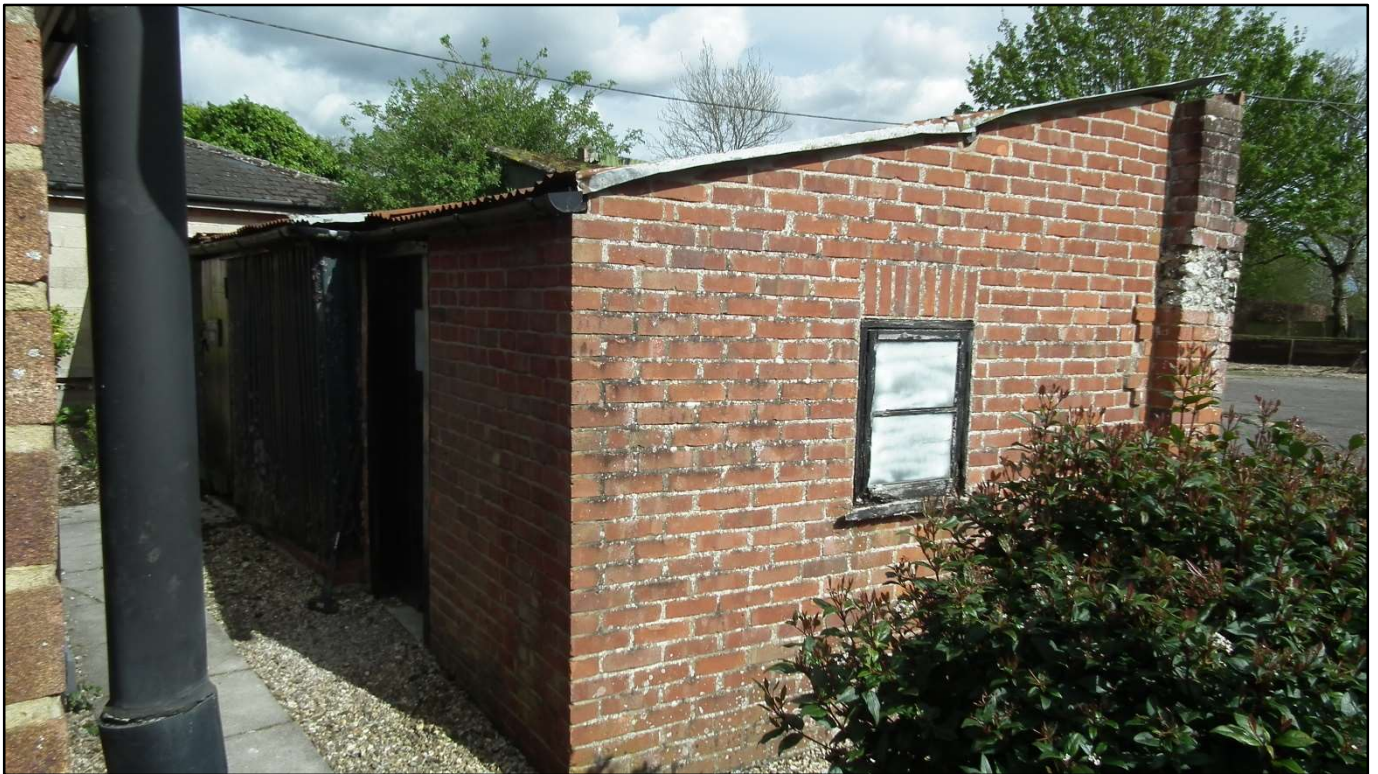
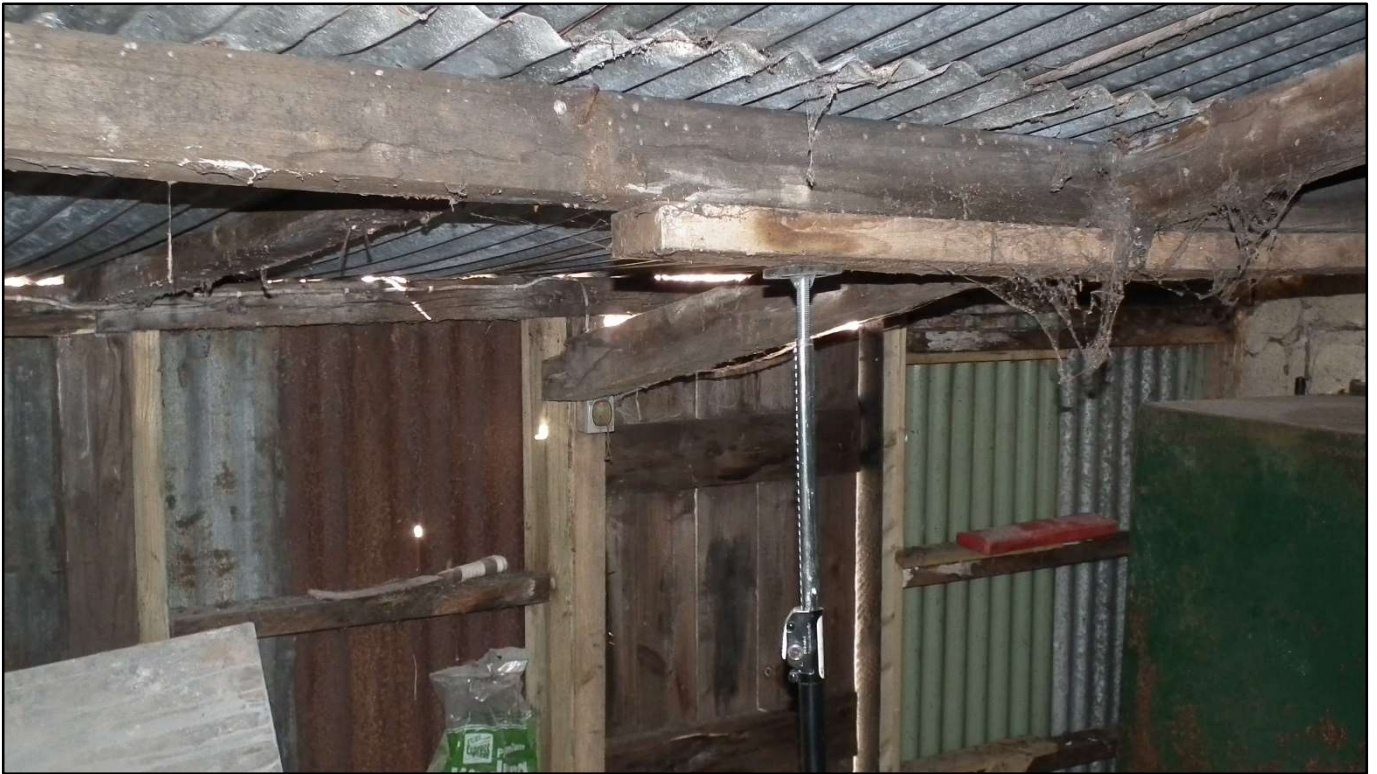
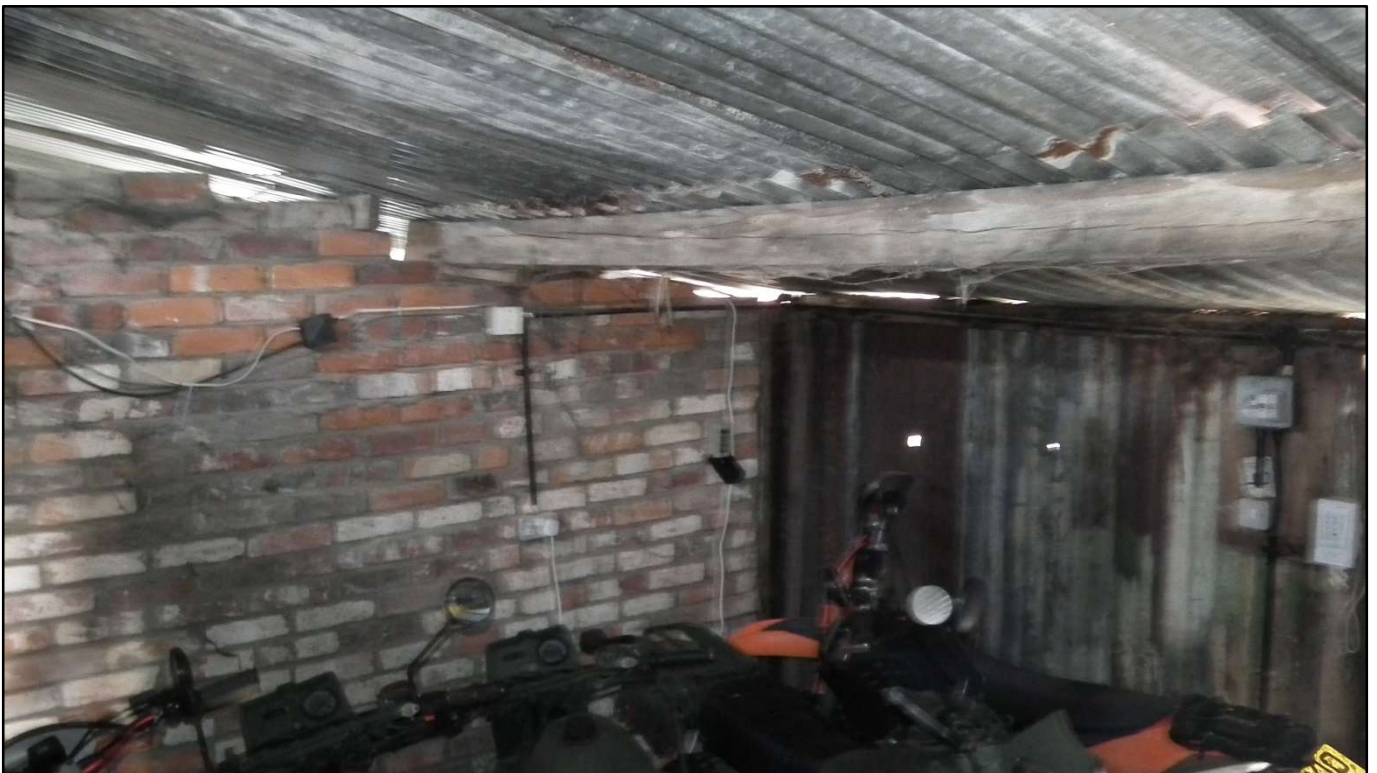
Appendix A

To the South Side of the property, to the South East side of the single storey element, there is currently an old timber framed structure that is roofed and clad with corrugated galvanised metal sheeting. It is back by a brick and flint wall, that forms the boundary. The roof of the structure is in a very bad structural state, and is currently being propped to prevent total collapse.

The structure itself will be removed, leaving the boundary wall at the rear in position. Pictures of this structure have been included within Appendix A.
