## BS5837:2012 TREE SURVEY AND ARBORICULTURAL IMPACT ASSESSMENT: 1 Surley Walk, Windsor, Berkshire

Dated: 11th March 2024

Our reference: GHA/DS/222160:24

Location: 1 Surley Walk, Windsor, Berkshire

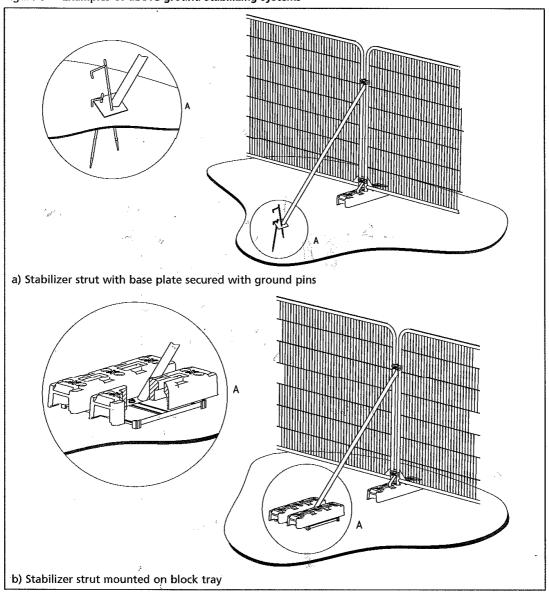
Figure 3 Examples of above-ground stabilizing systems

## <u>Appendix C</u> TREE FENCING DETAIL

BRITISH STANDARD BS 5837:2012

The position of the fence MUST be marked out with biodegradable marker paint on site and agreed with appropriate representatives from the LPA and contractor. The fencing MUST be erected prior to any works in the vicinity of the trees and removed only when all development activity is complete. The protective fencing MUST be as that shown in BS 5837 (see Appendix C). The herras panels MUST be joined together using a minimum of two anti-tamper couplers which MUST be installed so they can only be removed from the inside of the fence. The panels

MUST supported by stabilizer struts, which MUST be installed on the inside and secured to the ground using pins or appropriate weights.
