## SOUTH WEST BARN

Alexandrina Blount Welful Lake House, Northleach, Gloucestershire, GL54 3PR South West Barn\_Proposed Plans and Elevations

100-102 Rev B April 2024

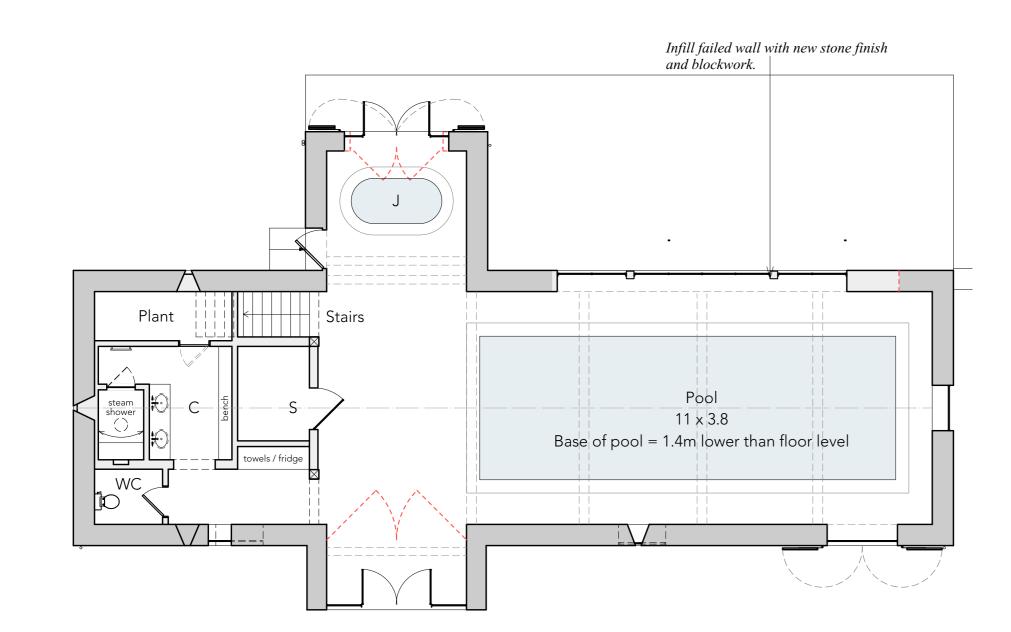
GROUND FLOOR PLAN

New slender metal profile window in slightly enlarged opening.
