CLIENT:	AESC UK
PROJECT:	AESC Plant Three
SUBJECT:	Appendix 12.18 River Morphological Report
JOB NO.:	NT15821
DATE:	15 th April 2024
PREPARED BY:	Ryan Evans – Senior Ecologist and Tosha Allen – Technical Director (Ecology)
REVIEWED AND APPROVED BY:	Tosha Allen – Technical Director (Ecology)

Appendix 2 – NT15821/ Figure 12.6 Rev A MoRPh Survey Results

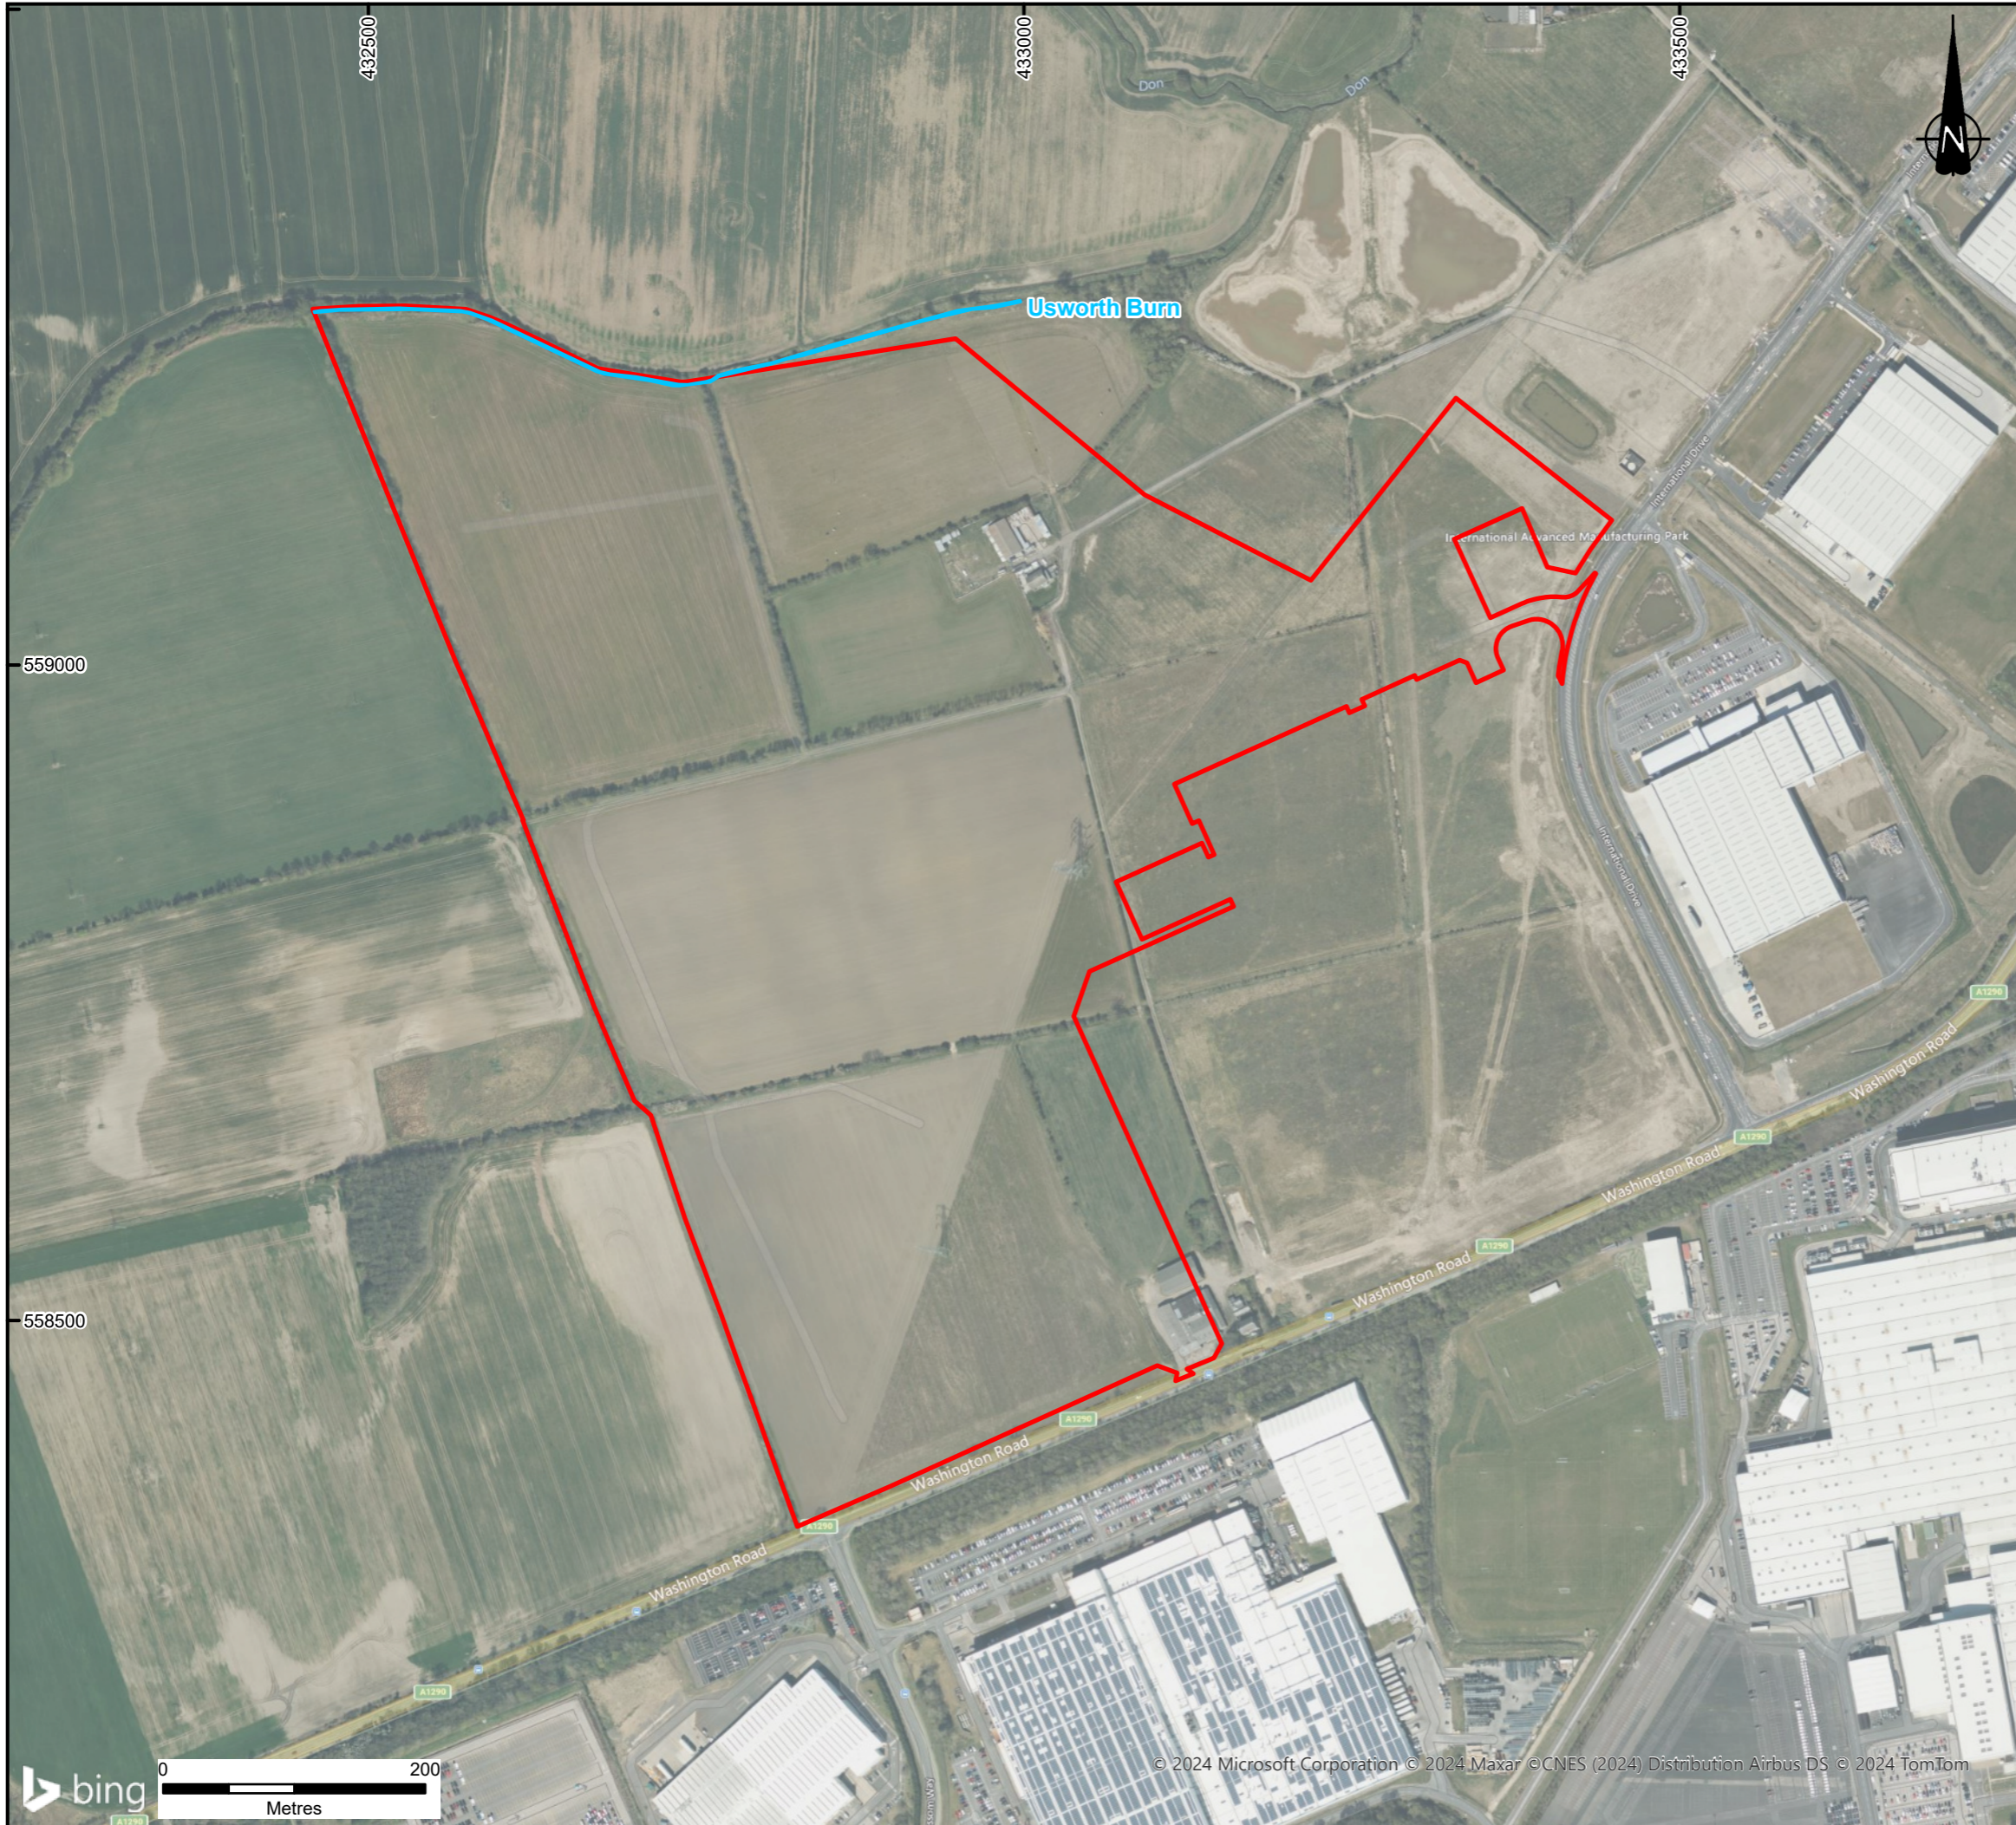
NT15821/ Figure 12.6 Rev A MoRPh Survey Results

- 4.1.1 The baseline condition of all four sub-reaches of the watercourse is ‘Moderate’. The river type was assessed as cobble/gravel straight sinuous.
- 4.1.2 Should the proposed development impact on the watercourses or land within 10m of the watercourses, additional assessments will be required to determine the condition scores post development. Should this be required, this technical note will be updated.

- Site Boundary
- Moderate Condition
