TIPTON BARTON COTTAGE, HAYNE HILL, TSJ			
WORKSHOP/GARAGE EXISTING ELEVATIONS			
Issued For		PLANNING APPROVAL	
Date	02/2024	By	PRS
Scale	1:50	Drwg No	002

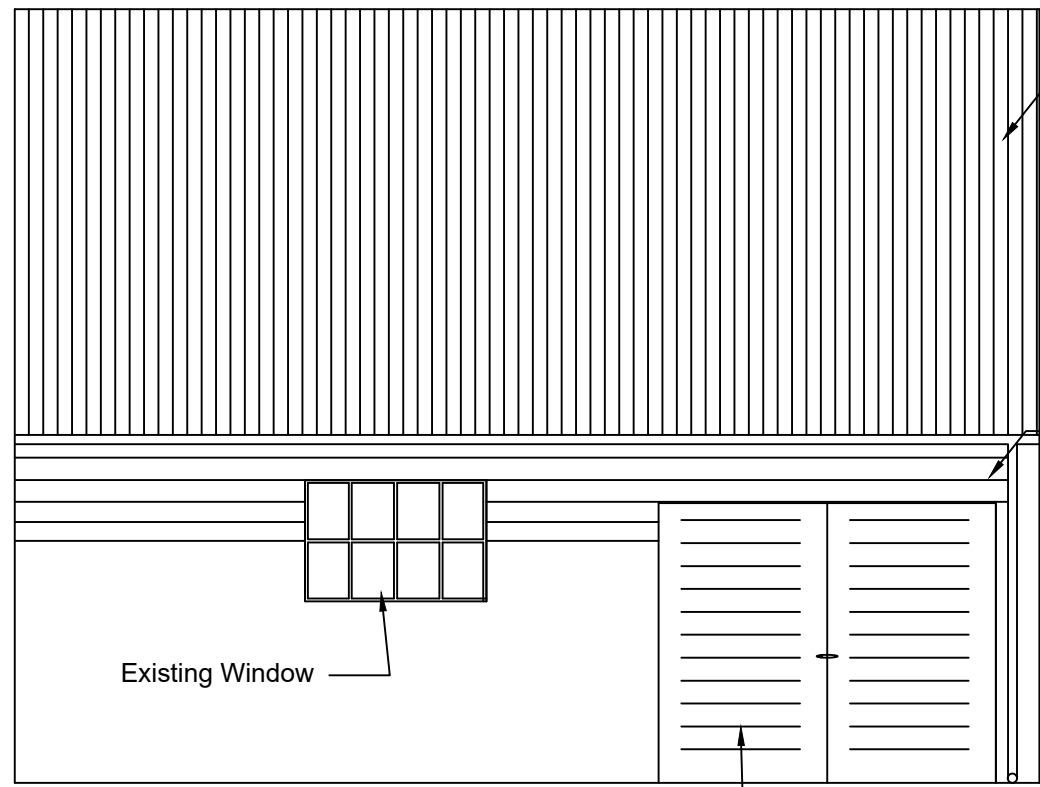
SOUTHERN ELEVATION

Existing Galvanized
Steel Corrugated
Roof Sheet

Existing Timber
Cladding

Existing Window

Existing Up and
Over Metal Garage
Door

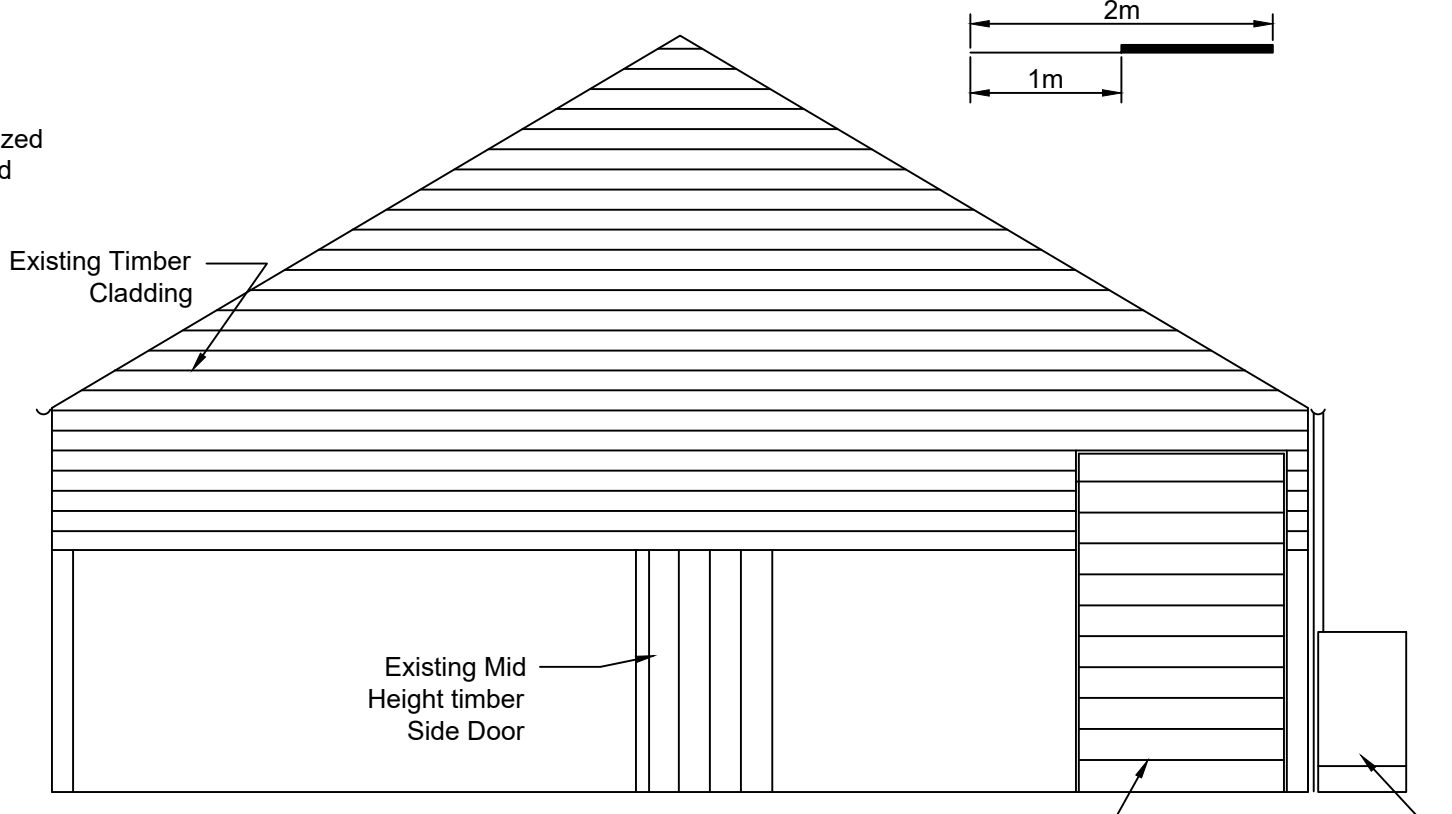
EASTERN ELEVATION

Existing Timber
Cladding

Existing Mid
Height timber
Side Door

Existing
Timber Infill

Existing Waterbutt
