Prebendal Landscape Material Samples

document supporting discharge of condition application relating to approved applications: 2023/0399/Lba & 2023/0398/Ful revision: -

16 April 2024

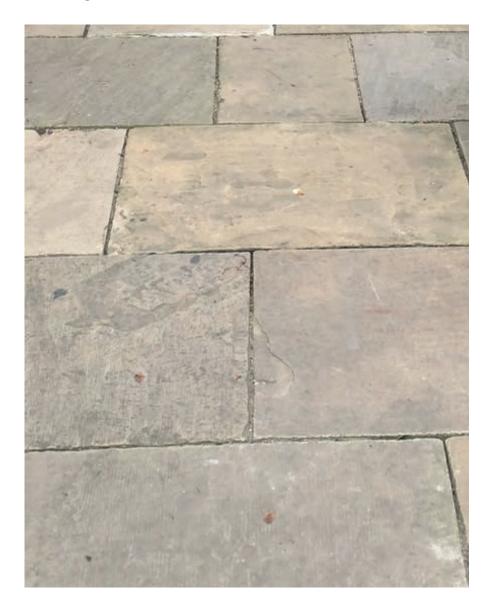
I.O2 RECLAIMED YORKSTONE

Reclaimed yorkstone flags. Laid coursed. Joints to be dry pointed and free draining.

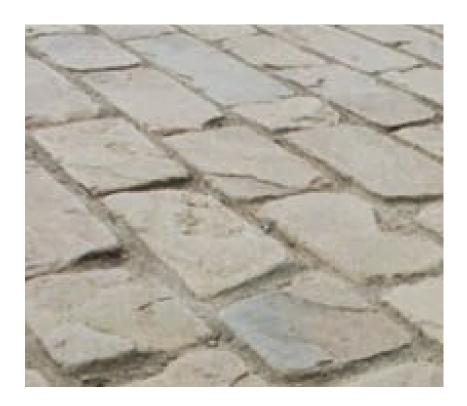
1.03 DARLEY STABLEYARD COBBLES

Darley Yorkshire sandstone stableyard cobbles. Laid coursed and joints to be dry pointed and free draining.

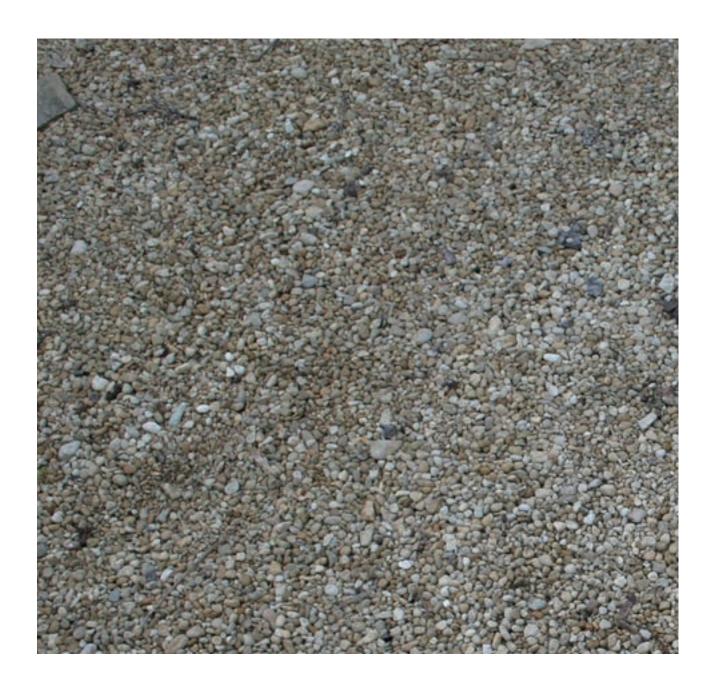
I.04 HOGGIN

Riverwashed South Cerney Hoggin and Gravel for the paths

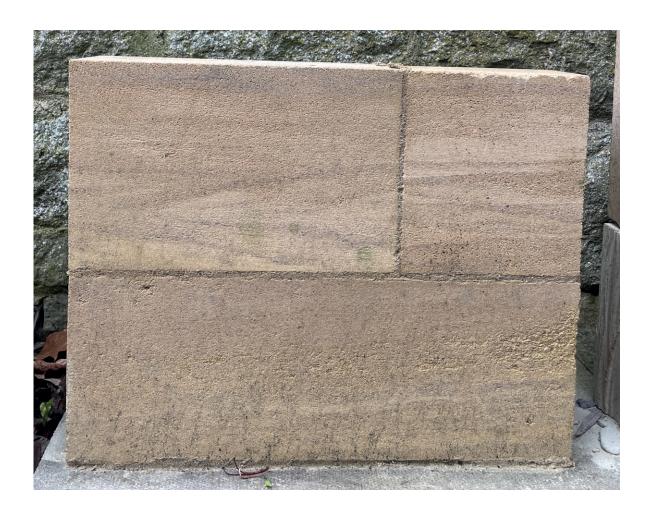
I.05 MEDWELL ASHLAR

Ashlar stone of Clipsham Medwell. 3mm joints pointed with natural lime mortar.

Note: Mortar mix to be a lime mortar used Hydraulic lime NHL 3.5 and sharp sand (1:3 mix)

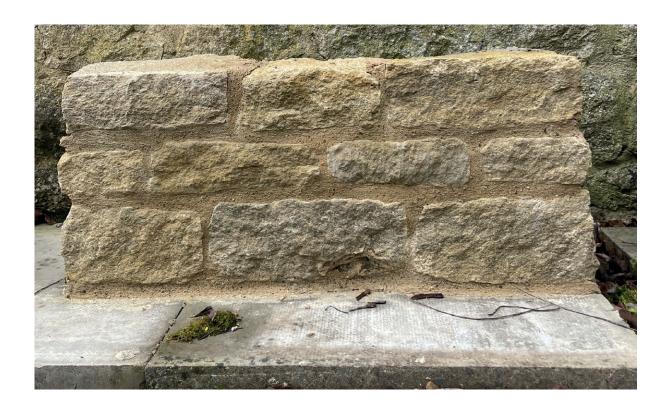
1.06 BIDWELL RUBBLE STONE

Bidwell rubble stone. Laid in varying sized courses with natural lime mortar.

Note: Mortar mix to be a lime mortar used Hydraulic lime NHL 3.5 and sharp sand (1:3 mix) with a bag rubbed or stipple brushed finish

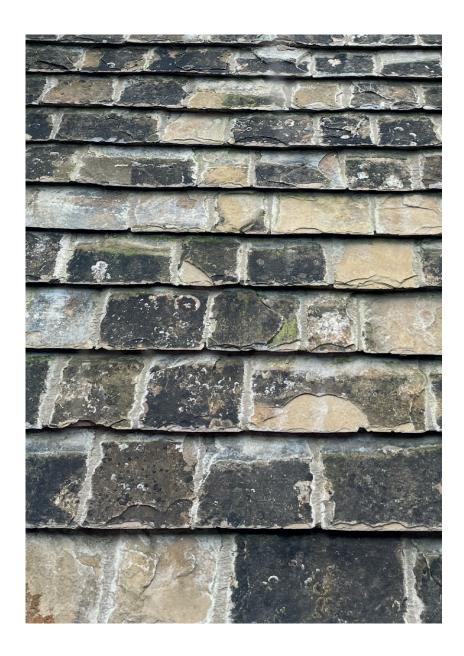
1.07 COLLYWESTON SLATE

Collyweston slate torched with natural lime mortar. Laid in diminishing courses.

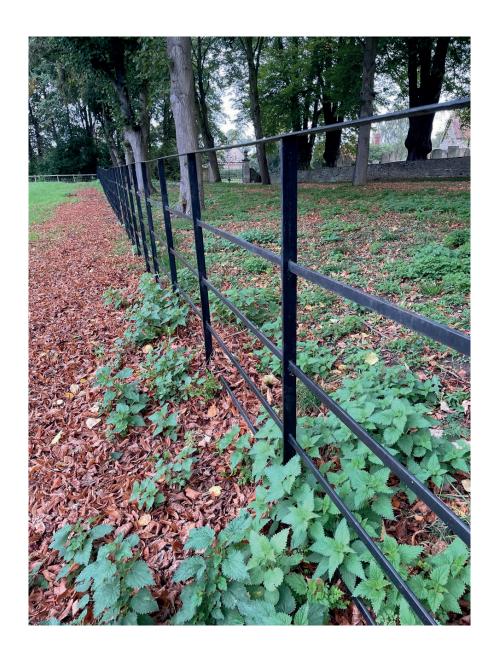
1.08 FENCING

Iron parkland rail fencing.
