Heritage Statement, 3 Church Street, Frome

3 Church Street, Frome BA11 1PW Mr A Harding

Design and Access Statement

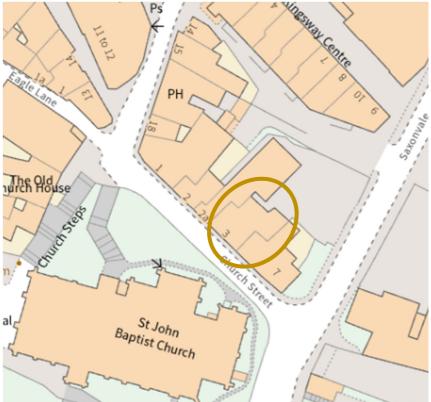
modern OS plan (subdivision between numbers 3 and 7 is not accurate)

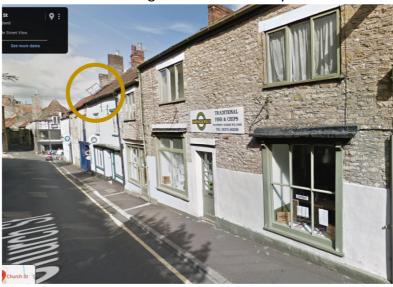
Rooflight to 2b Church Street shown on Google Earth

- 4.1.3 Two new Conservation Rooflights supplied by the Conservation Rooflight Company are proposed to be fitted to the front elevation of the roof, facing Church Street. These are to introduce light into the depth of the attic rooms. Note that there is another rooflight approved along Church Street in Listed property number 2b on the front elevation. In reality it is difficult to see the roofs from the street as the street is fairly narrow and there is no pavement opposite at the bottom of the retaining wall to the church yard.

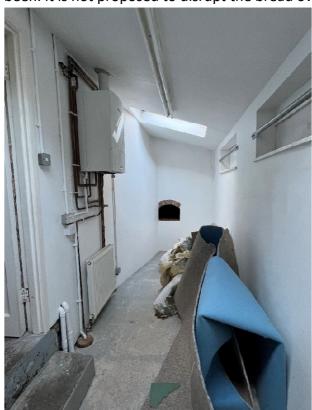
View looking towards historic bread oven. It is proposed to open a new door adjacent, further along the wall with the boiler.

- 4.2.3 The new entrance is proposed to connect to the stair by removing a section of historic rubblestone wall as shown on the drawings. This wall sits at right angles to what appears to be a former bread oven. There is no evidence as to where the associated fireplace might have been. It is not proposed to disrupt the bread oven in any way.

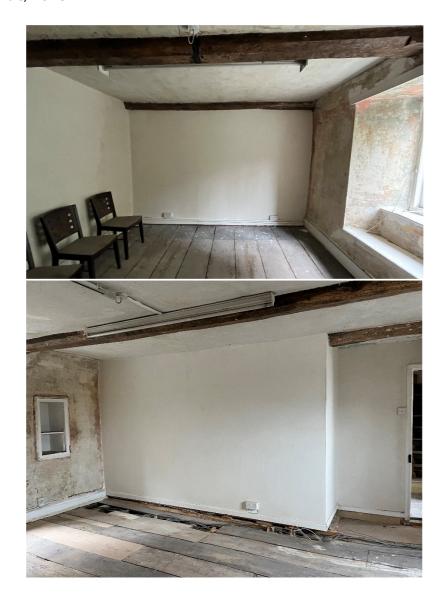
4.2.4 **First Floor** – the recently constructed partition is proposed to have an opening cut and bifold doors fitted. These will allow the two first floor spaces to be used flexibly whilst retaining two distinct rooms. The partition is shown below from both sides.

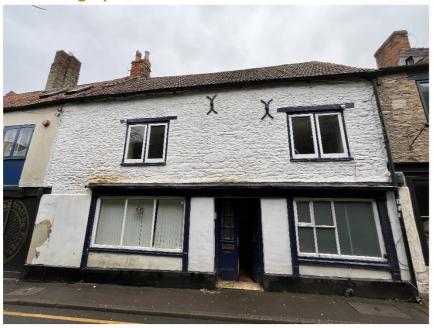
Front elevation facing Church Street

- 4.1.1 It is proposed to remove the modern paint which has been applied to the historic rubble stone walls to both the front and rear elevations. A sample area has been done to the stonework to the rear of number 7 using the DOFF system as a representative area of both addresses. This is available for inspection. It is noted that the erosion of the modern paint to the rear elevation has revealed an ochre coloured limewash and it is important that this is retained on the surface of the stone as evidence of the historic finish. The elevations are proposed to be reviewed and patch re-pointed using lime mortar. It is not proposed to reapply limewash.

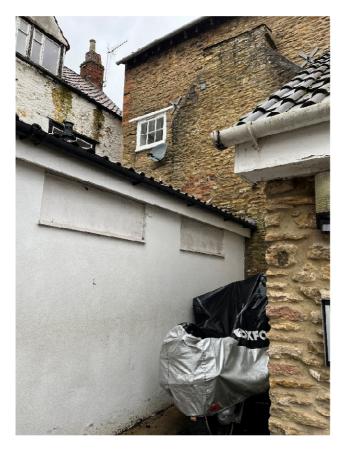
Rear elevation showing location of proposed new door

- 4.2.2 A new entrance to the rear of the property is proposed so that the customers of the hot desking spaces are kept separate from the creche for safeguarding reasons. A new w.c is proposed adjacent, within the modern lean-to as it will be required for the hot desking customers. Again, it is positioned close to existing drainage, and will no disrupt the historic fabric.

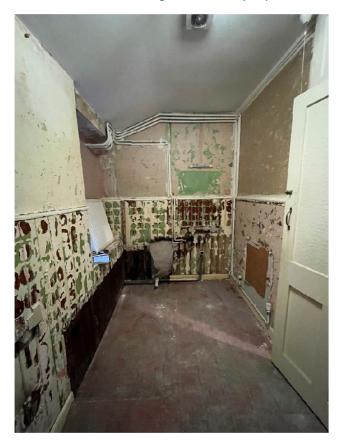
Existing wc – this is proposed to become the children's toilets for the creche

- 4.2.1 Ground Floor to the rear of the building the existing w.c is to be reconfigured to provide two toilets for use by the creche alongside a further adult toilet in the modern lean-to. All ill use existing drains close by.

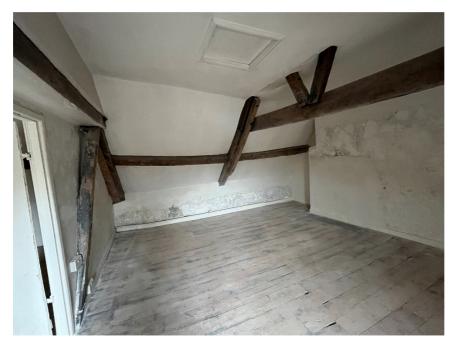
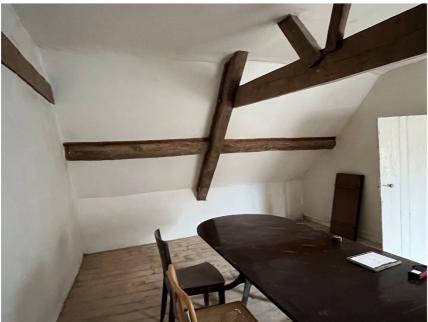
Attic rooms showing location of proposed rooflights
