Arboricultural Report

BS5837:2021 (Trees in Relation to Design, Demolition & Construction)

Site: Okewood House, Heath House Road, Woking, Surrey.

Date of report: April 10th 2024 **Surveyor:** Jon Harper cert.Arb (RFS) **Report reference:** 2024023 v1.0

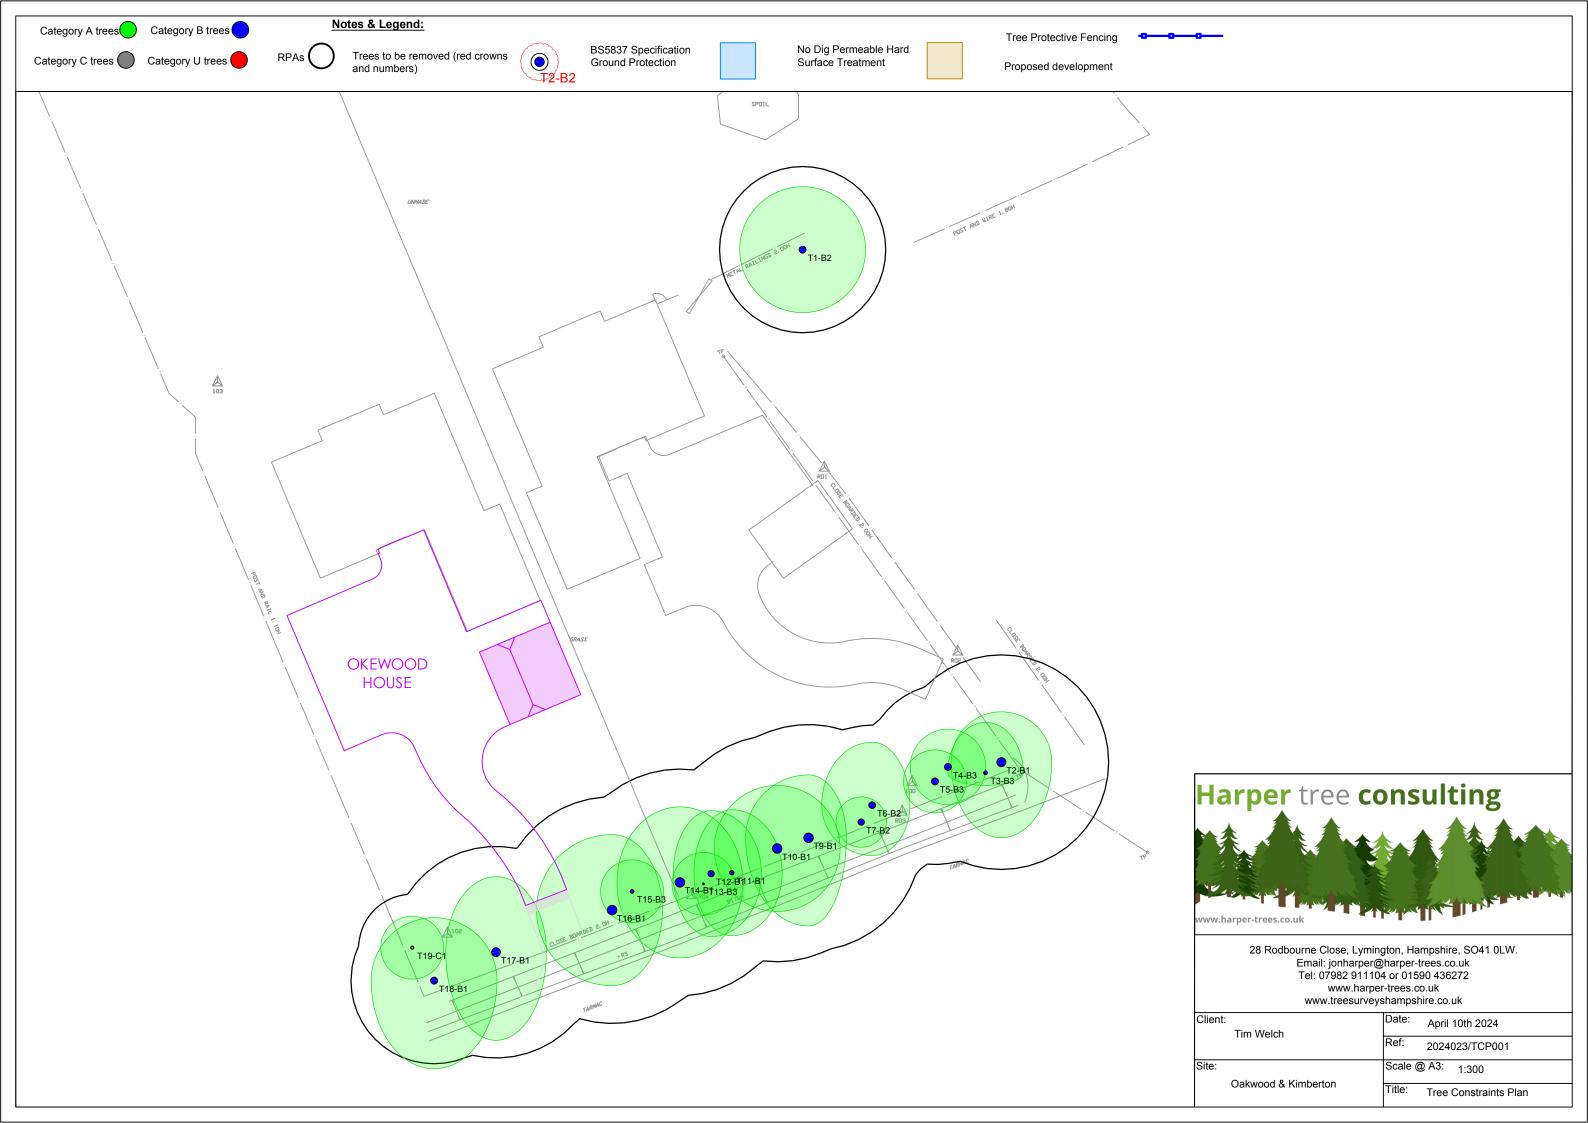
TREE CONSTRAINTS PLAN

The proposal, in this instance, is to construct a new double, timber framed, garage, and to reconfigure the drive layout as shown using the purple colour on the tree constraints plan (2024023/TCP001) in this report.

In our survey schedule, the RPA for each tree is indicated as the radius of a circle as well as in M². This is also plotted on the tree constraints plan and tree protection plan denoted by a heavy black line which merges the individual RPAs together where there is more than one tree.

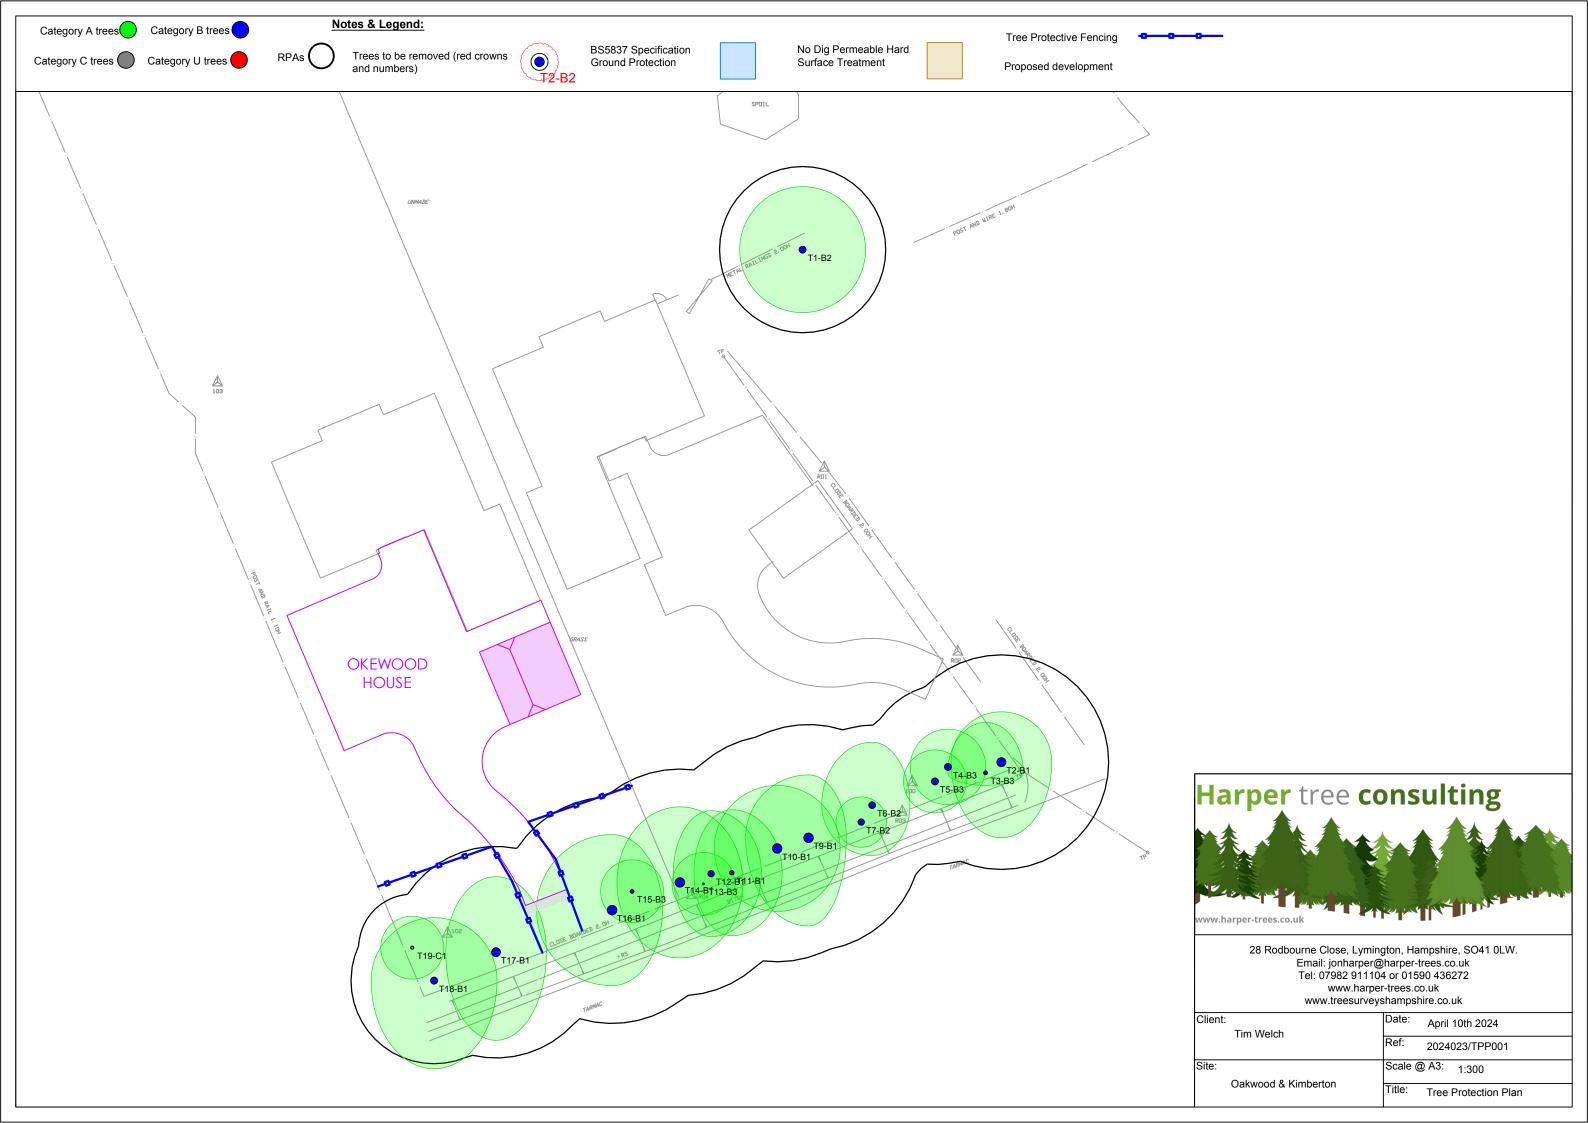
TREE PROTECTION PLAN

The required tree protective fencing should be installed to fence off the construction exclusion zone(s), or CEZ, shown on the tree protection plan (Figure 2). This must only be altered or moved as agreed in writing by the Local Planning Authority following advice from a competent Arboricultural Consultant.

The Tree Protective fencing will be 2.4m Heras fencing as specified in the BS. The fencing will be supported by rubber or concrete feet with supporting struts firmed into the ground on the side of the trees. The purpose of the supports is to prevent the fencing being moved during the development. Clear signs will be attached to the fencing (e.g. Tree Protective Fencing – Keep Out).
