Outline Specification

Conservation Outline Specification (COS) - February 2021

Photographs

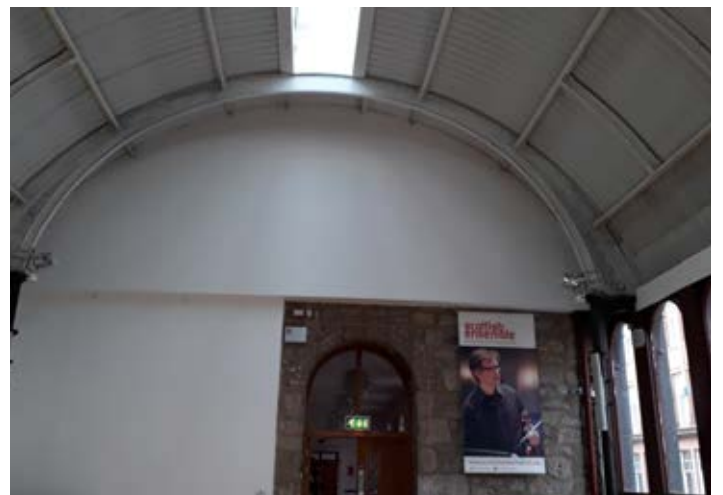
Roof 1A

Underside of roof 1A

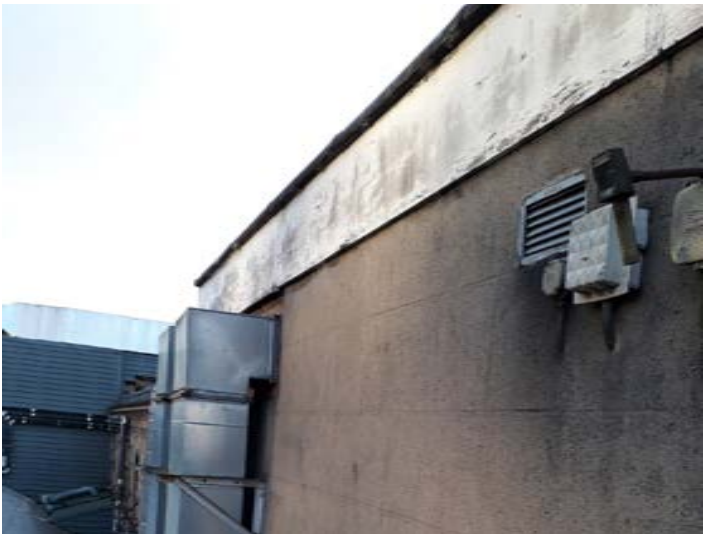
Roof 1B

Poor fascia to plant room
Refer to item 11 in Scope of Work CHF-1B

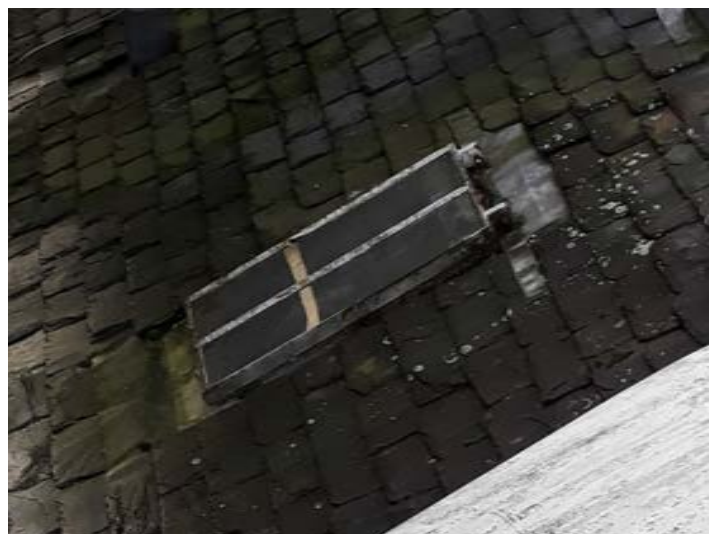
Poor flashing to skylight

Refer to item 14 in Scope of Work CHF-1B

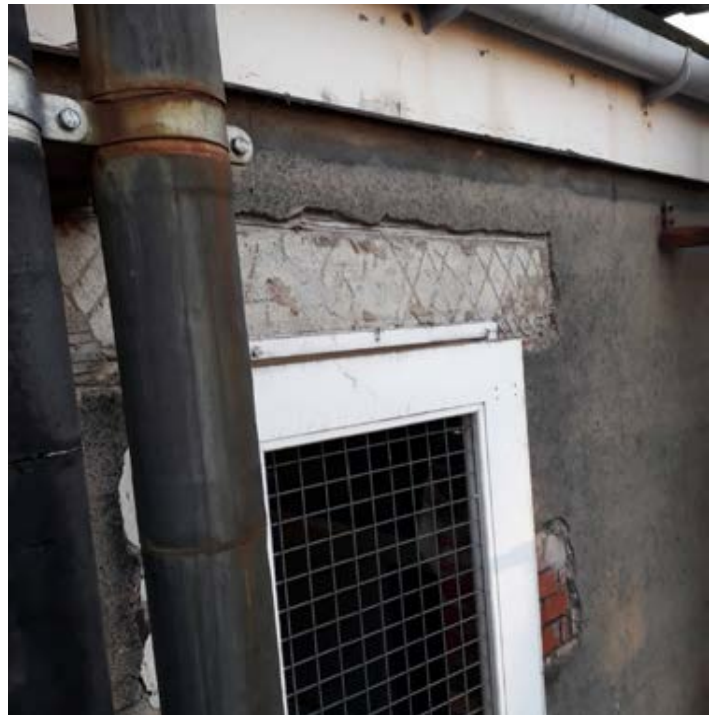
Roof 1B

Poor render on plant room walls
Refer to item 17 in Scope of Work CHF-1B

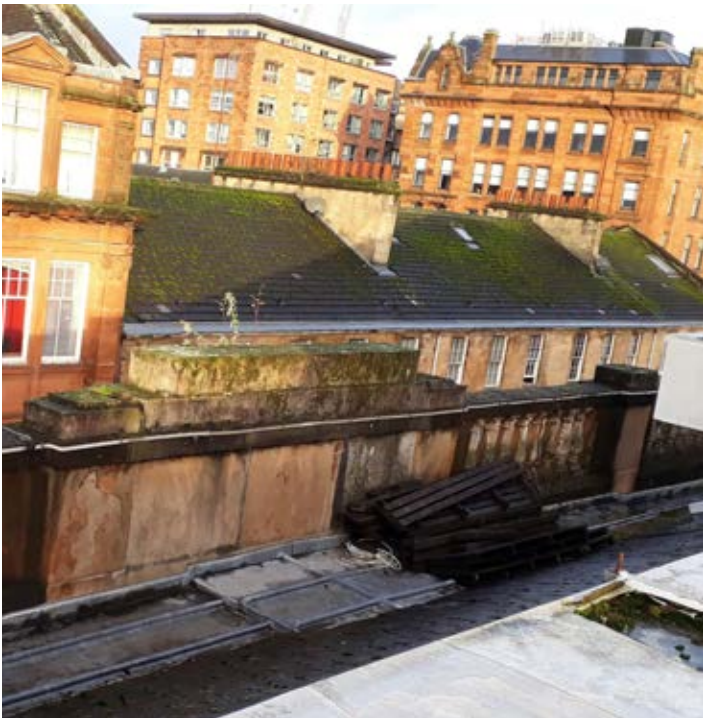
Duckboards stored on lead gutters
Refer to items 23 in Scope of Work CHF-1B

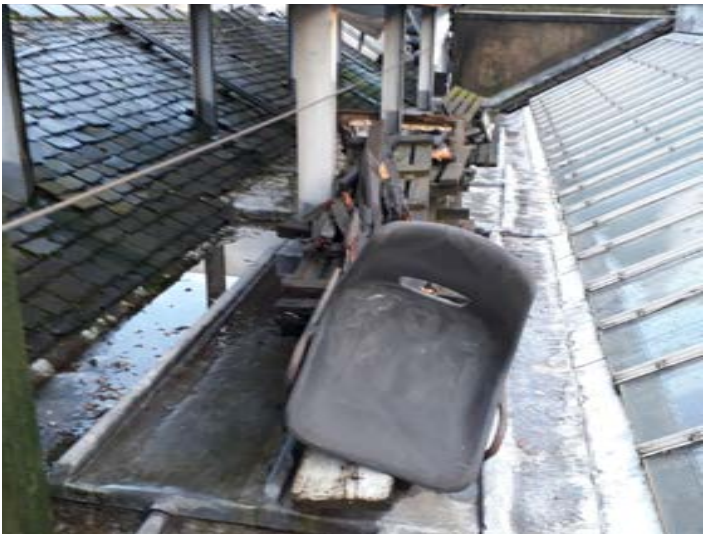
Roof 1B

Duckboards and other items stored on lead gutters
Refer to items 23 in Scope of Work CHF-1B

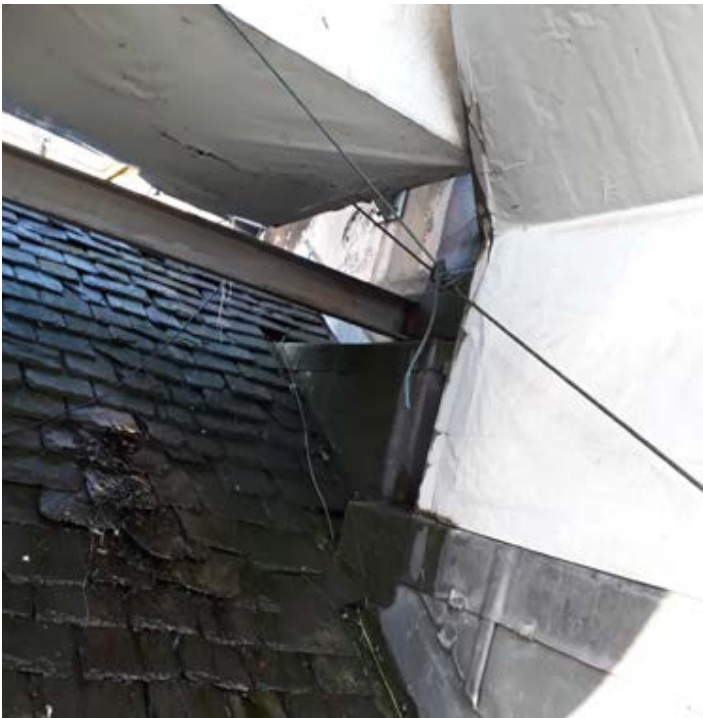
Ducts close to roof - no access available over roof. New Safety Line required
Refer to items 18 in Scope of Work CHF-1C

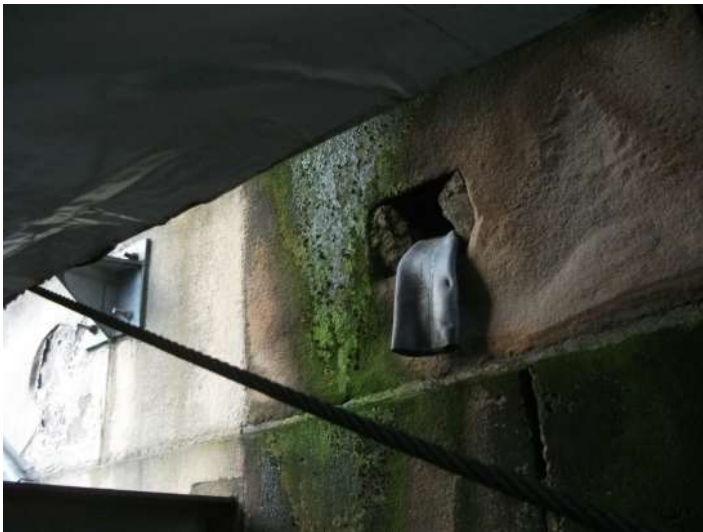
Roof 1C

Bent overflow pipe
Refer to item 2 in Scope of Work CHF-1C

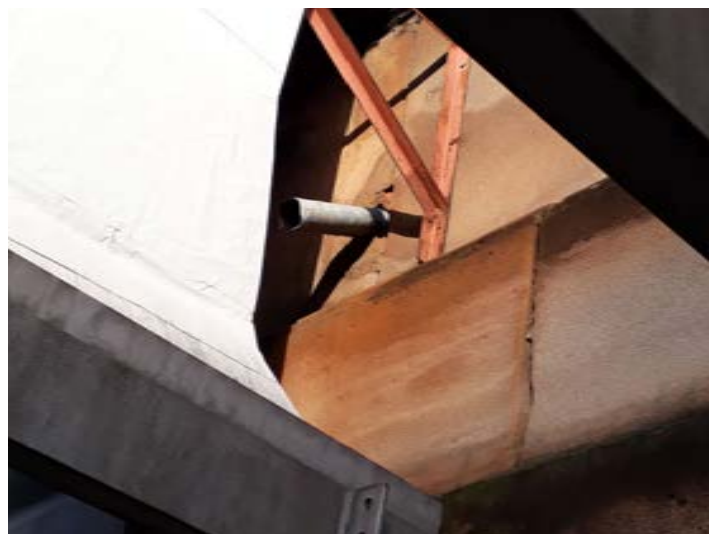
Outlet at end of gutter (in Roof 1B) is too high. New downpipe to be fitted
Refer to item 15 in Scope of Work CHF-1C

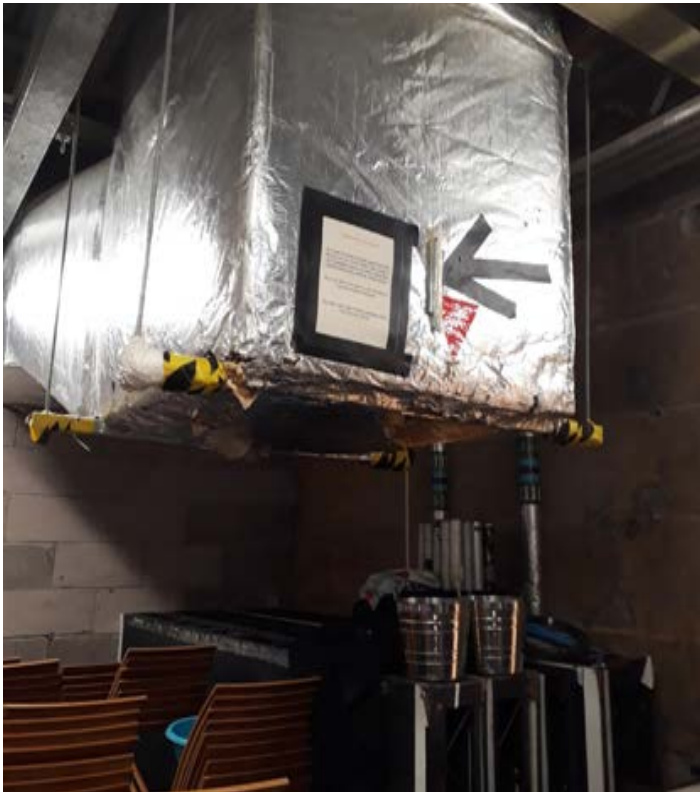
Base of duct within chair store off the Recital Room - water ingress evident

Refer to item 1 in Scope of Work CHF-1C

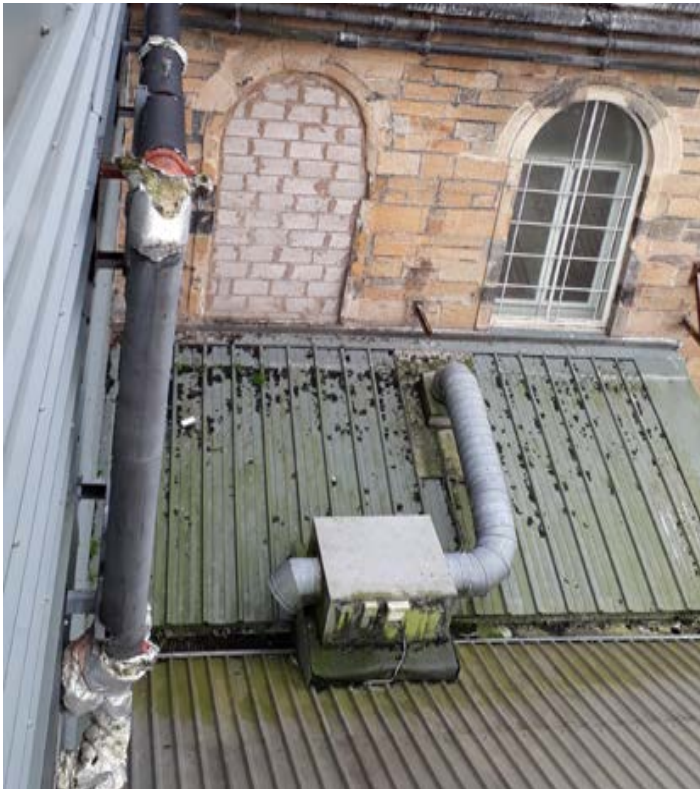
View of 'GUTTER E'. Gutter to be relined and safe access provided.

Refer to items 6 & 16 in Scope of Work CHF-2

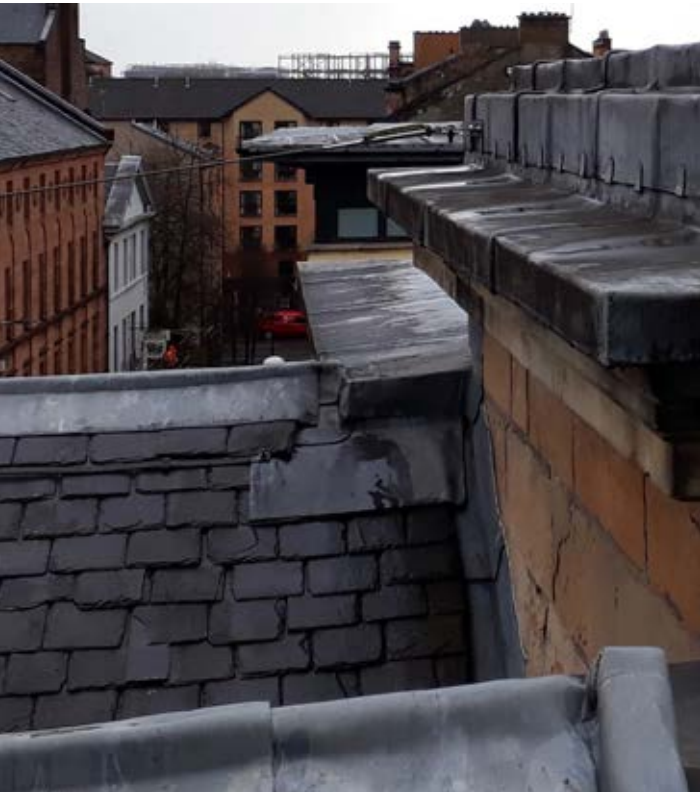
Complicated junction between Roof 3A ridge
and wall of Roof 3B
Refer to item 2 in Scope of Work CHF-3A

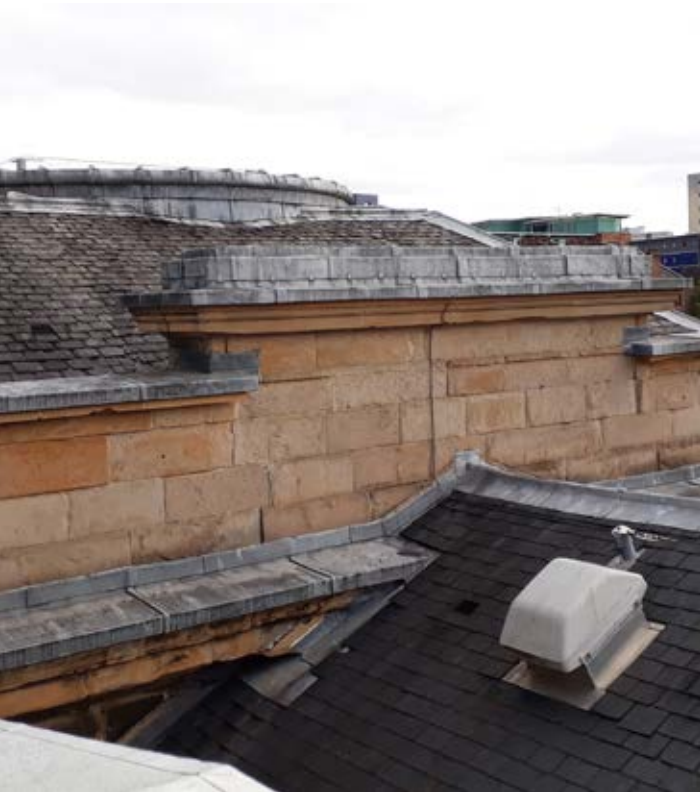
Roof 3B

Poor pointing in stonework
Refer to item 3 in Scope of Work CHF-3B

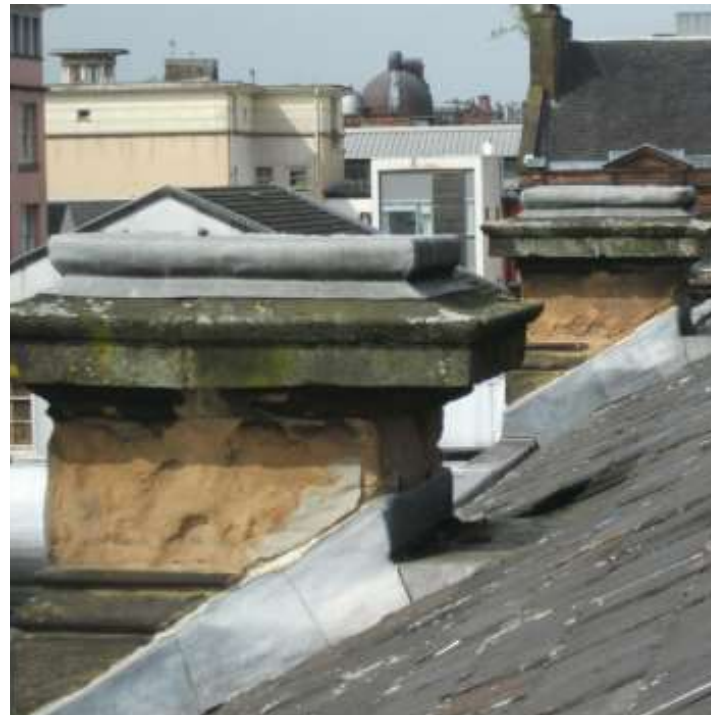
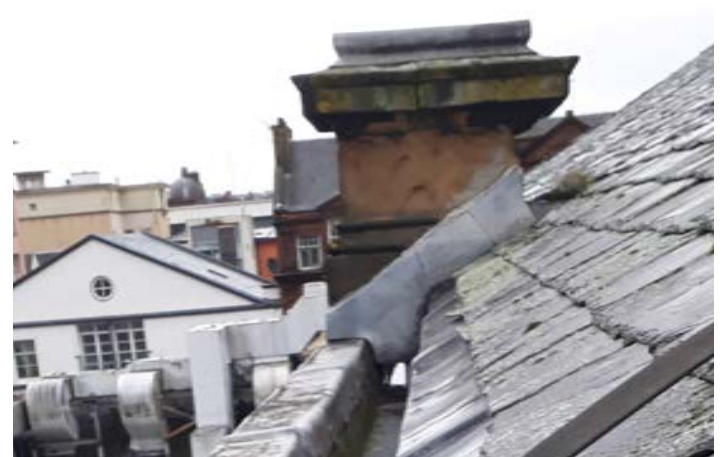
Poor leadwork around base of parapet
stones
Refer to items 2 & 3 in Scope of Work CHF-4

2.3a New lead valley and hip flashings to be in code 7 lead. Existing ridge tiles to be removed and replaced with code 8 lead flashings and to be secured with terne-coated stainless steel clips. Any abutment and cover flashings to be in code 6 lead.
