## **04 MONTPELIER SQUARE - SW71JT**

LBMVarchitects - SITE INVESTIGATIONS PHOTOS - FLOORS AND ROOF STRUCTURE

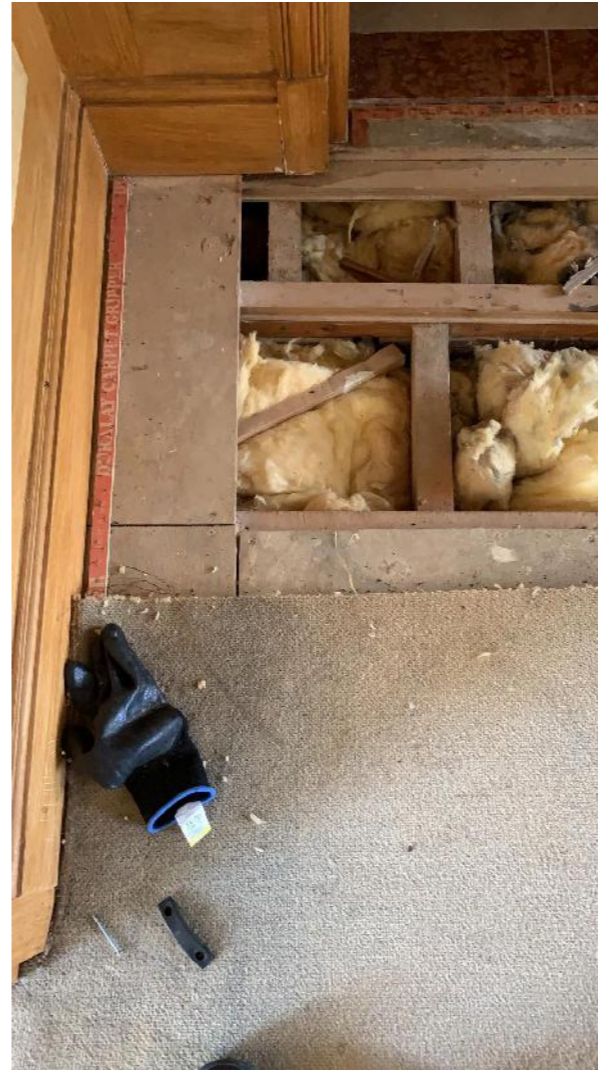
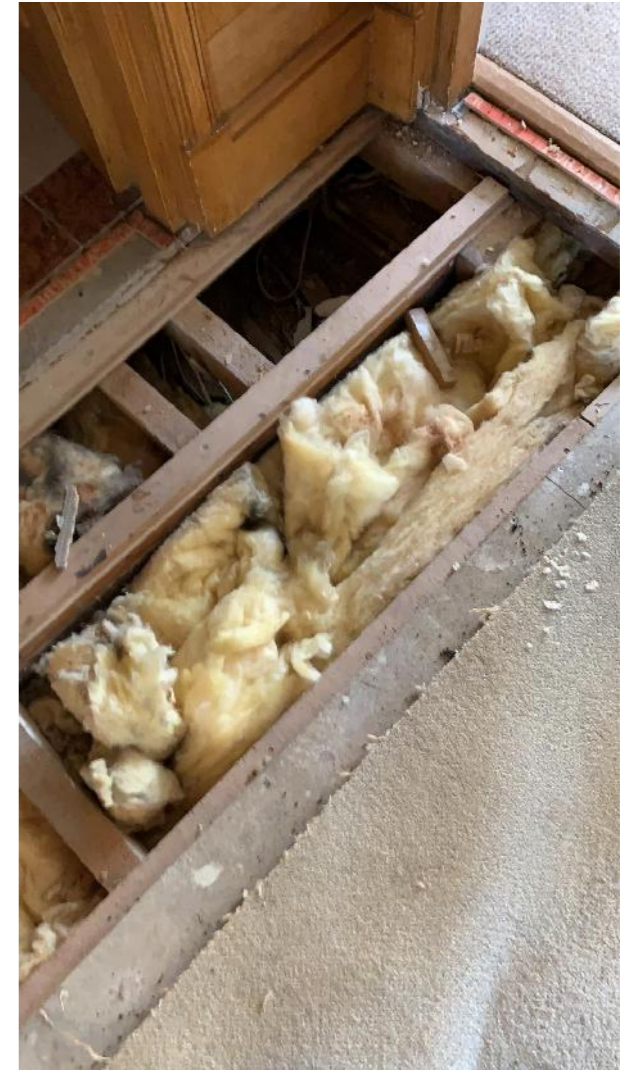
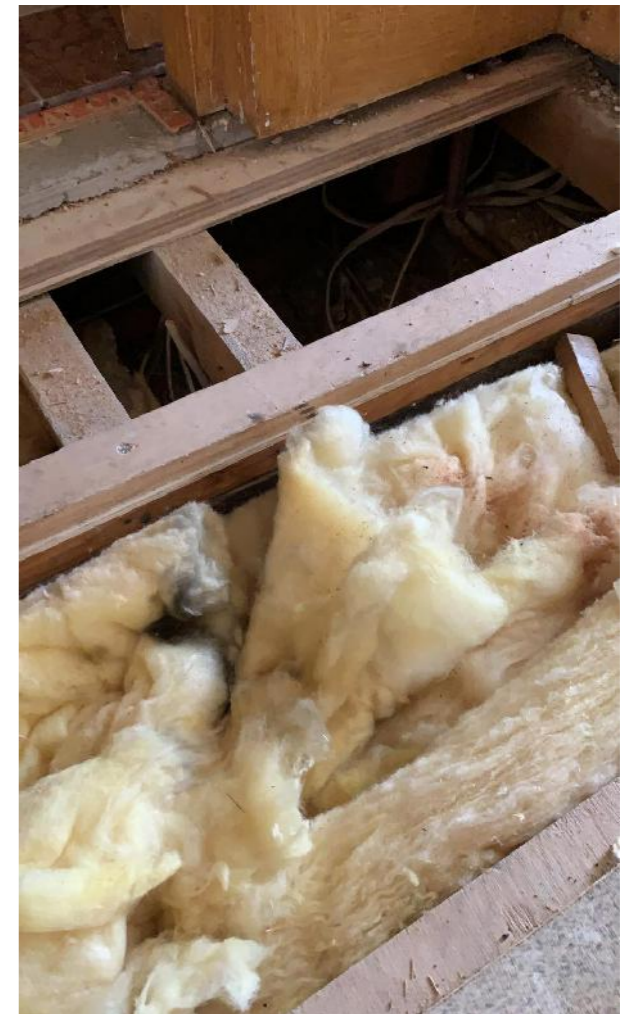
18

- 1 layer of Carpet
- 1 Layer of chipboard
- 1 layer of furrings
- Joists 140X40

Joists of recent manufacture

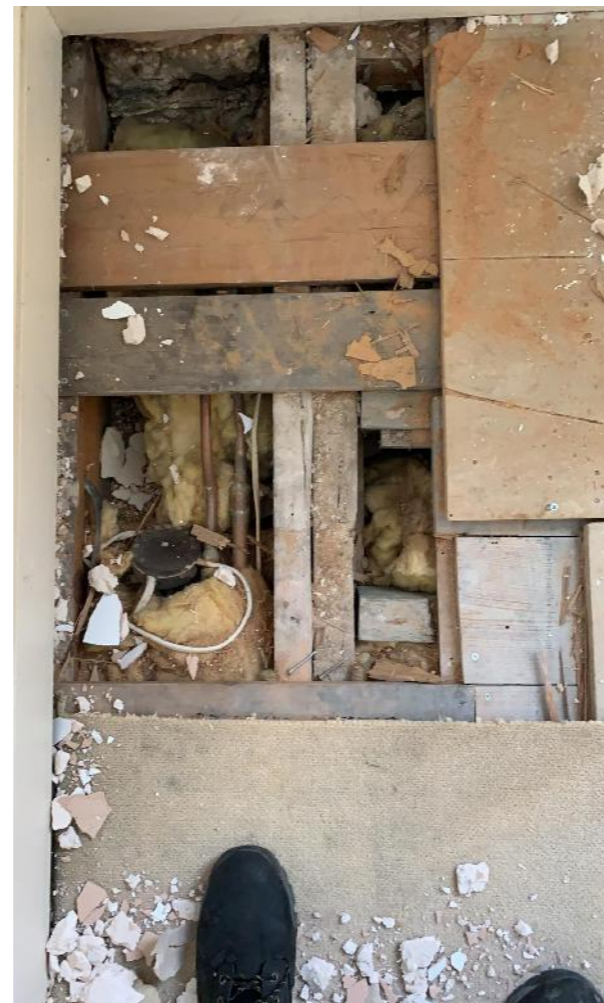
19

1 layer of Carpet with underlay  
1 layer of chipboard  
1 Layer of pine boards of recent manufacture  
Joists 200X40

A lot of alteration to joists

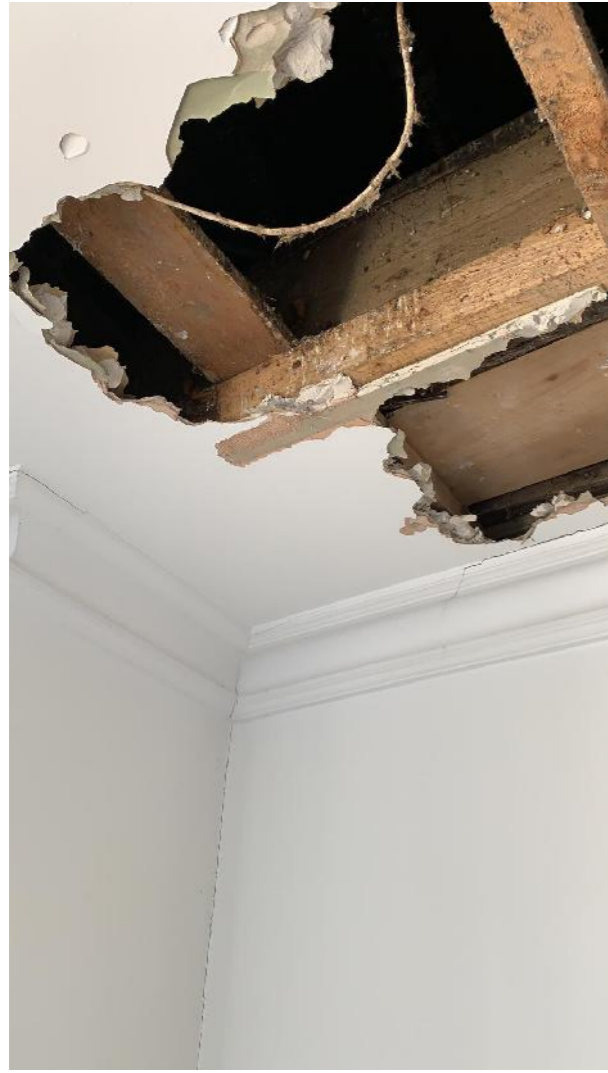
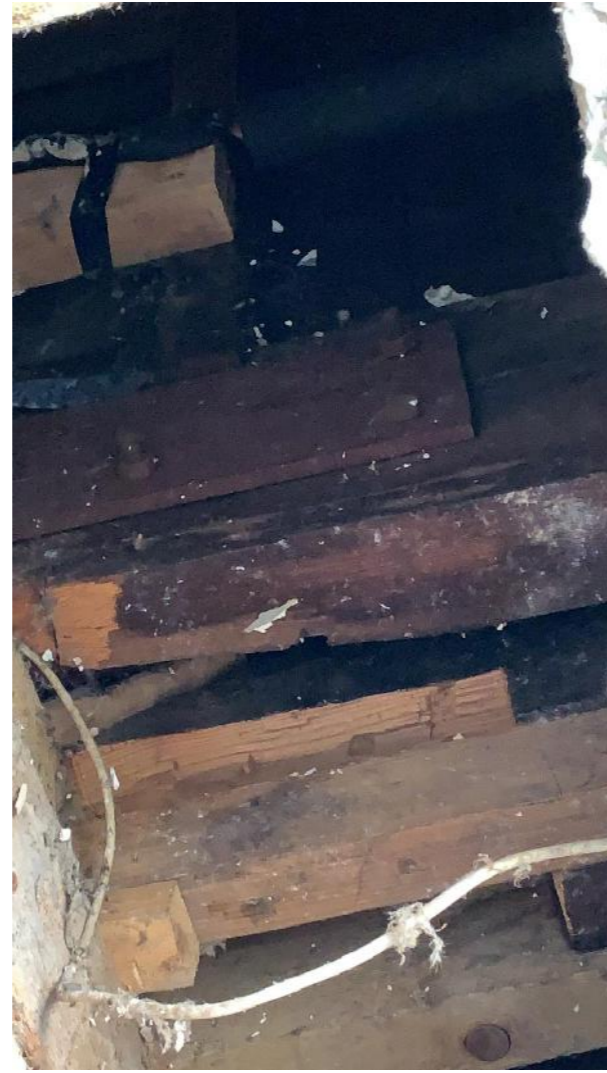
21

The roof was almost entirely rebuilt in the 90' following a partial collapse of the ceiling due of guttering blockage. New structural elements appear to be incorporated into the very fragemented original stucture It is also visible new insulation in between the rafters

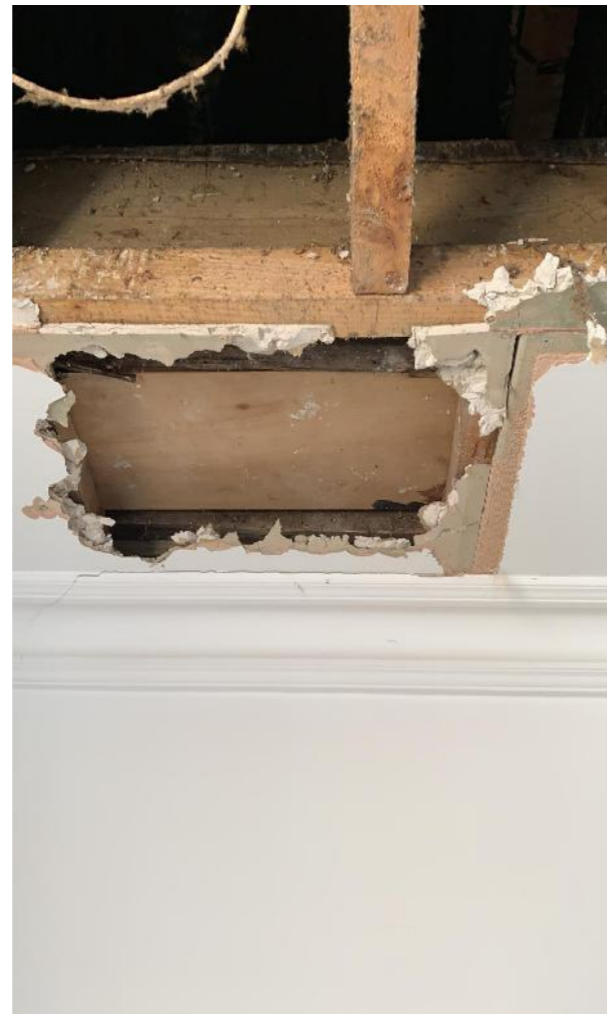
22

New roof timber structure visible and new insulation

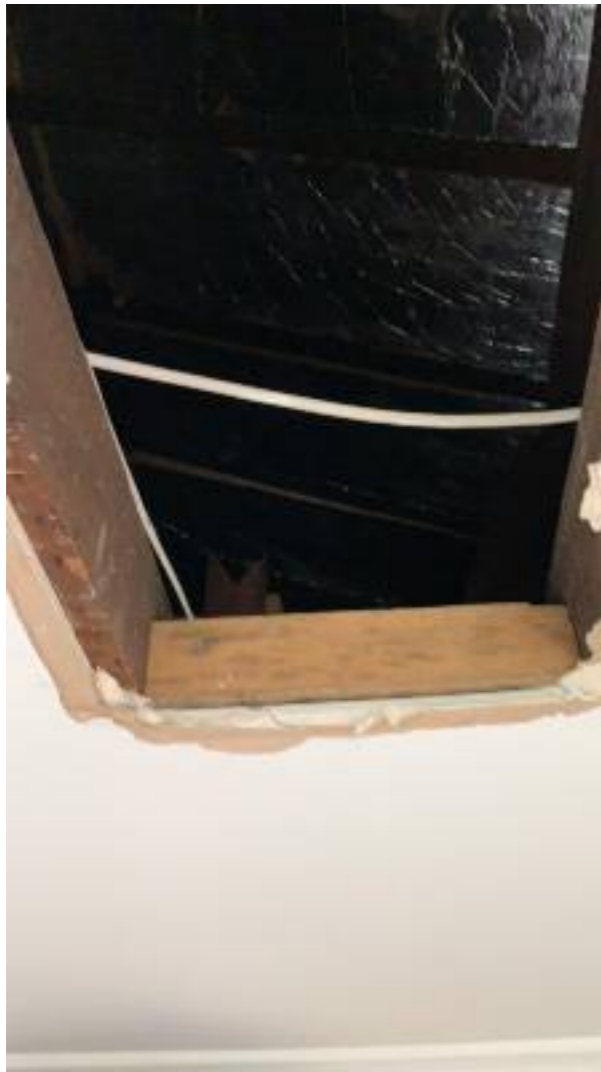
New roof structure visible  
New insulation  
Small fargments of the orginal roof structure , heavily altered

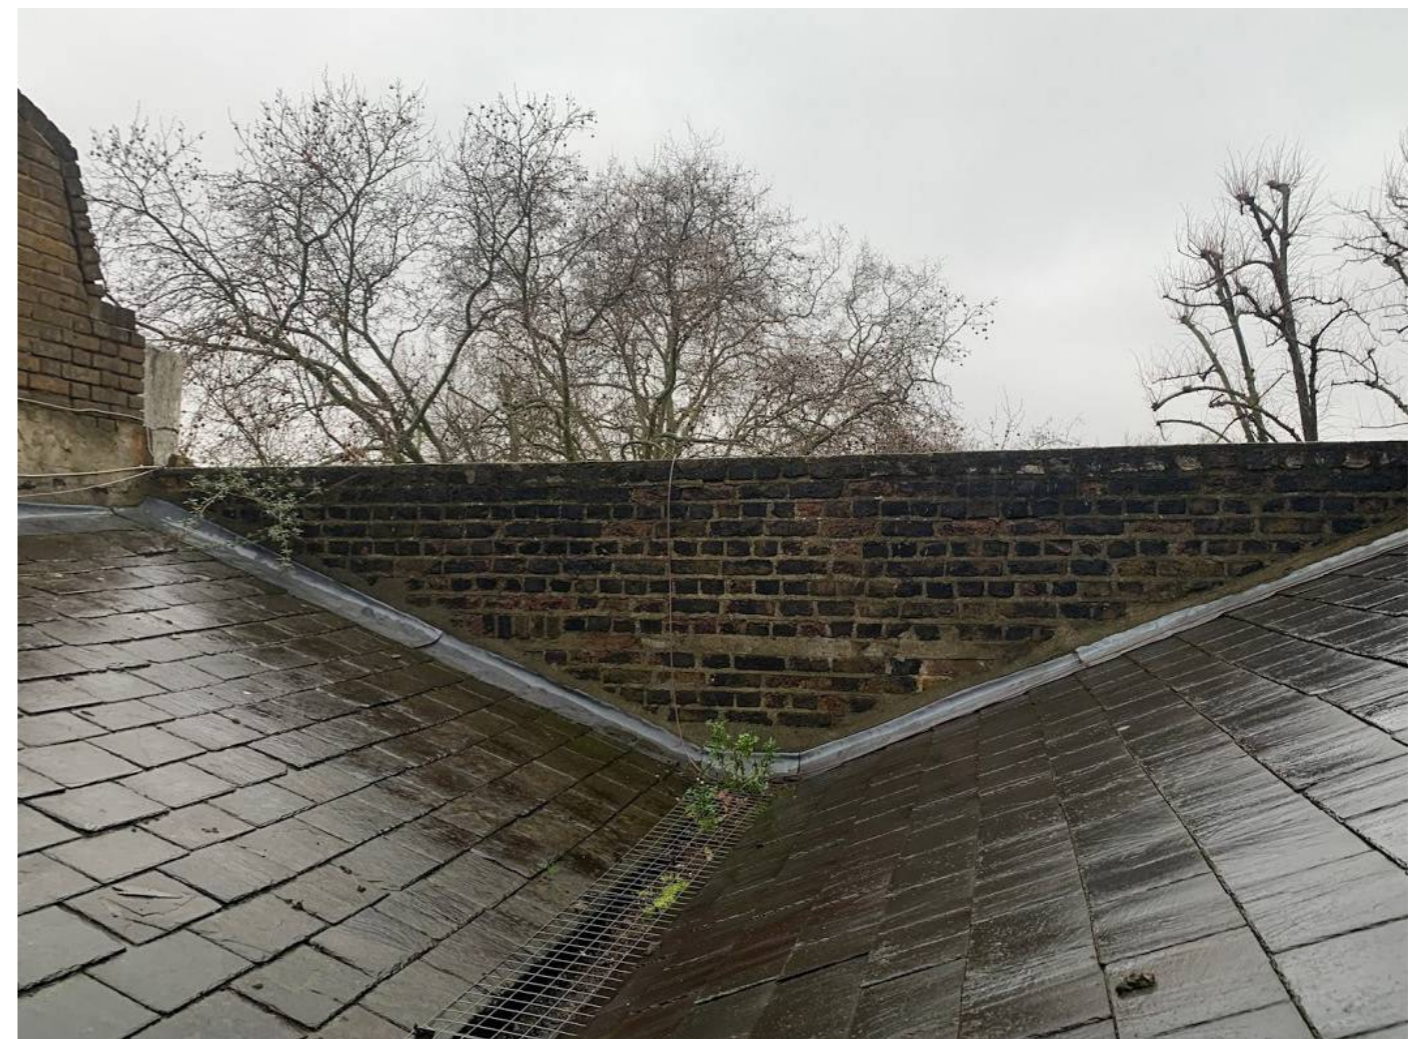
The top section of the rear wall of the building was entirely rebuilt following the collapse of the roof, as visible from the photo 25
