# Shutta Road Retaining Walls Route Report

**Division: CORMAC Consultancy**

**Site name:** Shutta Road, Looe

Report No: CN1701503/01/01

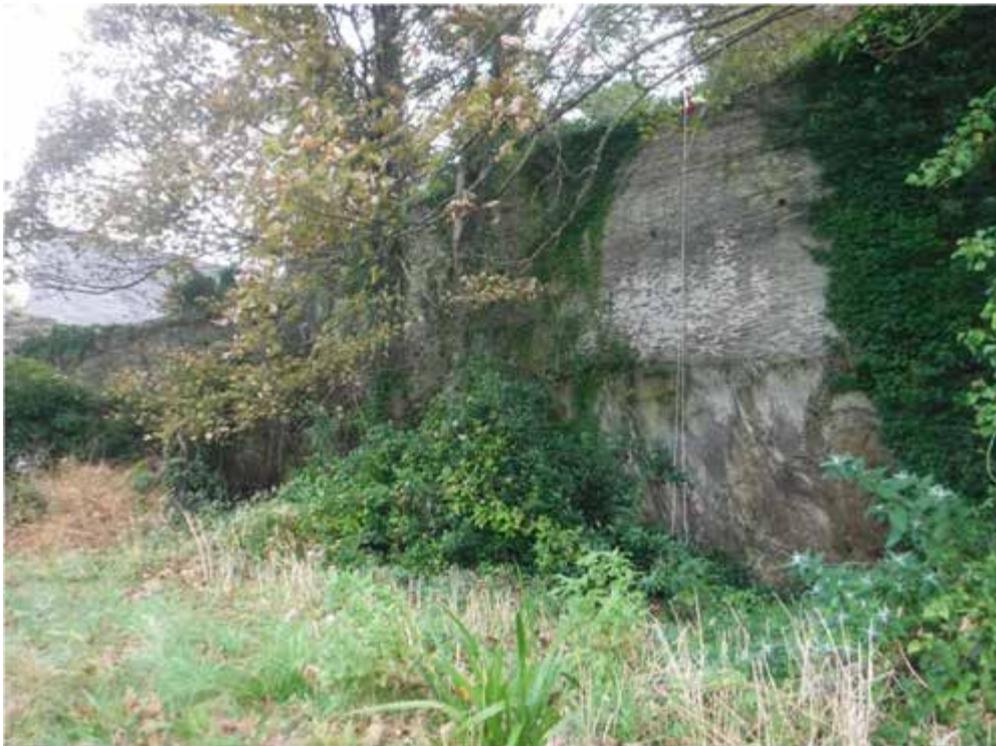
**Photo 1: General view showing the north end of the west elevation**

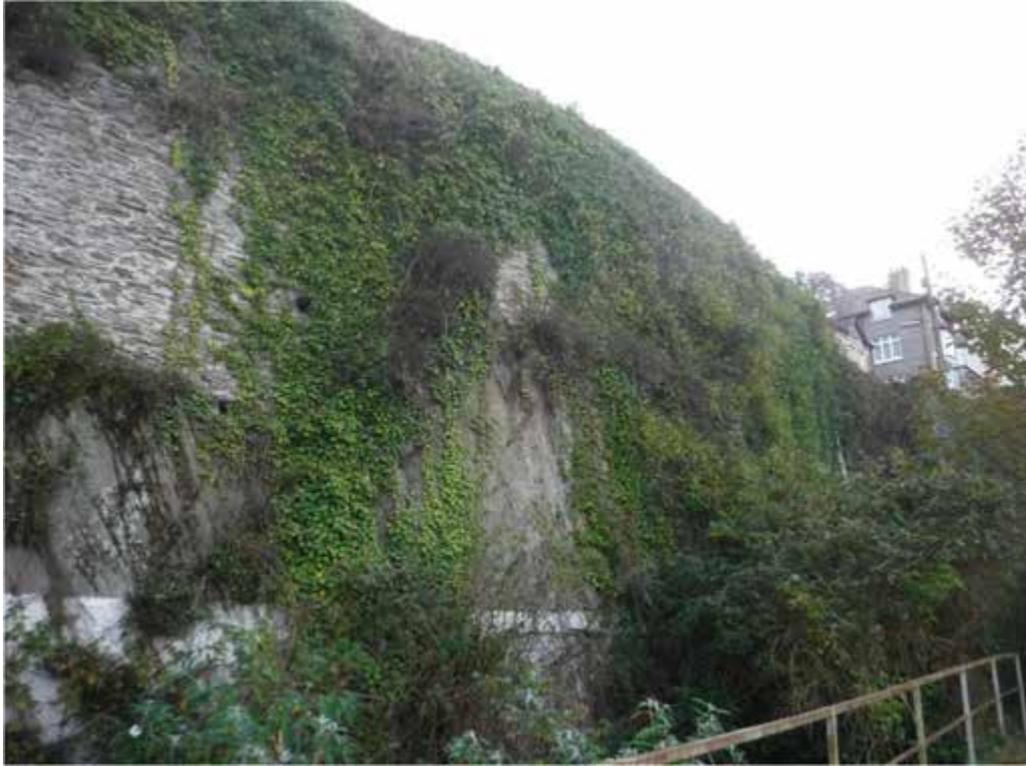
**Photo 2: General view showing the south end of the west elevation**

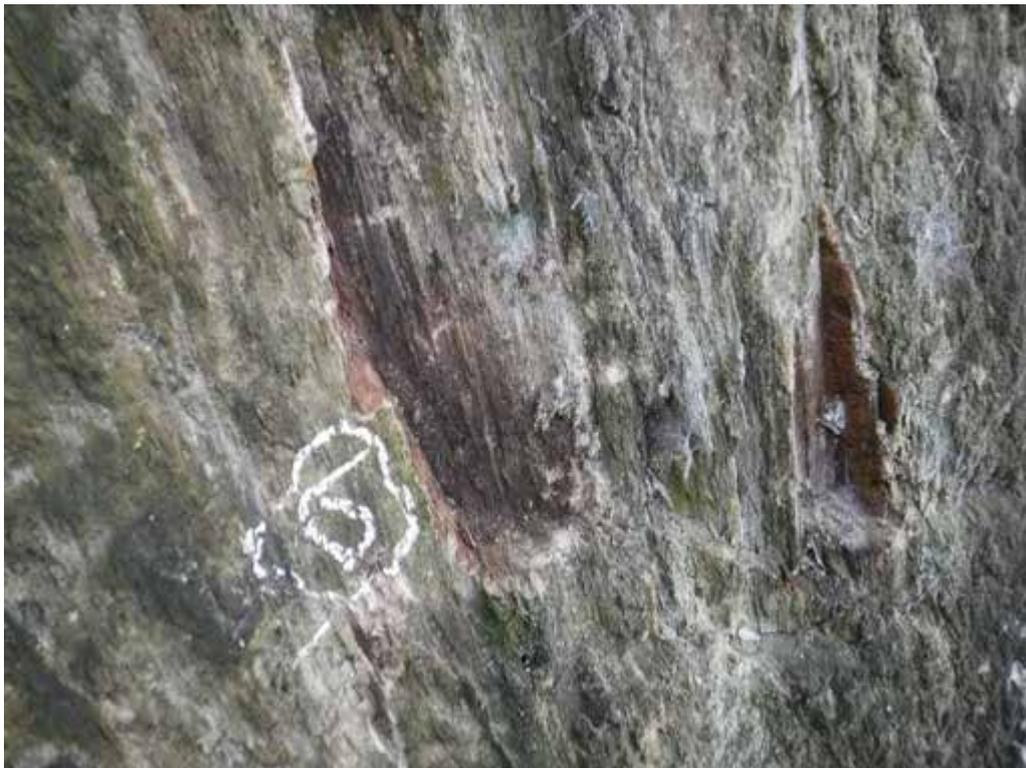
**Photo 3: View showing the typical condition of the bedrock. Note the two areas easily removed**

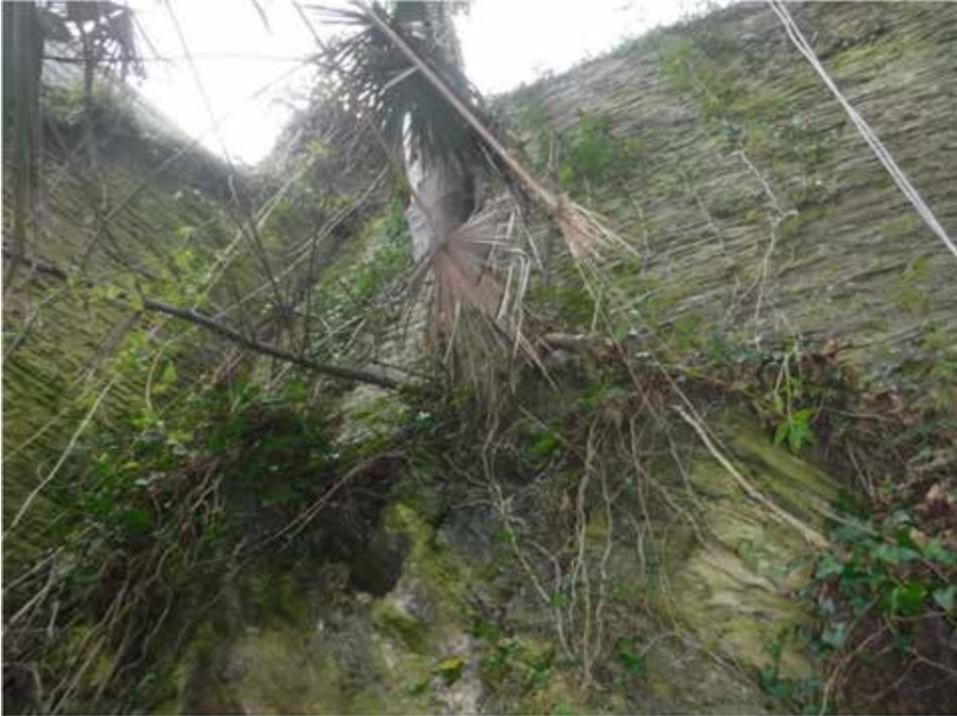
**Photo 4: View showing the tree growth at chainage 2m and the protruding bedrock**

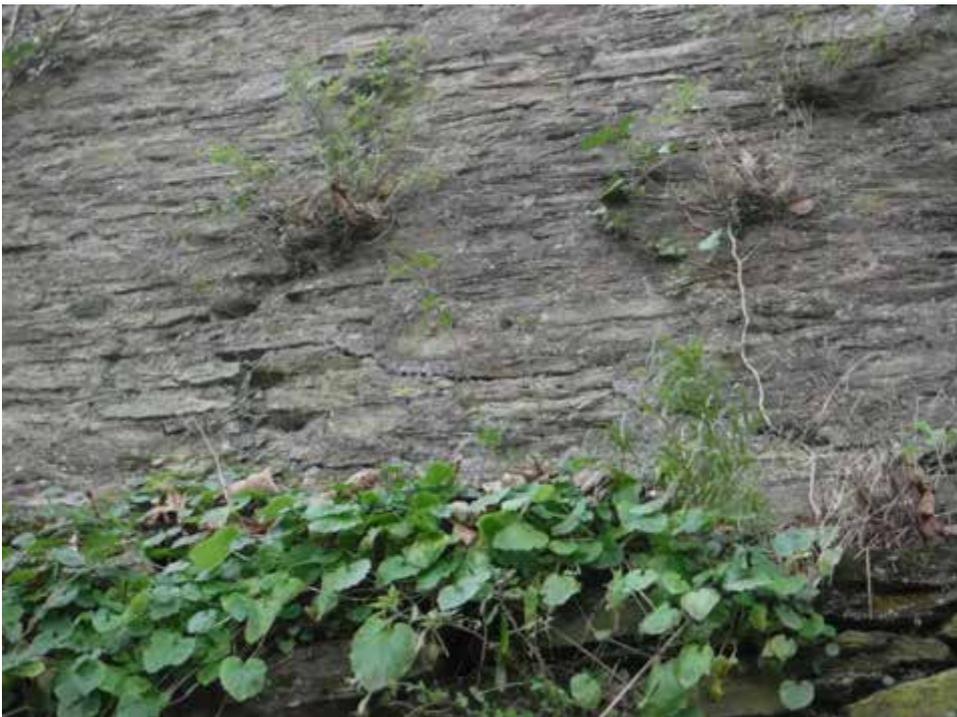
**Photo 5: View showing the horizontal and stepped crack adjacent to the tree growth at chainage 2m**

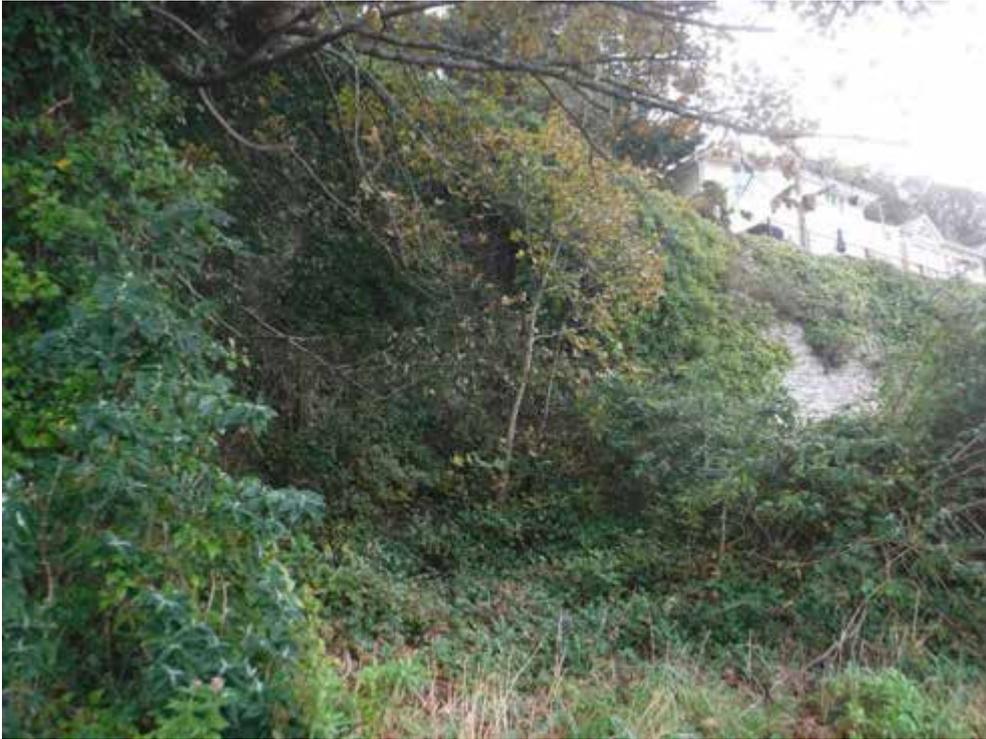
**Photo 8: View showing the vegetation growth obscuring the wall at chainage 20m**

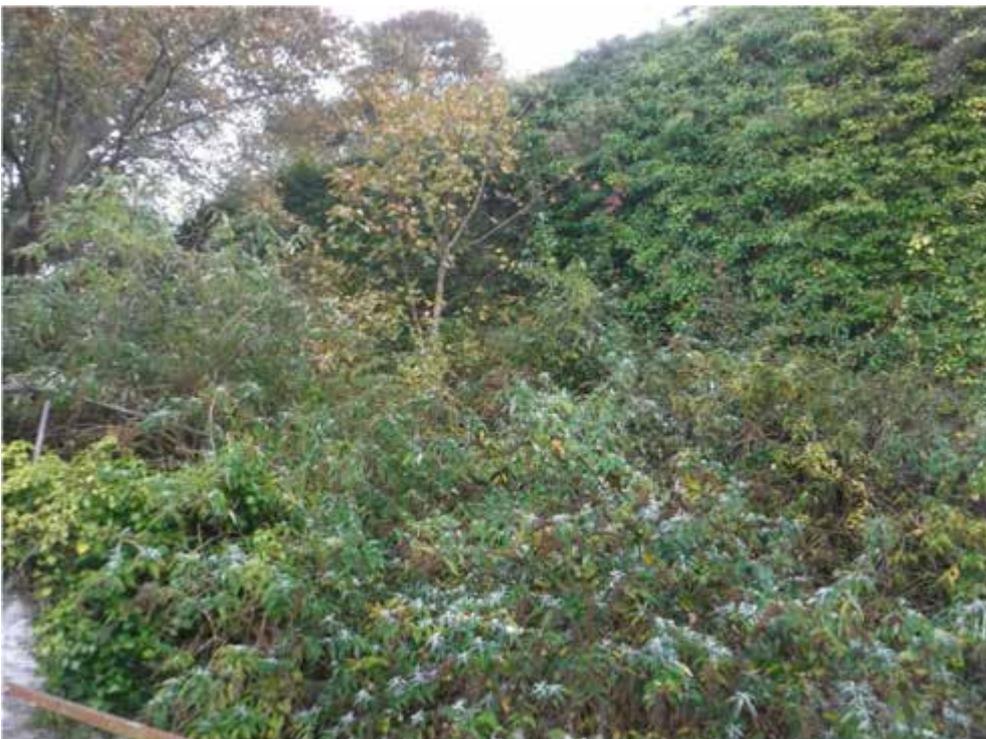
**Photo 9: View showing the vegetation growth obscuring the wall at chainage 31m**

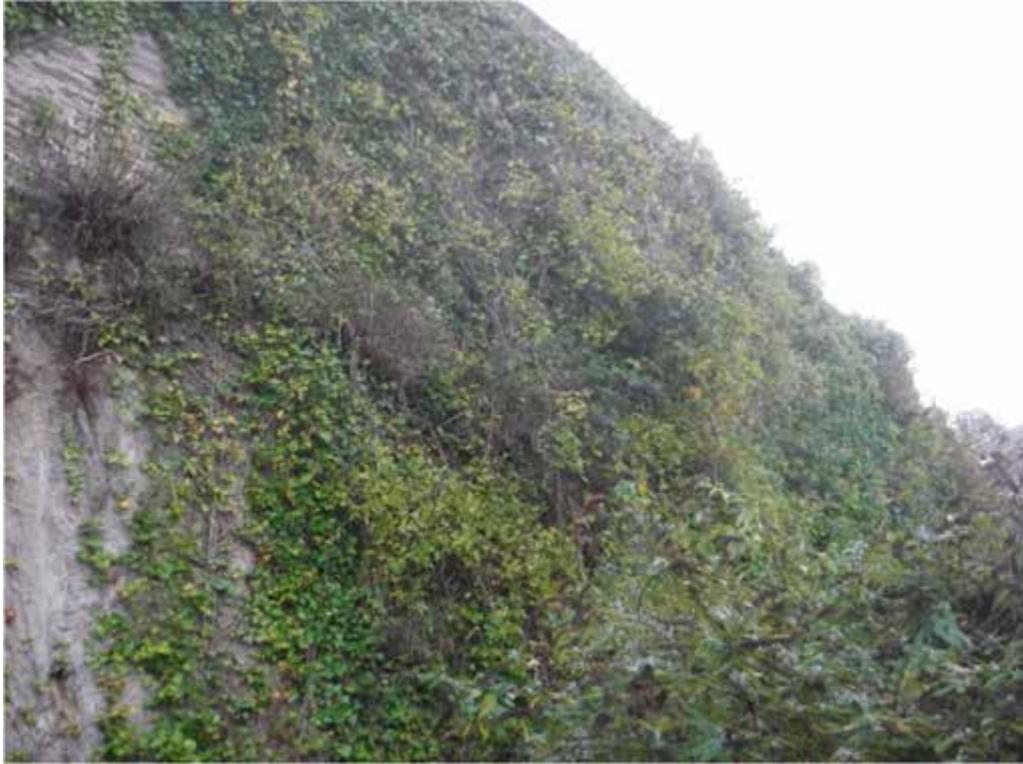
**Photo 10: View showing the vegetation growth obscuring the wall at chainage 43m**

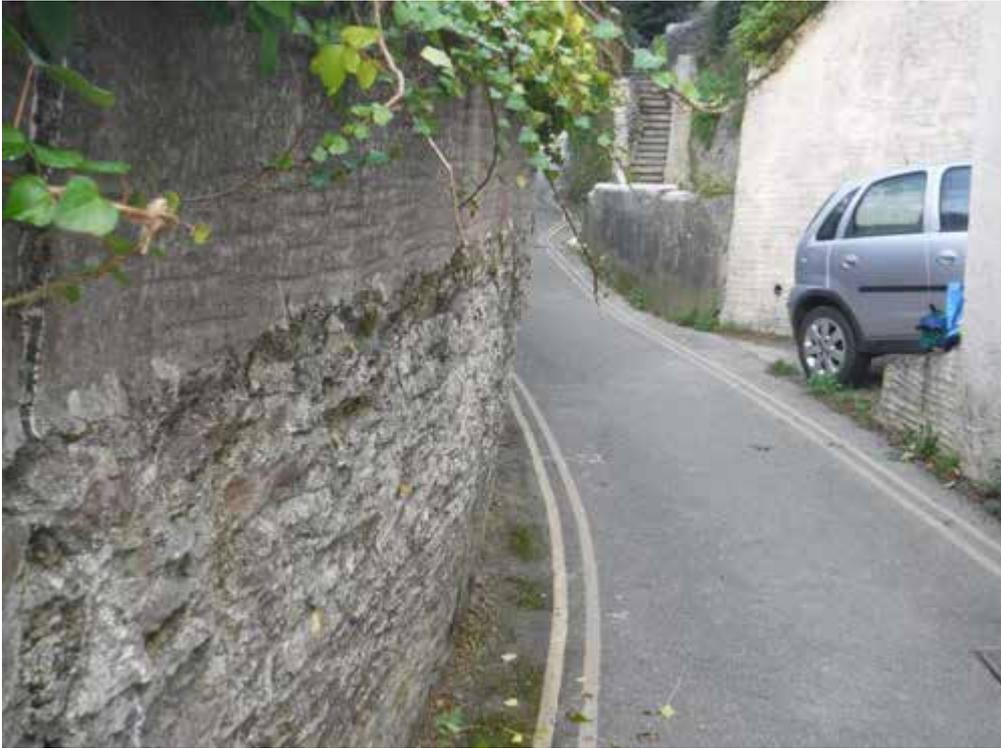
**Photo 18: View showing the parapet leaning towards the carriageway at chainage 35m (looking north)**

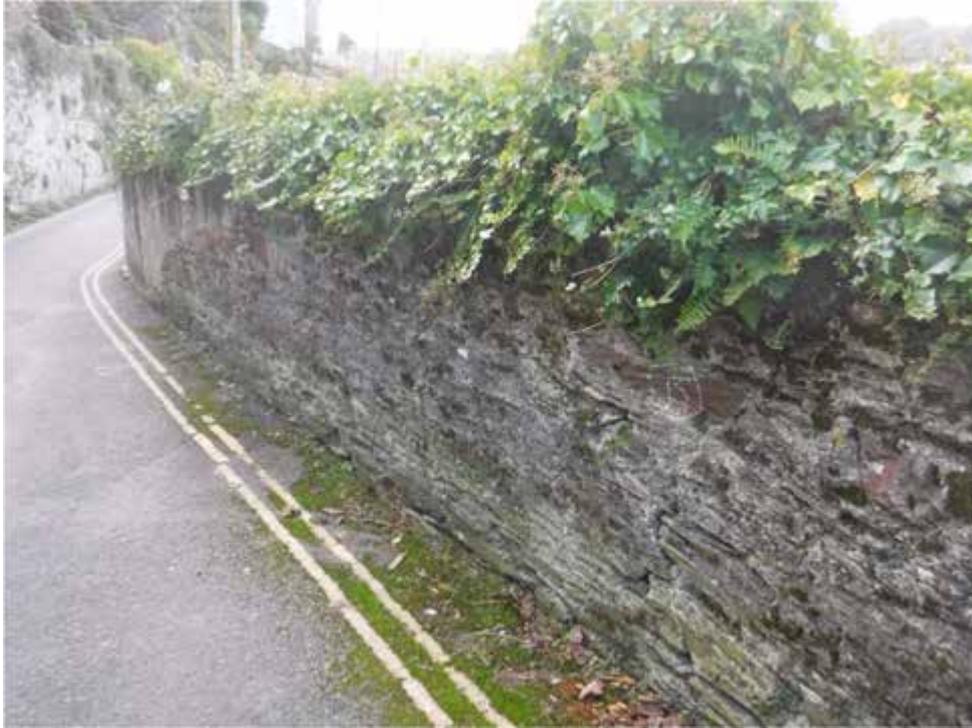
**Photo 22: View showing the vegetation growth atop the parapet towards the south end of the structure**

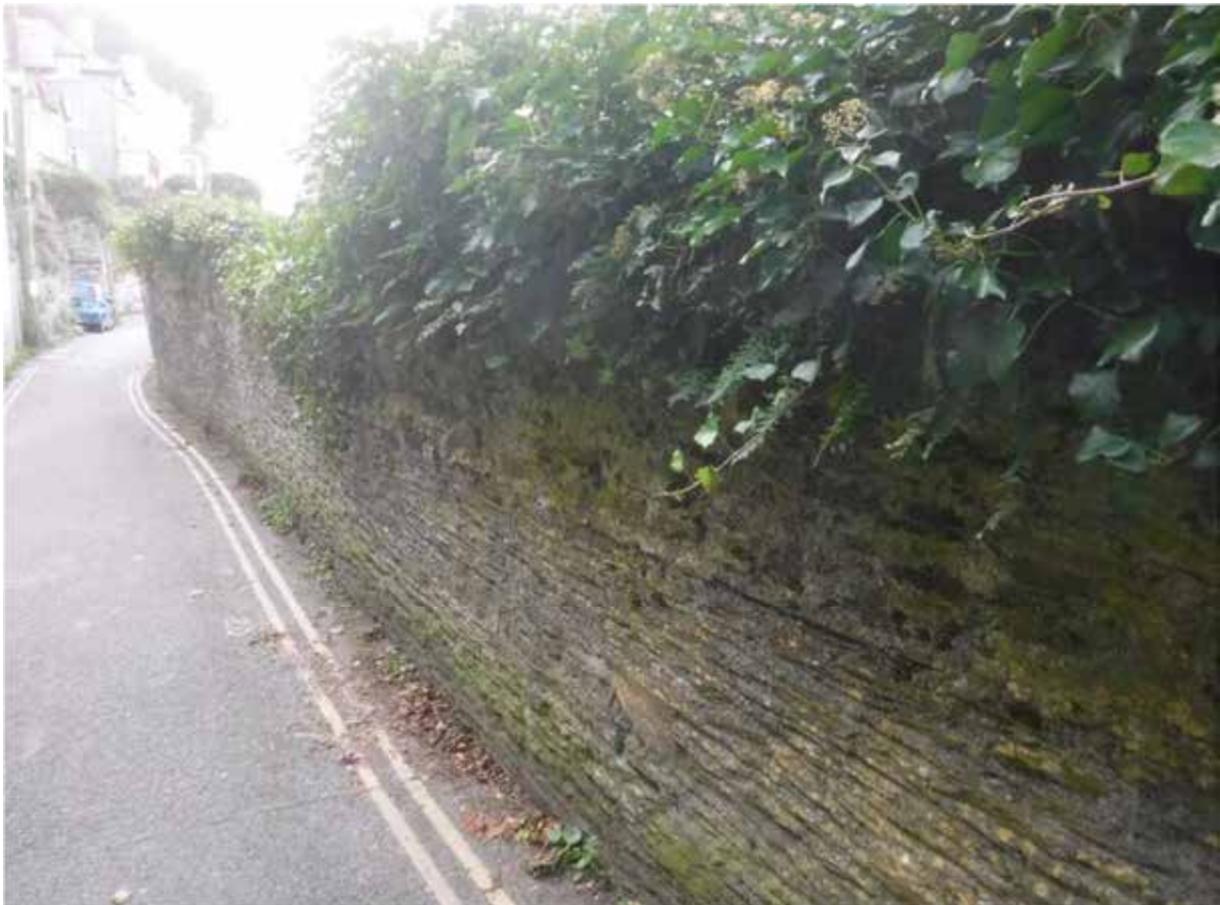
**Photo 23: View showing the vegetation growth atop the parapet towards the north end of the structure**

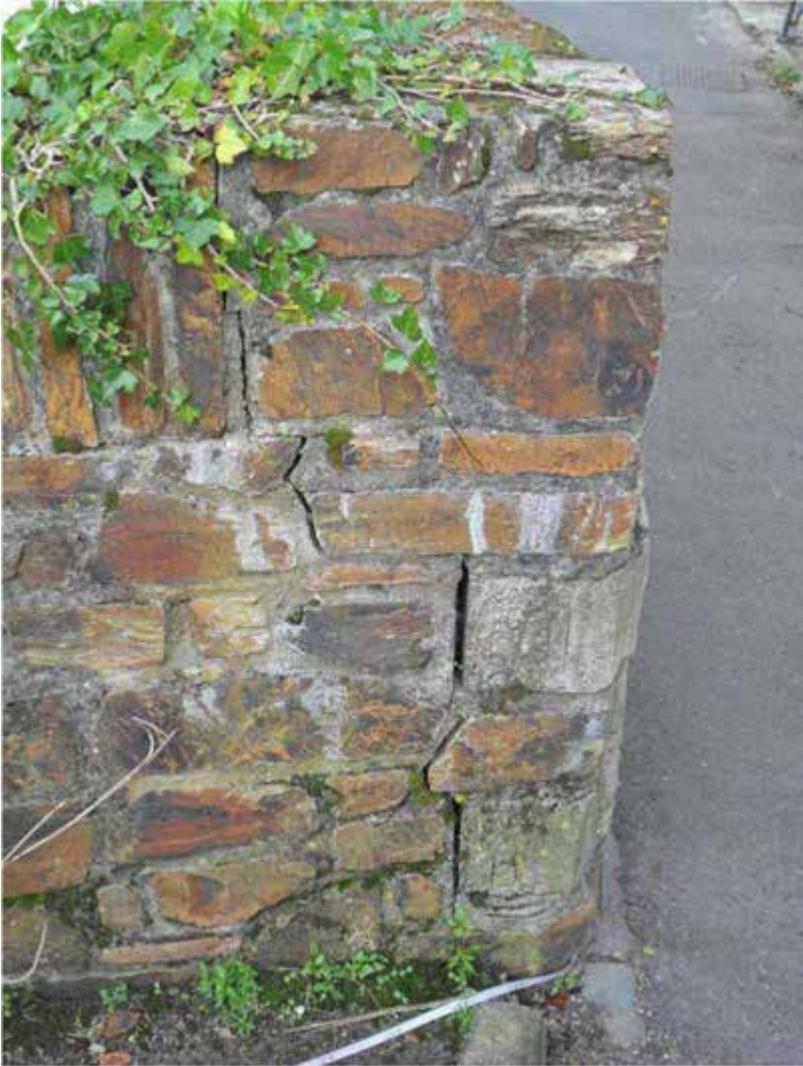
**Photograph 24 – Vertical crack where the new construction meets the old and the crack is transferred to the other side of the wall**

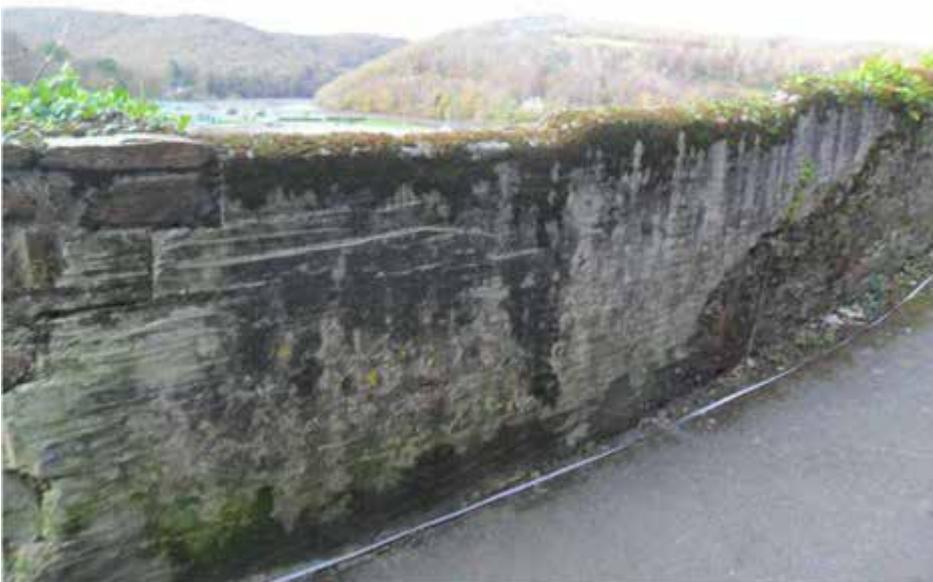
**Photograph 25 – Concrete construction of wall presumed as a past repair**

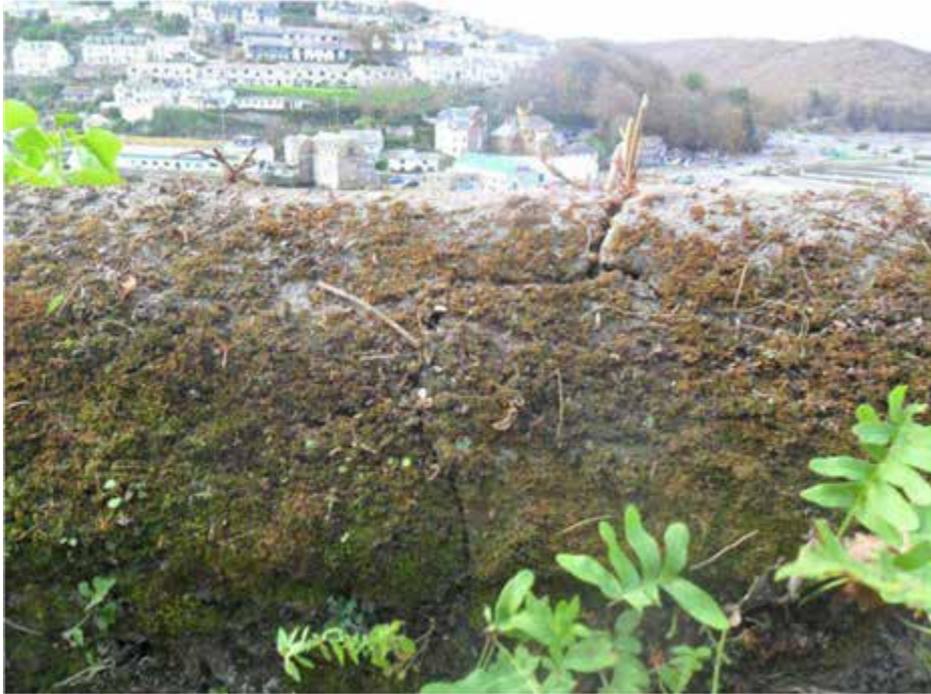
**Photograph 26 – Crack in coping mortar facing**

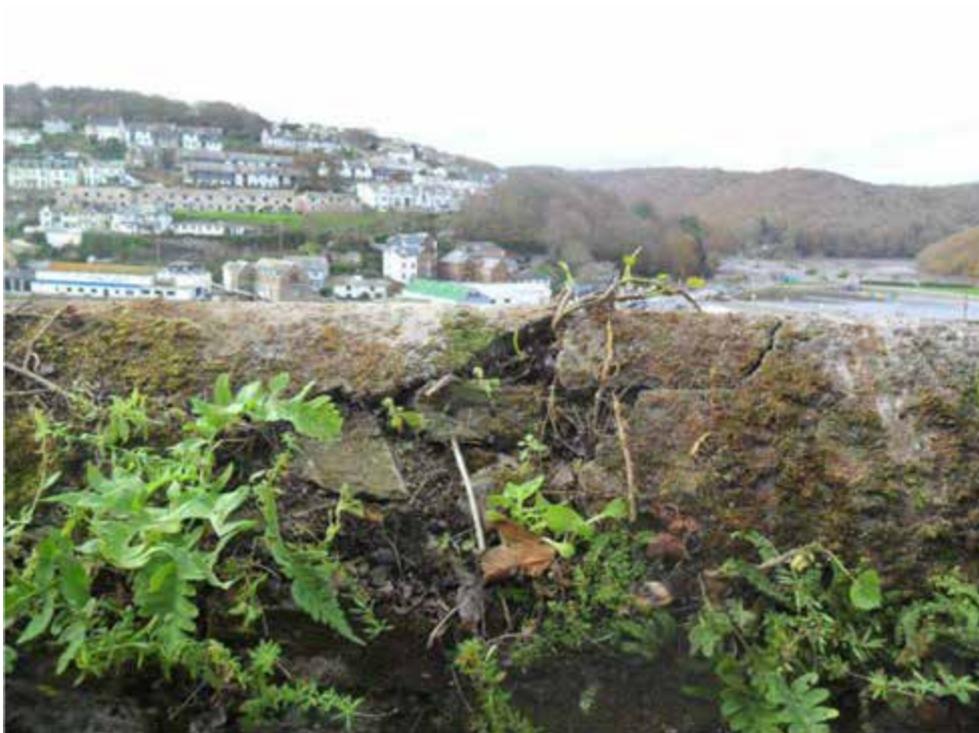
**Photograph 27 – Section of coping mortar missing**

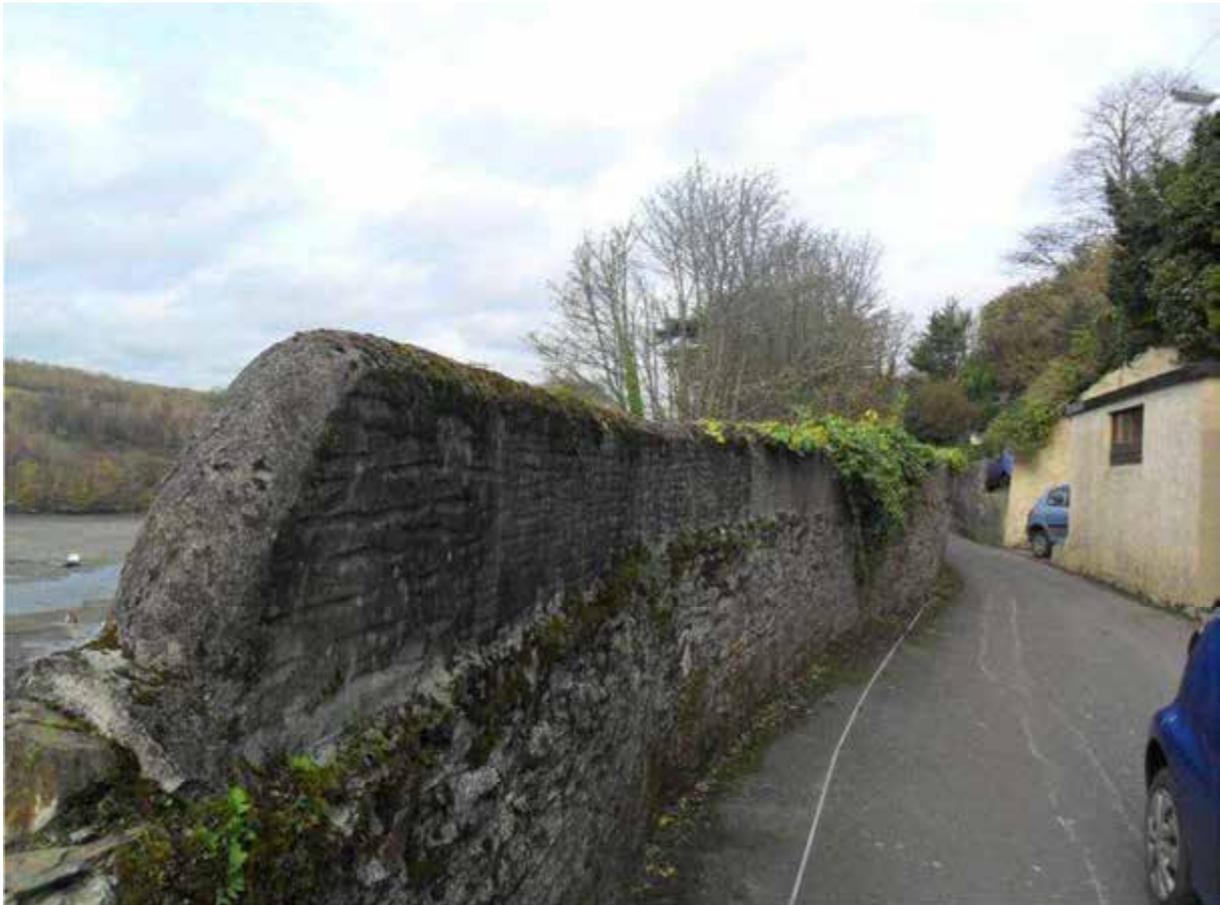
**Photograph 28 – A section of wall that has been added on top of the wall and is also loose, that made it unsafe to abseil over and so the wall below was inspected from ground level where possible.**

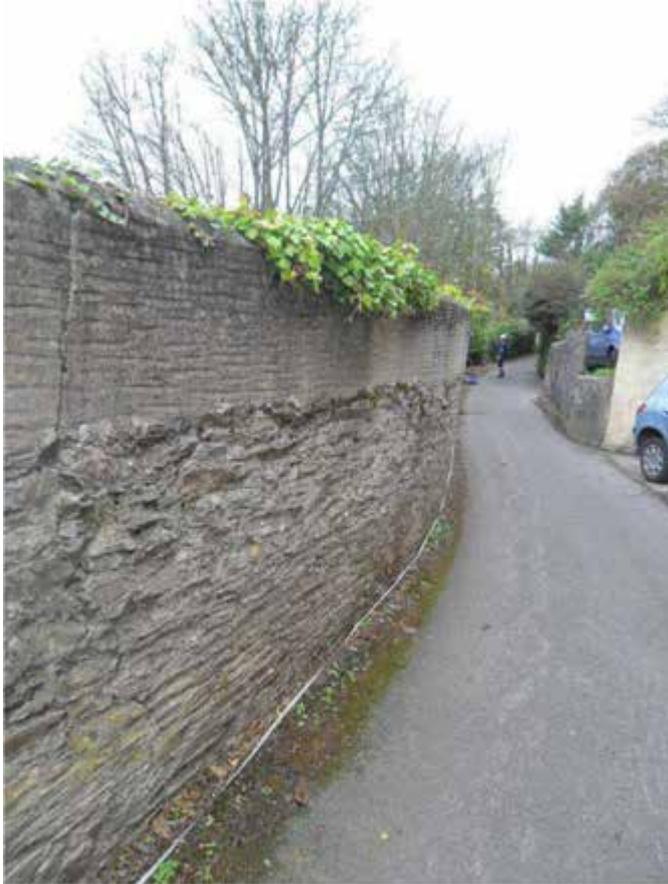
**Photograph 29 – Wall seems to be bowing inwards and if the top section was to fall, it is possible for the wall to fall onto the road.**

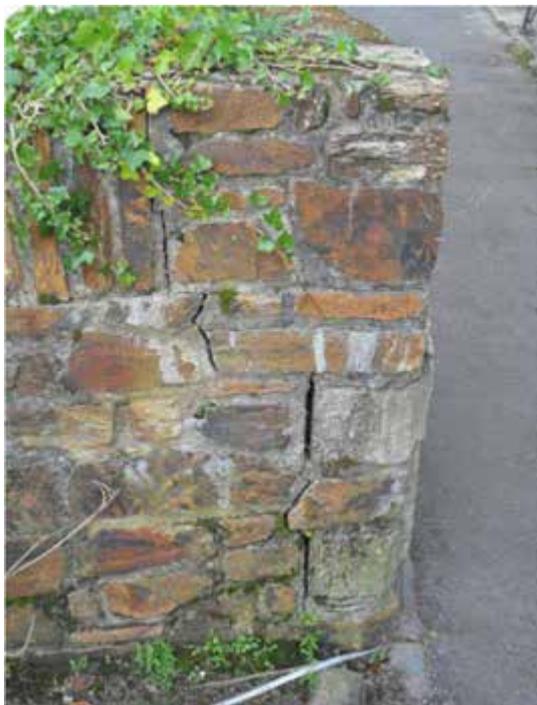
Photograph 1 – Vertical crack where the new construction meets the old and the crack is transferred to the other side of the wall

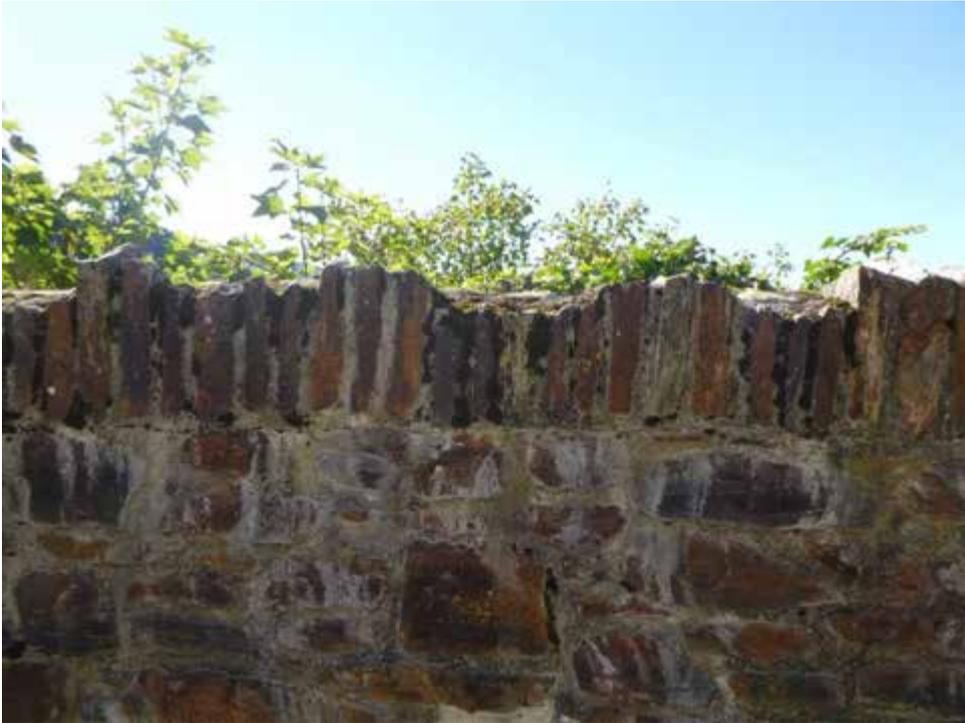
**Photograph 2 – Parapet in good condition some leachate, vegetation visible on wall.**

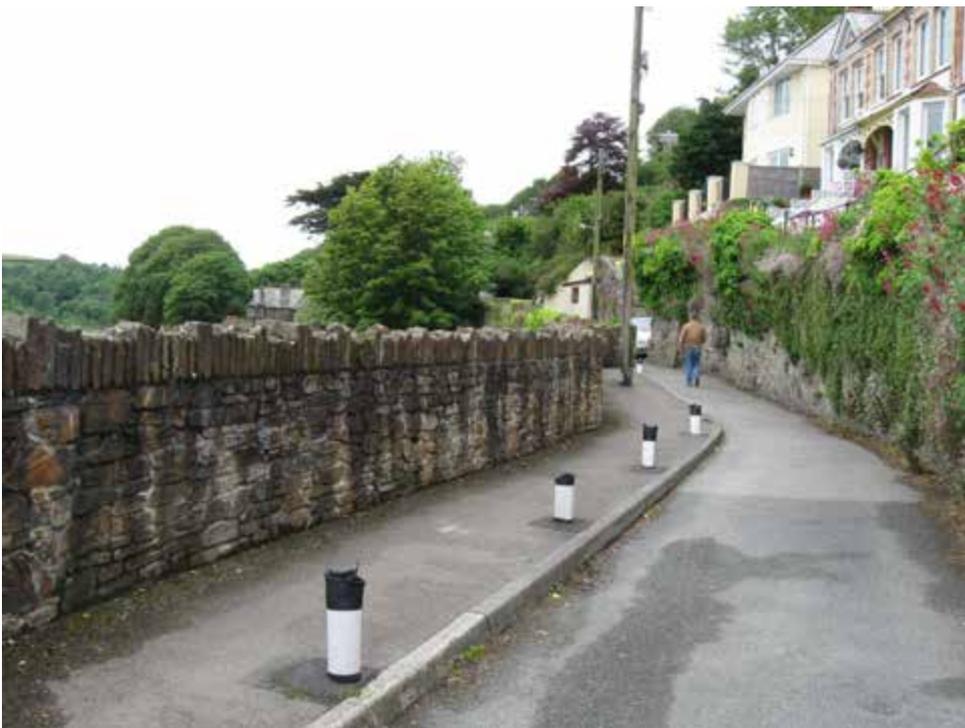
**Photograph 3 – Parapet in good condition, bollards all damaged some missing.**

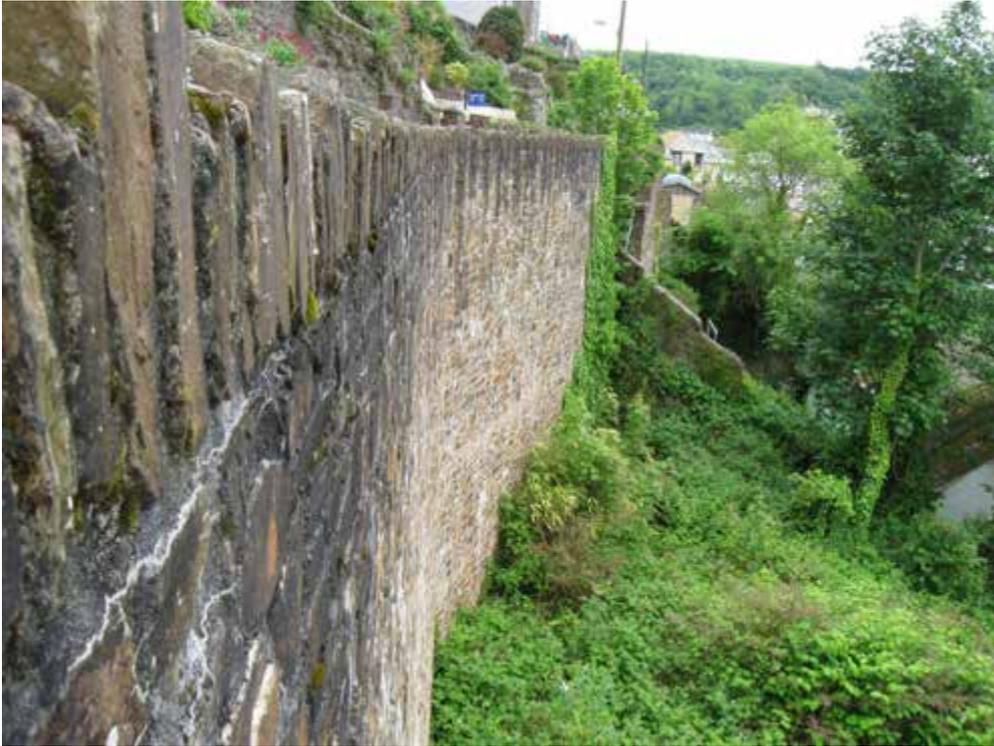
**Photograph 4 – Wall in good condition, some ivy growth visible.**

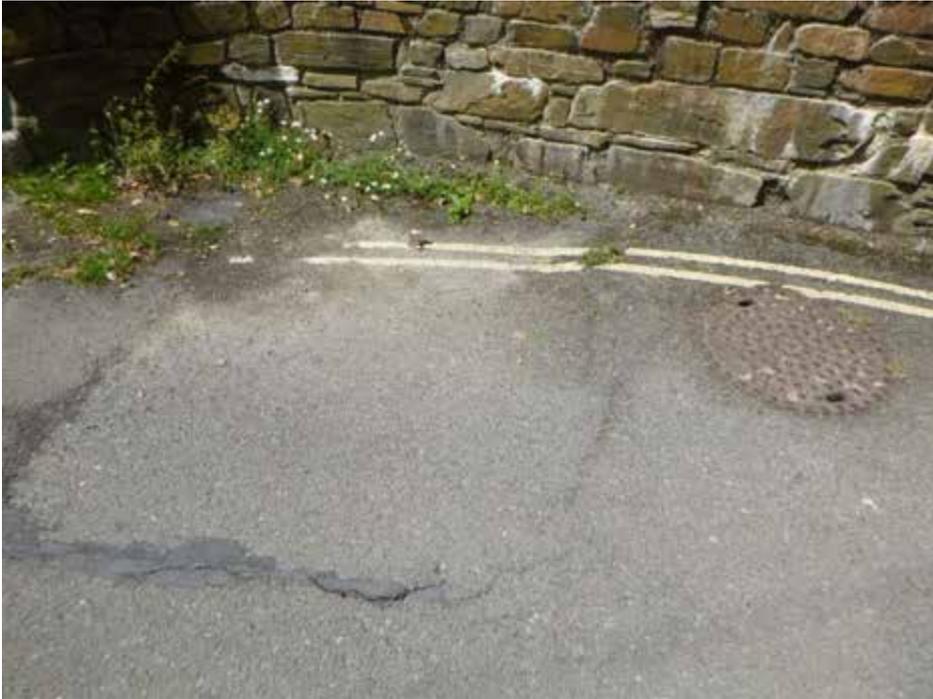
**Photograph 2: View of road surface note old repair patch in road showing signs of movement near the foul water drain.**

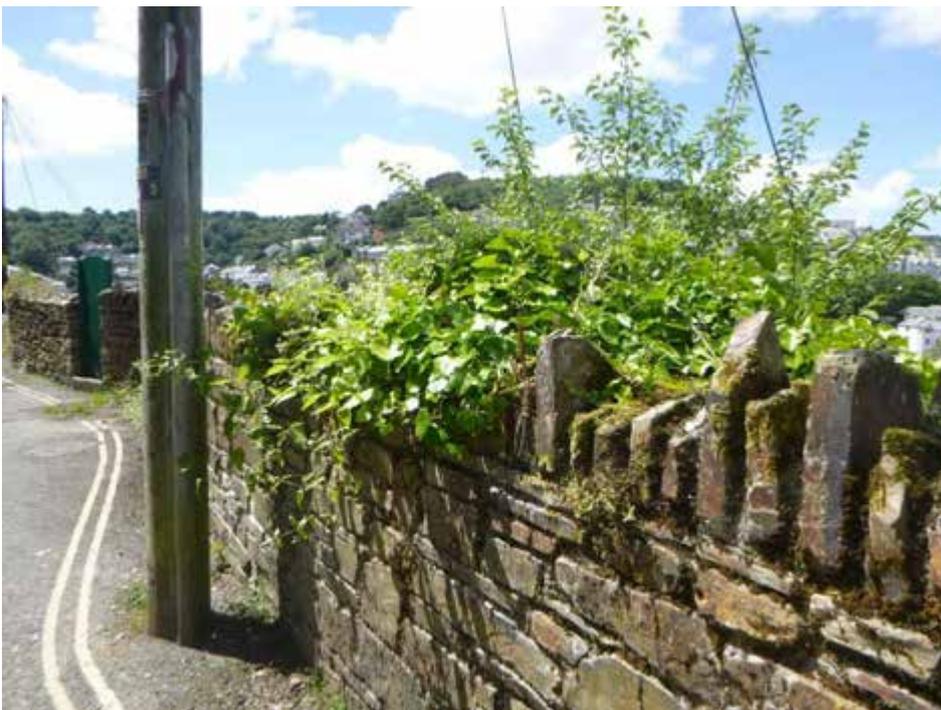
**Photograph 3: View of telegraph pole and vegetation growth on Parapet.**

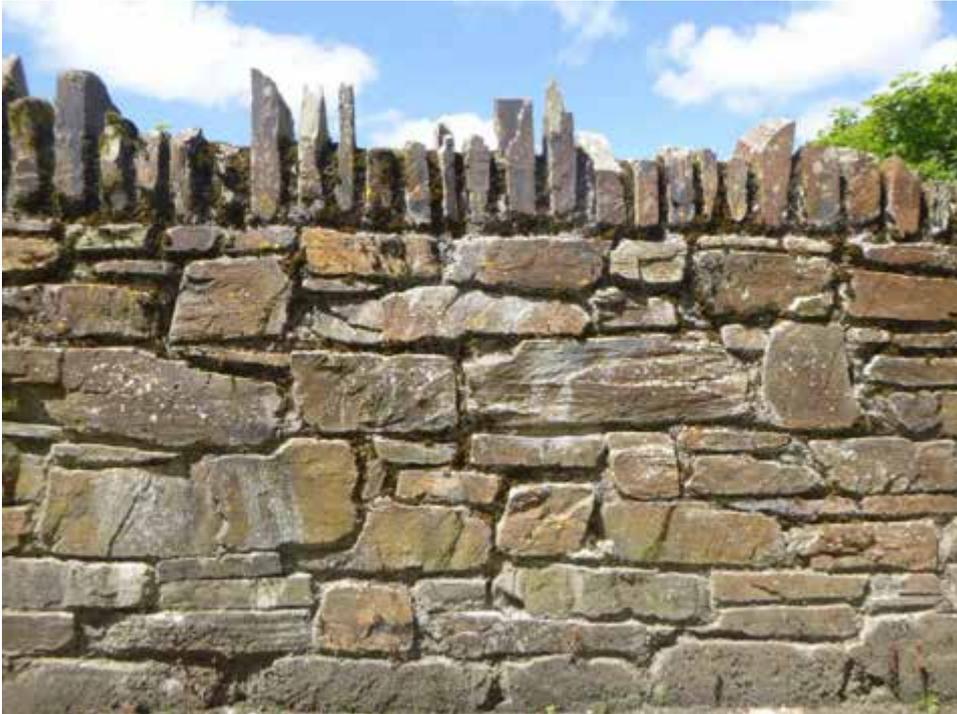
**Photograph 4: Parapet in good condition, Cock and Hen style coping**

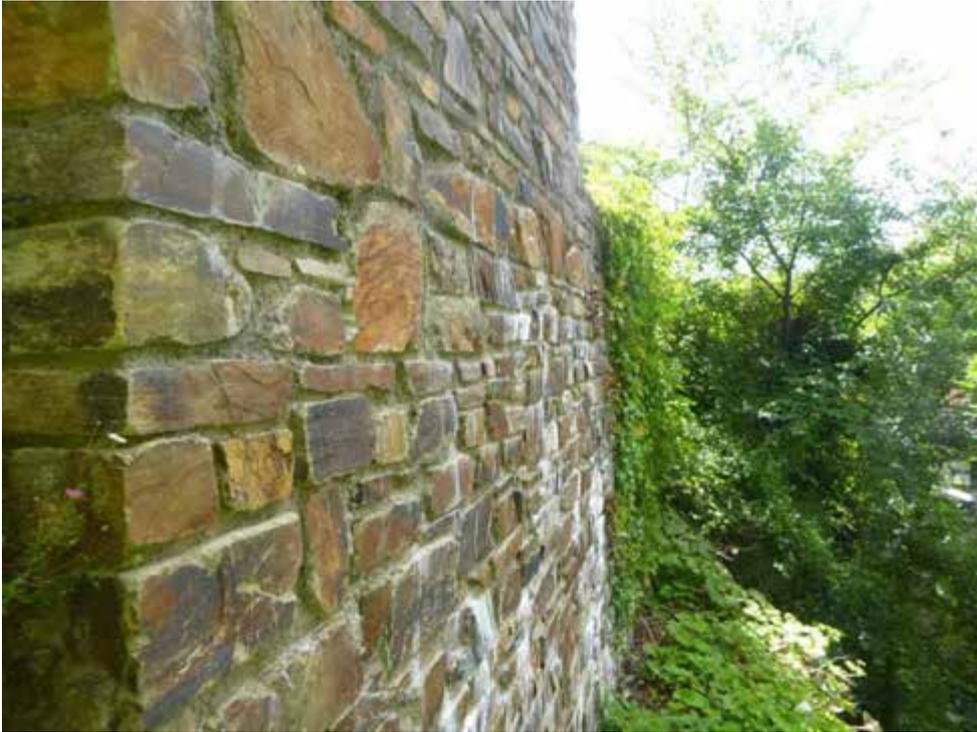
**Photograph 6: View of Retaining Wall Face good general condition, note Ivy growth.**

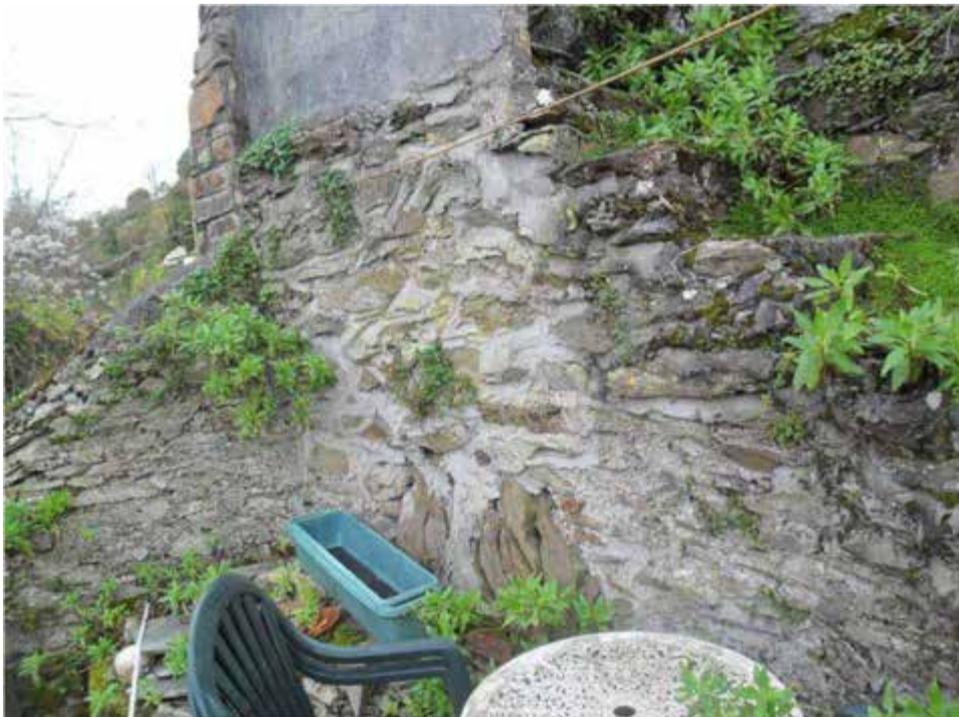
Photograph 1 – Repointed area of wall.

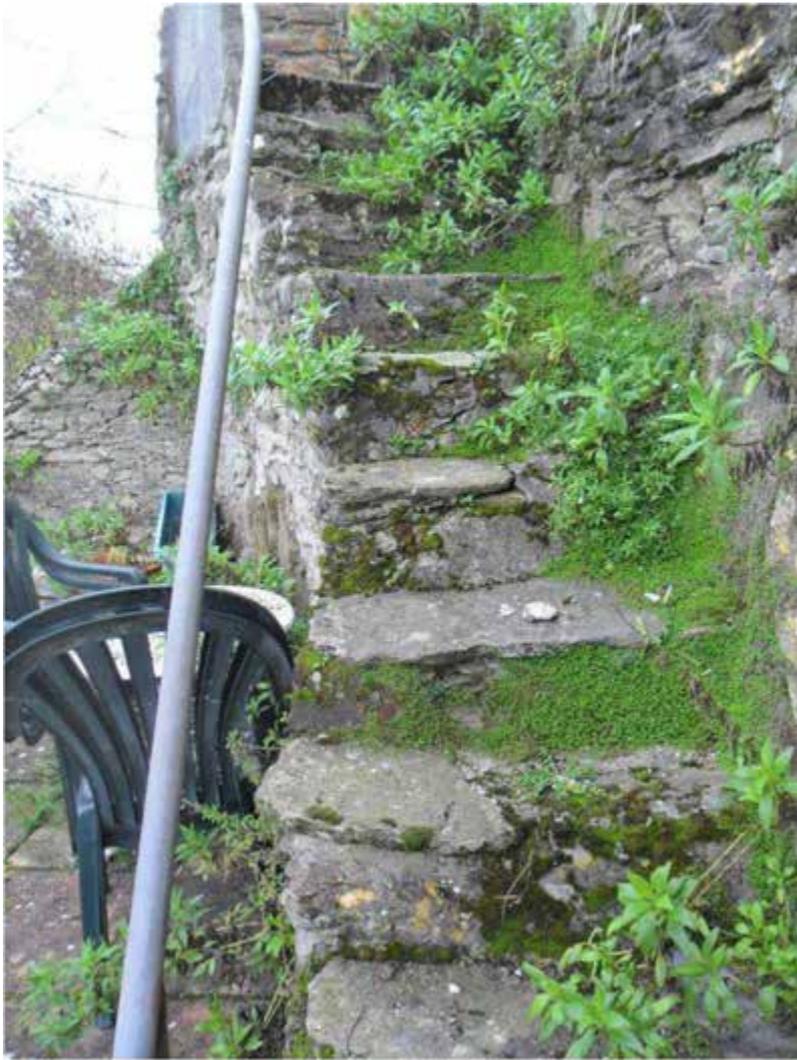
**Photograph 2 – Stairs, showing the vegetation present and the degree of lean that is on the wall**

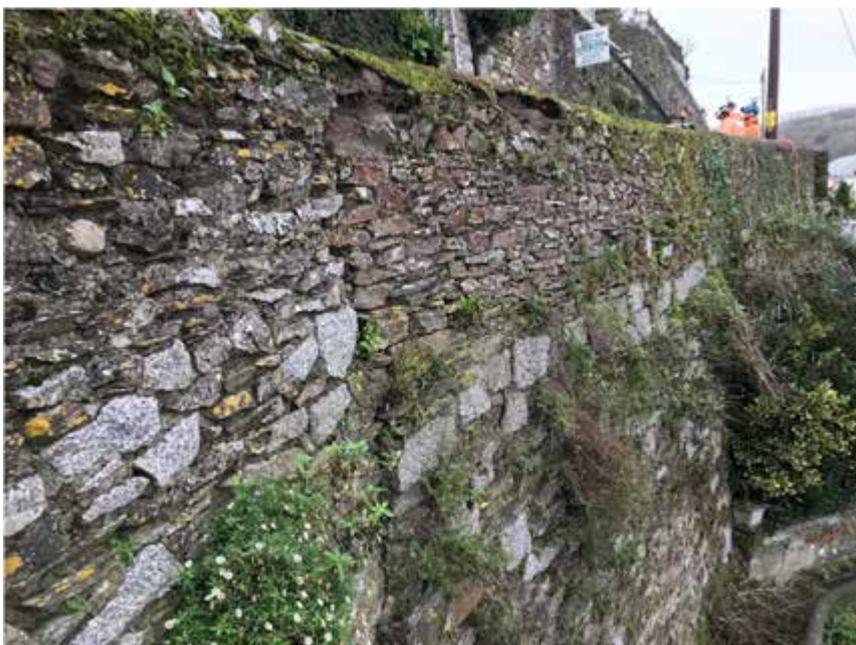
**Photograph 3 – Vertical Crack / Joint where the wall changes direction, note recent stone and coping loss**

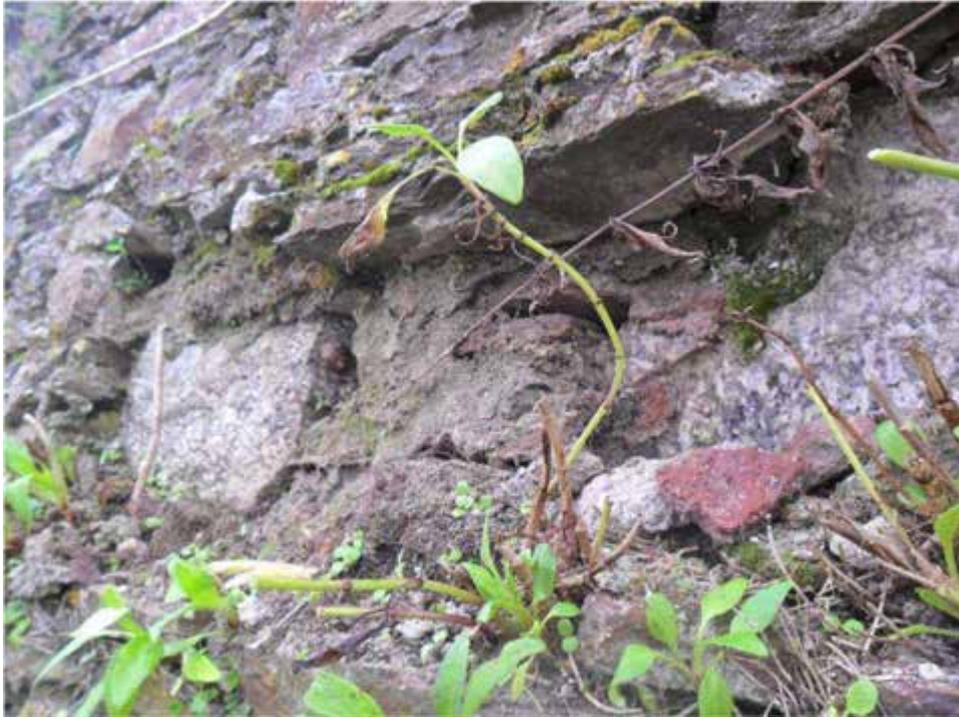
**Photograph 4 – Facing missing on stonework**

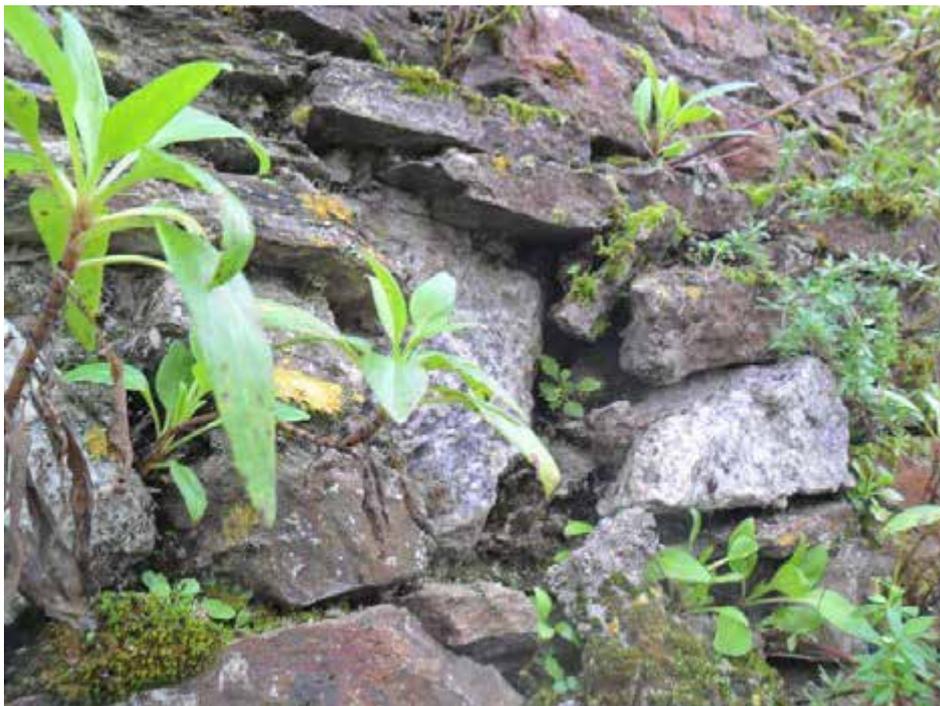
**Photograph 5 – Minor stonework displacement and missing masonry infill between large stones.**

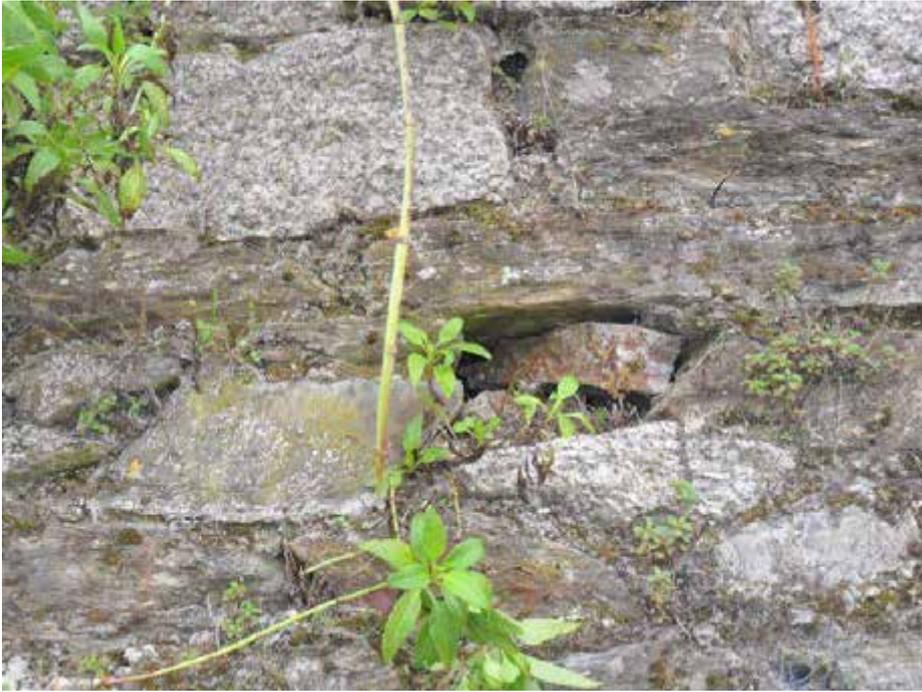
**Photograph 7 – Loose and missing stonework**
