# Shutta Road Retaining Walls Route Report

**Division: CORMAC Consultancy**

**Site name:** Shutta Road, Looe

Report No: CN1701503/01/01

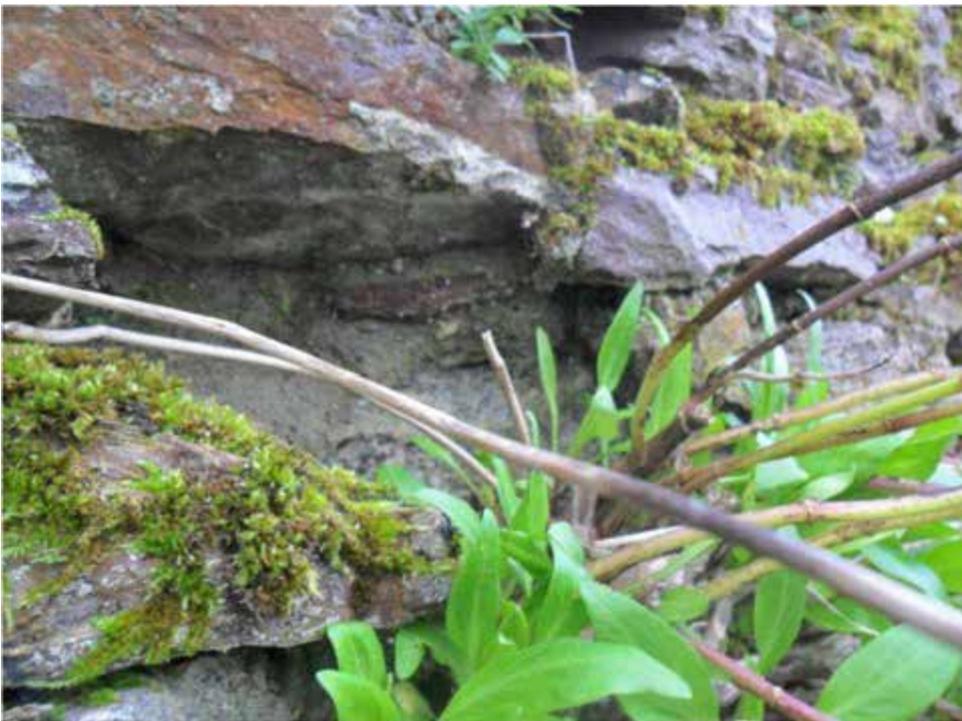
**Photograph 8 – Missing stonework**

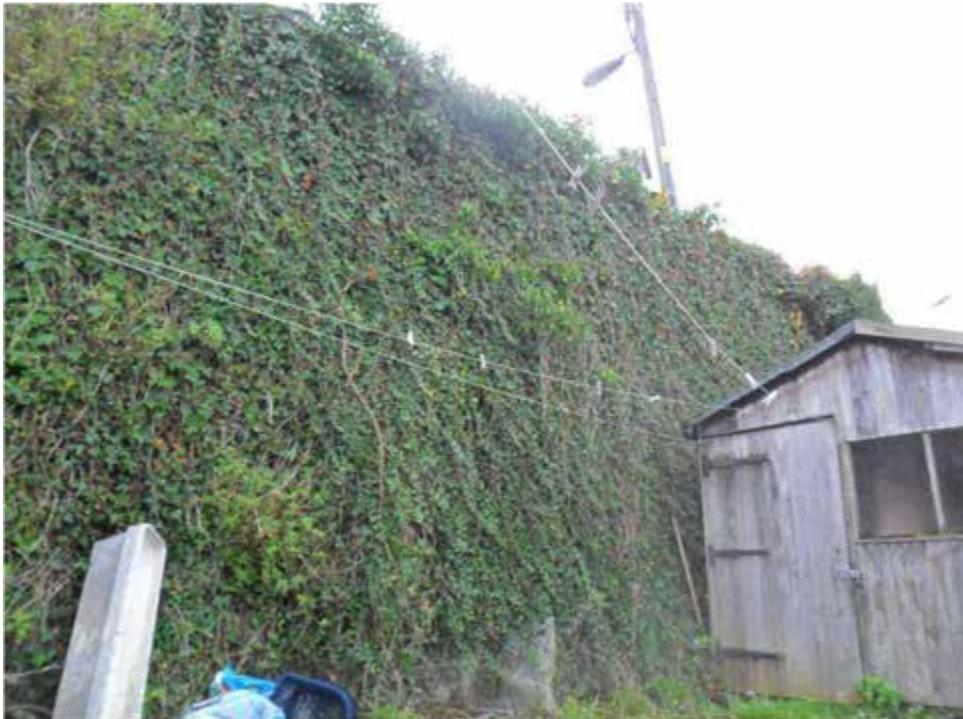
**Photograph 9 – Vegetation growth present on the wall**

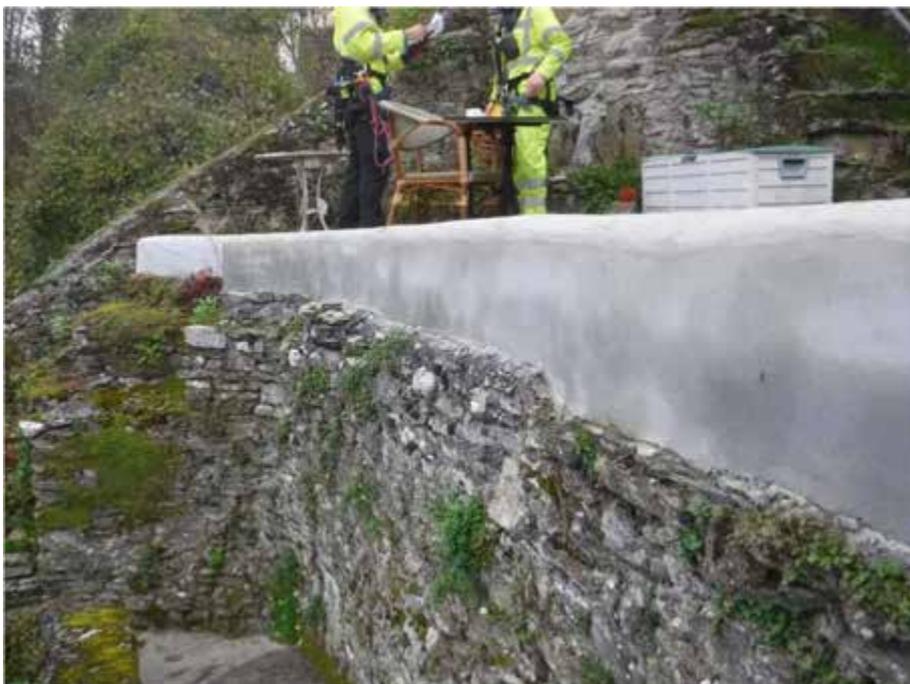
**Photograph 10 – Render facing of lower wall extension**

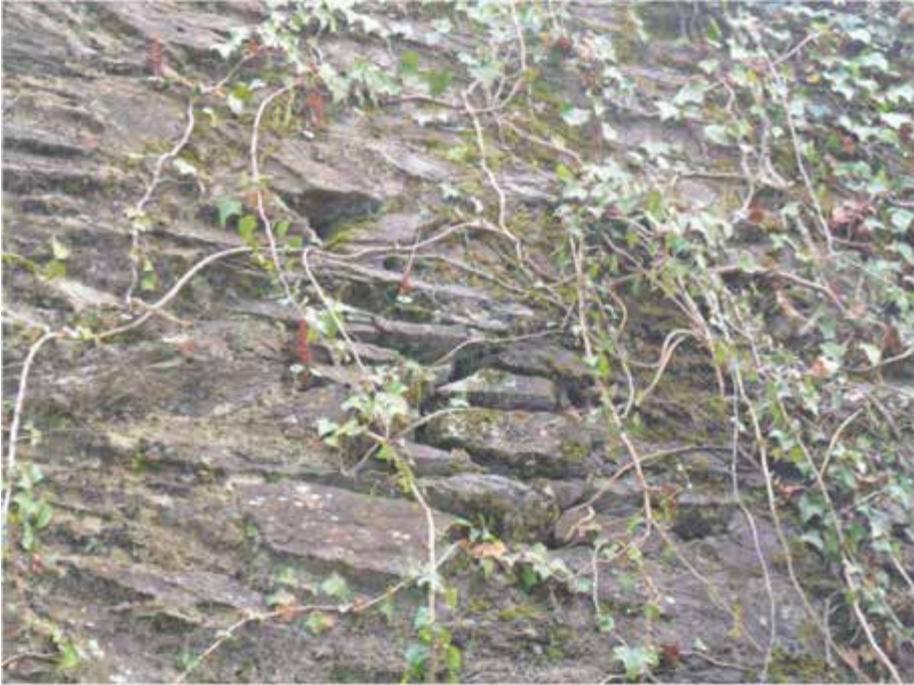
**Photograph 11 – Open mortar joints**

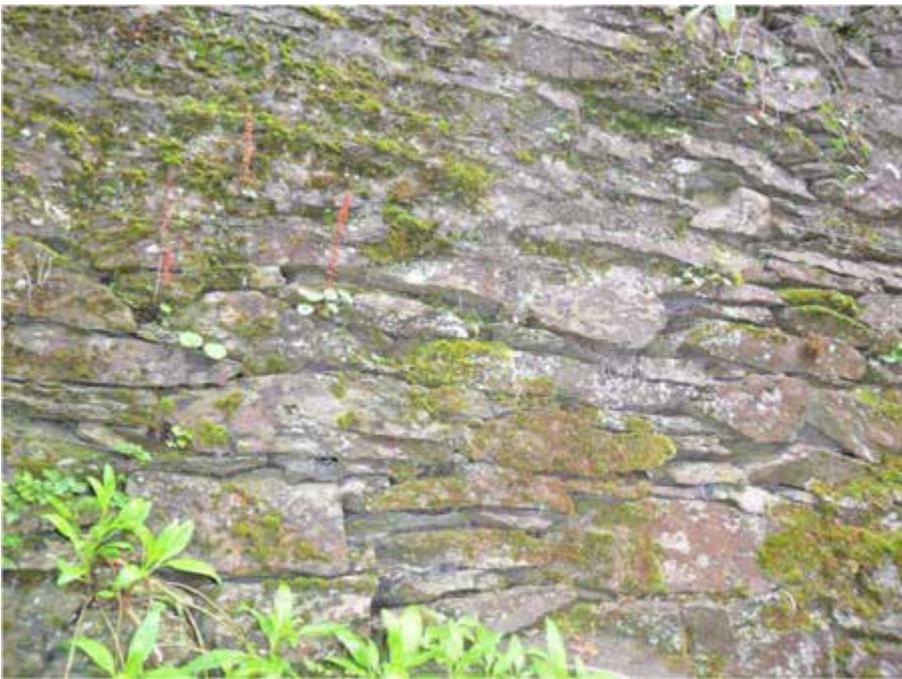
**Photograph 12 – Open mortar joints.**

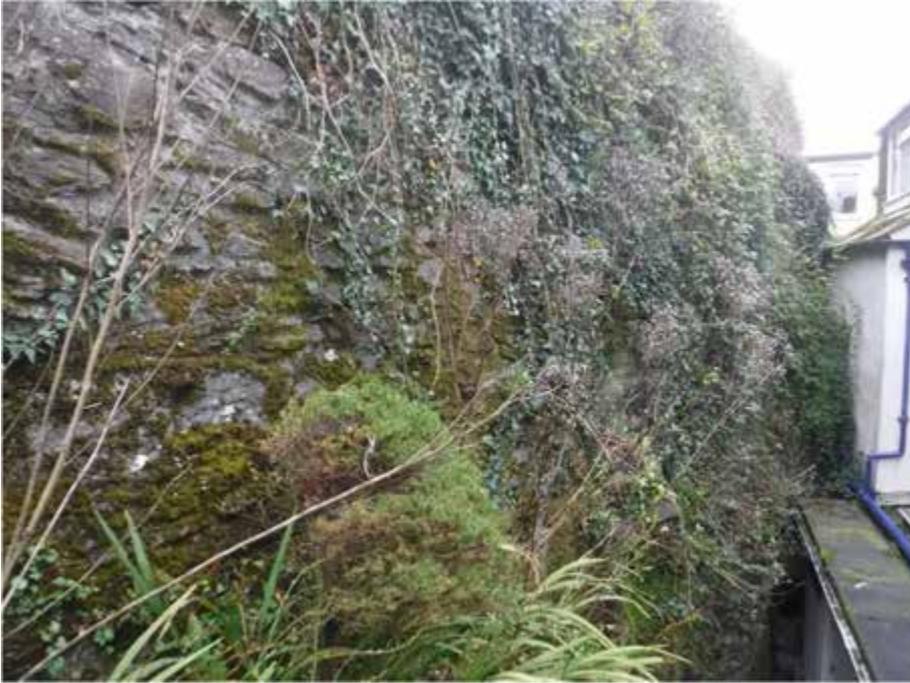
**Photograph 13 – Vegetation growth present on the lower section of the wall**

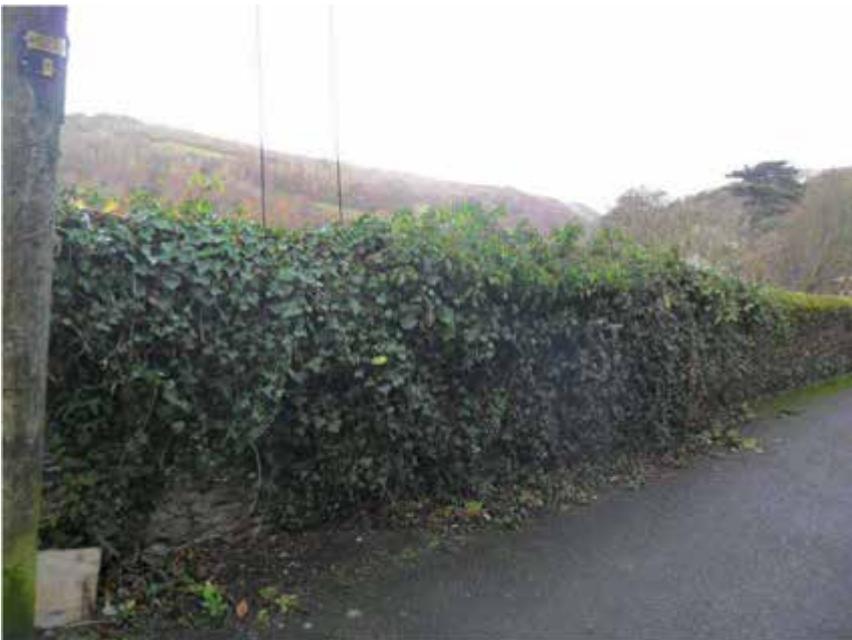
**Photograph 14 – Vegetation growth**

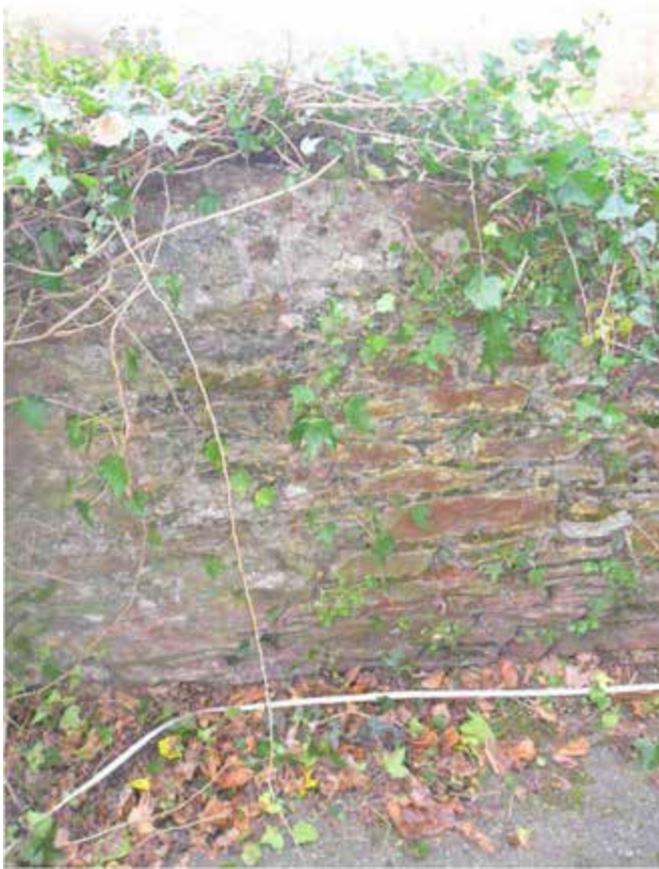
**Photograph 15 – Vertical/diagonal crack to 10mm wide**

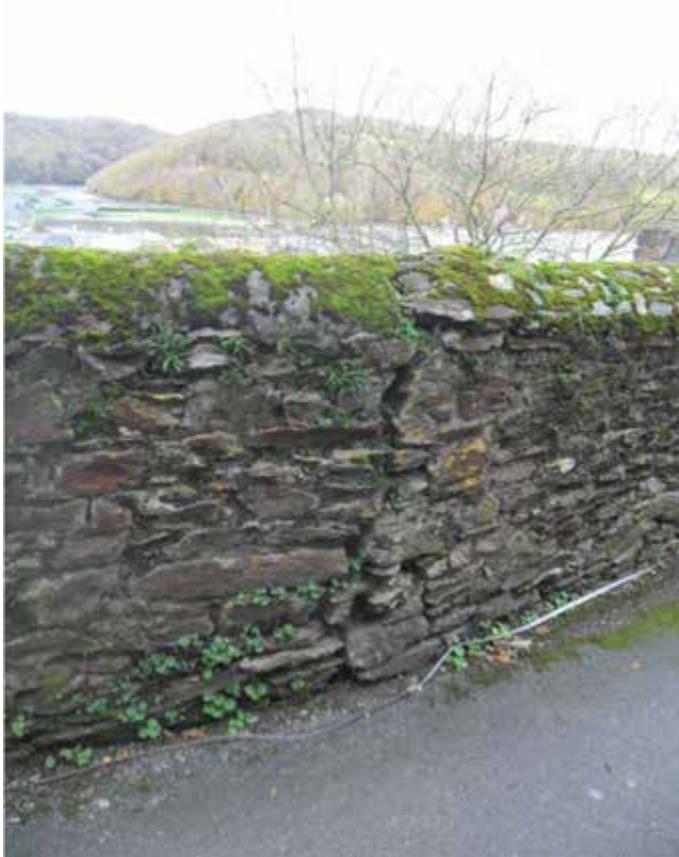
**Photograph 14 – Vertical crack / rough open masonry joint where wall changes direction**

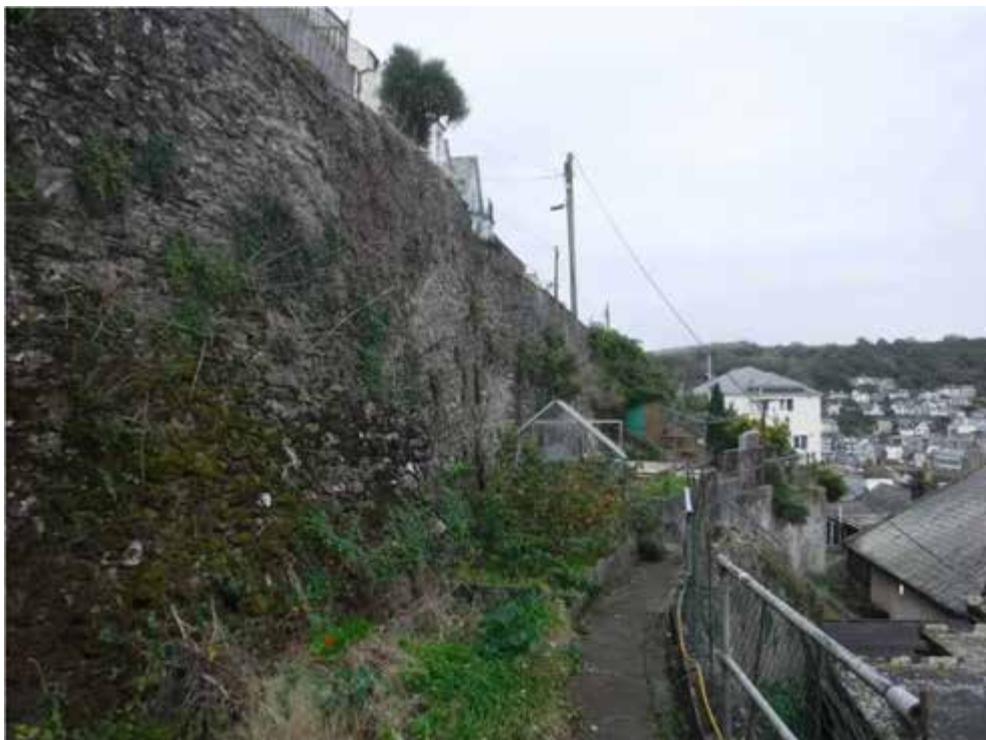
Photo 1: General view of the west elevation, upper section.

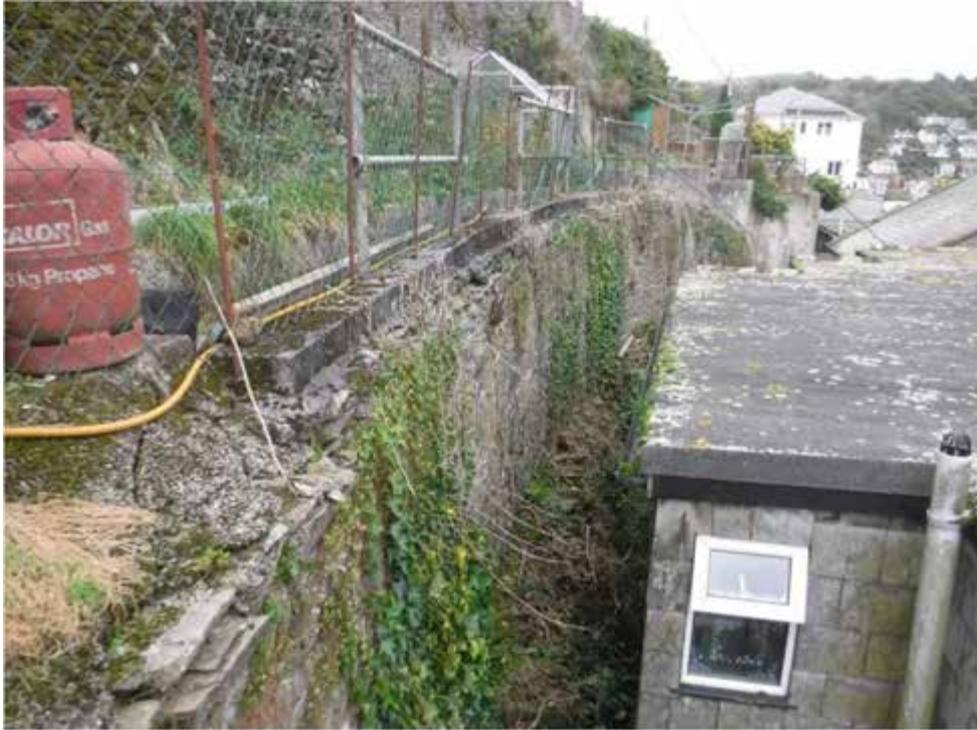
**Photo 2: General view showing the west elevation of the wall, lower section.**

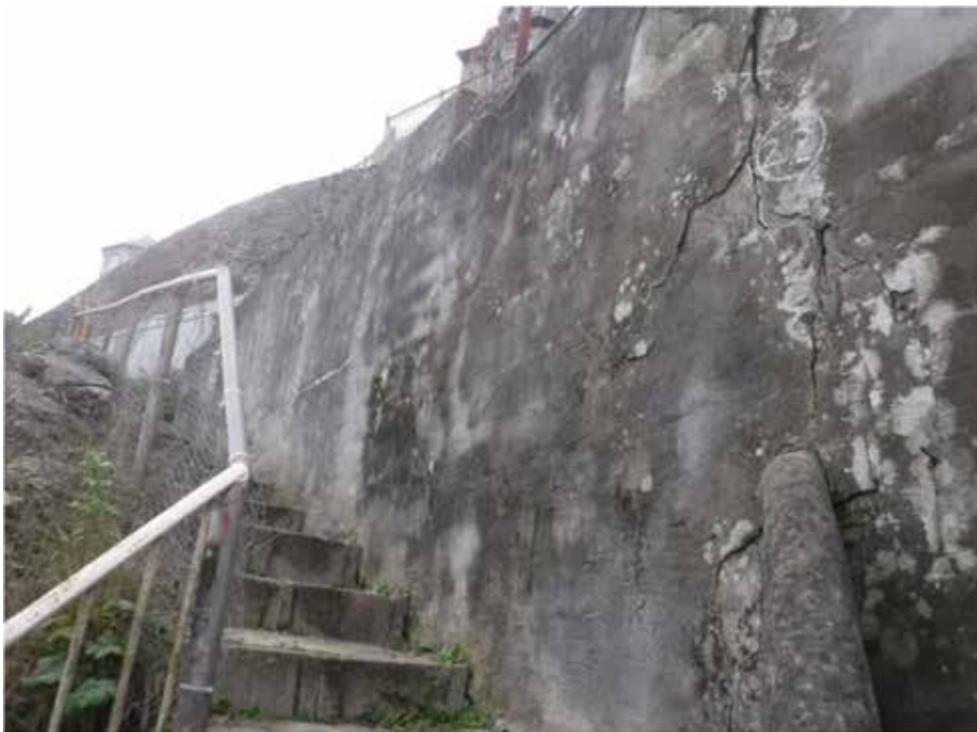
**Photo 3: General view showing the concrete render section of the lower wall above access steps.**

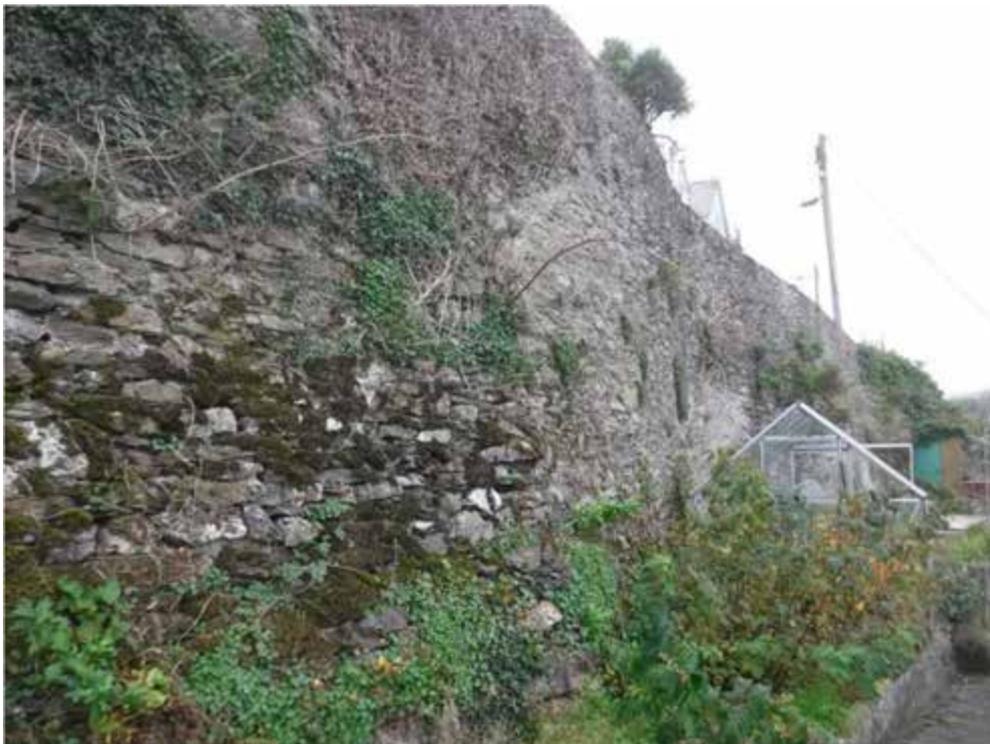
**Photo 9: View showing the typical condition of the upper wall.**

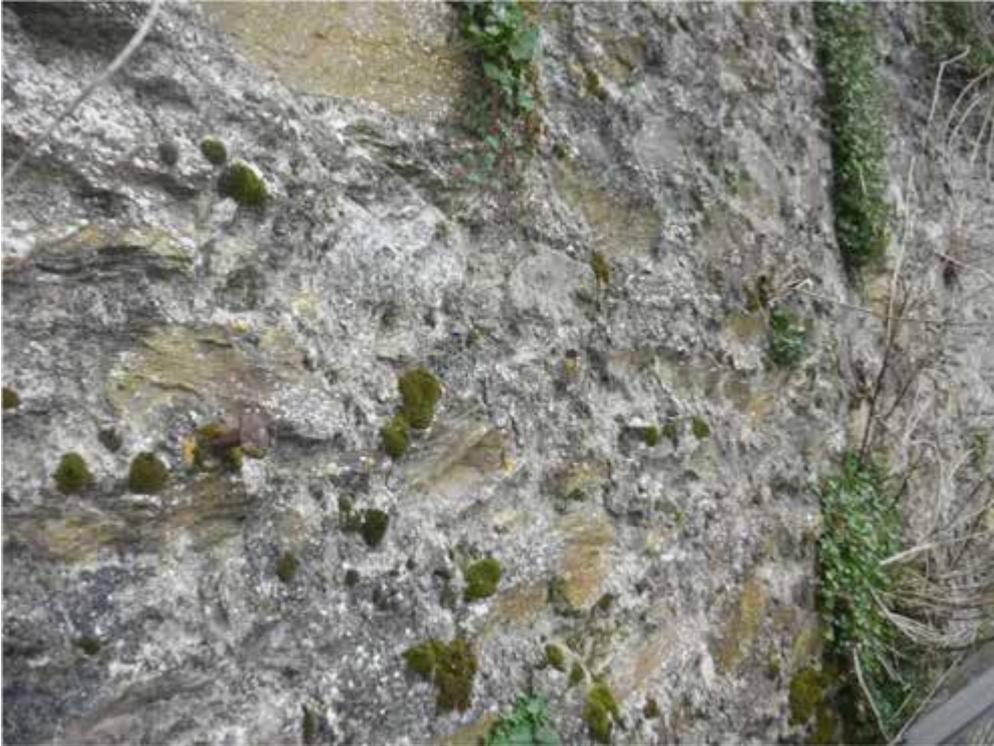
**Photo 10: Detailed view of the stone masonry and mortar (upper wall).**

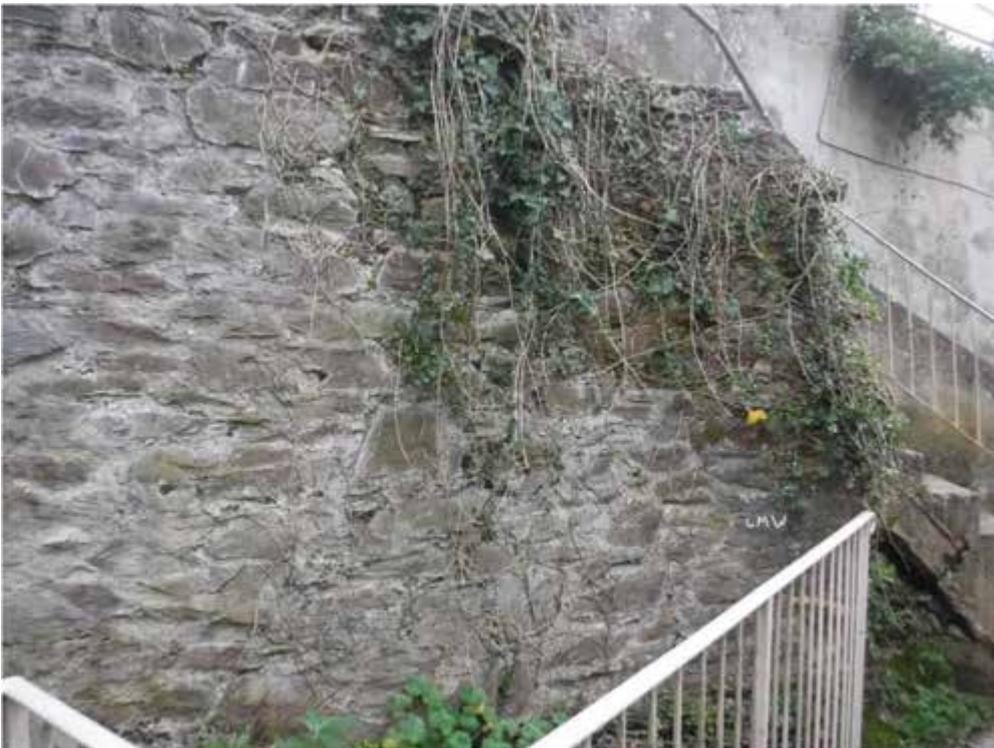
**Photo 11: View showing typical condition of the south end of the lower wall. Photo**

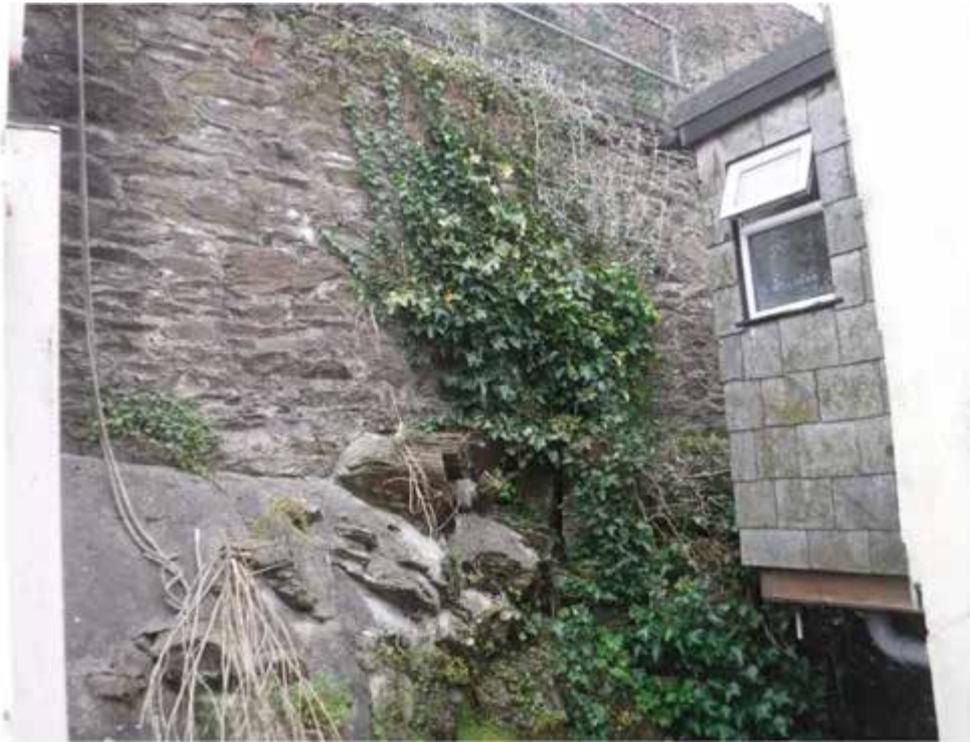
Photo 12: View showing typical condition of the north end of the lower wall.

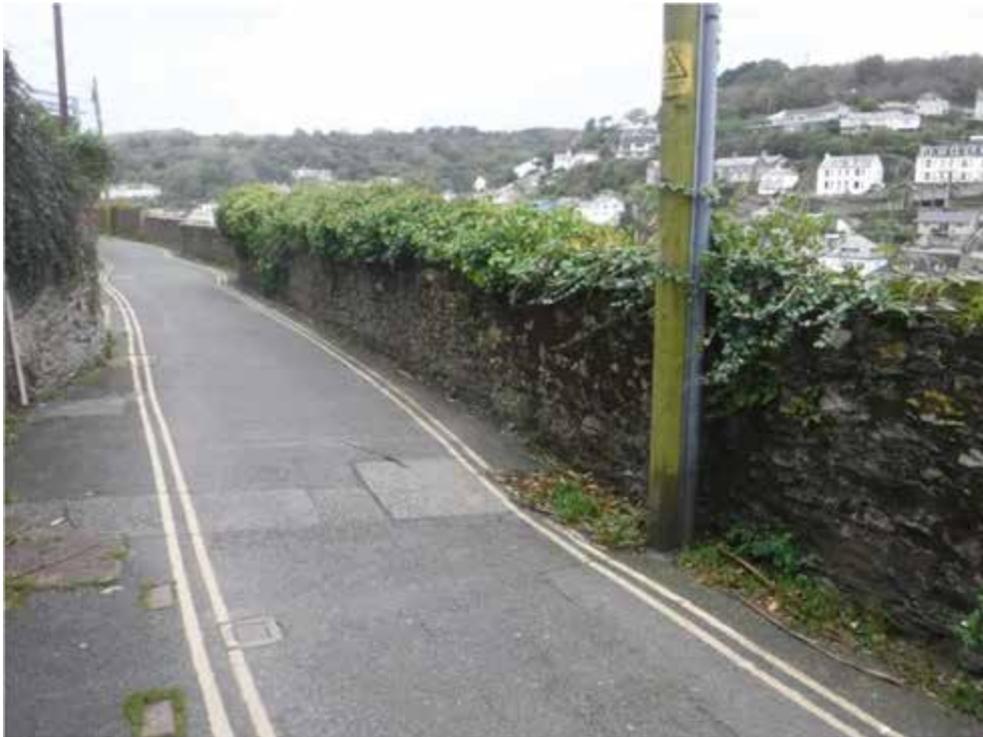
**Photo 18: View showing the vegetation growth to the parapet (south end).**

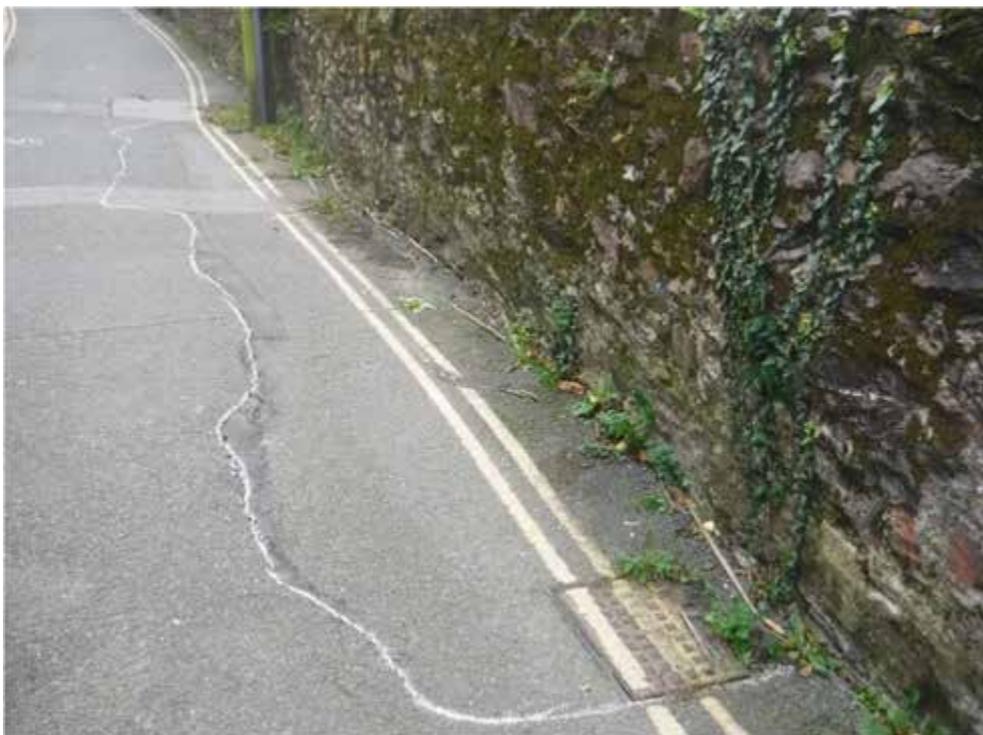
**Photo 19: View showing the area of sunken carriageway towards the south end of the structure.**

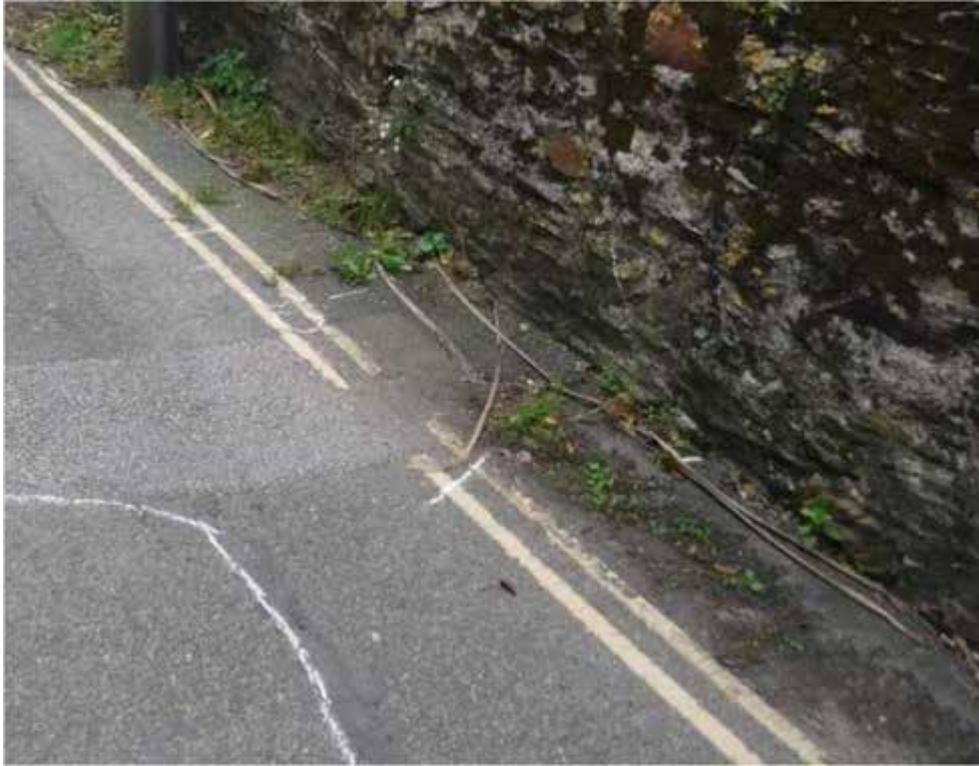
**Photo 20: View showing the gap between the carriageway surfacing and the parapet.**

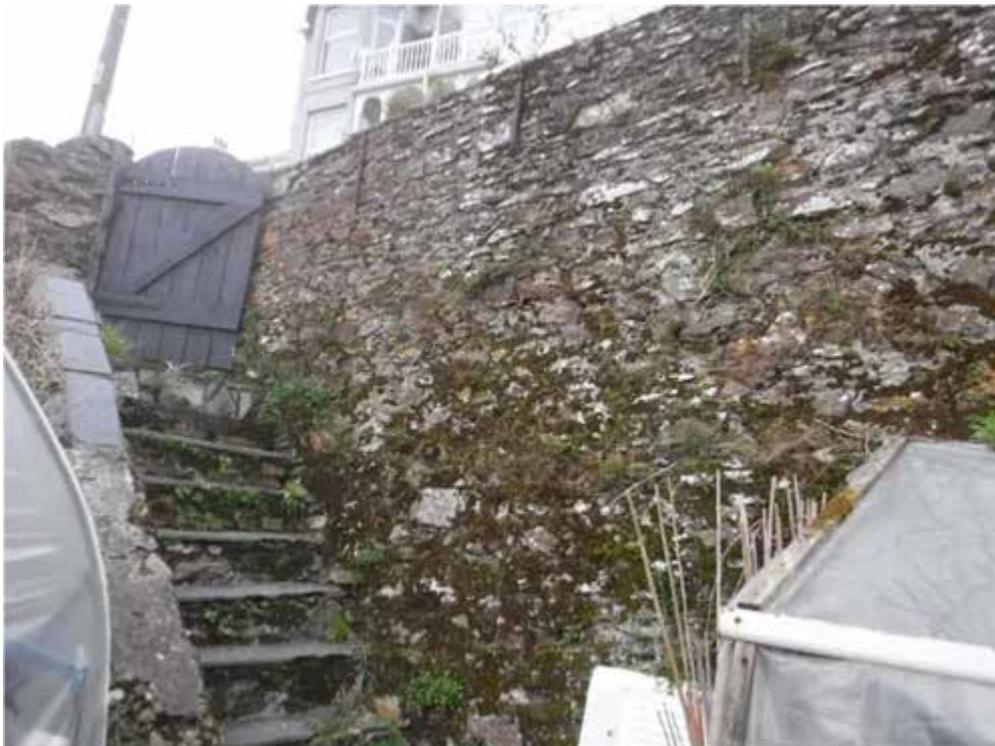
**Photo 21: View showing the access steps from the carriageway to the terraced garden**

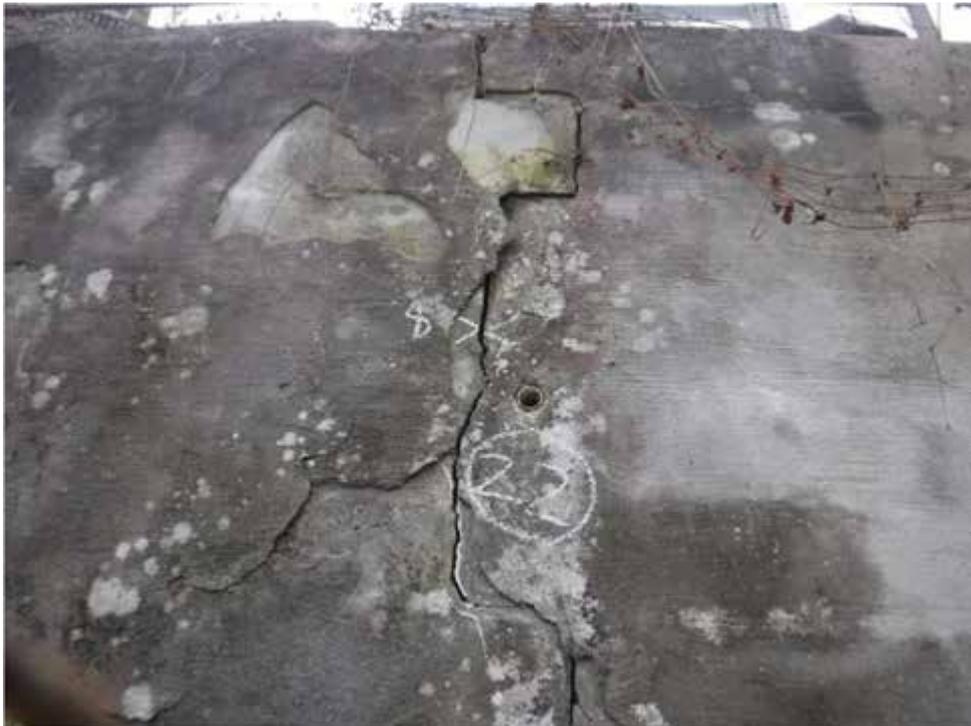
**Photo 22: View showing cracks and delaminated cement render in the concrete block wall.**

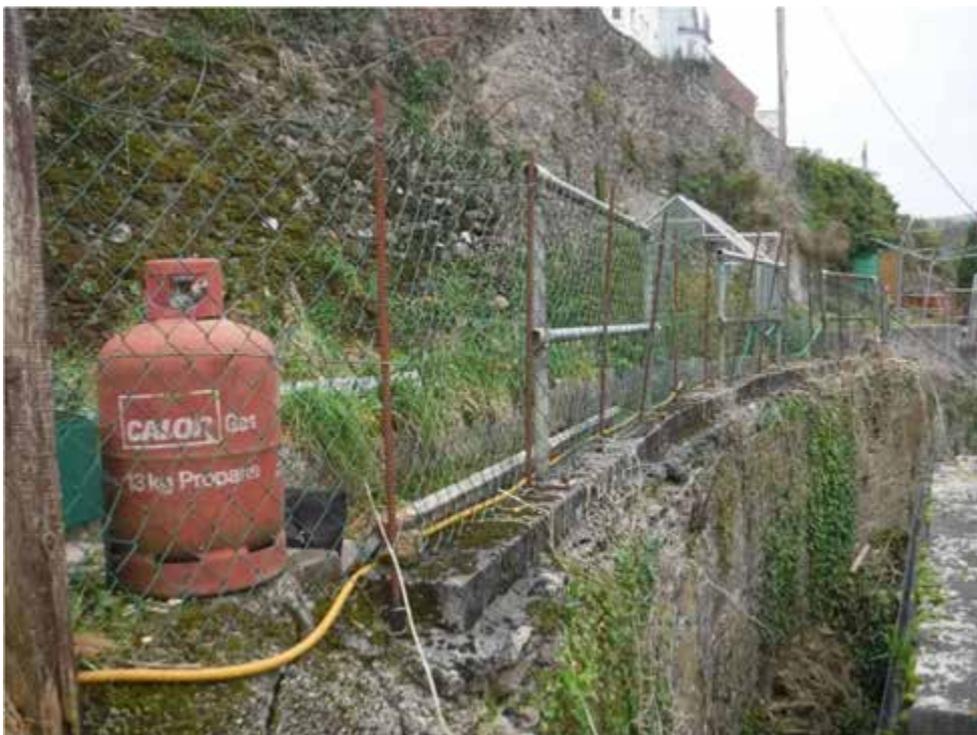
**Photo 23: View showing the handrail at the edge of the terrace garden.**

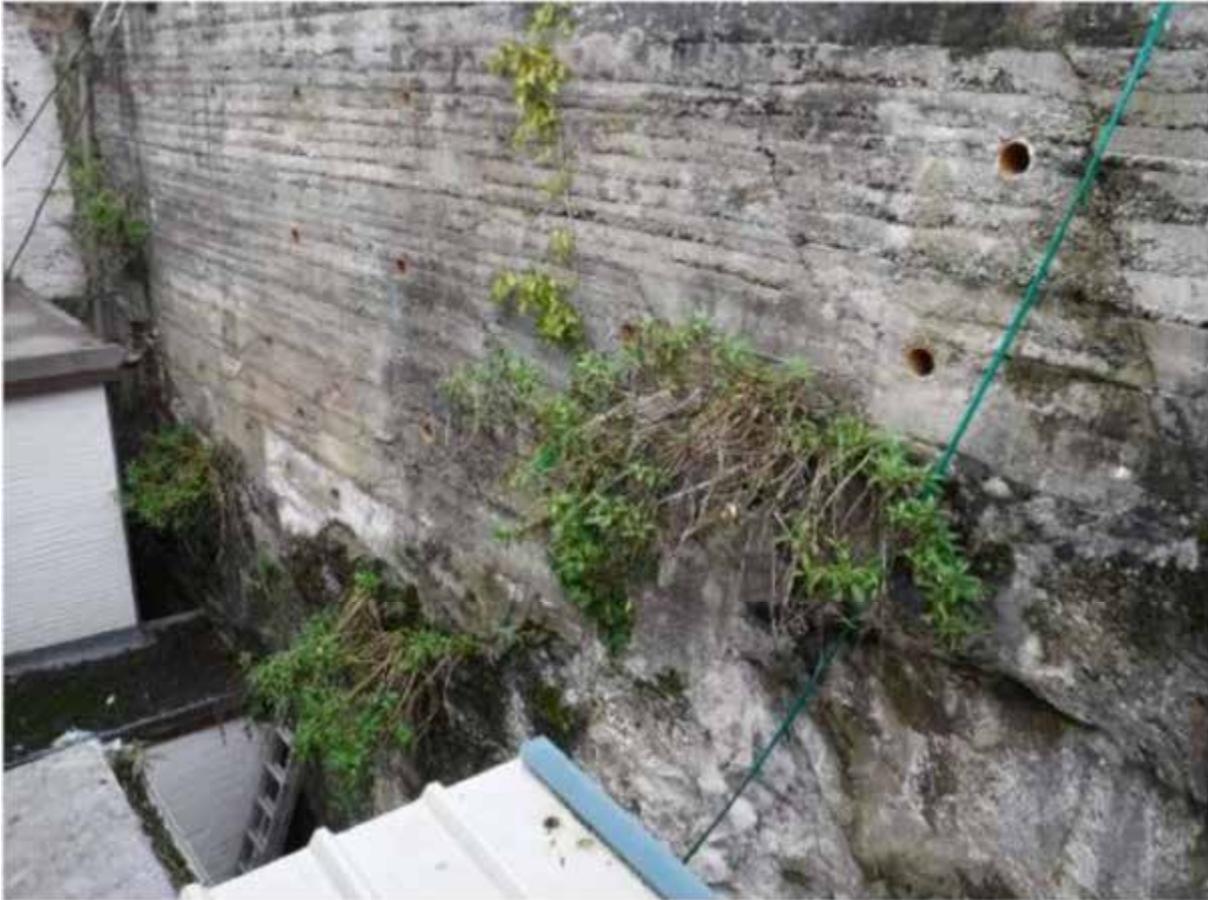
**Photo 14: General view looking north showing the lower section retaining wall from CH 10m.**

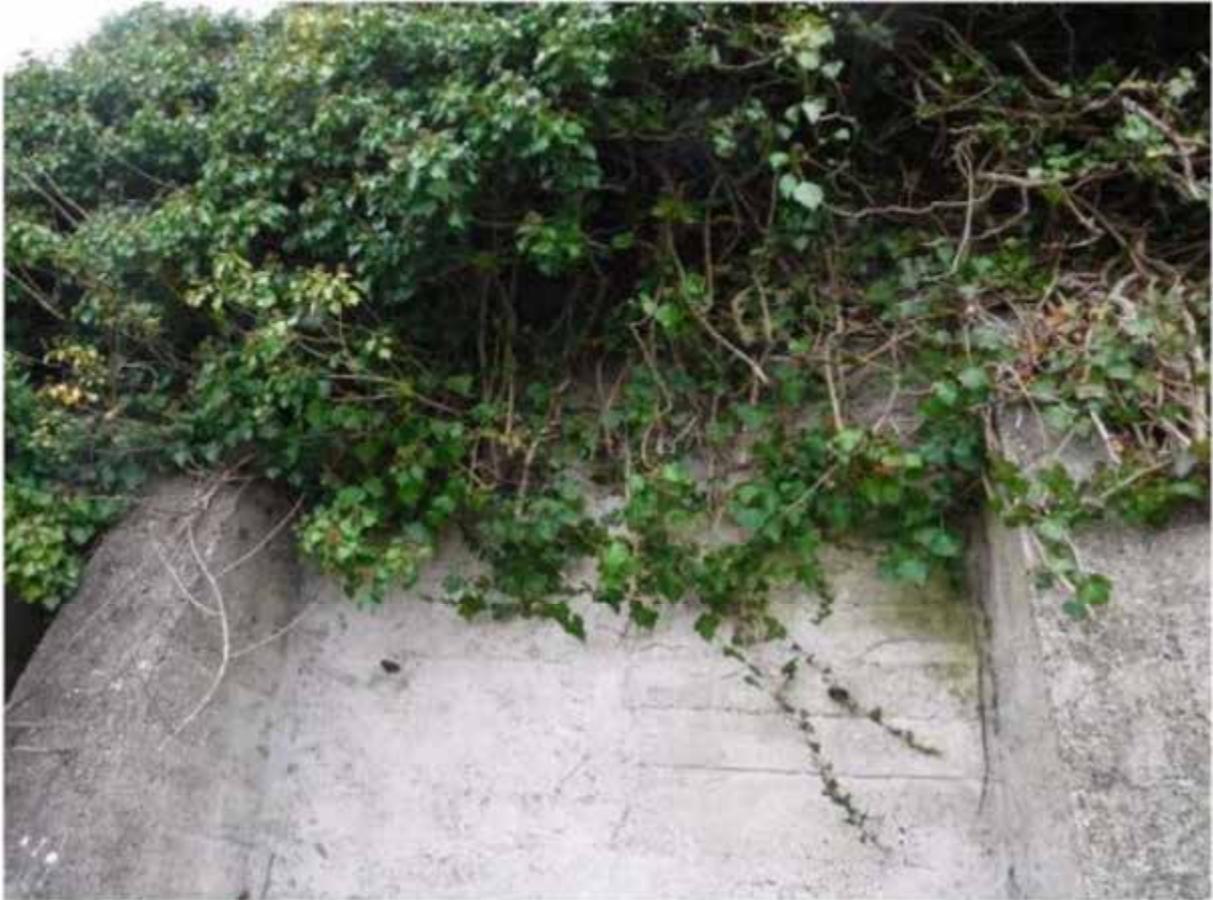
**Photo 24: Vegetation on the upper section of the retaining wall at CH 5m.**

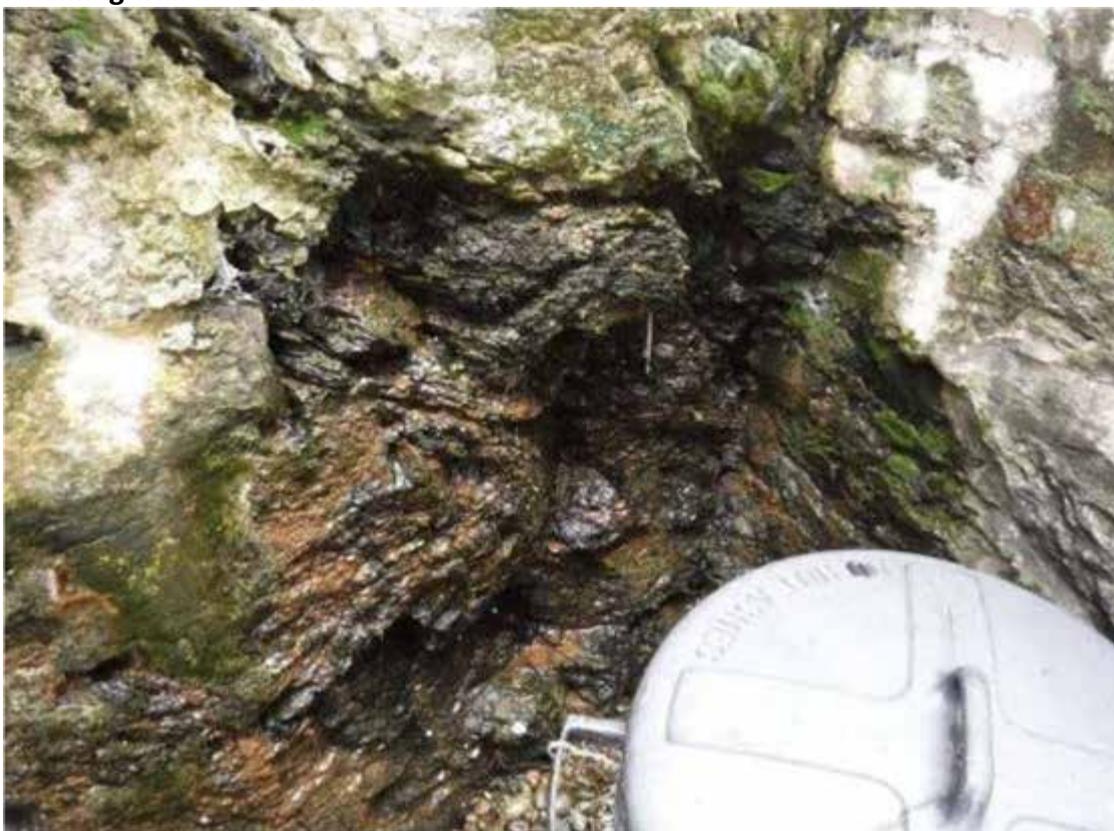
**Photo 27: View showing stone loss/weathering and water seepage in the lower section of retaining wall at CH 6m.**

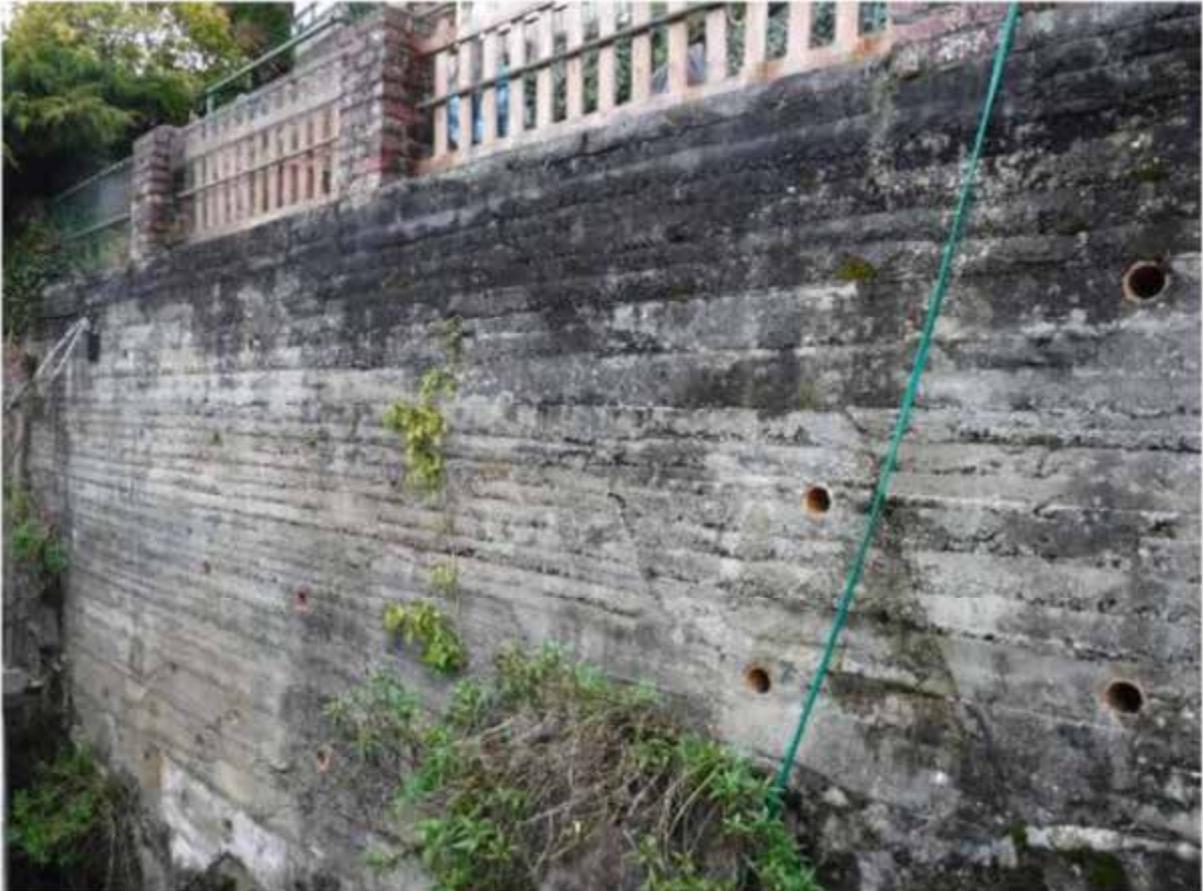
**Photo 30: View showing multiple weep hole outlets in the lower section of the retaining wall.**

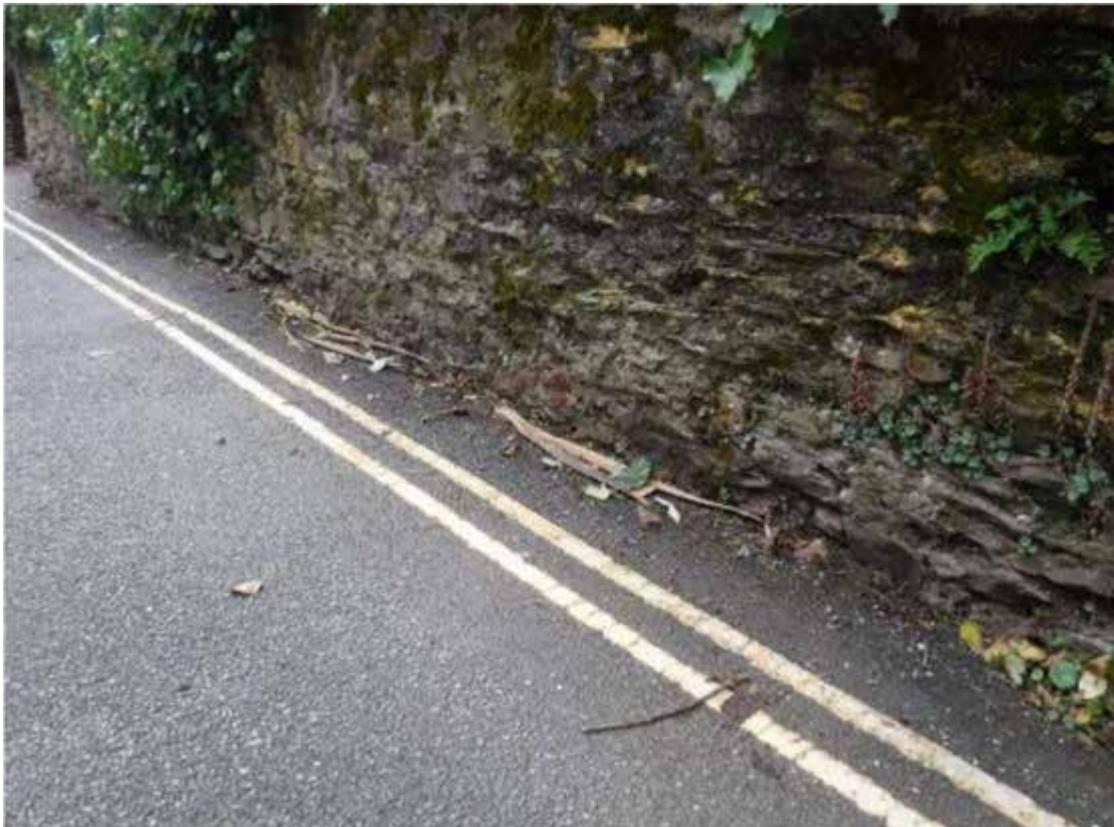
**Photo 31: View showing the erosion to the lower 400mm of the parapet above the upper section of the retaining wall.**

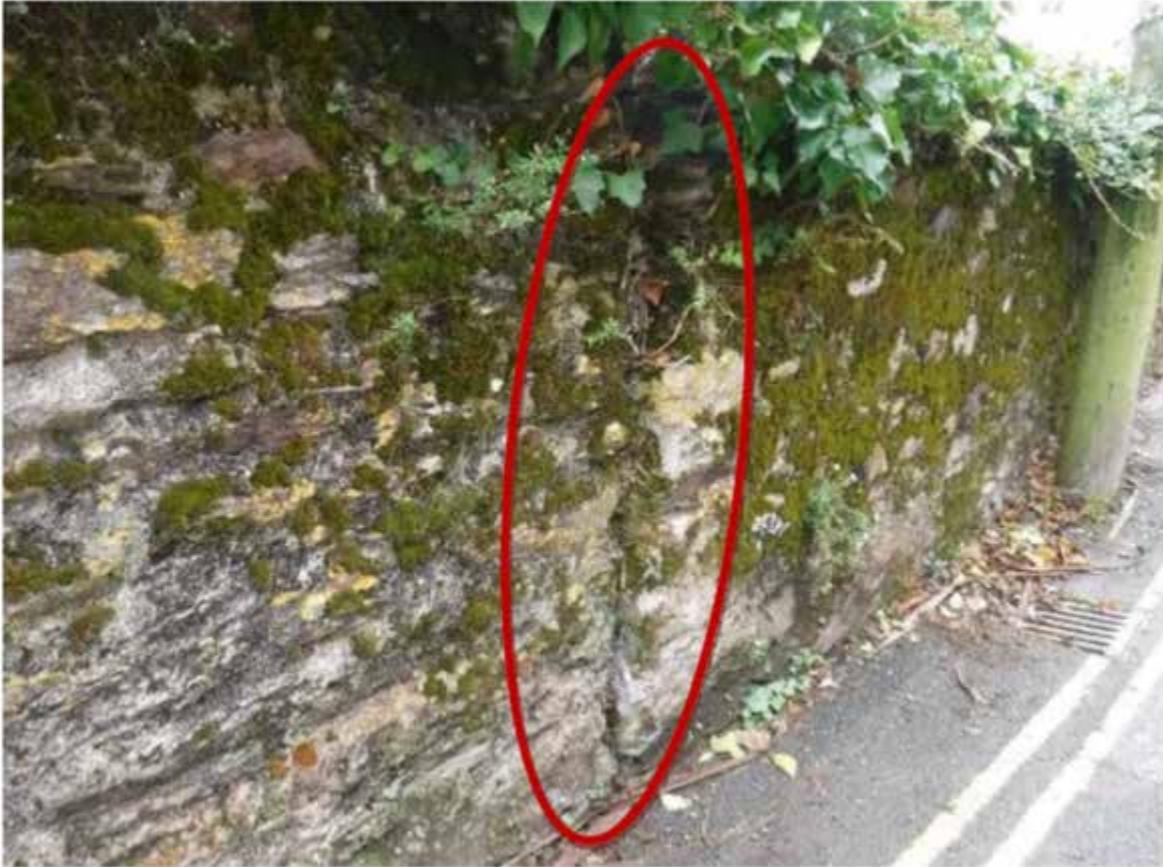
**Photo 33: View showing the parapet at CH 0m leaning towards the west.**

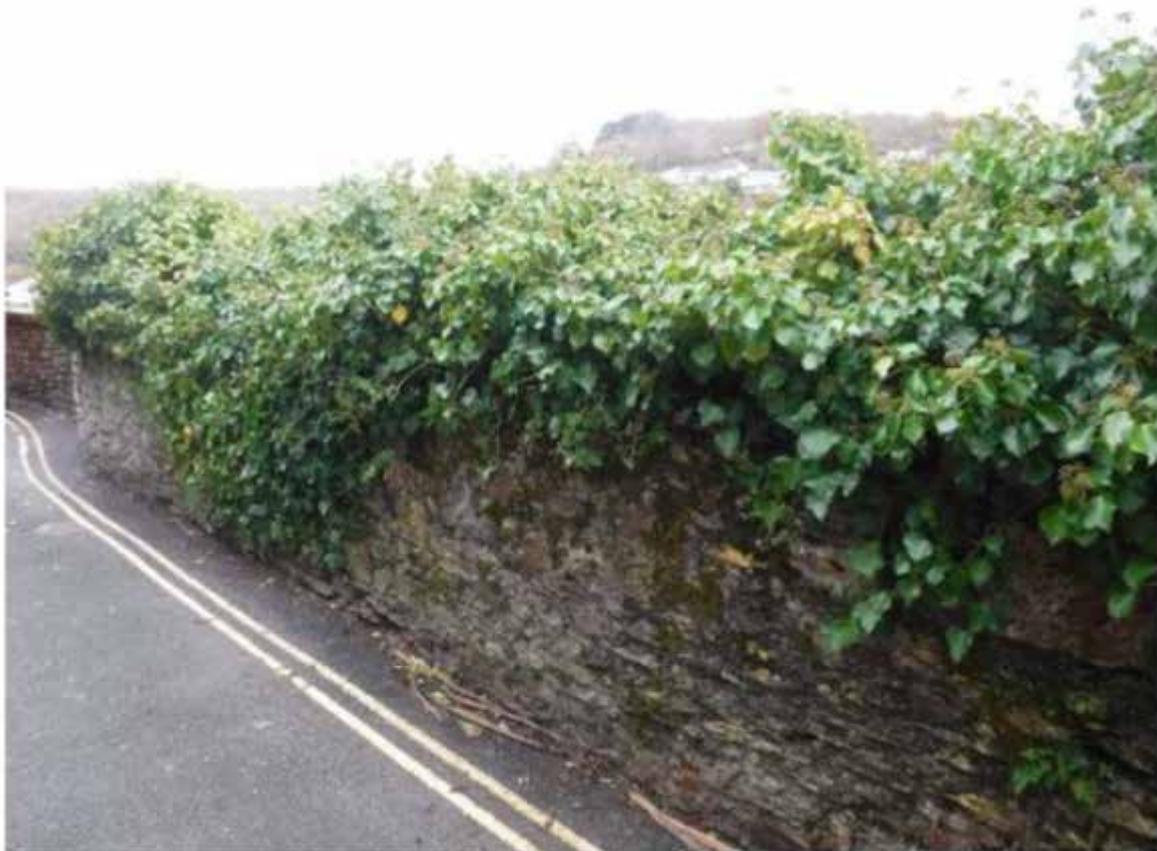
**Photo 34: View showing vegetation growth a top of the parapet of the upper section of the retaining wall**
