# Shutta Road Retaining Walls Route Report

**Division: CORMAC Consultancy**

**Site name:** Shutta Road, Looe

Report No: CN1701503/01/01

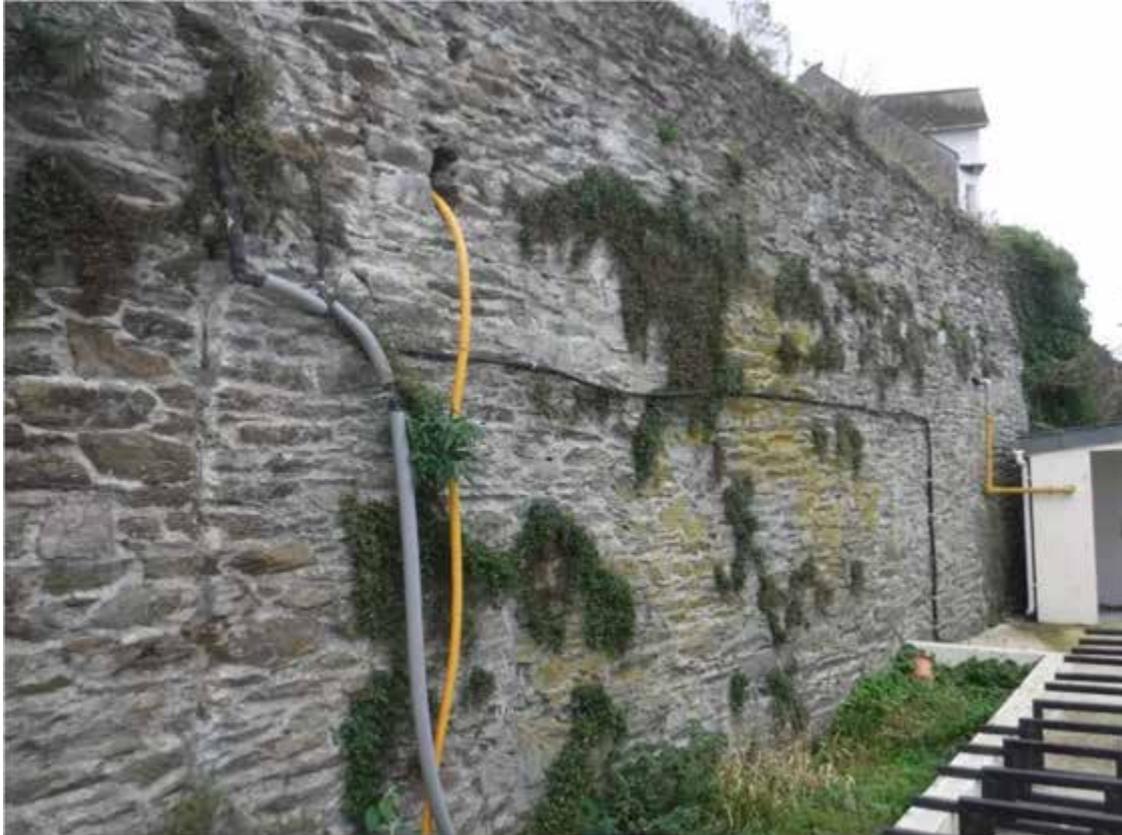
**Photo 4: View showing the vegetation growth to the wall**

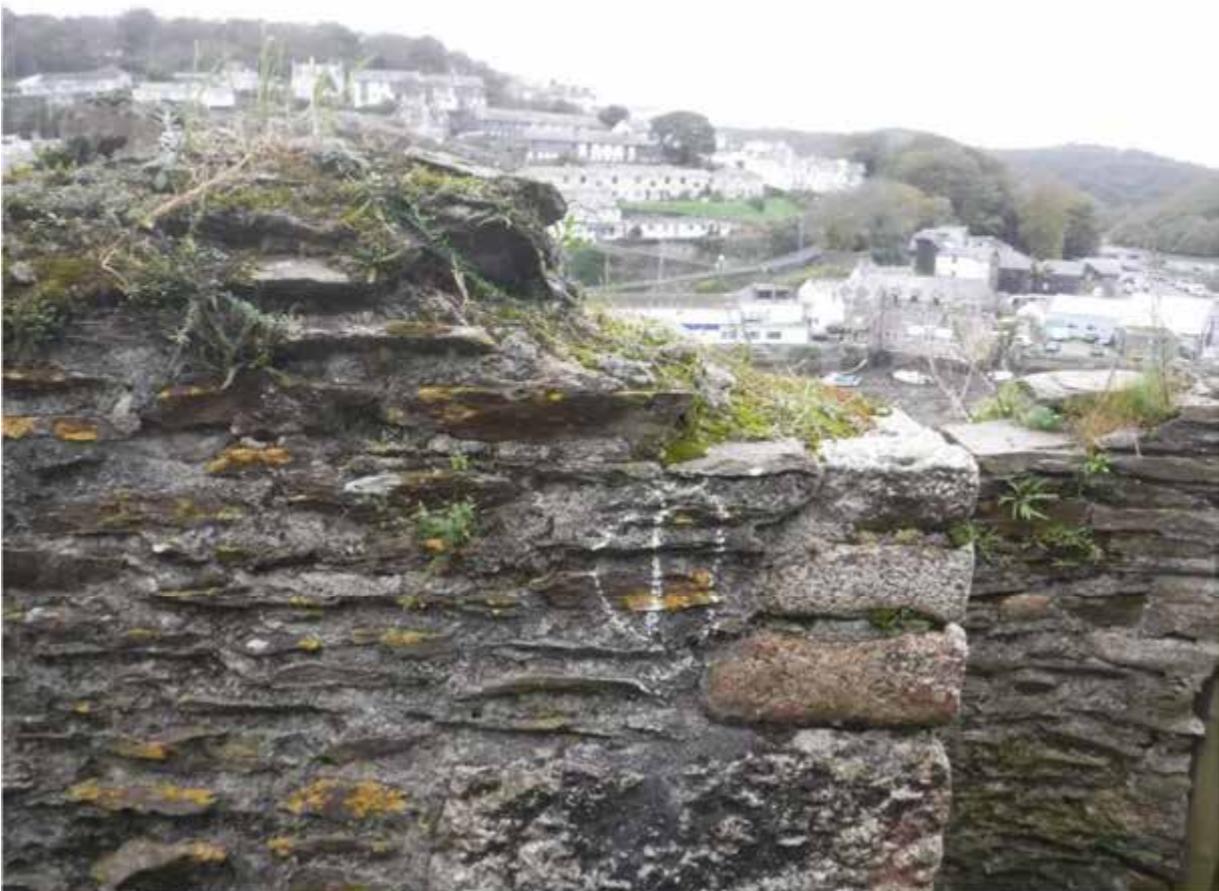
**Photo 7: View showing masonry loss to the parapet coping at the north end**

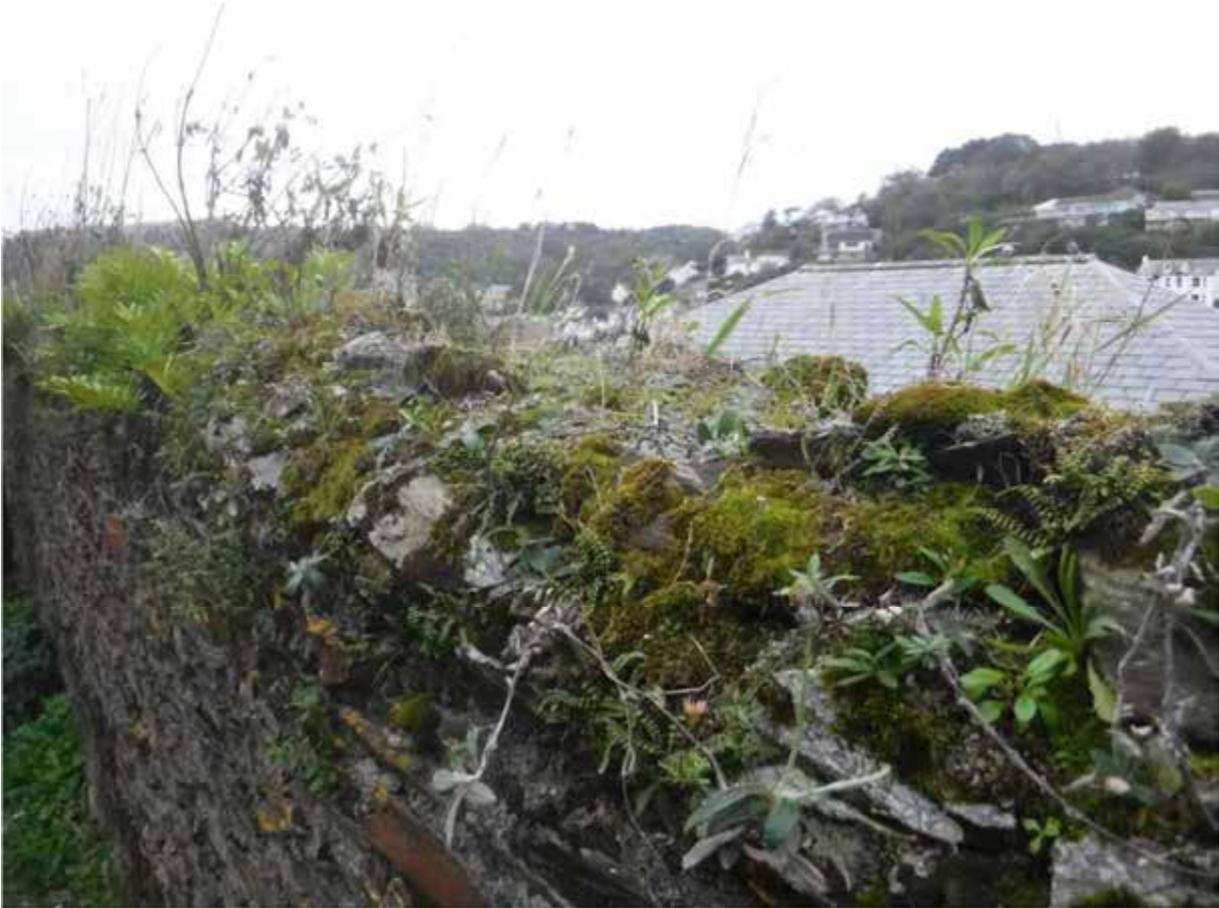
**Photo 8: View showing the vegetation growth to the parapet**

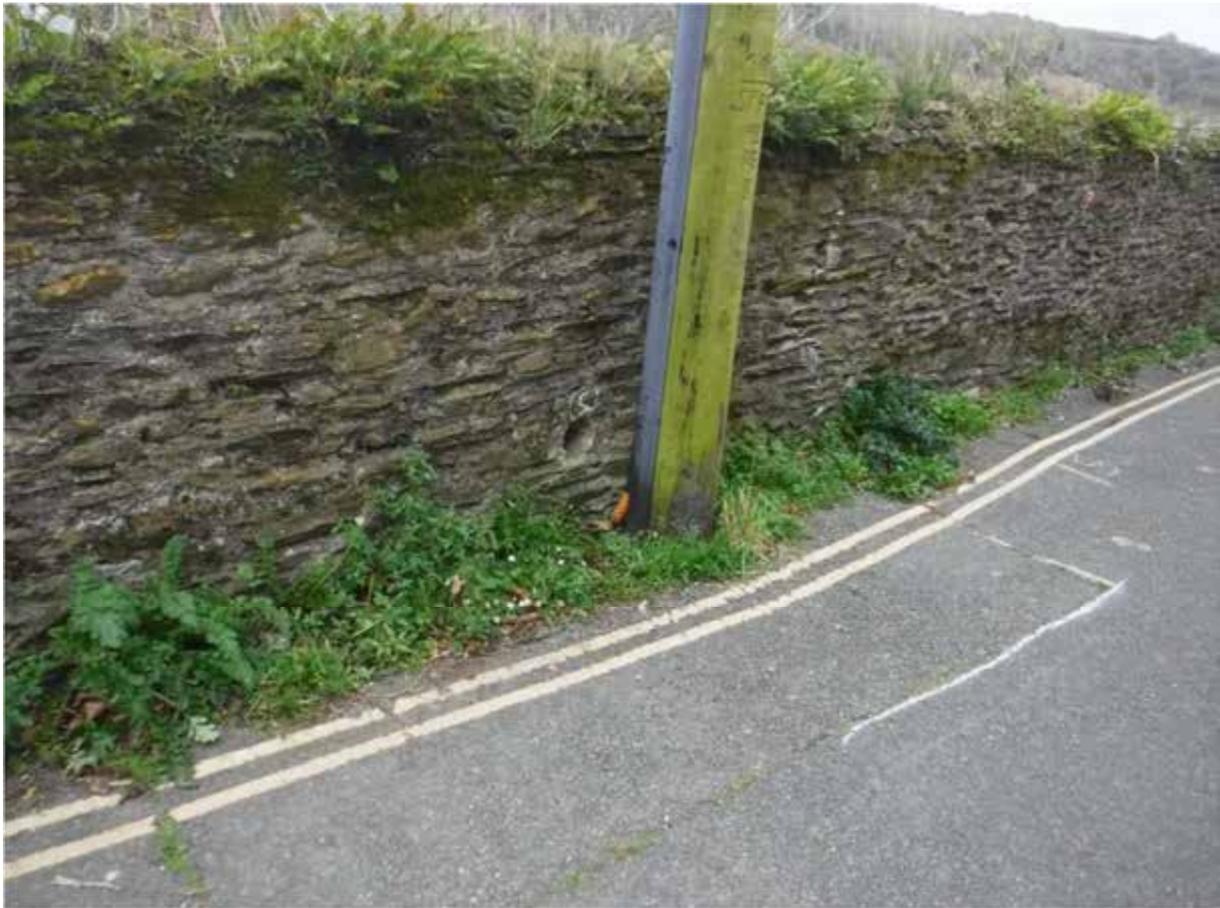
**Photo 14: View showing the sunken resurfacing adjacent to a BT utility pole**

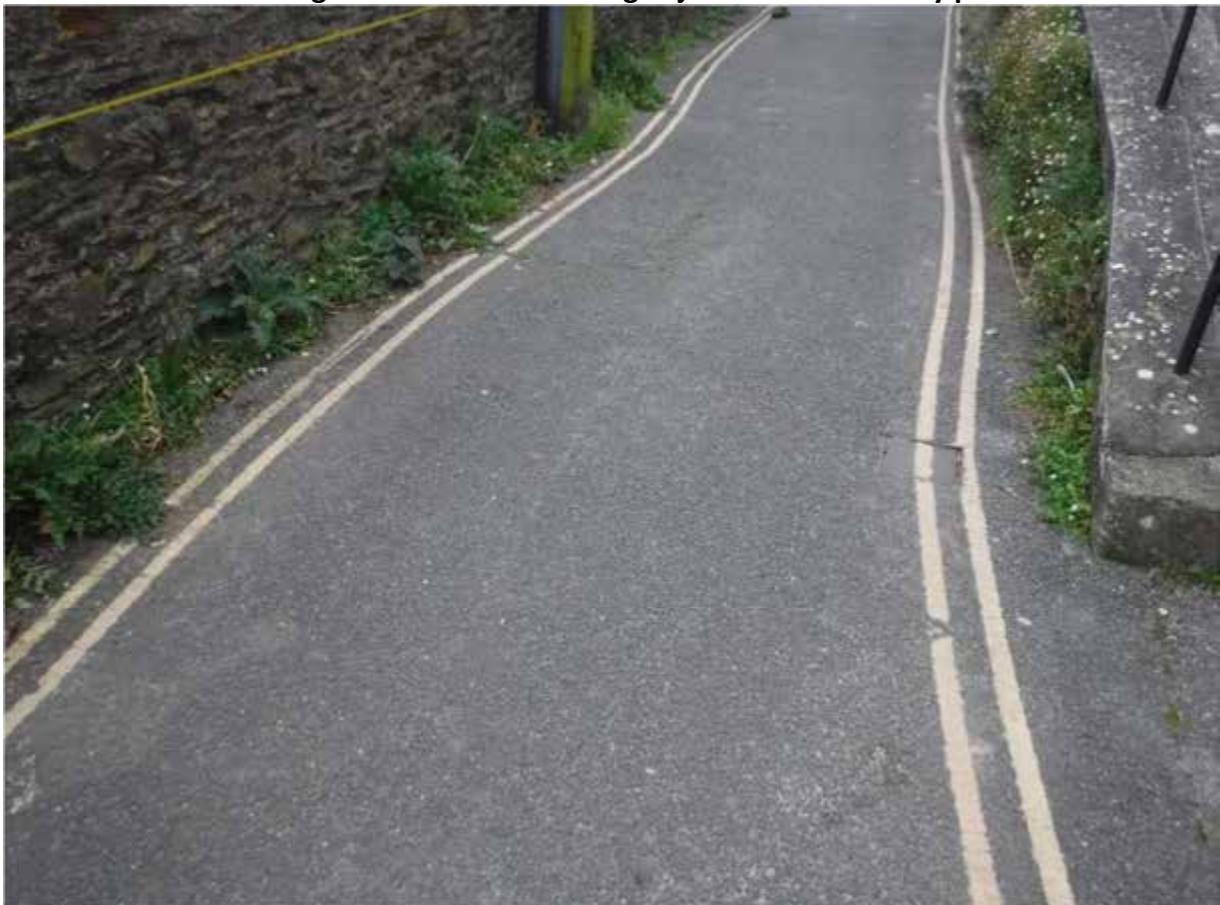
**Photo 15: View showing the vegetation growth to the edges of the carriageway**

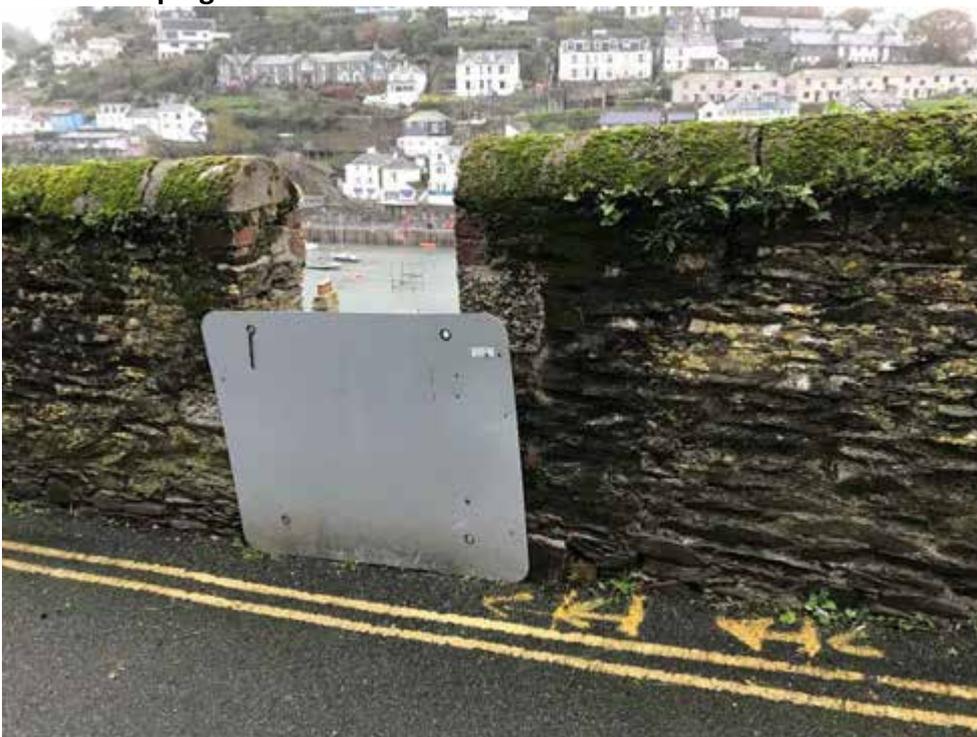
**Photograph 1 : General view of Parapet and road. Note old sign used as barrier. Domed concrete coping cracked and loose.**

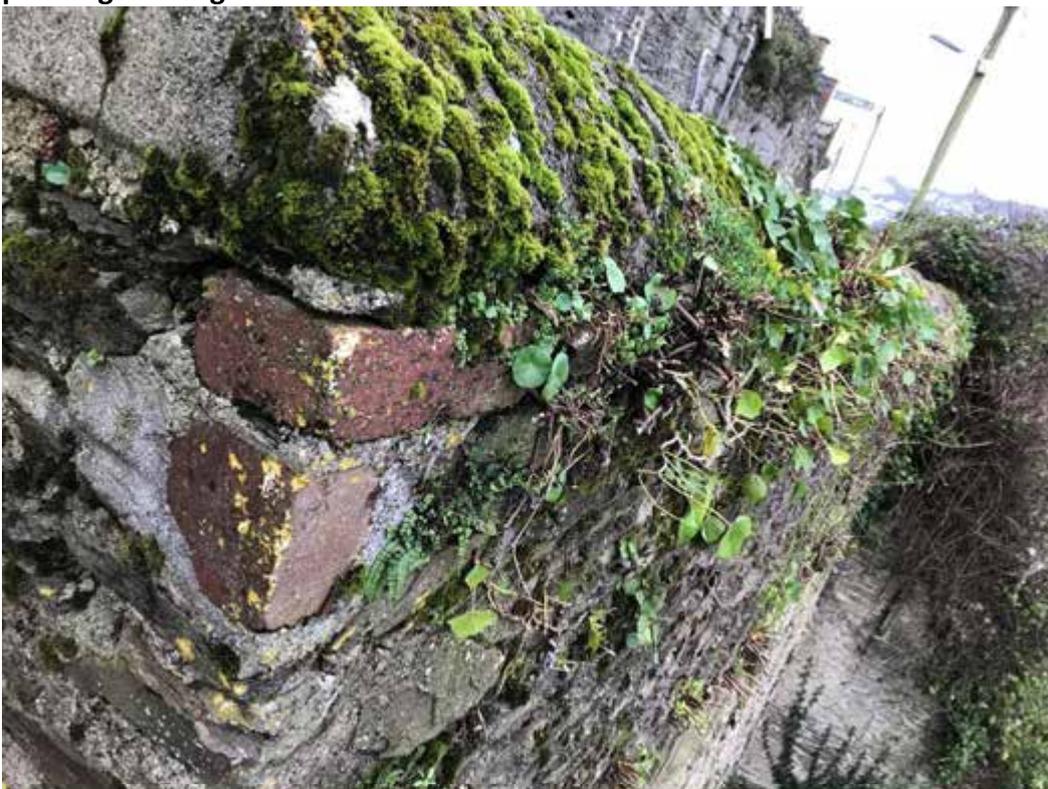
**Photograph 3 : View of retaining wall and adjoining buttress. Open joints evident in pointing and vegetation.**

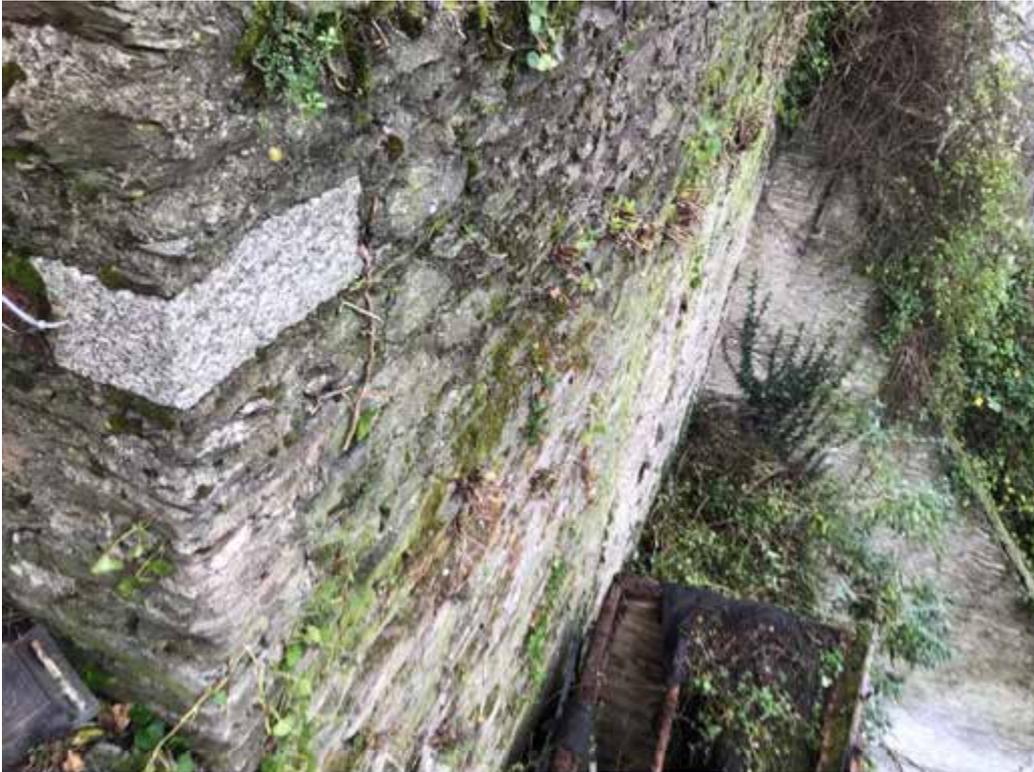
**Photograph 4: View of cementitious mortar dome coping and ivy growth. View of southern adjoining buttress.**

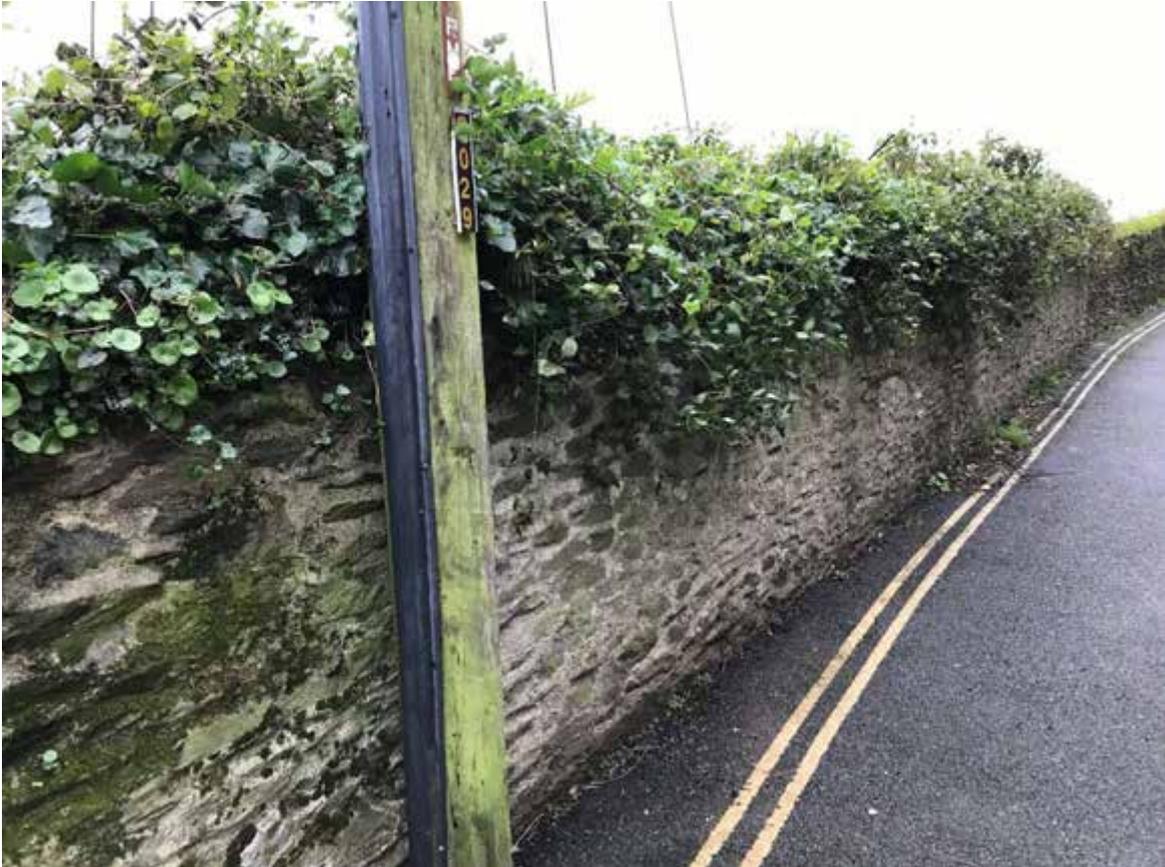
**Photograph 1: Ch 0 towards Ch 49.8 View of road and parapet, coping heavy with vegetation. Displacement of wall evident at joint with adjoining parapet wall.**

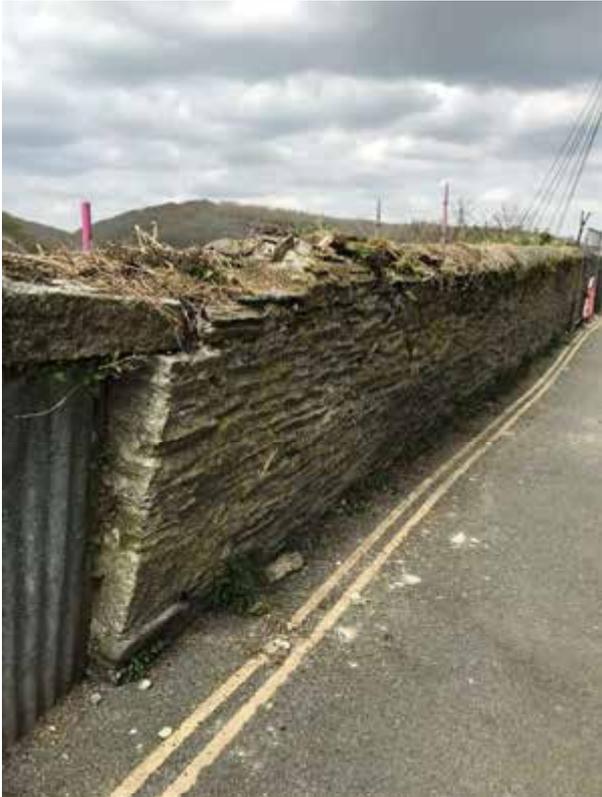
**Photograph 2 : Ch – 0 View of parapet lean and heavy vegetation to coping.**

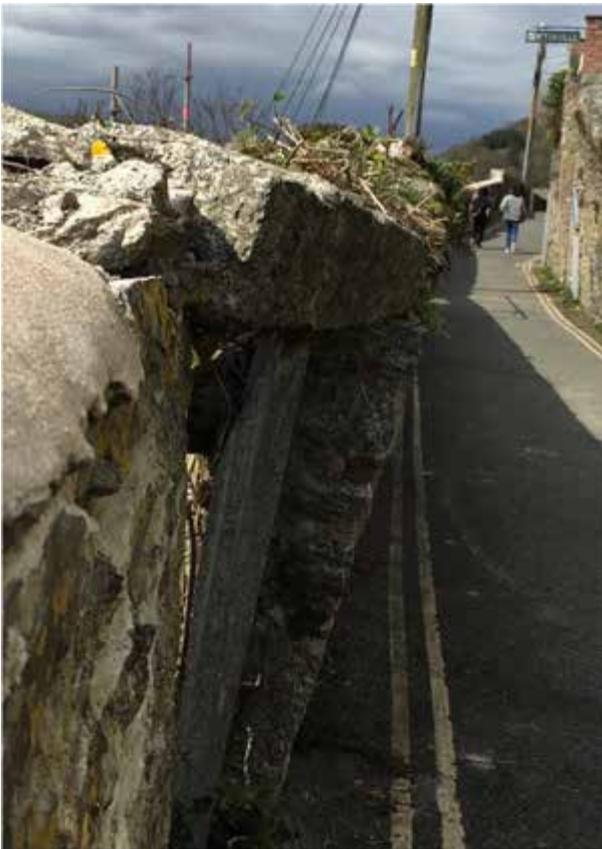
**Photograph 3: Ch – 32 View of leaning parapet, mortar loss to dome coping, debris on floor.**

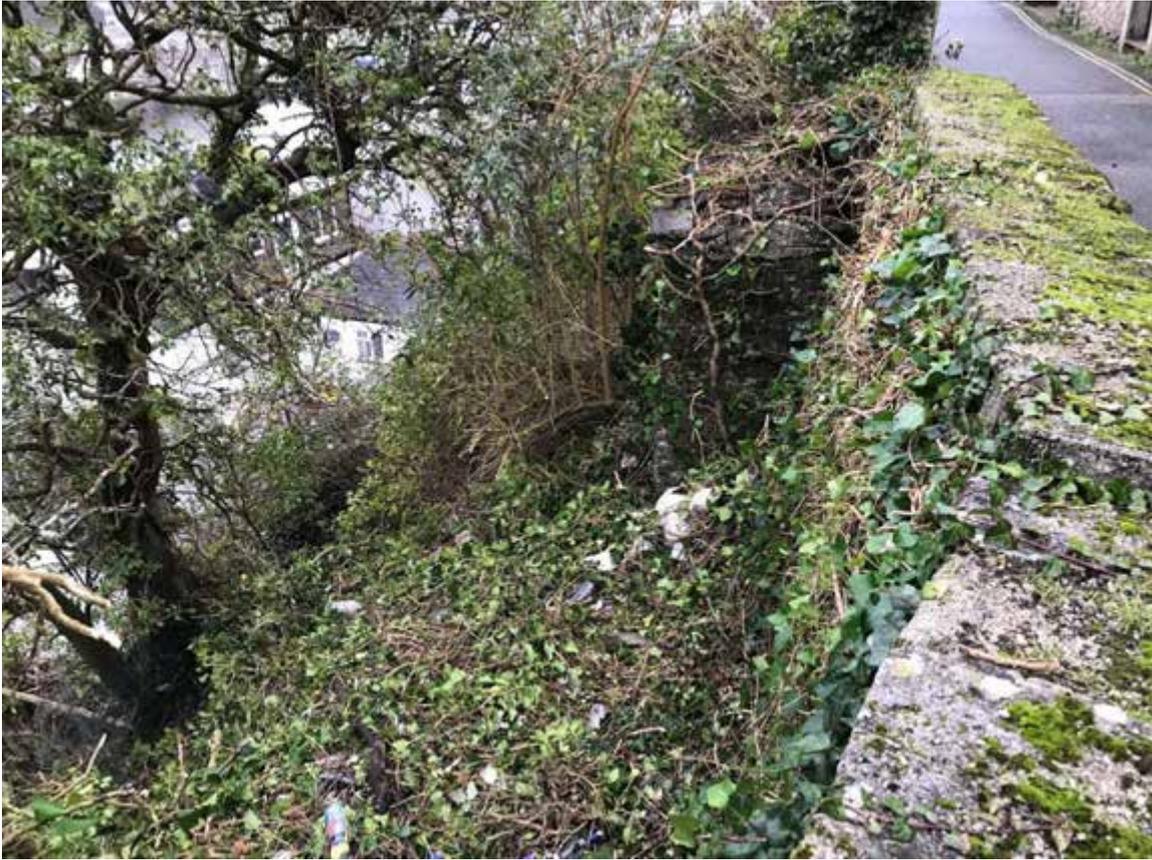
**Photograph 4 : Ch 32 View of shuttered opening and view of tilting parapet. This has moved significantly and is considered unsafe.**

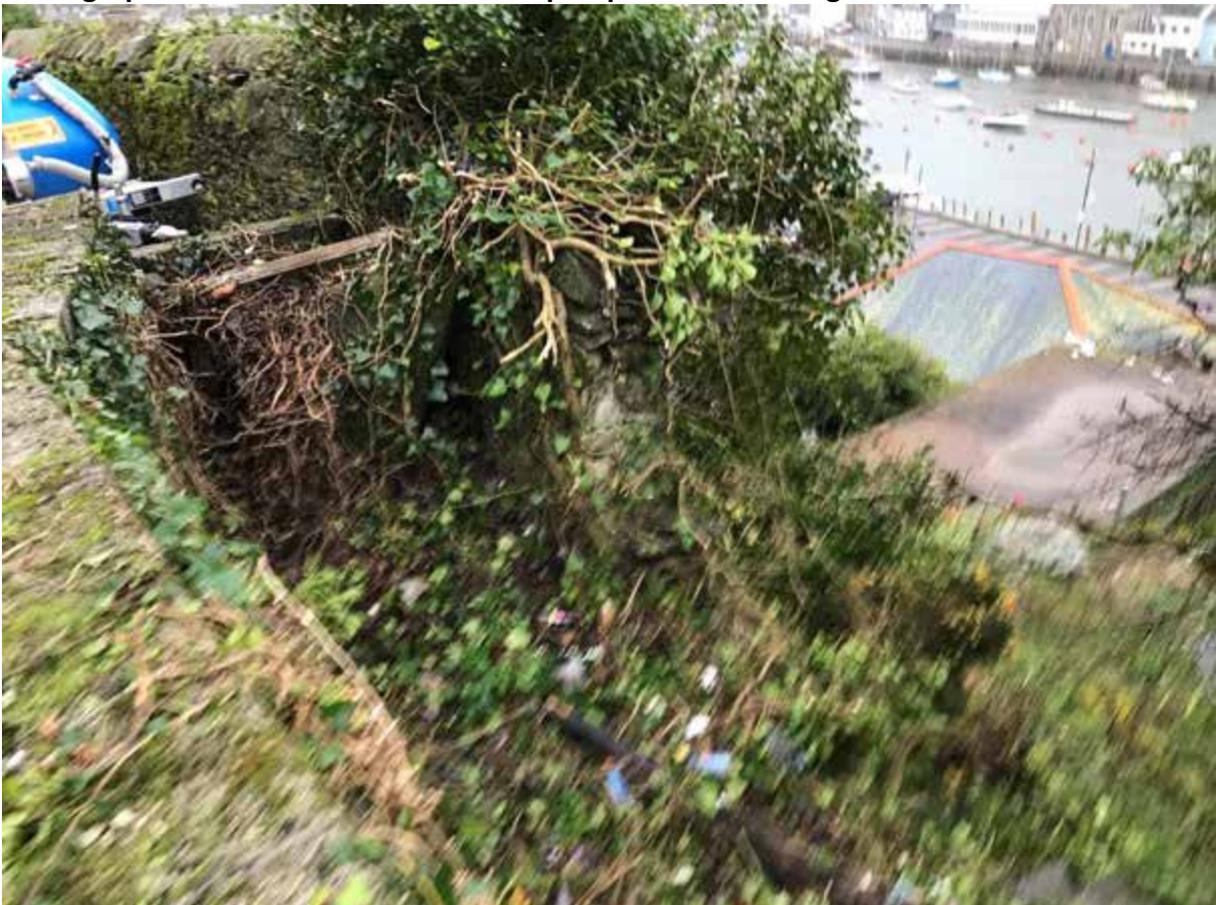
**Photograph 5 : Ch 49 towards 0. View of parapet and returning wall.**

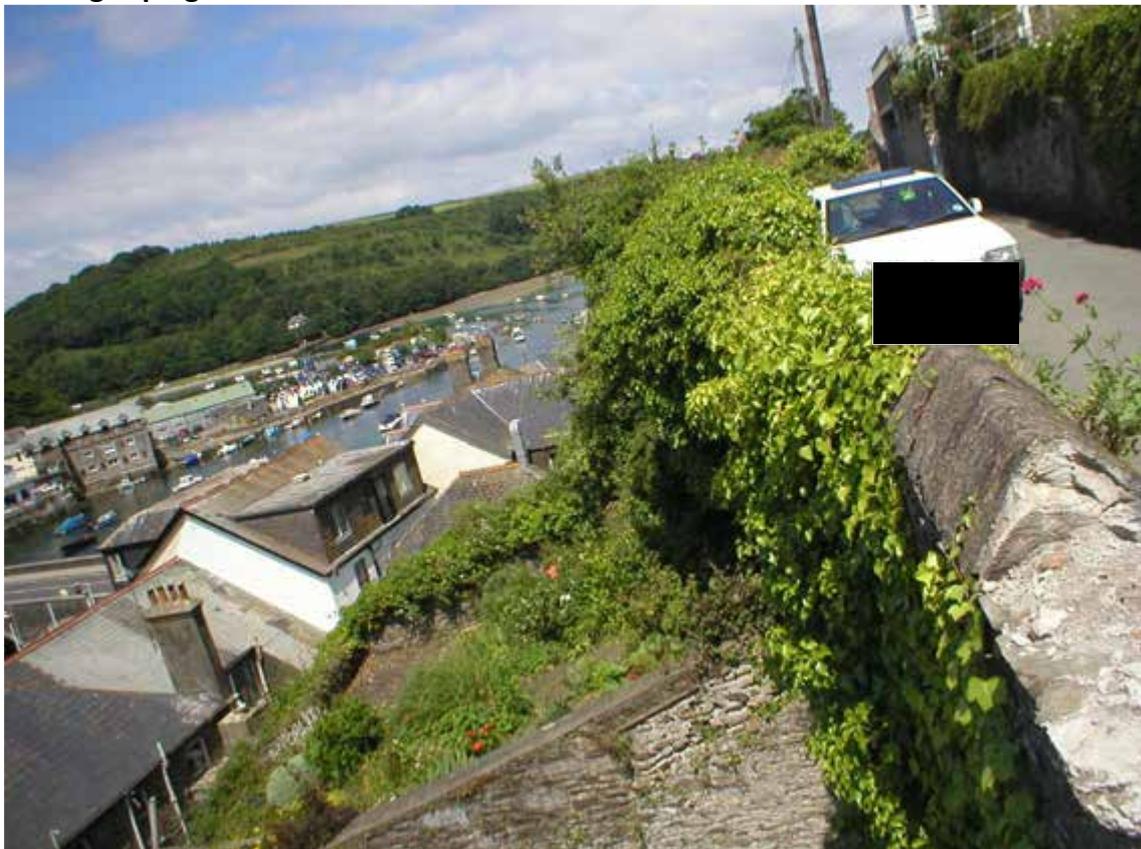
**Photograph 1 : Wesley Terrace (North) looking north. Blocked up access way, damaged missing coping.**

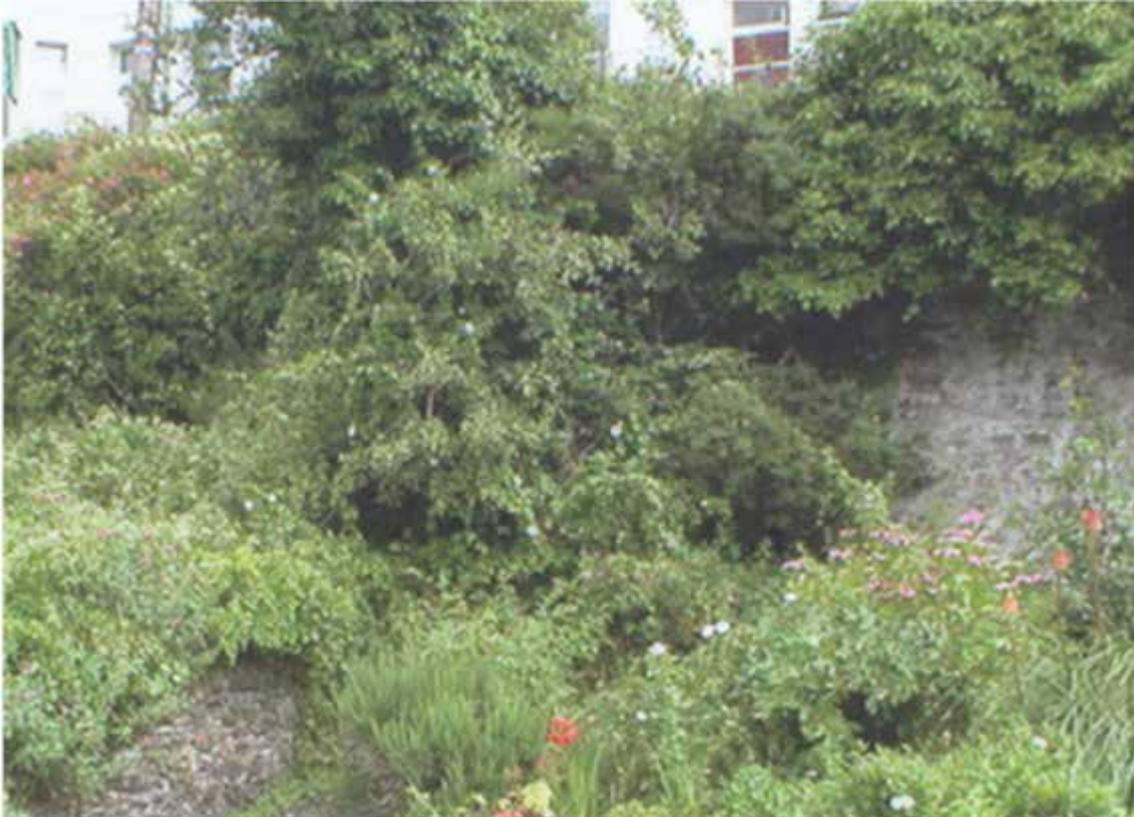
**Photograph 2: View over parapet looking north. Buttress wall visible below, extensive ivy growth visible on wall.**

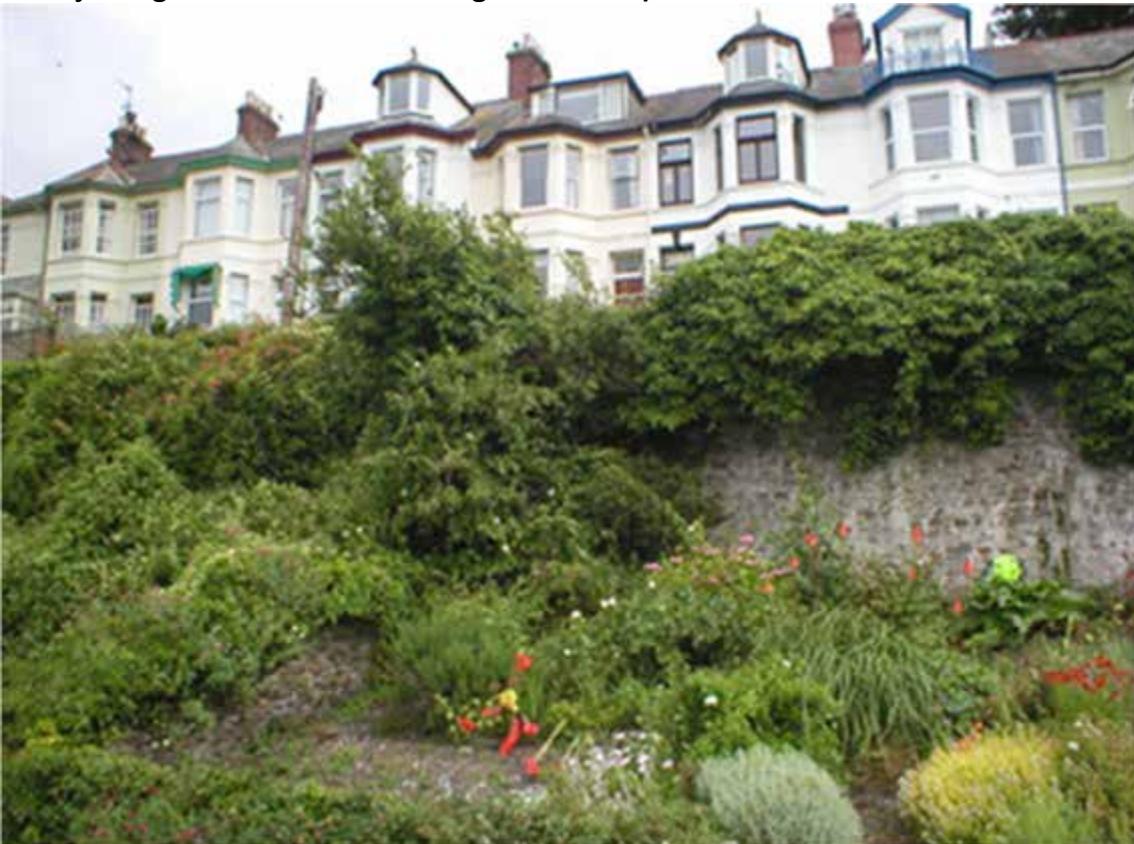
**Photograph 3: Start of wall looking from garden at base of wall (Note density of vegetation on adjoining wall section connecting to this wall)**

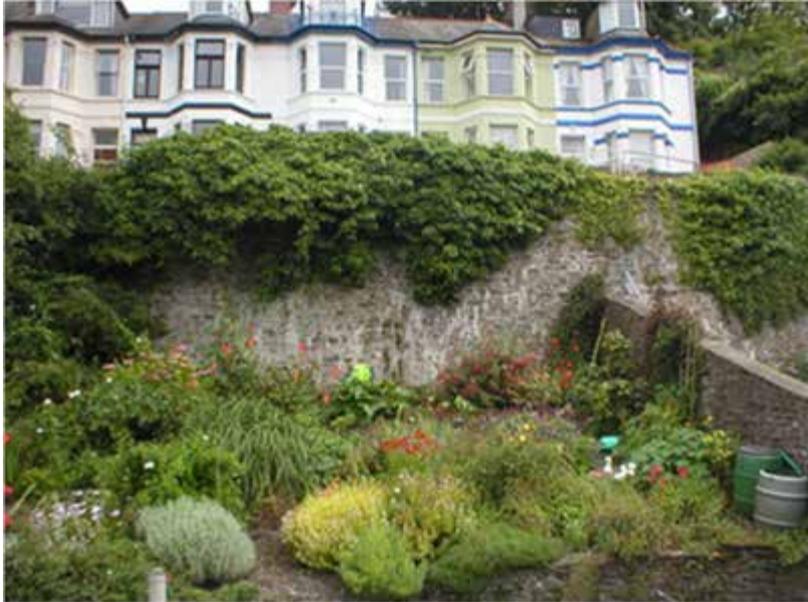
**Photograph 4: Ch. 0 to 10 View showing vegetation on top of wall and parapet.**

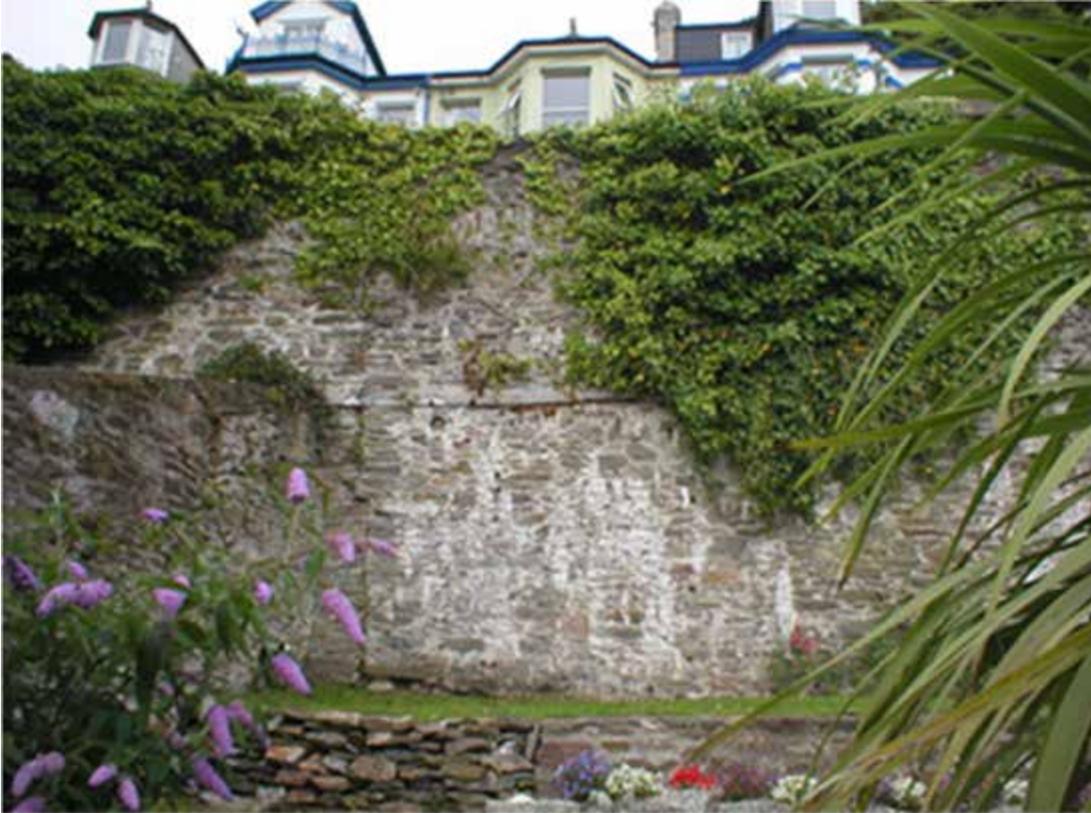
**Photograph 6: Ch. 5 to 21.08 End section of wall with sloping gardens in foreground.**

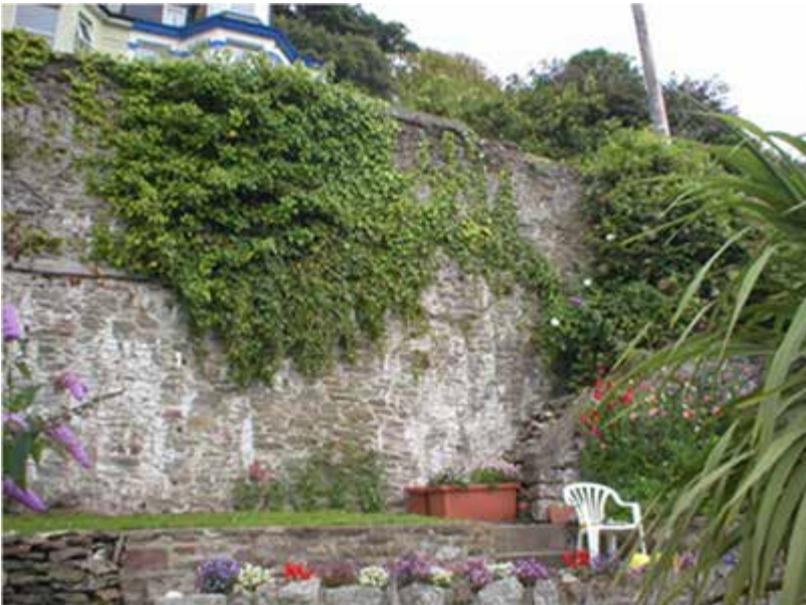
**Photograph 7: Ch. 11.45 to 16 View of wall showing outline of previous building at Ch. 11.78 to 14.58.**

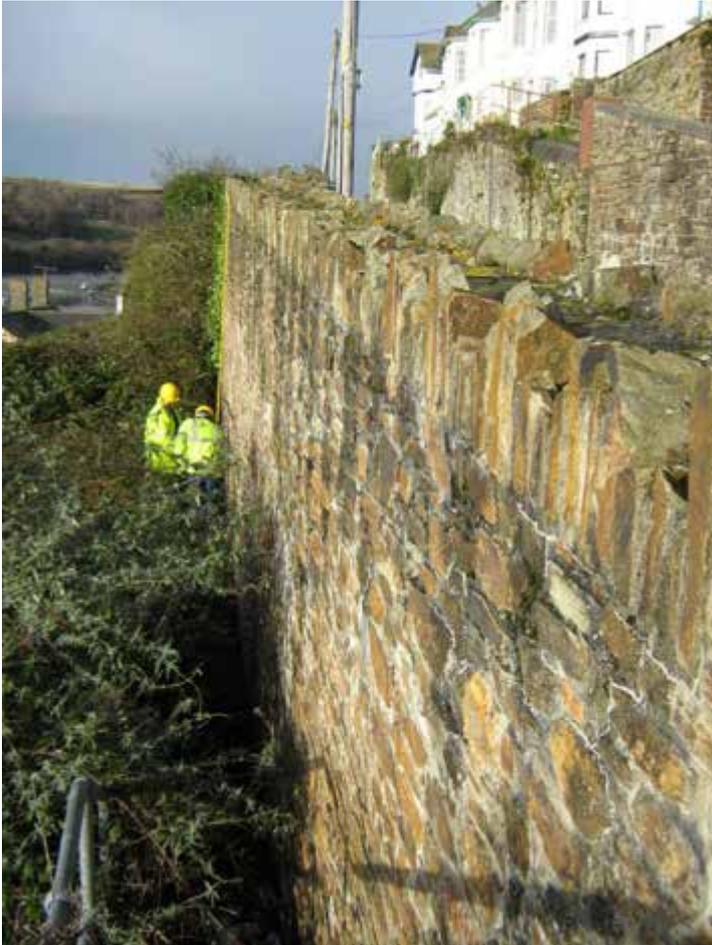
**Photograph 1: View of wall face looking south**

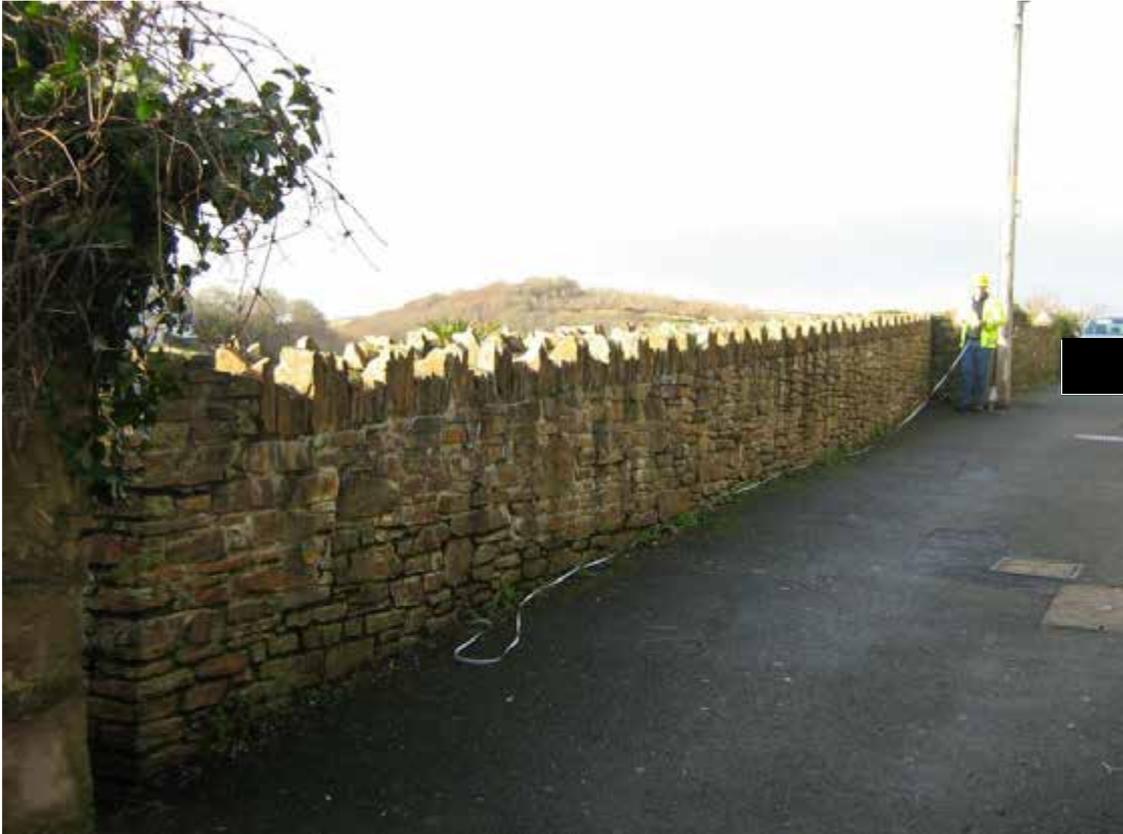
**Photograph 2: View of parapet looking south**
