Re: Stoford Developments, ICON Harlow – Statement of Practical Completion

STATEMENT OF PRACTICAL COMPLETION

ICON HARLOW UNIT B ELECTRICAL PROGRESS INSPECTION REPORT

UNIT B SNAG LIST

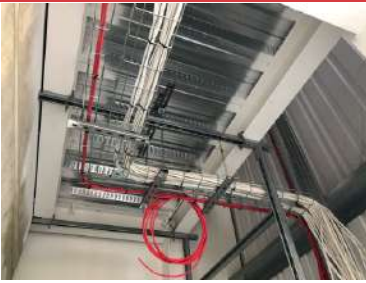
OBSERVATION 1

1F/2F store - additional support should be provided adjacent to cable tray.

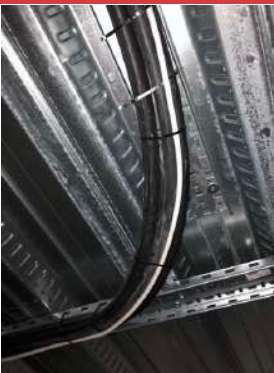
OBSERVATION 2

1F allocated welfare area - cable tray to be cut to avoid SWA cables pressing against the flange.

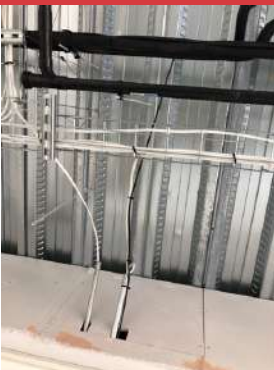
OBSERVATION 3

1F open plan office - mechanical control cable to be segregated from LV cable.

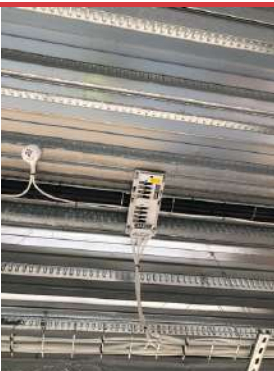
OBSERVATION 4

1F open plan office - LCM to be spaced 100 mm from SWA cables.

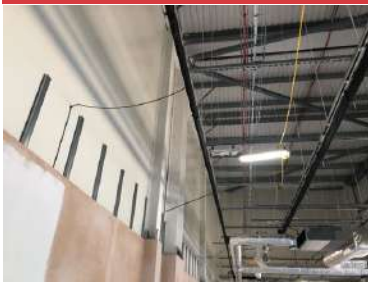
OBSERVATION 5

2F open plan office - all mechanical control cables to be supported.

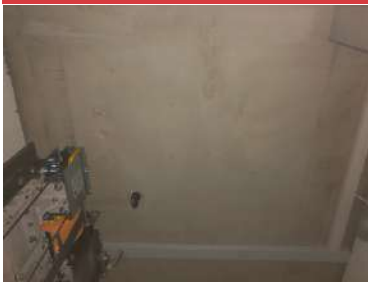
OBSERVATION 6

2F lift shaft - smoke detector to be installed to top of life shaft.

Please provide photographic evidence.

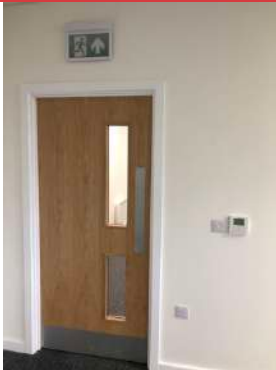
OBSERVATION 7

Office - all electrical accessories to be labelled with circuit reference.

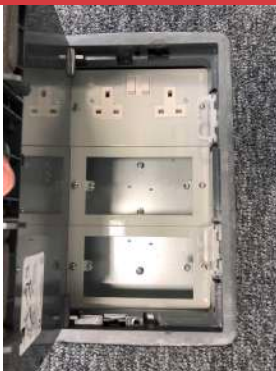
OBSERVATION 8

1F/2F open plan office - all floor boxes to be bolted and debris removed.

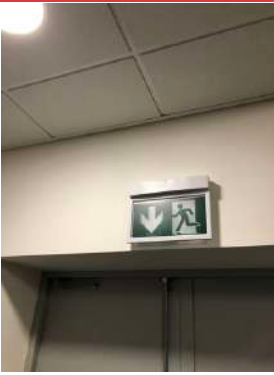
OBSERVATION 9

GF reception/MOE stair lobby/1F allocated welfare area/2F WC lobby - illuminated exit sign legend arrow should be pointing upwards.

GF MOE stair illuminated exit sign not operational in emergency.

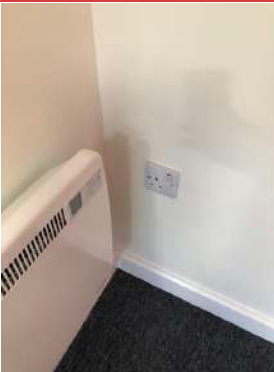
OBSERVATION 10

1F/2F stair lobby - single switched socket outlet to be located minimum 350 mm from corner.

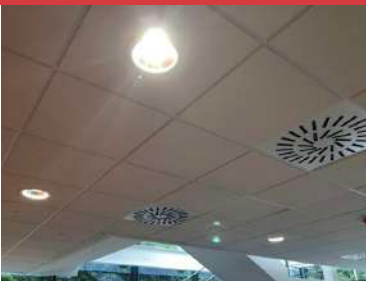
OBSERVATION 11

GF reception - please confirm the glare rating at 1.75 m.

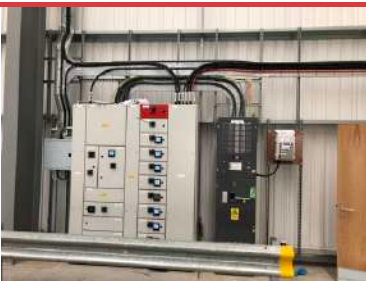
OBSERVATION 12

Warehouse/office stores - steel cable ties to be provided every 1000 mm to all clipped direct cables.

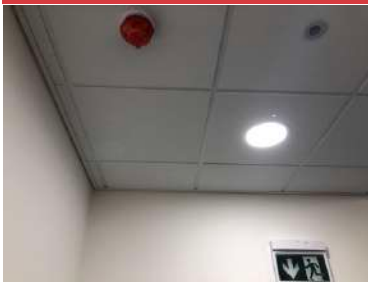
OBSERVATION 13

1F MOE stair lobby - smoke detector to be located minimum 500 mm from wall.

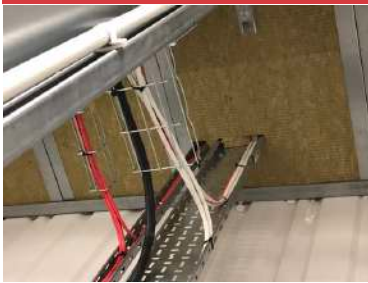
OBSERVATION 14

Stores - PVC conduit to be replaced by metal conduit.

All BWIC to be fire stopped.

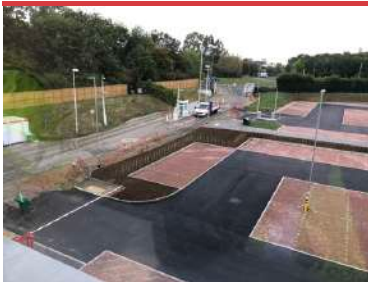
OBSERVATION 16

External - 1No. lighting column installed to the north instead of south side of the car park entrance.

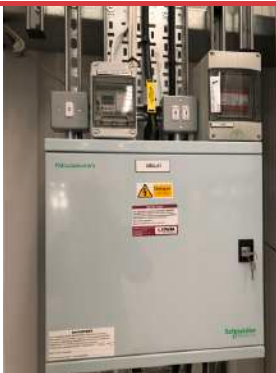
OBSERVATION 17

All distribution boards dates of inspection should be filled.

All emergency lighting test key switches to be labelled with circuit reference.

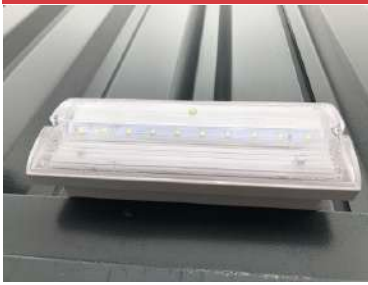
OBSERVATION 18

External - water droplets should be removed from emergency bulkhead luminaire.

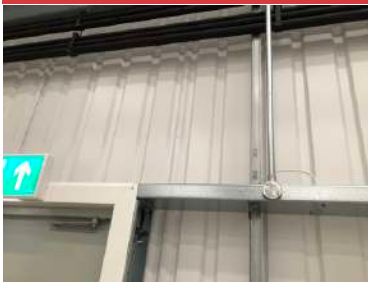
OBSERVATION 19

Warehouse - all LV cables to be tidied and fully supported on sheeting rails.

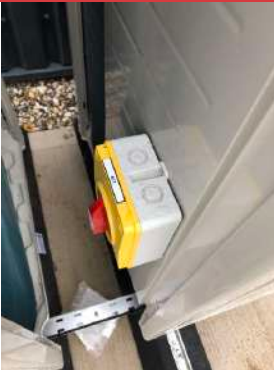
OBSERVATION 20

Warehouse/stores/external - all isolators for dock doors/fan/lift/AC condensers to be labelled with circuit reference.

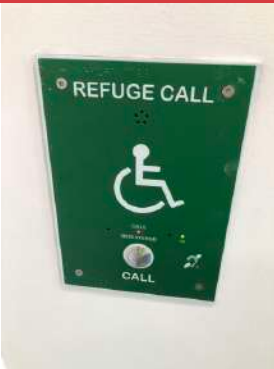
OBSERVATION 21

1F MOE stair - disabled refuge outstation beeps constantly during communication.

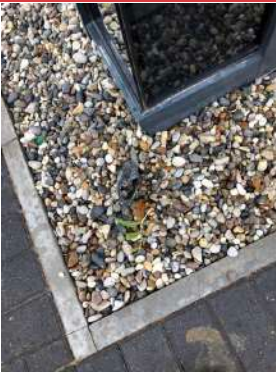
OBSERVATION 22

External - redundant LV cables to be removed.

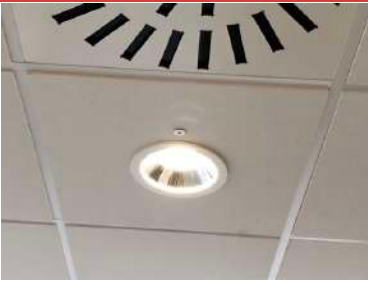
OBSERVATION 23

Open plan offices/shower/WC lobbies - recessed PIR/emergency downlight were not fully flushed with ceiling tile.

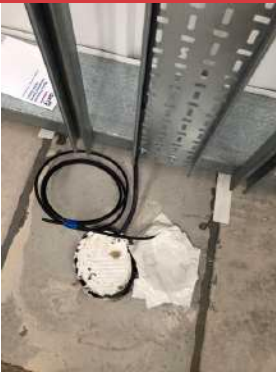
OBSERVATION 24

Warehouse/GF store- LV cables to be protected by metal conduit.

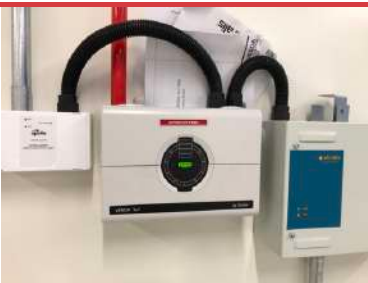
OBSERVATION 25

3F plant deck, GF/2F stores - all fire alarm interfaces to be labelled.

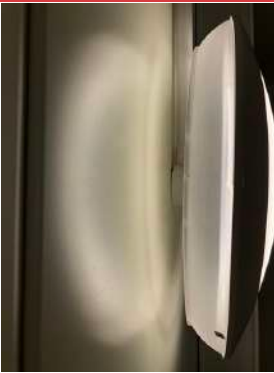
OBSERVATION 26

3F stair lobby - surface mounted luminaire to be mounted on wall not besa box.

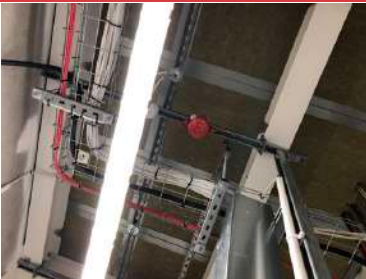
OBSERVATION 27

Stores/stair lobbies - all point detectors covers to be removed.

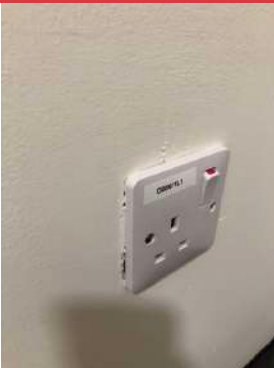
OBSERVATION 28

2F allocated welfare area - socket outlet surrounds to be made good.

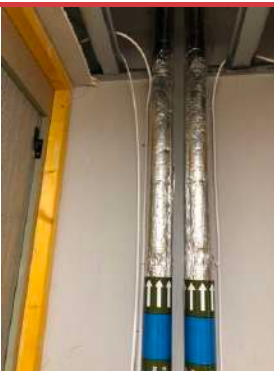
OBSERVATION 29

2F WC service cupboard - all LV cables to be supported.

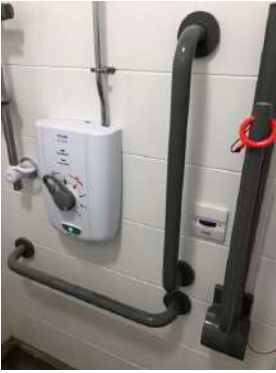
OBSERVATION 30

1F/2F disabled shower - disabled toilet alarm reset button to be minimum IP44 rated.

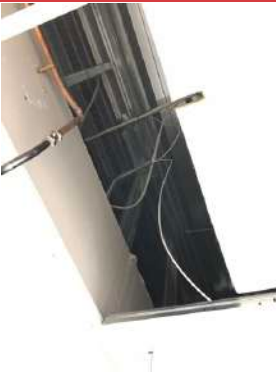
OBSERVATION 31

2F disabled shower - all cables in ceiling void to be supported.

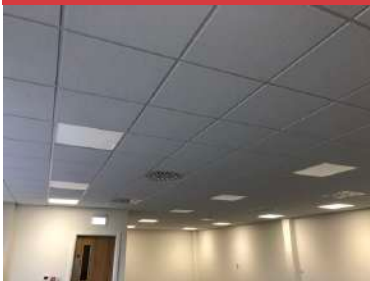
OBSERVATION 32

2F open plan office - 1No. modular luminaire adjacent to MOE exit door not dimmed.

Office - packaging to be removed from illuminated exit signs.

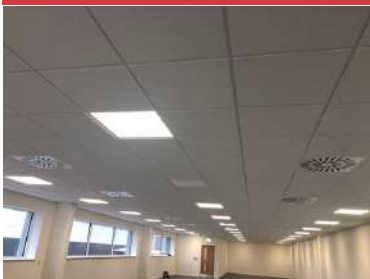
OBSERVATION 33

2F open plan office - 1No. modular luminaire was not operational.

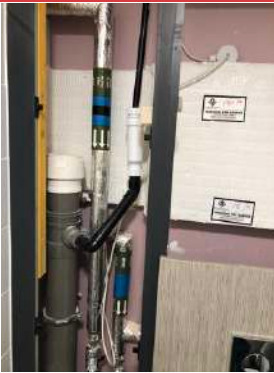
OBSERVATION 34

GF unisex WC, 1F/2F WCs - mechanical cables to be shortened and clipped direct.

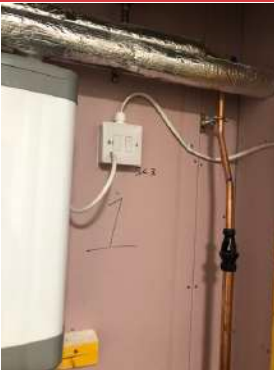
OBSERVATION 35

GF unisex WC, 1F/2F WCs/WC lobbies/cleaners cupboard - all electrical accessories for mechanical services in wall/ceiling void/under sink to be labelled with circuit reference.

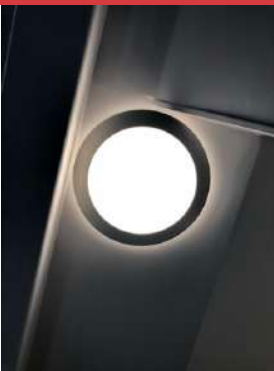
OBSERVATION 36

Stair/store - emergency LED indicators were not visible.

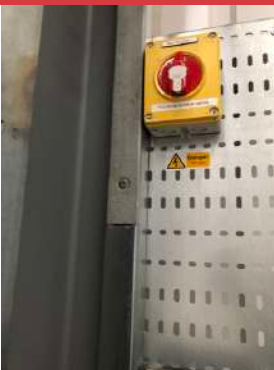
OBSERVATION 37

Warehouse - all steel trunking lid gaps to be sealed.

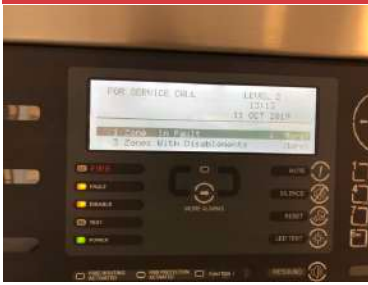
OBSERVATION 38

GF reception - VESDA panel battery need replacing.

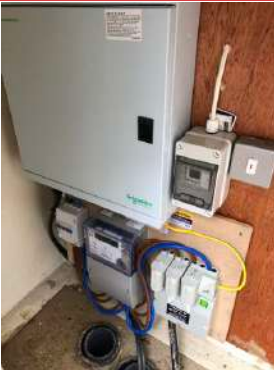
OBSERVATION 39

External landlord feeder pillar adjacent to Unit B - distribution board and key switch to be labelled.

All ducts to be sealed.

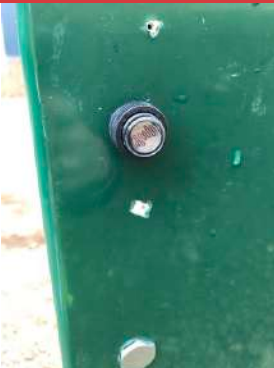
OBSERVATION 40

External landlord feeder pillar adjacent to Unit B - all holes to be sealed.

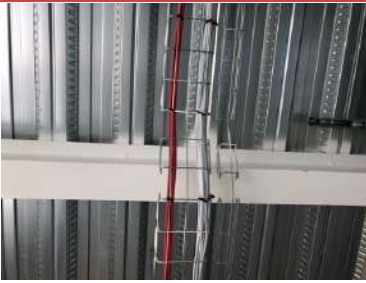
OBSERVATION 1

GF reception - cable basket to be supported by steel cable ties.

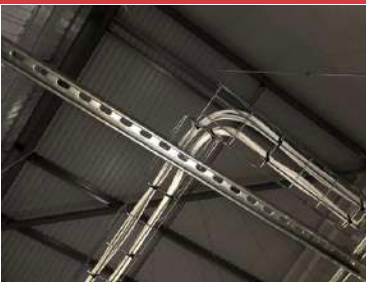
OBSERVATION 2

1F open plan office - cable basket to be levelled.

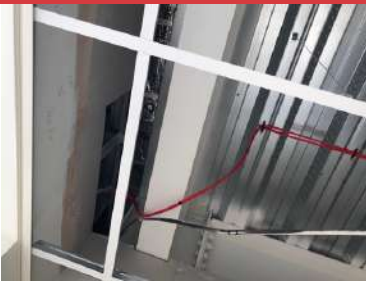
OBSERVATION 3

GF MOE stair - fire alarm cables to be supported.

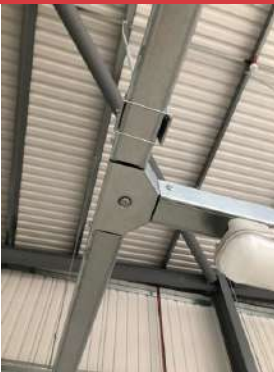
OBSERVATION 4

2F plant deck/stores/warehouse - steel trunking lid gaps to be sealed.

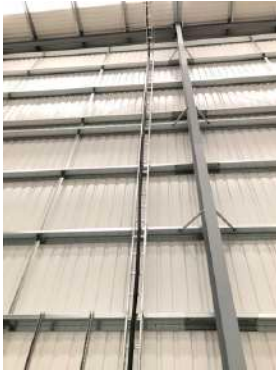
OBSERVATION 5

Warehouse/office stores - SWA cable to be supported by steel cable ties.

All earthing conductors to be labelled.

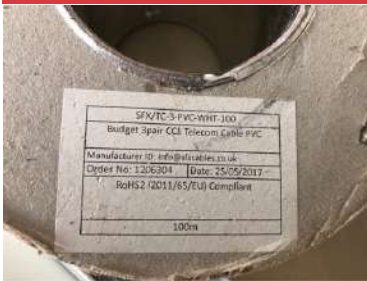
OBSERVATION 6

Please confirm if telecom cables installed are minimum class Eca rated.

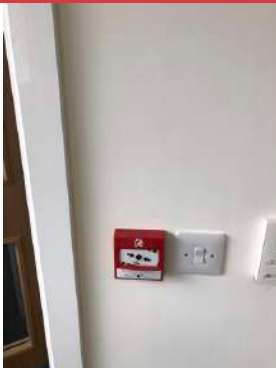
OBSERVATION 7

1F open plan office - all MCPs to be fitted with polycarbonate cover.

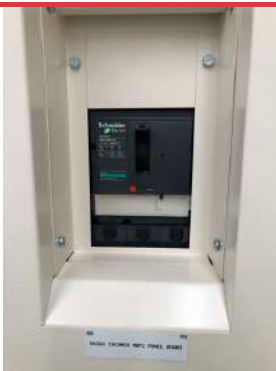
OBSERVATION 8

Warehouse - gaps between LV panel board enclosure and switch disconnector to be closed.

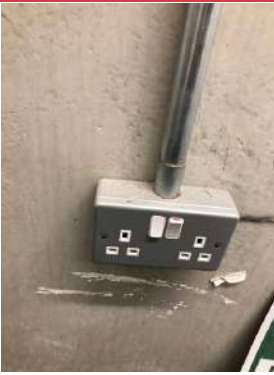
OBSERVATION 9

Warehouse/office - all electrical accessories to be labelled with circuit reference.

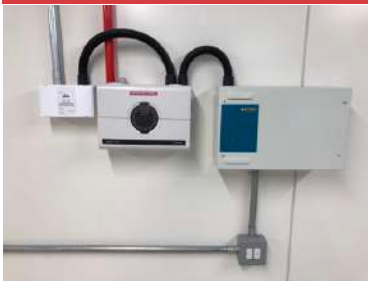
OBSERVATION 10

2F plant deck/1F store/GF reception - all fire alarm interfaces to be labelled.

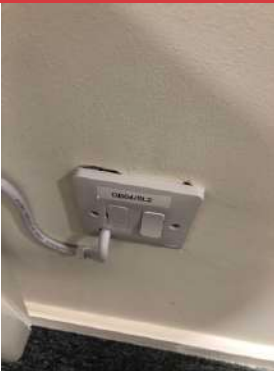
OBSERVATION 11

1F lift lobby - all electrical accessories to be grouted.

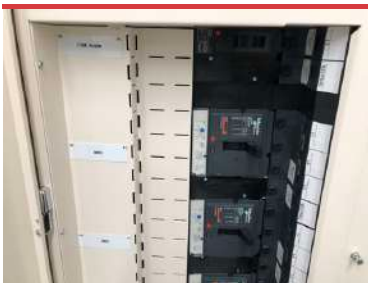
OBSERVATION 12

Warehouse - MCCB serving fire alarm and disabled refuge should include the wording of "DO NOT SWITCH OFF".

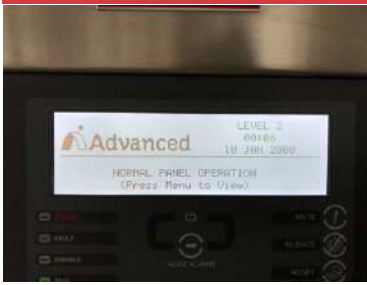
OBSERVATION 13

GF reception - fire alarm panel date to be changed.

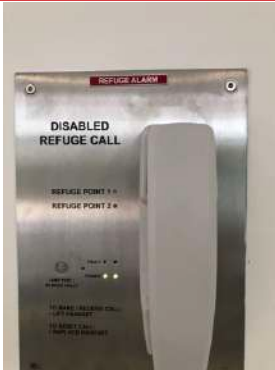
OBSERVATION 14

GF reception - disabled refuge alarm outstation location to be labelled.

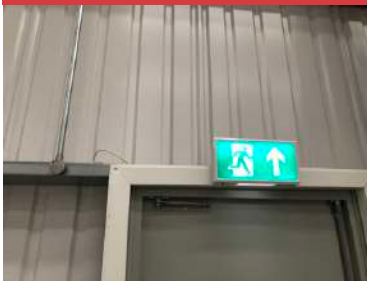
OBSERVATION 15

Warehouse - all LV cables to be tidied and fully supported on sheeting rails.

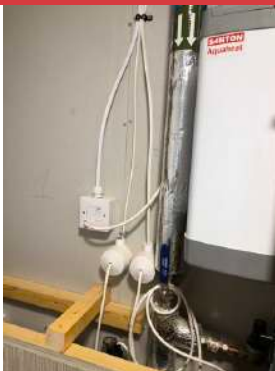
OBSERVATION 16

GF disabled WC, 1F WCs/WC lobbies/cleaners cupboard - all electrical accessories for mechanical services in wall/ceiling void/under sink to be labelled with circuit reference.

All mechanical cables to be shortened and clipped direct.

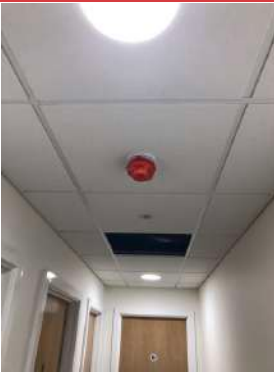
OBSERVATION 17

GF WC corridor - smoke detector cover to be removed.

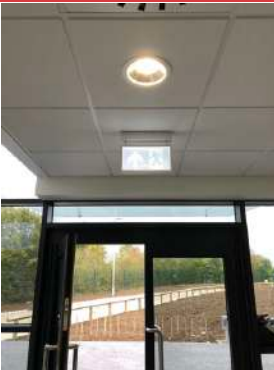
OBSERVATION 18

GF reception - packaging to be removed from illuminated exit signs.

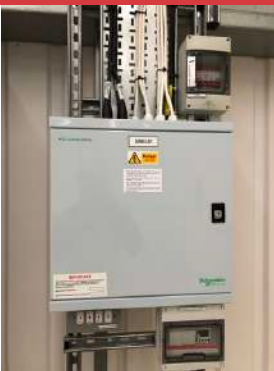
OBSERVATION 19

Warehouse - all distribution boards dates of inspection should be filled.

All emergency lighting test key switches to be labelled with circuit reference.

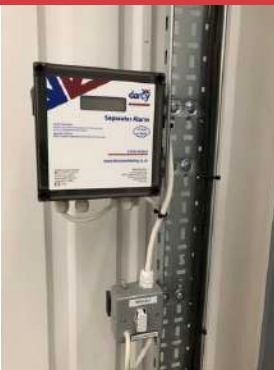
OBSERVATION 20

Warehouse - fuse carrier for petrol interceptor to be inserted.

Petrol interceptor not terminated.

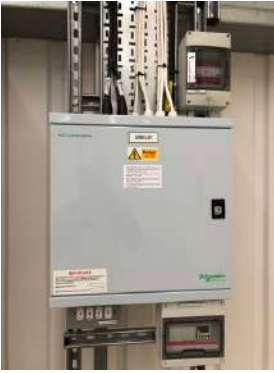
OBSERVATION 21

Warehouse - all distribution boards to be lockable.

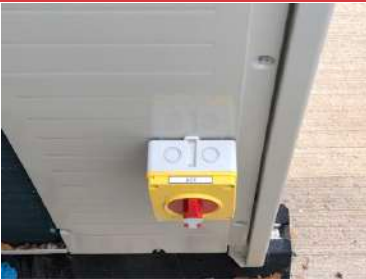
OBSERVATION 22

Warehouse/stores/external - all isolators for dock doors/lift/AC condenser to be labelled with circuit reference.

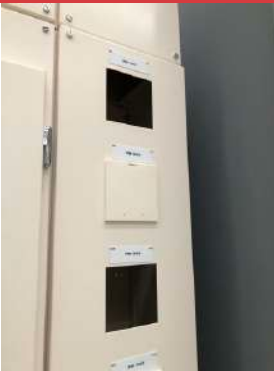
OBSERVATION 23

Warehouse - all cut outs for meters to be fitted with blank plates.

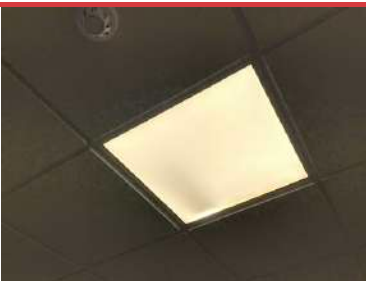
OBSERVATION 24

1F open plan office - 1No. modular luminaire is damaged and should be replaced.

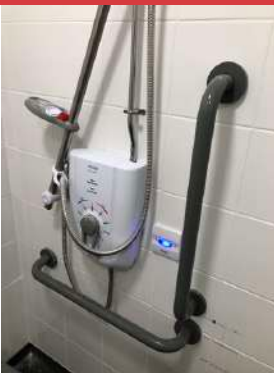
OBSERVATION 27

1F disabled shower - disabled toilet alarm reset button to be minimum IP44 rated.

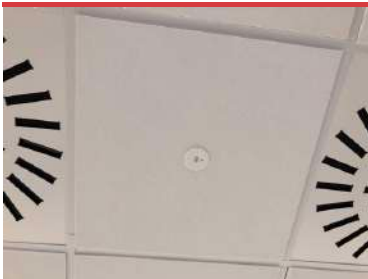
OBSERVATION 28

1F open plan office - 1No. emergency downlight LED indicator was not operational.

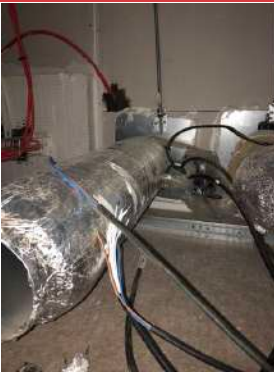
OBSERVATION 29

GF reception - smoke damper not terminated to fire alarm interface.

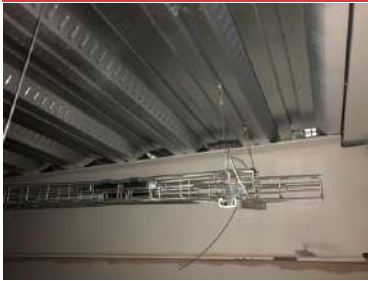
OBSERVATION 30

GF reception - wired basket to be levelled.

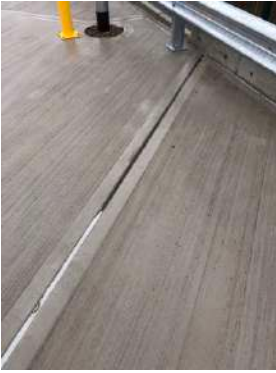
ISSUE 1 COMPLETE MASTIC

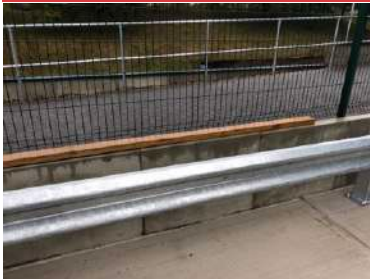
ISSUE 2 REMOVE TIMBER PLANK

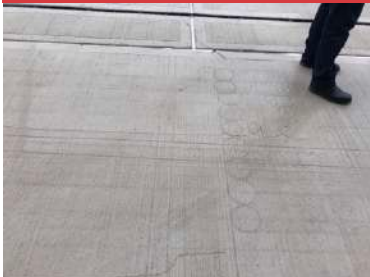
ISSUE 3 REVIEW SCRATCHES ON SLAB

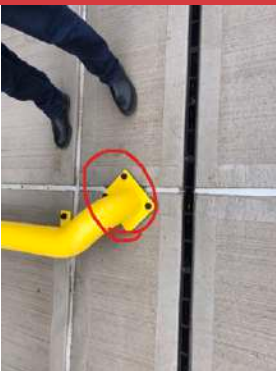
ISSUE 4 REVIEW POSITION OF DOCK GUIDS

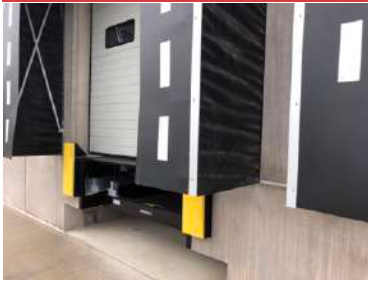
ISSUE 6 CLEAN DOCK GUIDES

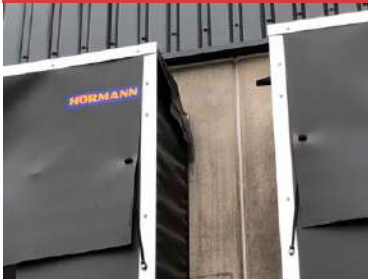
ISSUE 7 PROVIDE DOCK OVERFLOW

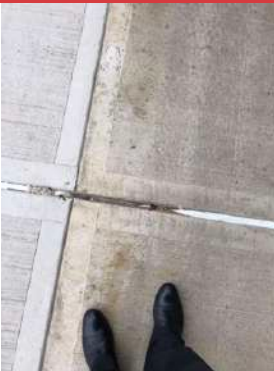
ISSUE 8 REDO MASTIC

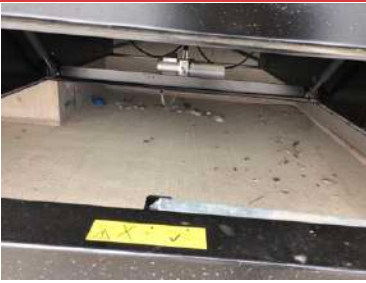
ISSUE 9 CLEAN UNDER DOCKS

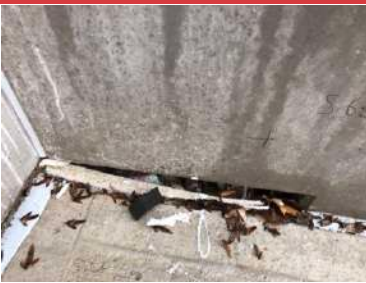
ISSUE 10 MORTAR BOTTOM OF RETAINING WALL

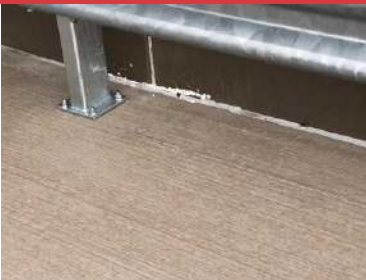
ISSUE 11 TIDY MASTIC AT BOTTOM OF RETAINING WALL

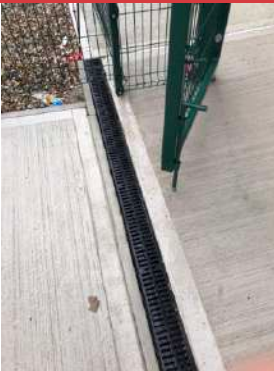
ISSUE 14 TIDY UP CONCRETE INFILL DETAIL

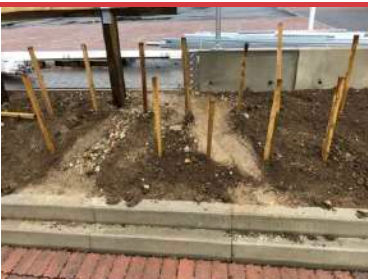
ISSUE 19 TOP UP GRAVEL IN CAR PARK

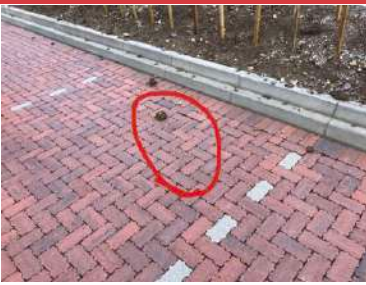
ISSUE 20 RELANDSCAPE CUT THROUGH

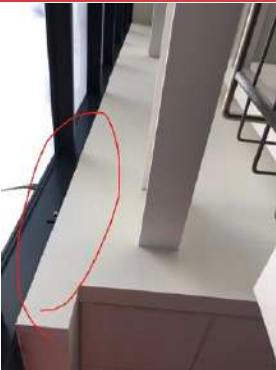
ISSUE 26 TOUCH UP UNDERSIDE OF BULKHEAD

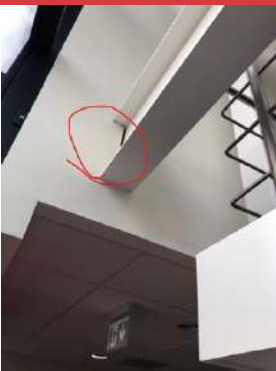
ISSUE 27 COMPLETE DECORATIONS TO CORNER

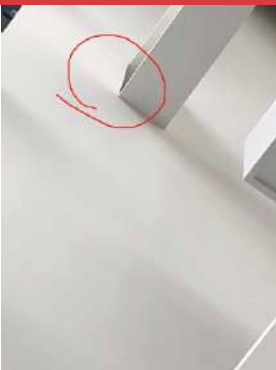
ISSUE 28 COMPLETE DECORATION TO BEAM INFILL

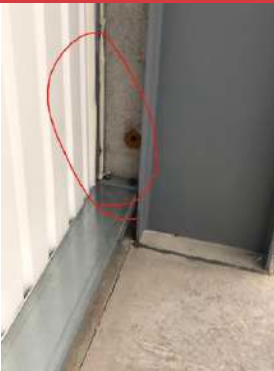
ISSUE 31 REMOVE TAPE THROUGHOUT WAREHOUSE

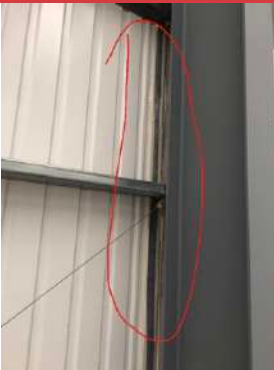
ISSUE 32 REMOVE TAPE

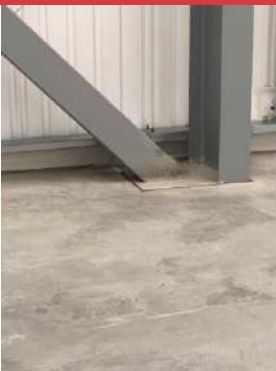
ISSUE 35 REMOVE TAPE FROM SERVICE PENETRATION

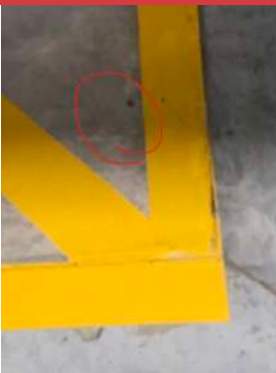
ISSUE 39 SEAL AROUND BASE OF SVP

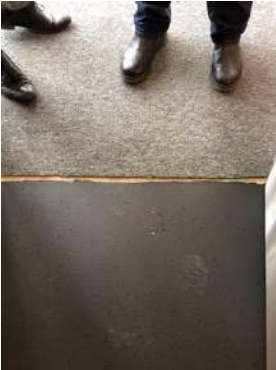
ISSUE 42 FIT CARPET TILES

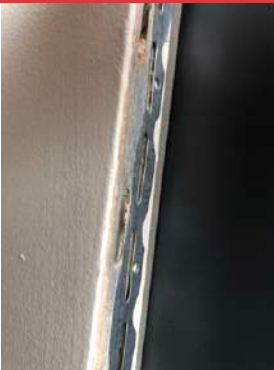
ISSUE 48 MASTIC BEAD TO MIRROR

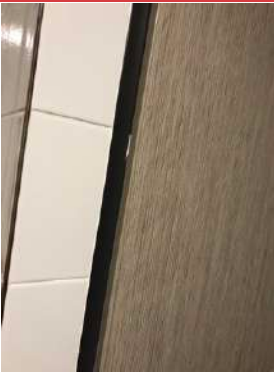
ISSUE 50 COMPLETE CLADDING

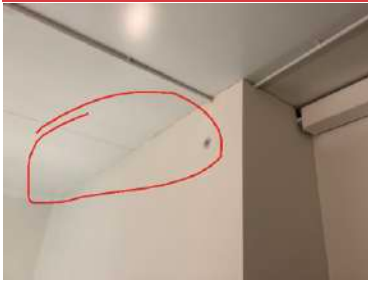
ISSUE 57 CLEAN PAINT FROM DOOR

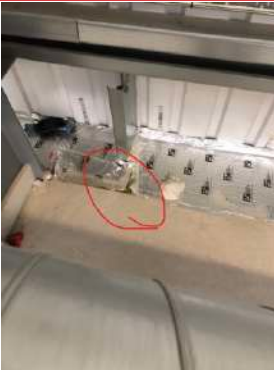
ISSUE 58 MASTIC PLASTERBOARD JOINT

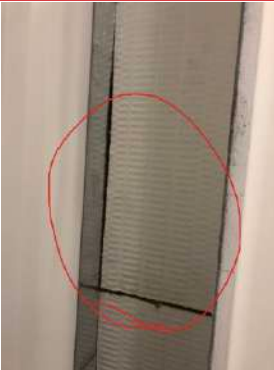
ISSUE 62 REDECORATE DETAIL

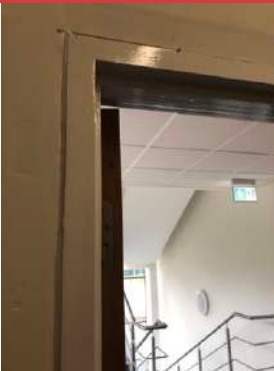
ISSUE 64 SEAL INTUMESCENT INSULATION

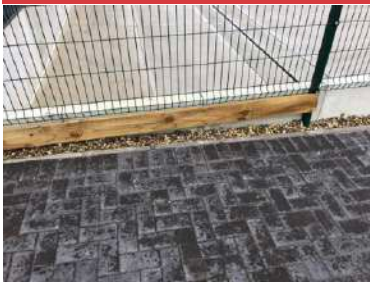
ISSUE 70 PROVIDE STEEL PLATE THRESHOLD

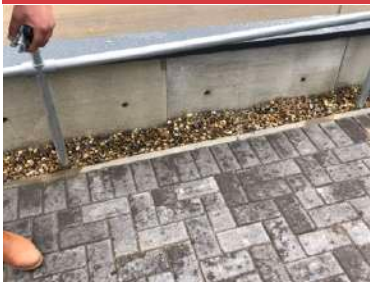
ISSUE 71 REMOVE TIMBER BATTON

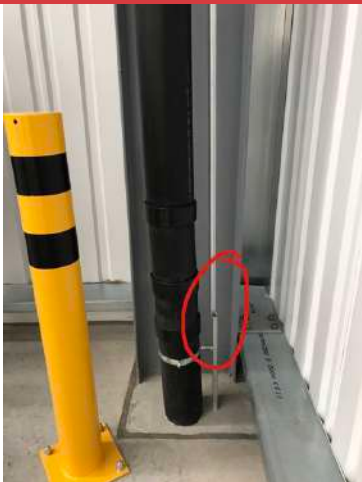
27
Penetration to have mastic.

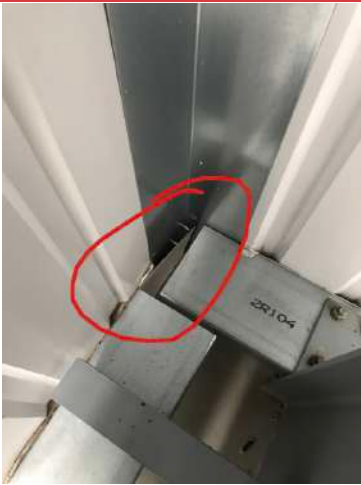
28
Not joined.

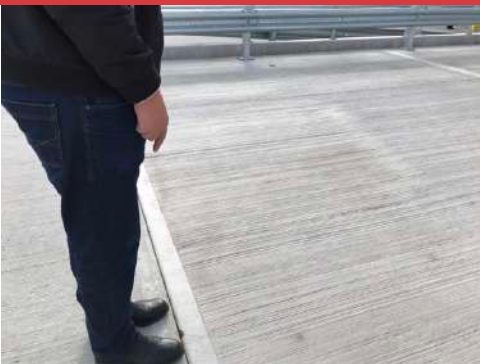
44

Concrete to be clean.

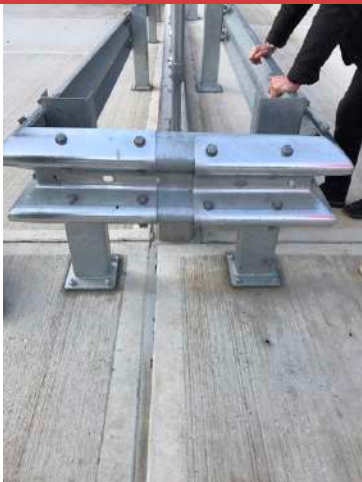
45

Chip in concrete.

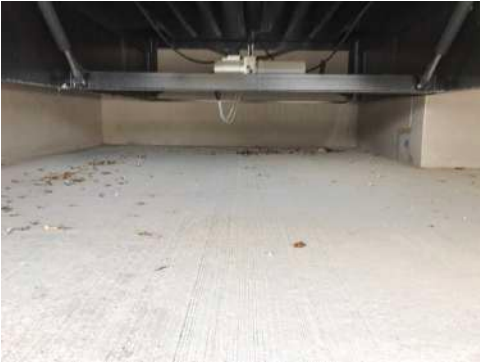
47

Rubbish under dock levellers.

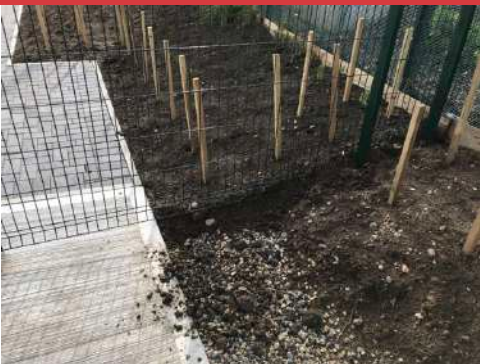
51

Rear footpath to be cleaned.
