**Report No.:** J177345 V2  
**Nature of Work:** Demolition Survey  
**Issue Date:** 12/01/2021  
**Client Name:** Regenda Homes  
Commutation Plaza, 1 Commutation Row, Islington, Liverpool,  
L3 8QF  
**Site Address:** Prospect Court (1-6), Rossall Road, Thornton-Cleveleys, FY5  
1HQ

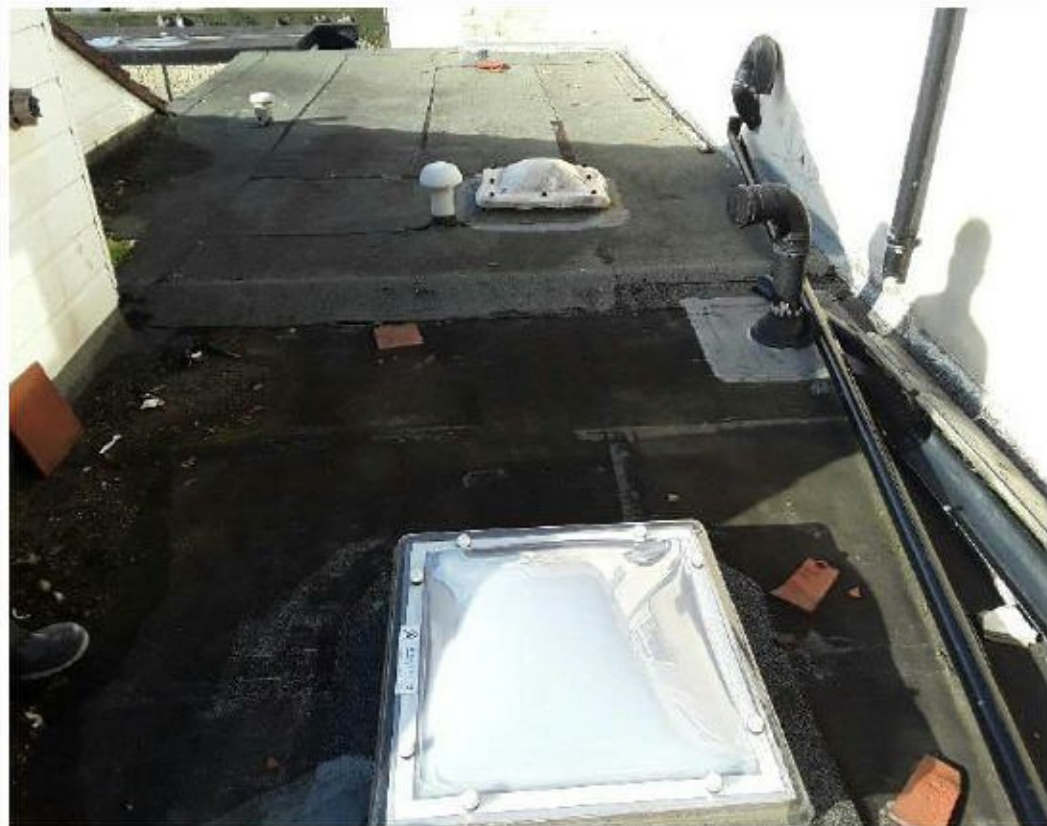
<b>Location:</b>	48 External	<b>Block:</b>	Flats	<b>Floor Level:</b> E - External
<b>Sample No.:</b>	ZZ024285	<b>Portal Ref No.:</b>	121

<b>Item:</b>	Bitumen felt lined roof			
<b>Asbestos Content:</b>		<b>Result Based on:</b>		
No Asbestos Detected		Analysis of sample using PLM		
<b>Sample Analysed By:</b>	C Hay	<b>Extent:</b>	32 m <sup>2</sup>	
<b>Comments:</b> Present to low level flat roof and bay windows

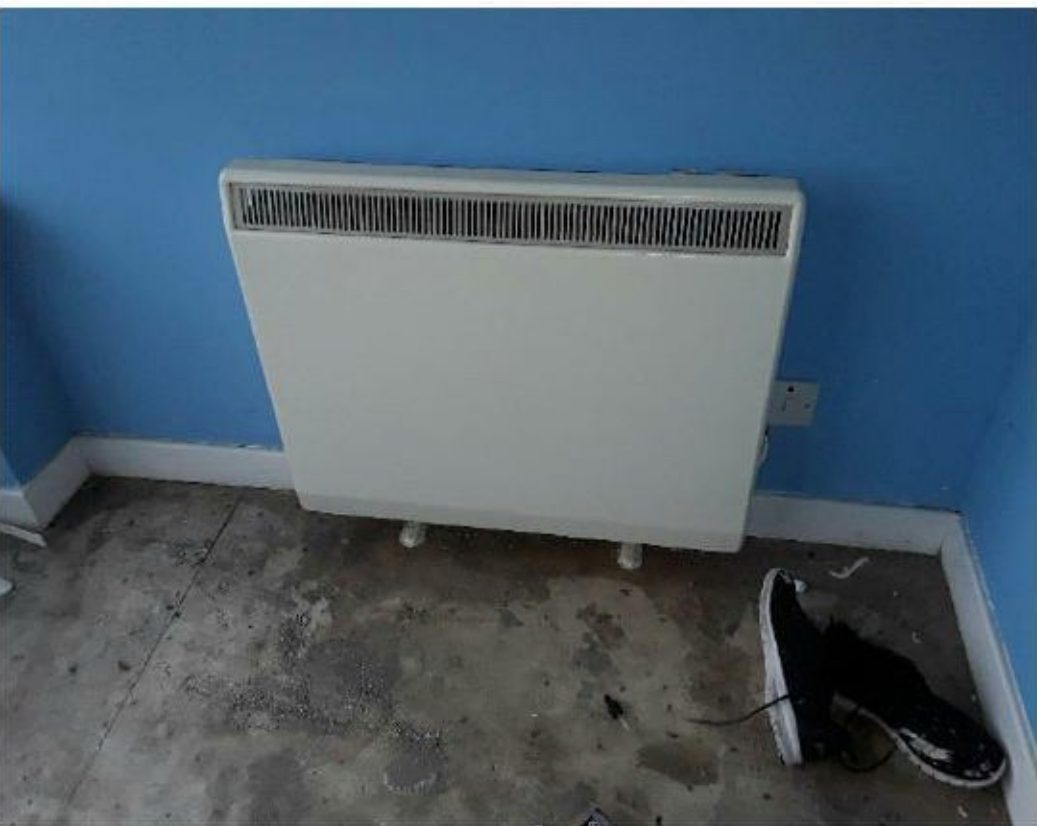
<b>Location:</b>	35 Bedroom	<b>Block:</b>	Flats	<b>Floor Level:</b>	1st Floor
<b>Sample No.:</b>	No sample - presumed	<b>Portal Ref No.:</b>	129

<b>Item:</b>	Asbestos Textile within electric heater				
<b>Asbestos Content:</b>	Result Based on:				
Chrysotile	Presumed				
<b>Sample Analysed By:</b>	Not applicable	<b>Extent:</b>	1 metres		
<b>Comments:</b> Presumed due to no safe access, live and connected

<b>Material Assessment Total Score: 5</b>		<b>Likelihood of Disturbance Assessment Total Score: 3</b>		<b>Management Assessment</b>  <b>Recommendations:</b> Program removal  <b>Reinspection Interval:</b> Not Applicable  <b>Overall Risk Category:</b> C8
<b>Product Type:</b>	2 (Asbestos textile)	<b>Location:</b>	2 (Rooms up to 100 sq m)	
<b>Condition:</b>	1 (Minor scratches)	<b>Accessibility:</b>	0 (Usually inaccessible or unlikely to be disturbed)	
<b>Surface Treatment:</b>	1 (Enclosed textile/paper)			
<b>Asbestos Type:</b>	1 (Chrysotile)	<b>Extent Score:</b>	1 (<10 sq m or 10m pipe run)

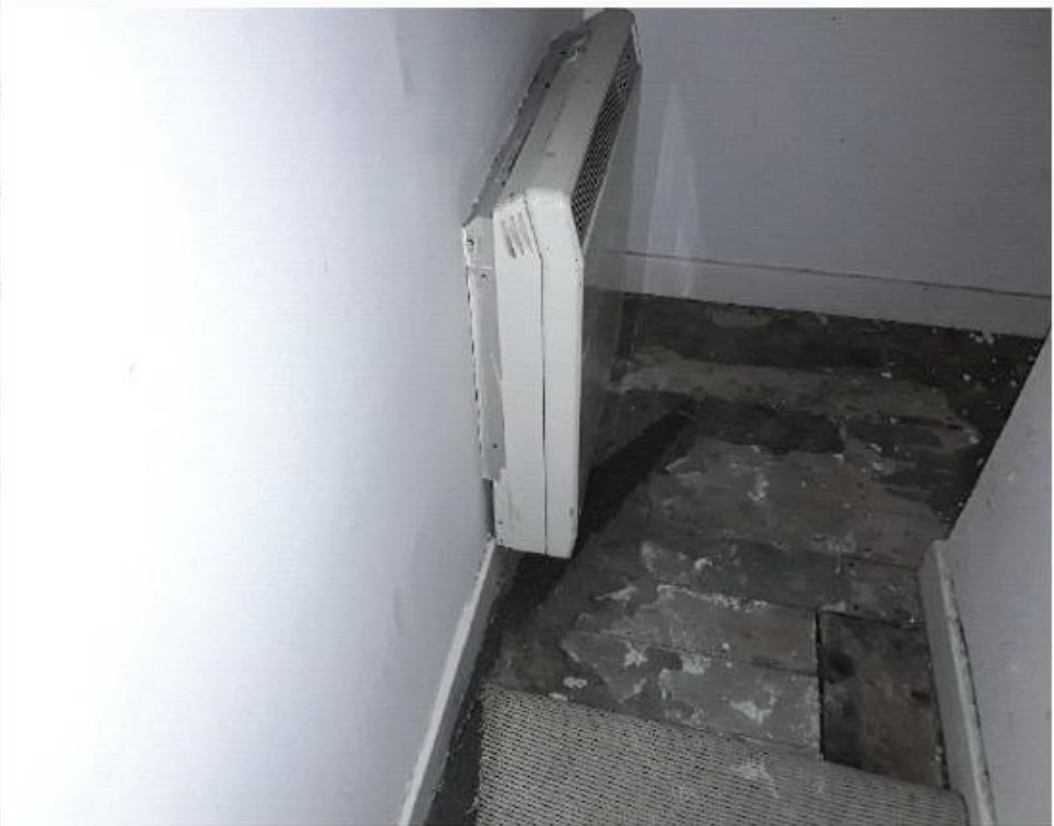
<b>Location:</b>	33 Hallway (Flat 5)	<b>Block:</b>	Flats	<b>Floor Level:</b> 1st Floor
<b>Sample No.:</b>	No sample - presumed	<b>Portal Ref No.:</b>	130

<b>Item:</b>	Asbestos Textile within electric heater			
<b>Asbestos Content:</b>	<b>Result Based on:</b>			
Chrysotile	Presumed			
<b>Sample Analysed By:</b>	Not applicable	<b>Extent:</b>	1 metres	
<b>Comments:</b> Presumed due to no safe access, live and connected

<b>Material Assessment Total Score: 5</b>		<b>Likelihood of Disturbance Assessment Total Score: 3</b>		<b>Management Assessment</b>  <b>Recommendations:</b> Program removal  <b>Reinspection Interval:</b> Not Applicable  <b>Overall Risk Category:</b> C8
<b>Product Type:</b>	2 (Asbestos textile)	<b>Location:</b>	2 (Rooms up to 100 sq m)	
<b>Condition:</b>	1 (Minor scratches)	<b>Accessibility:</b>	0 (Usually inaccessible or unlikely to be disturbed)	
<b>Surface Treatment:</b>	1 (Enclosed textile/paper)			
<b>Asbestos Type:</b>	1 (Chrysotile)	<b>Extent Score:</b>	1 (<10 sq m or 10m pipe run)

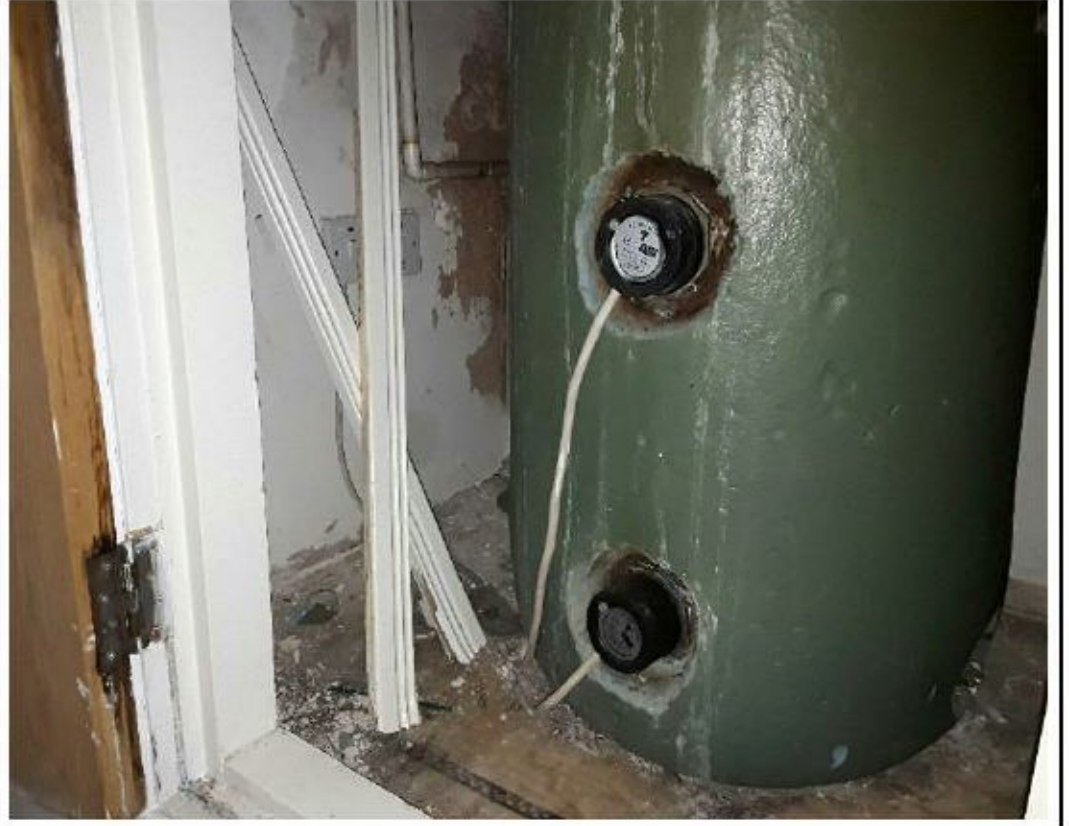
<b>Location:</b>	36 Cylinder Cupboard	<b>Block:</b>	Flats	<b>Floor Level:</b>	1st Floor
<b>Sample No.:</b>	ZZ024293	<b>Portal Ref No.:</b>	131

<b>Item:</b>	Gasket to copper cylinder				
<b>Asbestos Content:</b>		<b>Result Based on:</b>			
No Asbestos Detected		Analysis of sample using PLM			
<b>Sample Analysed By:</b>	J Harvey CCP Asbestos	<b>Extent:</b>	2 units		
<b>Comments:</b>

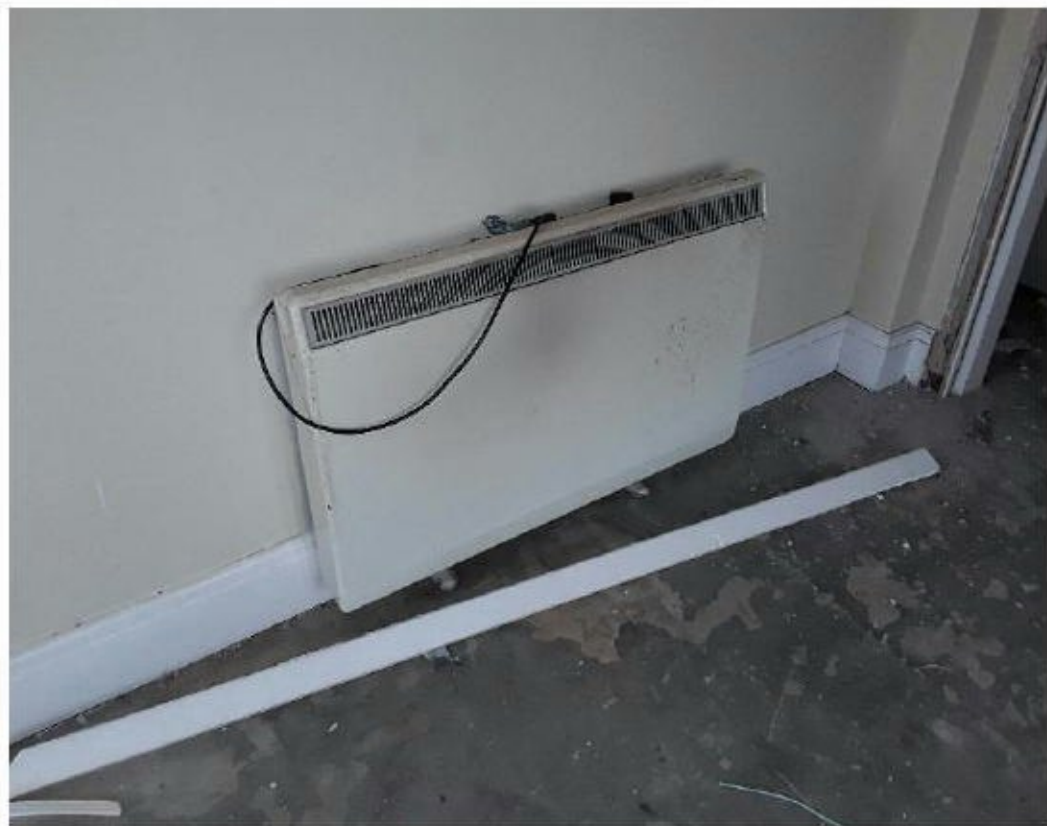
<b>Location:</b>	37 Living Room/Kitchen	<b>Block:</b>	Flats	<b>Floor Level:</b>	1st Floor
<b>Sample No.:</b>	No sample - presumed	<b>Portal Ref No.:</b>	134

<b>Item:</b>	Asbestos Textile within electric heater				
<b>Asbestos Content:</b>	<b>Result Based on:</b>				
Chrysotile	Presumed				
<b>Sample Analysed By:</b>	Not applicable	<b>Extent:</b>	1 metres		
<b>Comments:</b> Presumed due to no safe access, live and connected

<b>Material Assessment Total Score: 5</b>		<b>Likelihood of Disturbance Assessment Total Score: 3</b>		<p><b>Management Assessment</b></p> <p><b>Recommendations:</b> Program removal</p> <p><b>Reinspection Interval:</b> Not Applicable</p> <p><b>Overall Risk Category:</b> C8</p>
<b>Product Type:</b>	2 (Asbestos textile)	<b>Location:</b>	2 (Rooms up to 100 sq m)	
<b>Condition:</b>	1 (Minor scratches)	<b>Accessibility:</b>	0 (Usually inaccessible or unlikely to be disturbed)	
<b>Surface Treatment:</b>	1 (Enclosed textile/paper)			
<b>Asbestos Type:</b>	1 (Chrysotile)	<b>Extent Score:</b>	1 (<10 sq m or 10m pipe run)

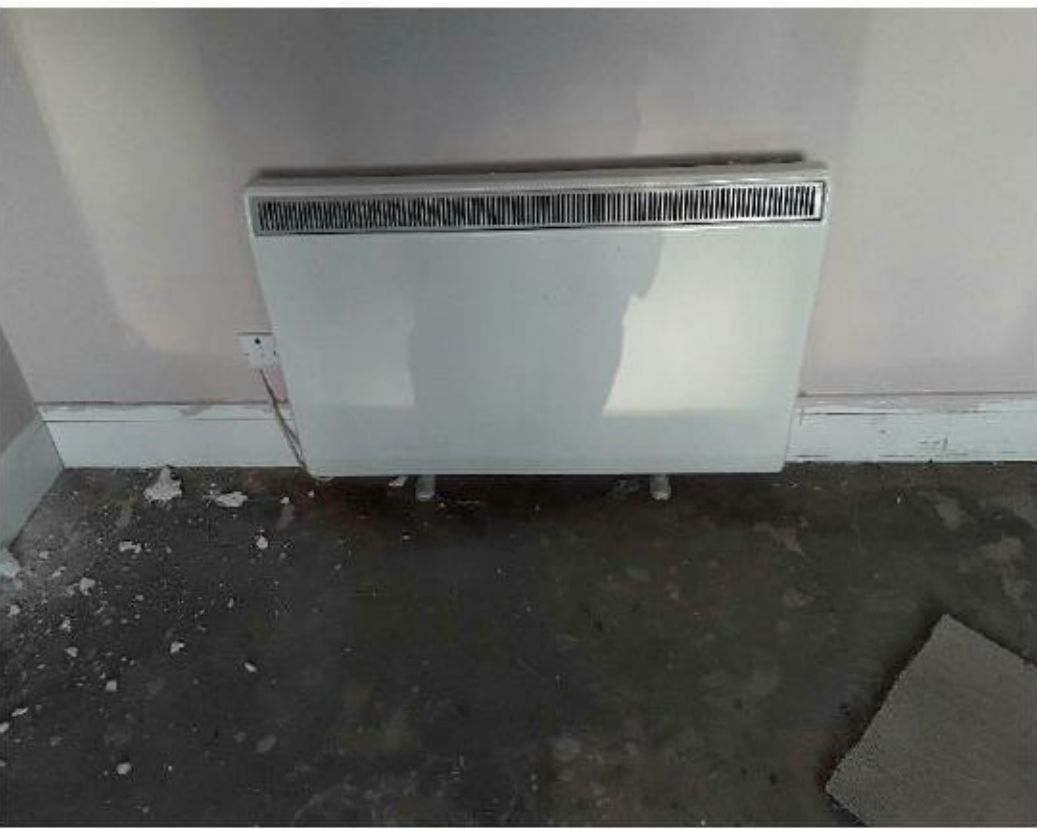
<b>Location:</b>	38 Bedroom	<b>Block:</b>	Flats	<b>Floor Level:</b>	1st Floor
<b>Sample No.:</b>	No sample - presumed	<b>Portal Ref No.:</b>	138

<b>Item:</b>	Asbestos Textile within electric heater				
<b>Asbestos Content:</b>	Result Based on:				
Chrysotile	Presumed				
<b>Sample Analysed By:</b>	Not applicable	<b>Extent:</b>	1 metres		
<b>Comments:</b> Presumed due to no safe access, live and connected

<b>Material Assessment Total Score: 5</b>		<b>Likelihood of Disturbance Assessment Total Score: 3</b>		<p><b>Management Assessment</b></p> <p><b>Recommendations:</b> Program removal</p> <p><b>Reinspection Interval:</b> Not Applicable</p> <p><b>Overall Risk Category:</b> C8</p>
<b>Product Type:</b>	2 (Asbestos textile)	<b>Location:</b>	2 (Rooms up to 100 sq m)	
<b>Condition:</b>	1 (Minor scratches)	<b>Accessibility:</b>	0 (Usually inaccessible or unlikely to be disturbed)	
<b>Surface Treatment:</b>	1 (Enclosed textile/paper)			
<b>Asbestos Type:</b>	1 (Chrysotile)	<b>Extent Score:</b>	1 (<10 sq m or 10m pipe run)

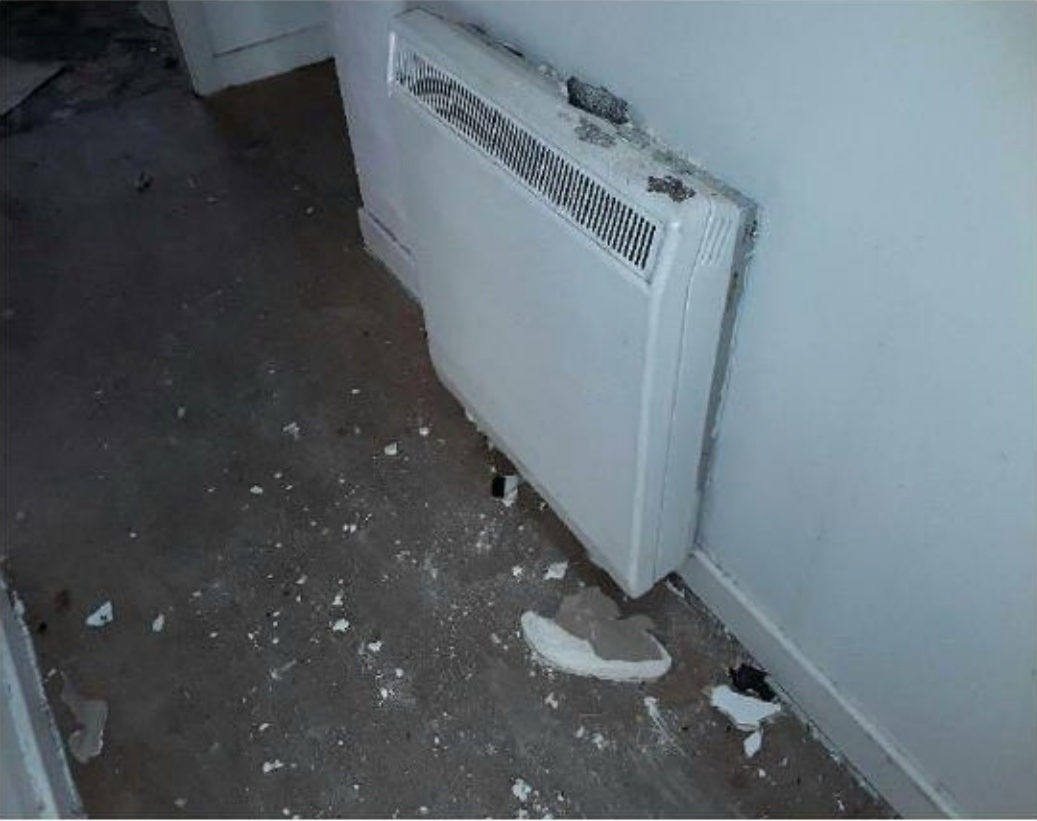
<b>Location:</b>	40 Hallway (Flat 6)	<b>Block:</b>	Flats	<b>Floor Level:</b>	1st Floor
<b>Sample No.:</b>	No sample - presumed	<b>Portal Ref No.:</b>	140

<b>Item:</b>	Asbestos Textile within electric heater				
<b>Asbestos Content:</b>	Result Based on:				
Chrysotile	Presumed				
<b>Sample Analysed By:</b>	Not applicable	<b>Extent:</b>	1 metres		
<b>Comments:</b> Presumed due to no safe access, live and connected

<b>Material Assessment Total Score: 5</b>		<b>Likelihood of Disturbance Assessment Total Score: 3</b>		<p><b>Management Assessment</b></p> <p><b>Recommendations:</b> Program removal</p> <p><b>Reinspection Interval:</b> Not Applicable</p> <p><b>Overall Risk Category:</b> C8</p>
<b>Product Type:</b>	2 (Asbestos textile)	<b>Location:</b>	2 (Rooms up to 100 sq m)	
<b>Condition:</b>	1 (Minor scratches)	<b>Accessibility:</b>	0 (Usually inaccessible or unlikely to be disturbed)	
<b>Surface Treatment:</b>	1 (Enclosed textile/paper)			
<b>Asbestos Type:</b>	1 (Chrysotile)	<b>Extent Score:</b>	1 (<10 sq m or 10m pipe run)

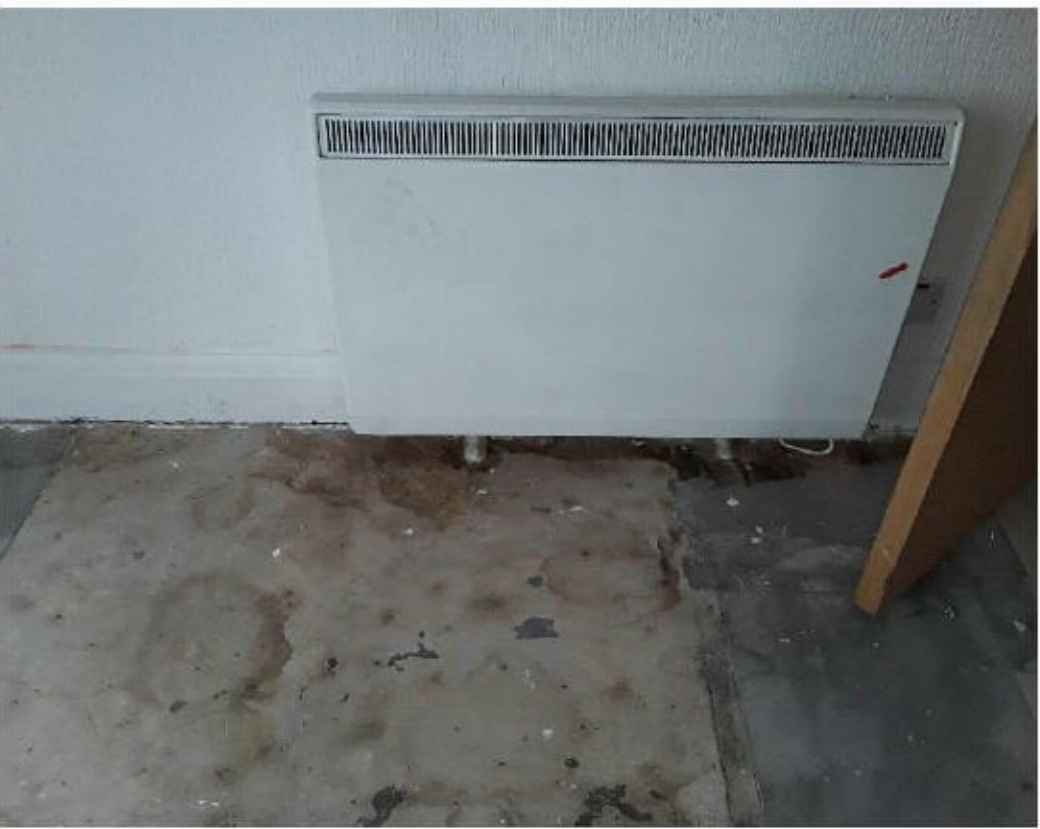
<b>Location:</b>	42 Living Room	<b>Block:</b>	Flats	<b>Floor Level:</b>	1st Floor
<b>Sample No.:</b>	No sample - presumed	<b>Portal Ref No.:</b>	144

<b>Item:</b>	Asbestos Textile within electric heater				
<b>Asbestos Content:</b>	Result Based on:				
Chrysotile	Presumed				
<b>Sample Analysed By:</b>	Not applicable	<b>Extent:</b>	1 metres		
<b>Comments:</b> Presumed due to no safe access, live and connected

<b>Material Assessment Total Score: 5</b>		<b>Likelihood of Disturbance Assessment Total Score: 3</b>		<b>Management Assessment</b>  <b>Recommendations:</b> Program removal  <b>Reinspection Interval:</b> Not Applicable  <b>Overall Risk Category:</b> C8
<b>Product Type:</b>	2 (Asbestos textile)	<b>Location:</b>	2 (Rooms up to 100 sq m)	
<b>Condition:</b>	1 (Minor scratches)	<b>Accessibility:</b>	0 (Usually inaccessible or unlikely to be disturbed)	
<b>Surface Treatment:</b>	1 (Enclosed textile/paper)			
<b>Asbestos Type:</b>	1 (Chrysotile)	<b>Extent Score:</b>	1 (<10 sq m or 10m pipe run)

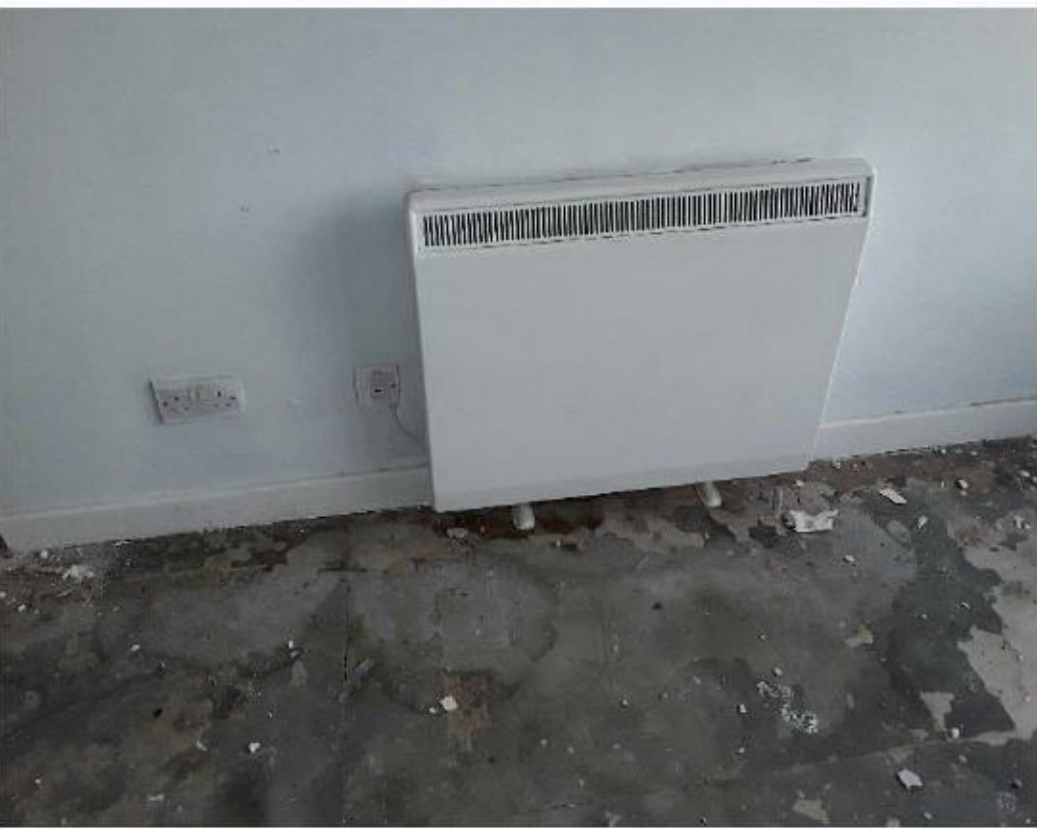
<b>Location:</b>	45 Bedroom	<b>Block:</b>	Flats	<b>Floor Level:</b>	1st Floor
<b>Sample No.:</b>	No sample - presumed	<b>Portal Ref No.:</b>	149

<b>Item:</b>	Asbestos Textile within electric heater				
<b>Asbestos Content:</b>	Result Based on:				
Chrysotile	Presumed				
<b>Sample Analysed By:</b>	Not applicable	<b>Extent:</b>	1 metres		
<b>Comments:</b> Presumed due to no safe access, live and connected

<b>Material Assessment Total Score: 5</b>		<b>Likelihood of Disturbance Assessment Total Score: 3</b>		<b>Management Assessment</b>  <b>Recommendations:</b> Program removal  <b>Reinspection Interval:</b> Not Applicable  <b>Overall Risk Category:</b> C8
<b>Product Type:</b>	2 (Asbestos textile)	<b>Location:</b>	2 (Rooms up to 100 sq m)	
<b>Condition:</b>	1 (Minor scratches)	<b>Accessibility:</b>	0 (Usually inaccessible or unlikely to be disturbed)	
<b>Surface Treatment:</b>	1 (Enclosed textile/paper)			
<b>Asbestos Type:</b>	1 (Chrysotile)	<b>Extent Score:</b>	1 (<10 sq m or 10m pipe run)

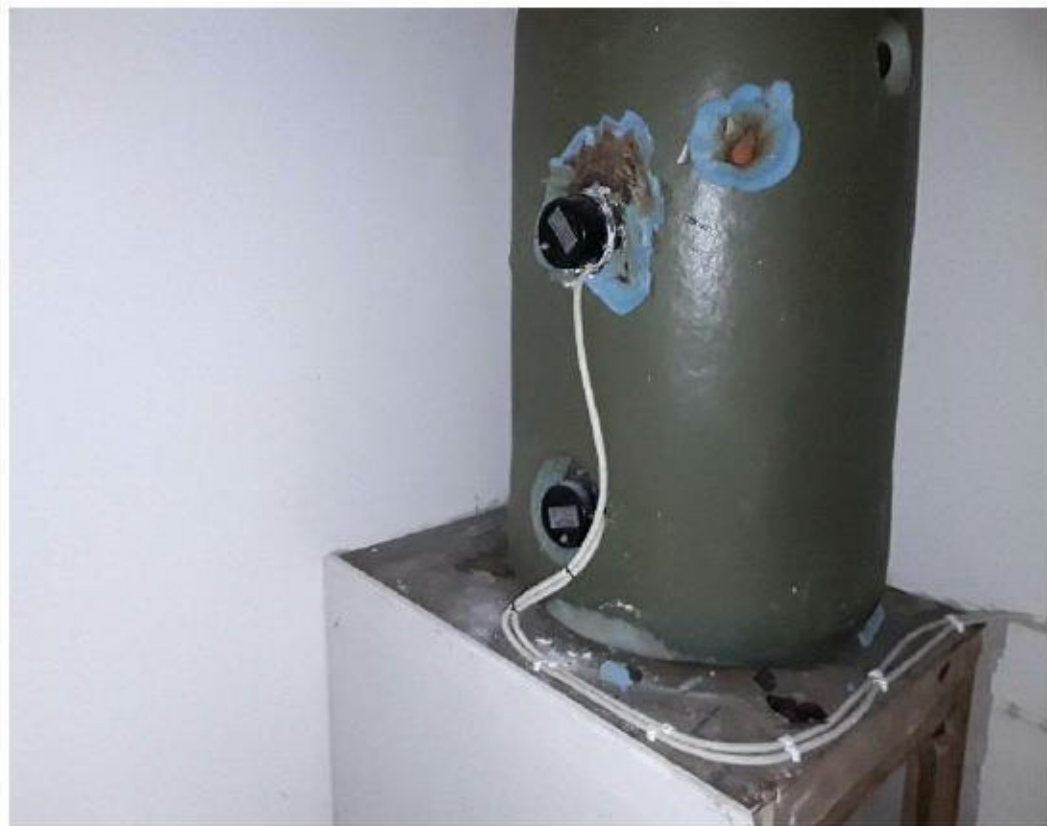
<b>Location:</b>	46 Cylinder Cupboard	<b>Block:</b>	Flats	<b>Floor Level:</b>	1st Floor
<b>Sample No.:</b>	ZZ024294	<b>Portal Ref No.:</b>	150

<b>Item:</b>	Gasket to copper cylinder				
<b>Asbestos Content:</b>		<b>Result Based on:</b>			
No Asbestos Detected		Analysis of sample using PLM			
<b>Sample Analysed By:</b>	J Harvey CCP Asbestos	<b>Extent:</b>	2 units		
<b>Comments:</b>

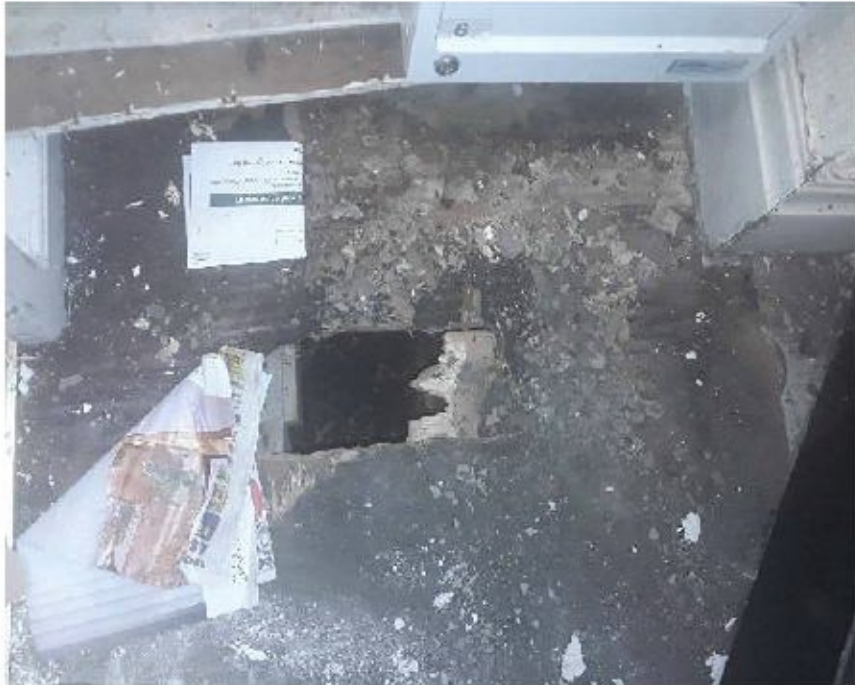
01 (01 Entrance Lobby) Beyond timber floorboards

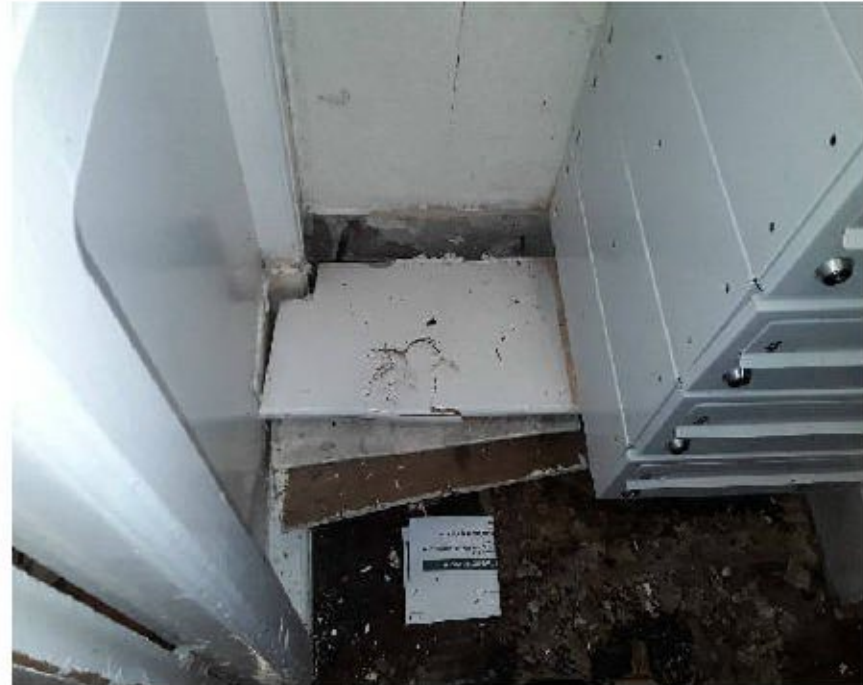
02 (01 Entrance Lobby) Internally to timber boxing

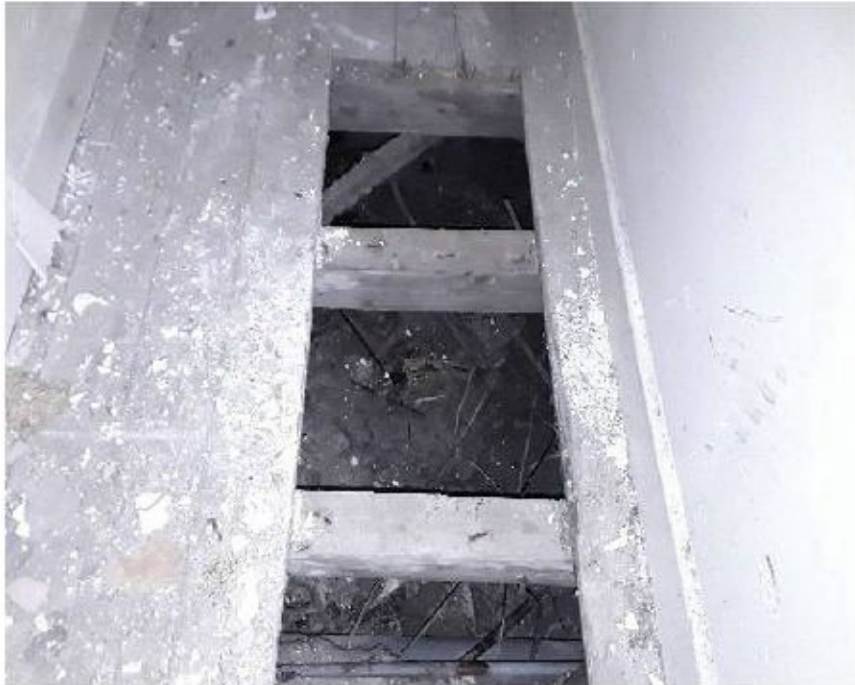
05 (03 Understairs Cupboard)  
Beyond timber floorboards

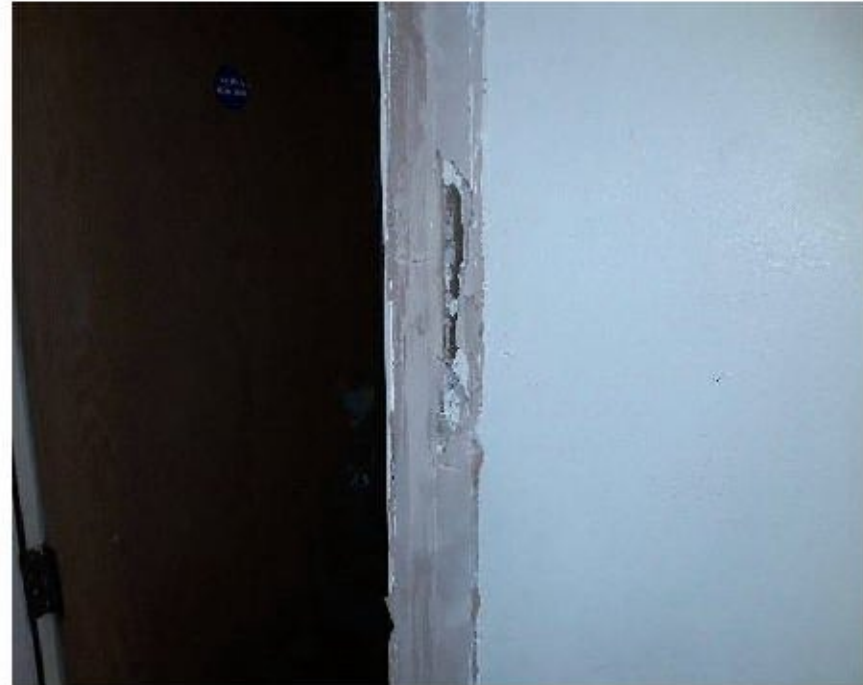
06 (03 Understairs Cupboard)  
Beyond timber door frame

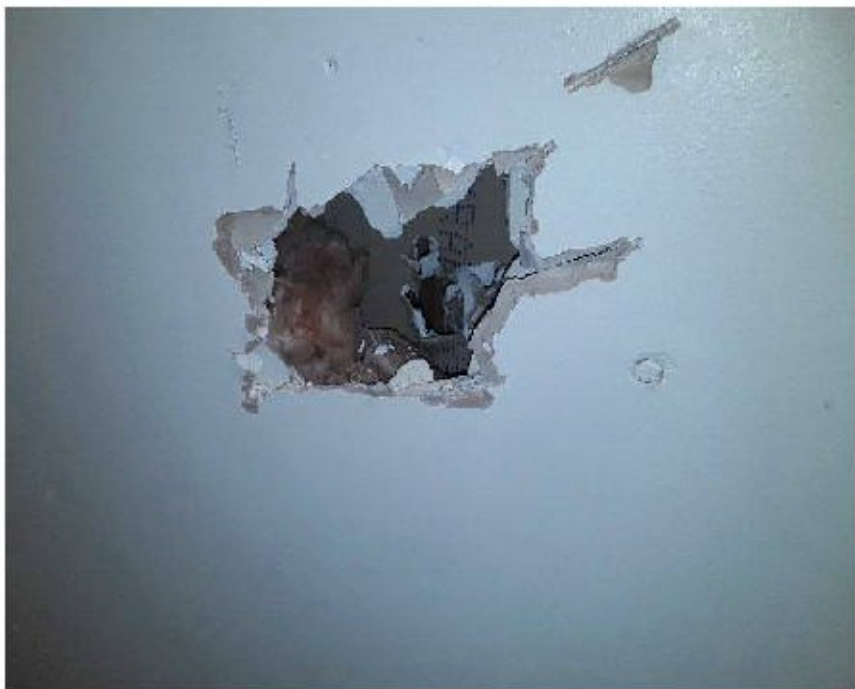
07 (04 Hallway) Beyond plaster to  
plasterboard

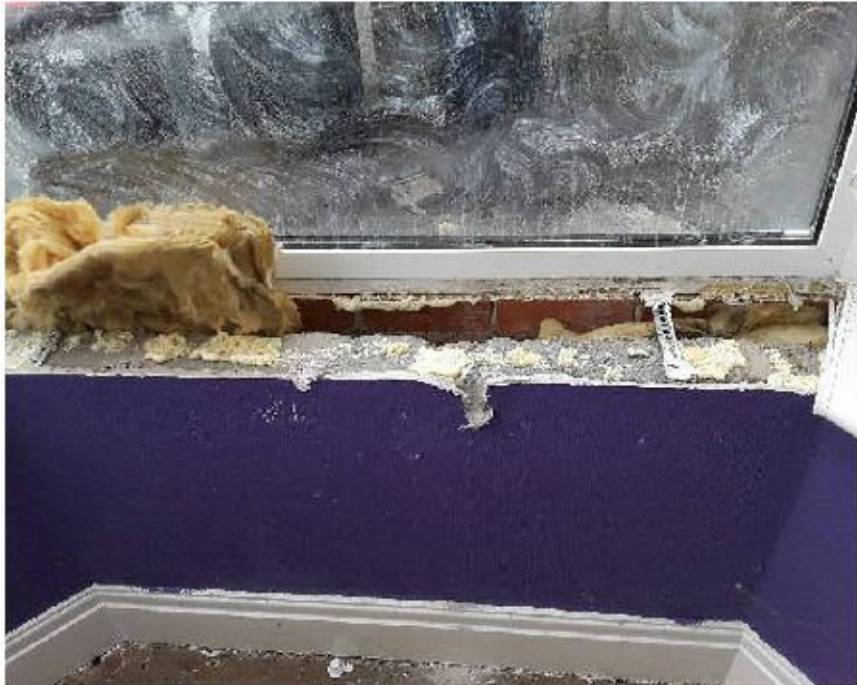
09 (06 Living Room) Beyond timber window sill

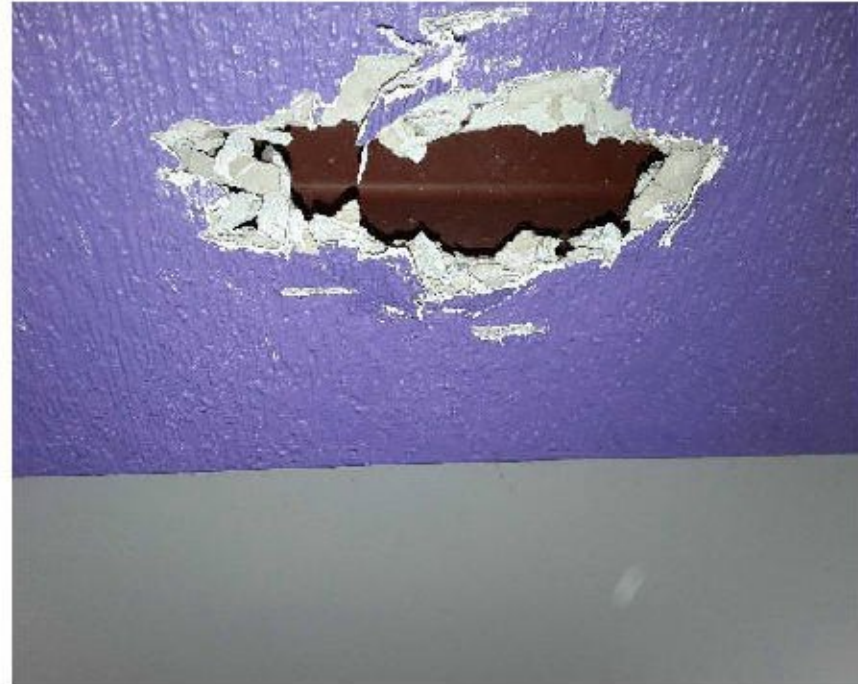
10 (06 Living Room) Plasterboard boxing housing steel structural support beam

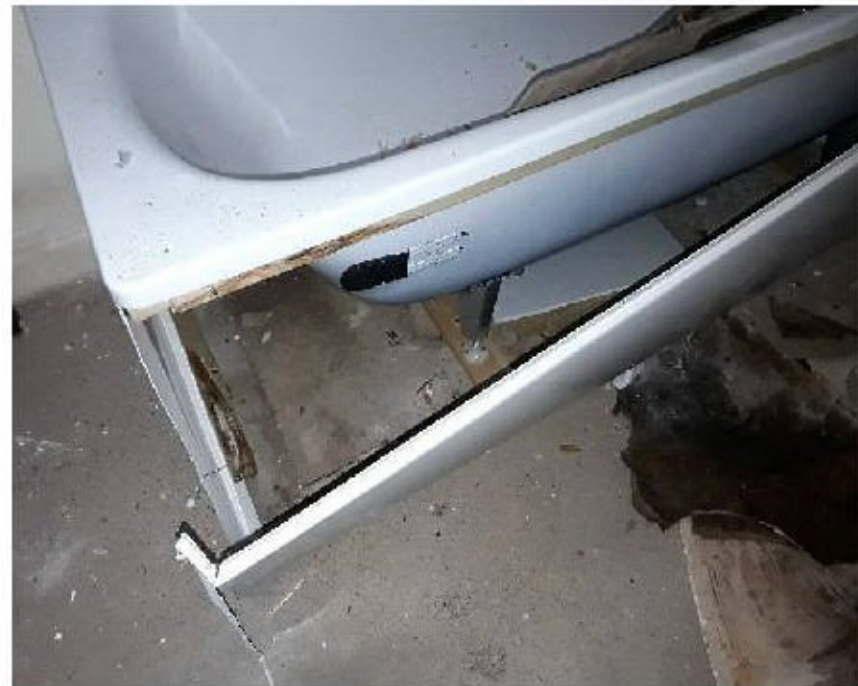
12 (09 Bathroom) Beyond plastic bath panel

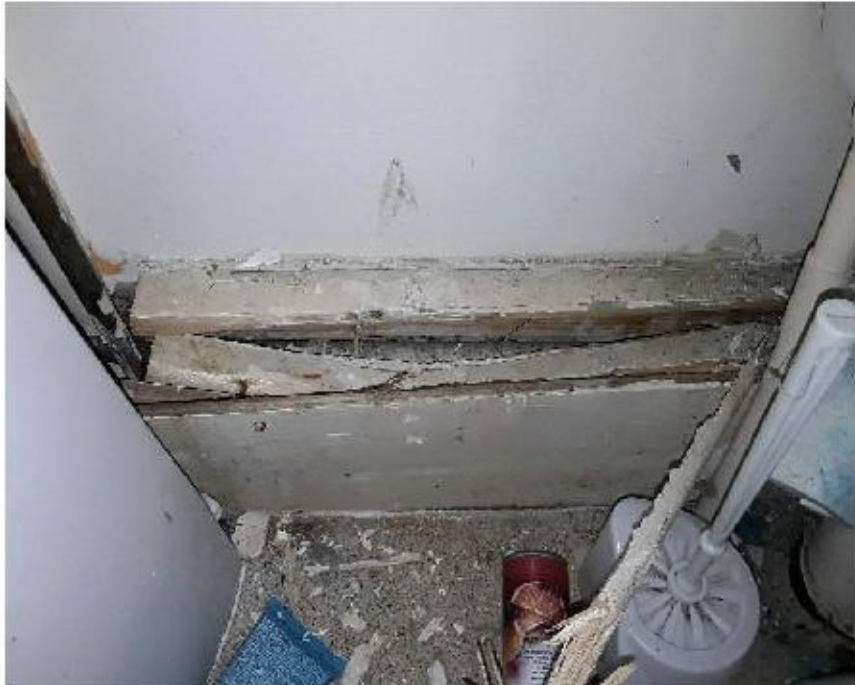
13 (09 Bathroom) Internally to timber boxing

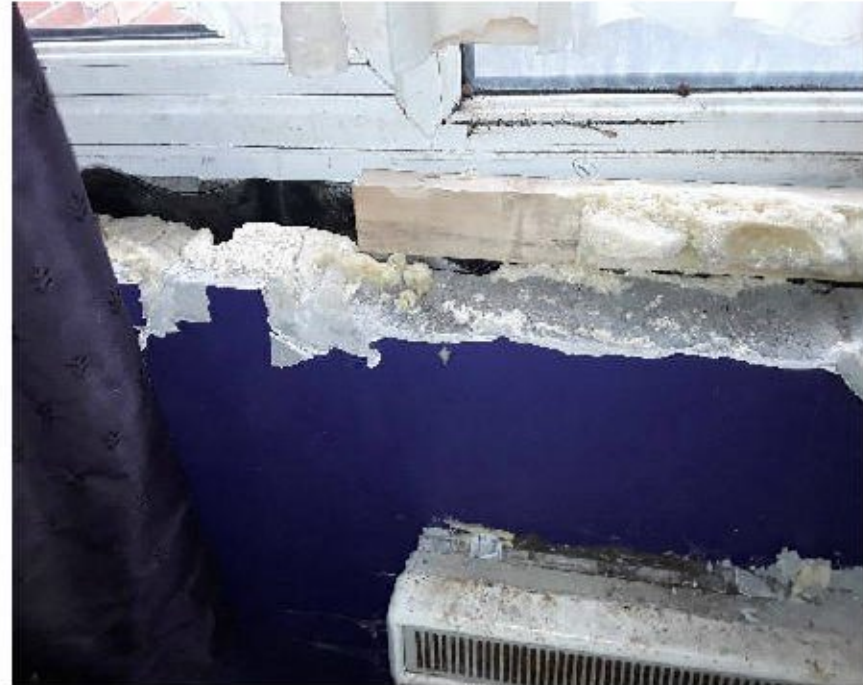
14 (11 Dining Room) Beyond timber window sill

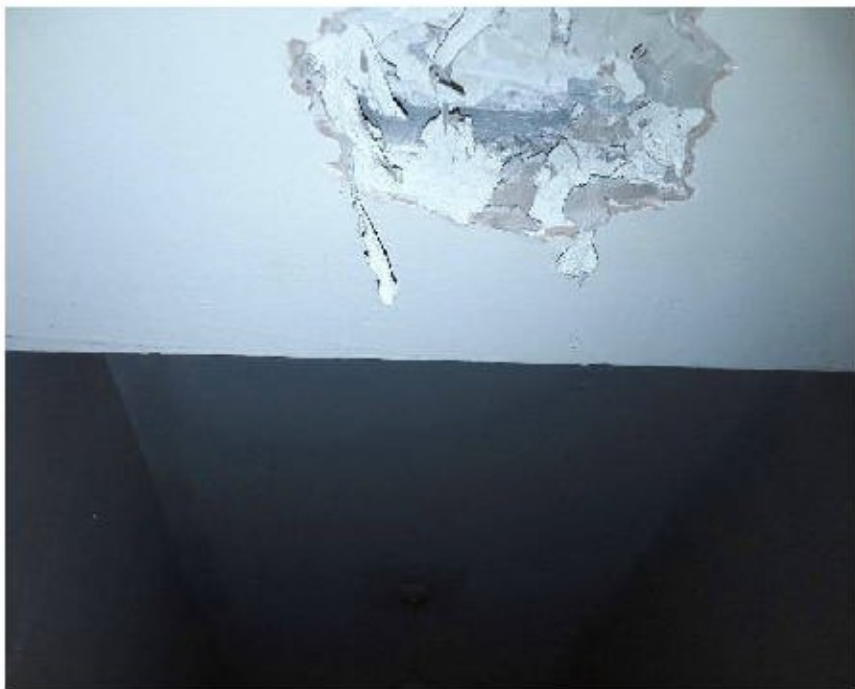
15 (13 Hallway) Beyond plasterboard cladding to beam

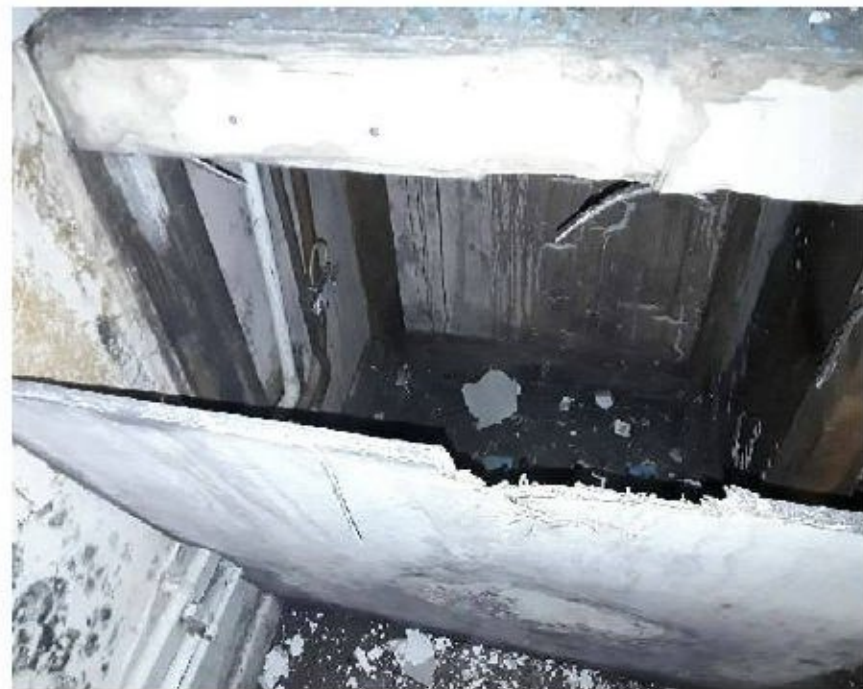
16 (14 Cylinder Cupboard) Internally to timber boxing

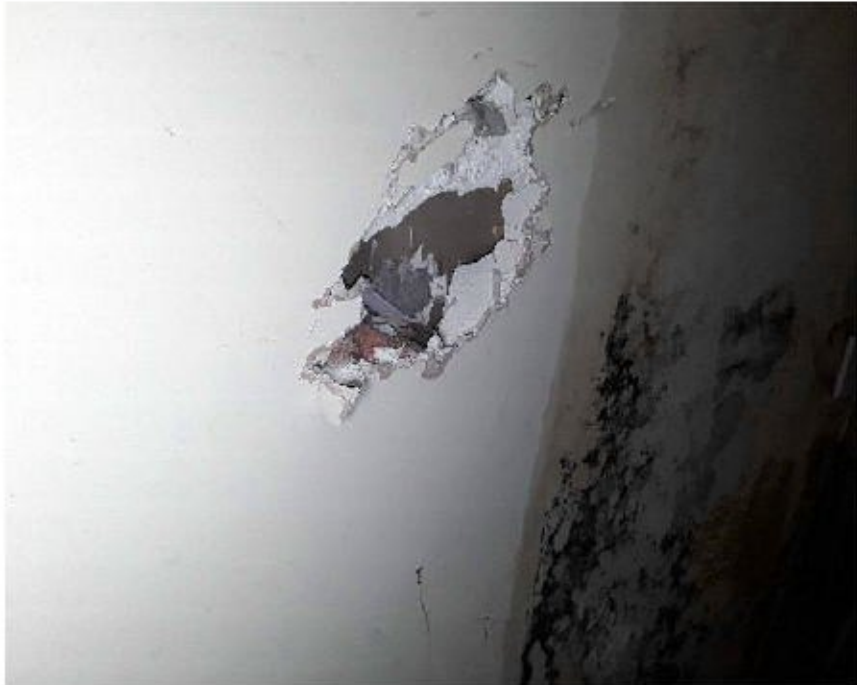
17 (14 Cylinder Cupboard) Beyond plaster to plasterboard wall

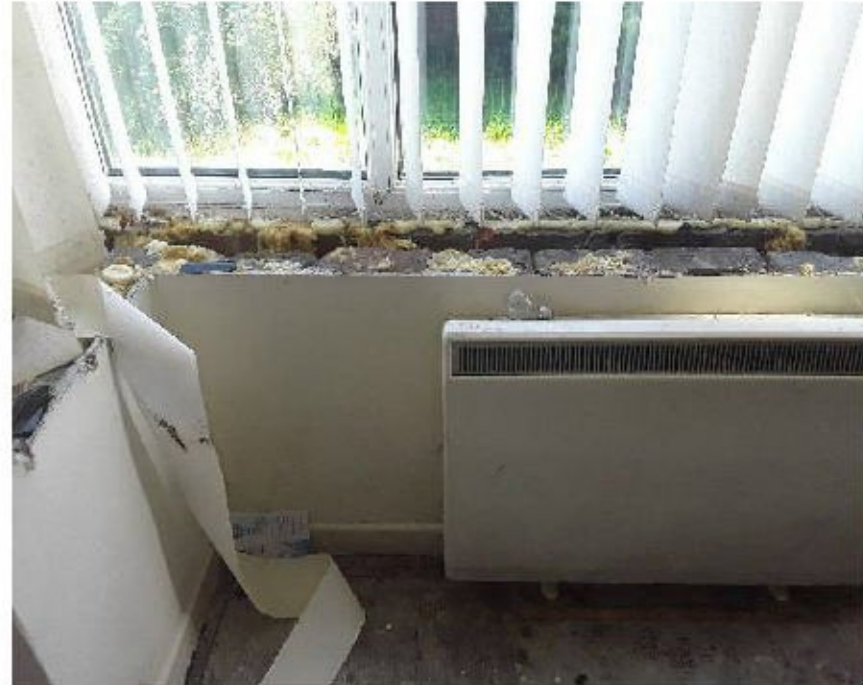
18 (15 Dining Room) Beyond timber window sill

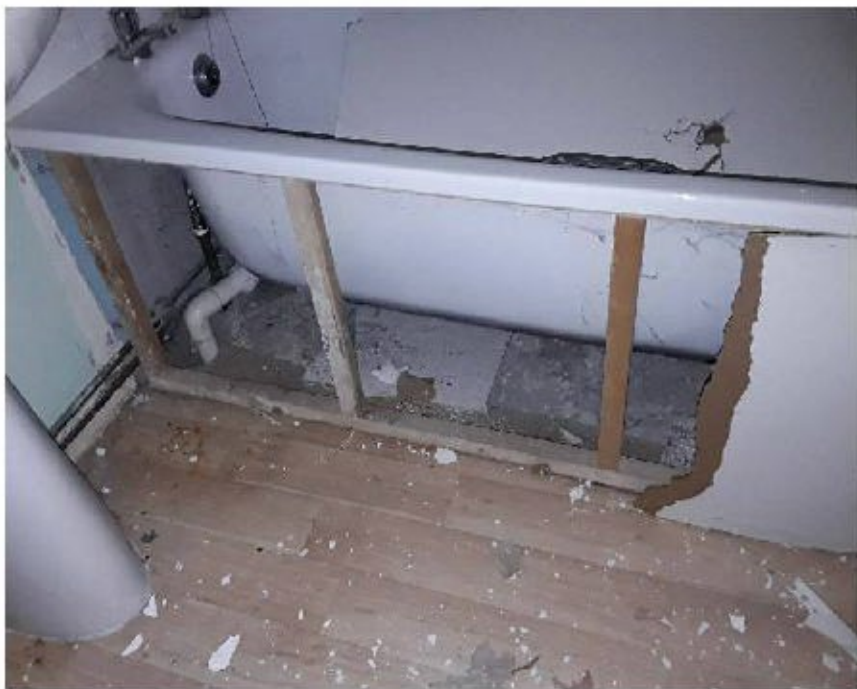
19 (16 Bathroom) Beyond timber bath panel

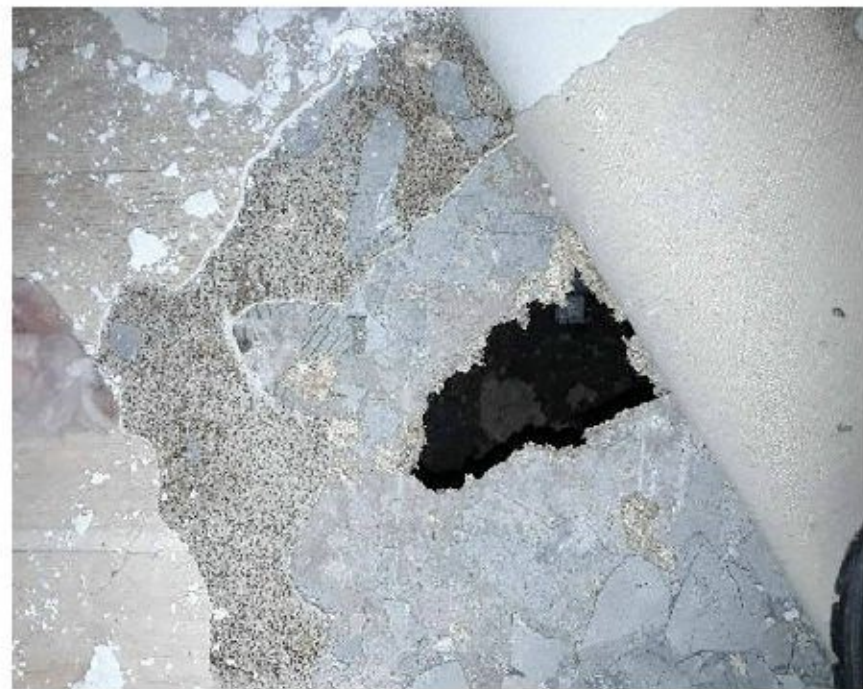
20 (16 Bathroom) Beyond timber floorboards

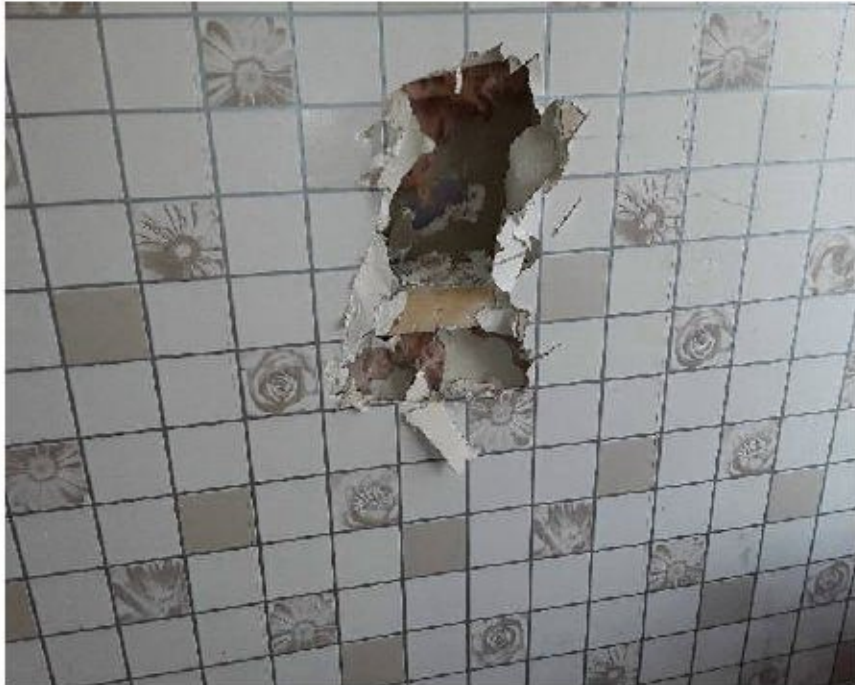
21 (17 Kitchen) Beyond plaster to plasterboard wall

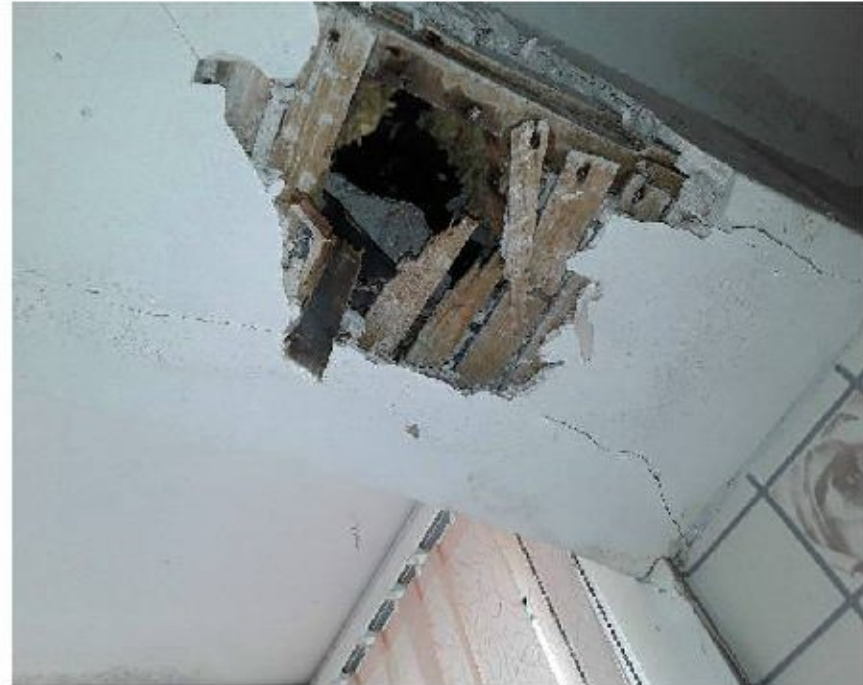
22 (17 Kitchen) Internally to lath and plaster boxing

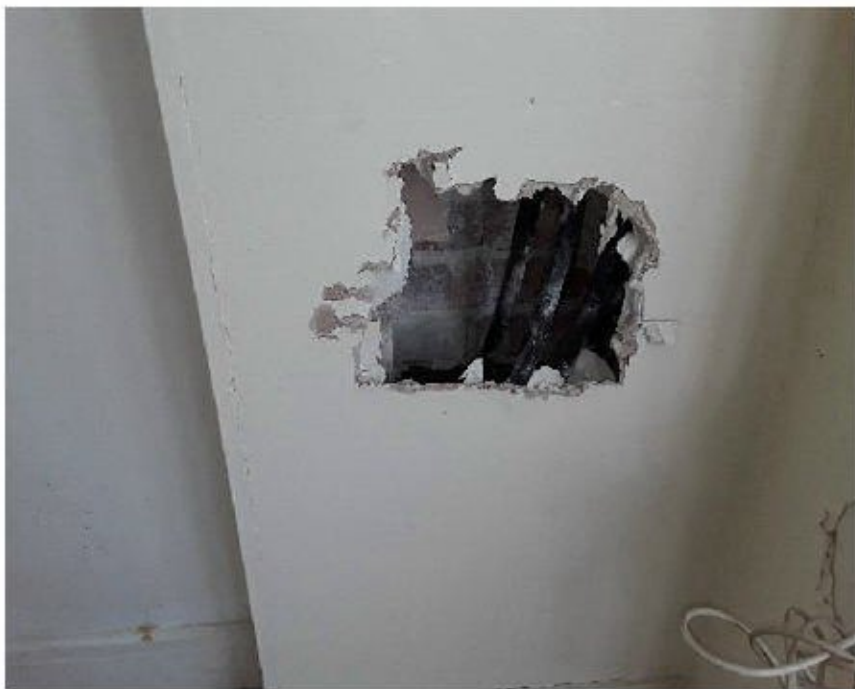
23 (18 Living Room) Internally to plasterboard boxing

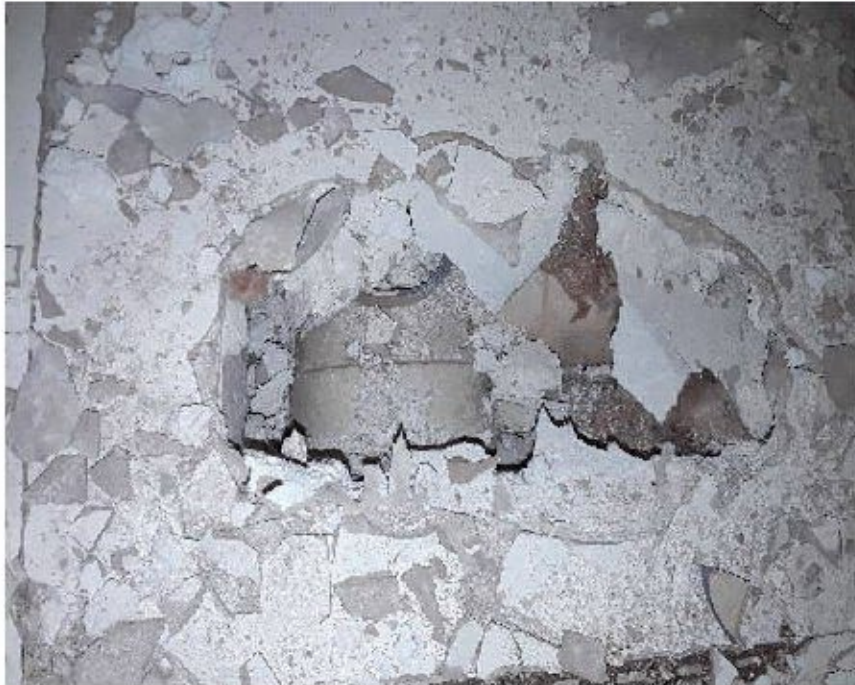
25 (19 Bedroom) Internally to plasterboard boxing
