**Report No.:** J177345 V2  
**Nature of Work:** Demolition Survey  
**Issue Date:** 12/01/2021  
**Client Name:** Regenda Homes  
Commutation Plaza, 1 Commutation Row, Islington, Liverpool,  
L3 8QF  
**Site Address:** Prospect Court (1-6), Rossall Road, Thornton-Cleveleys, FY5  
1HQ

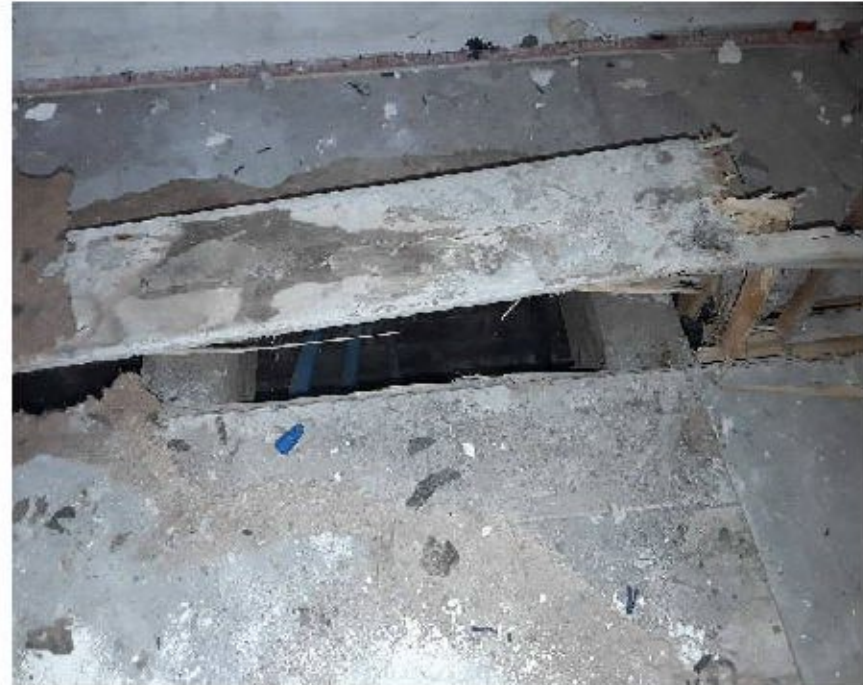
26 (19 Bedroom) Beyond timber floorboards

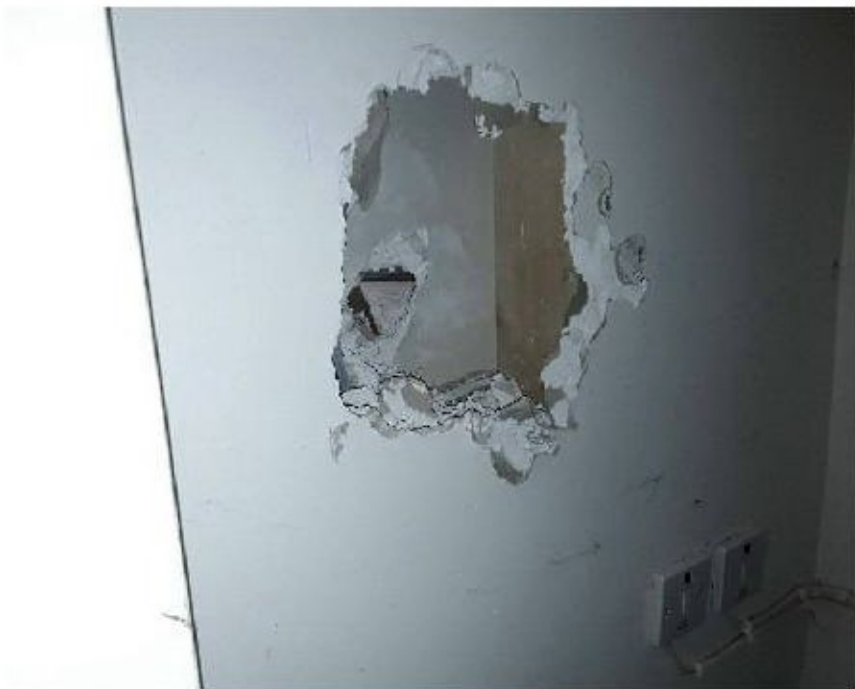
27 (21 Cylinder Cupboard) Beyond plaster to plasterboard wall

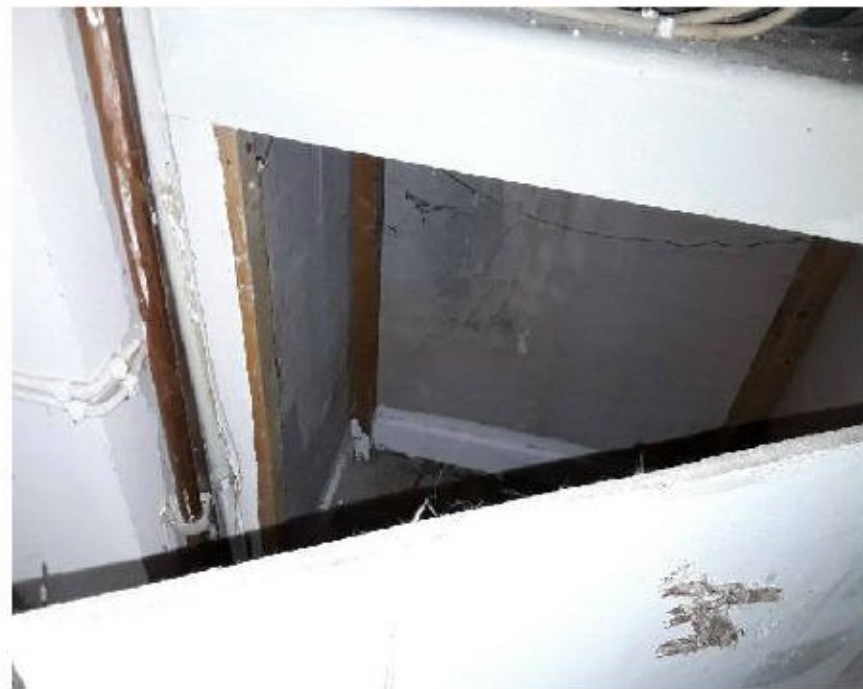
28 (21 Cylinder Cupboard) Internally to timber boxing

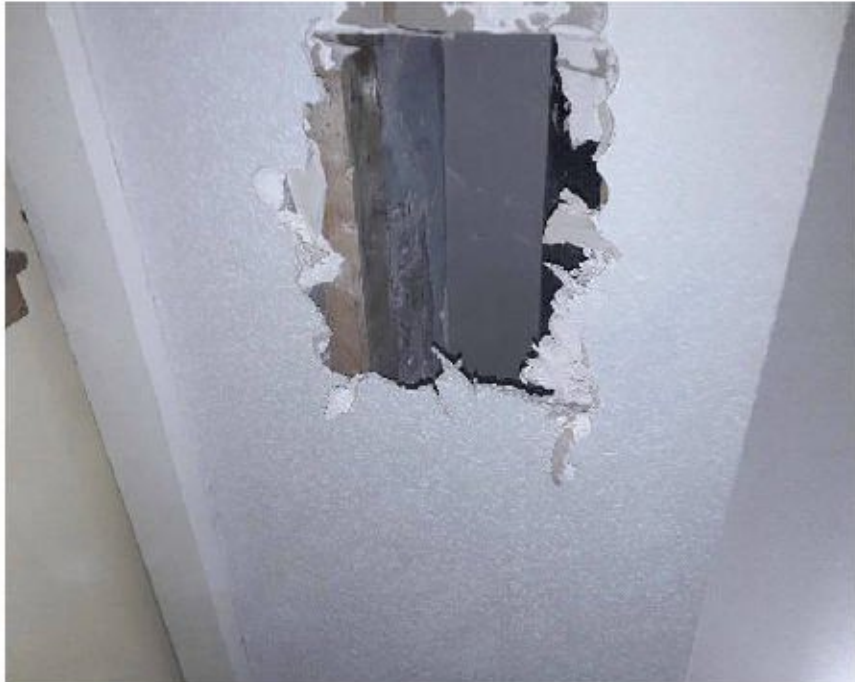
29 (22 Lobby) Internally to plasterboard boxing

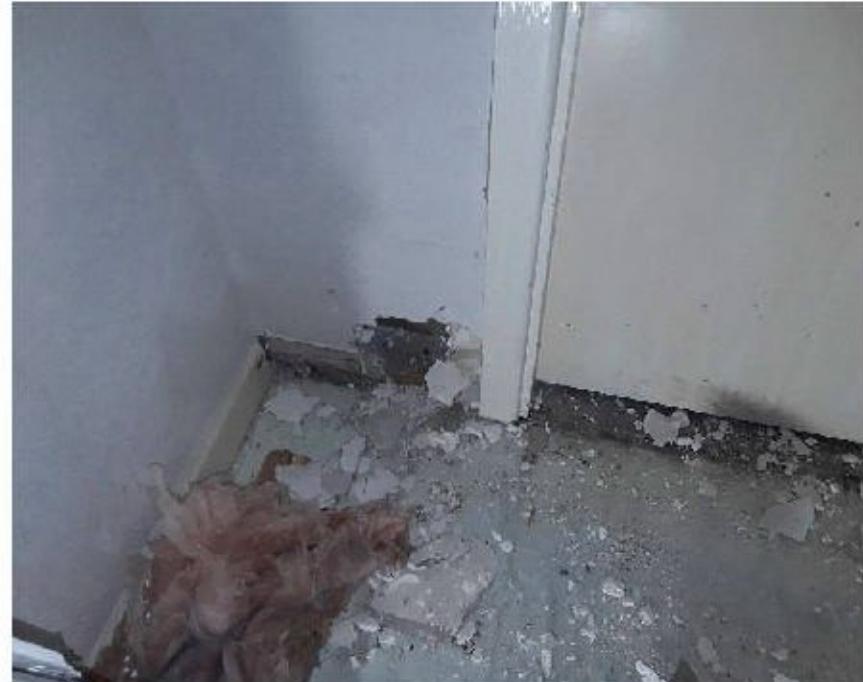
30 (22 Lobby) Beyond timber skirting boards

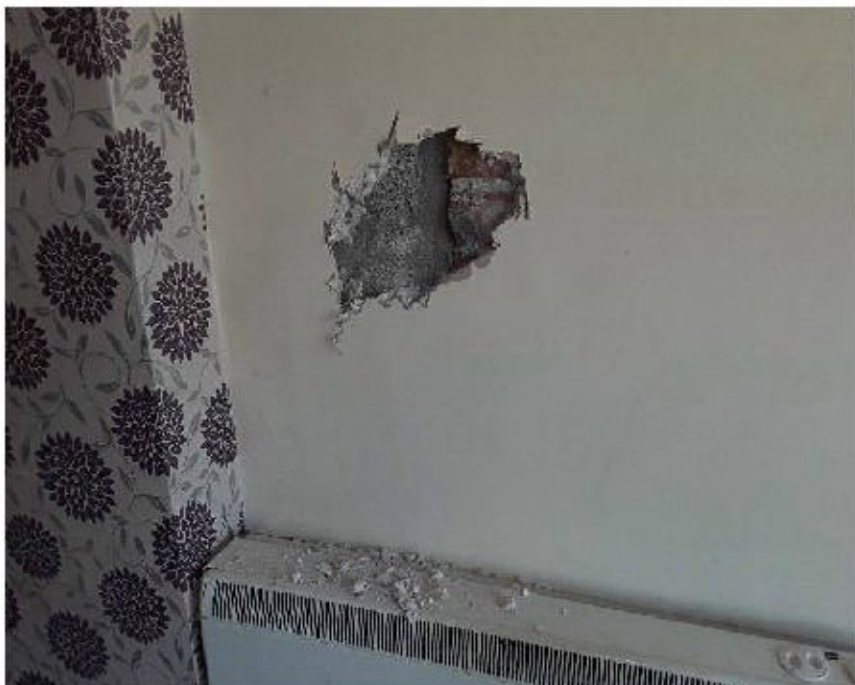
31 (24 Living Room) Beyond plaster to plasterboard wall

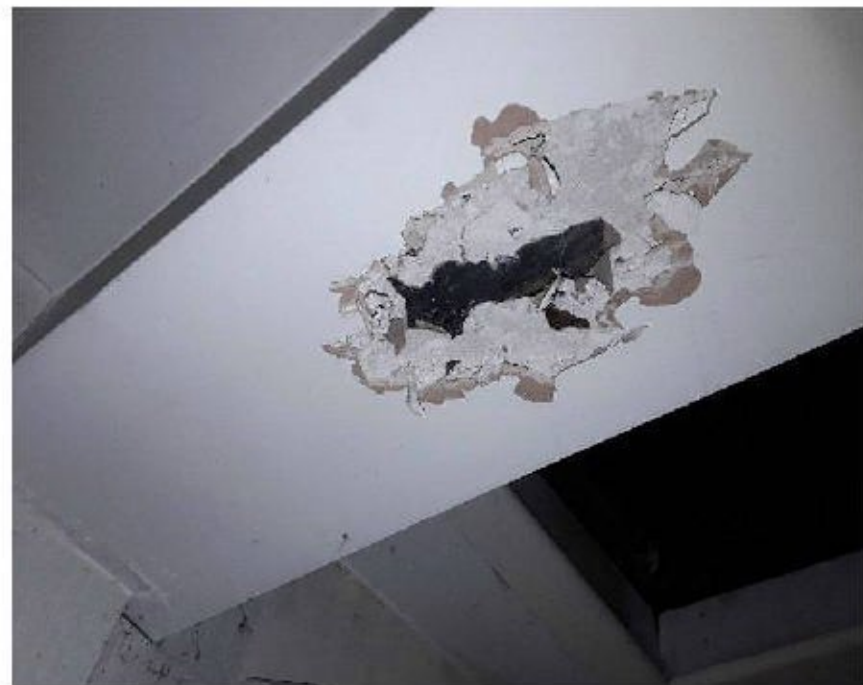
32 (25 Hallway) Beyond plaster to plasterboard cladding to beam

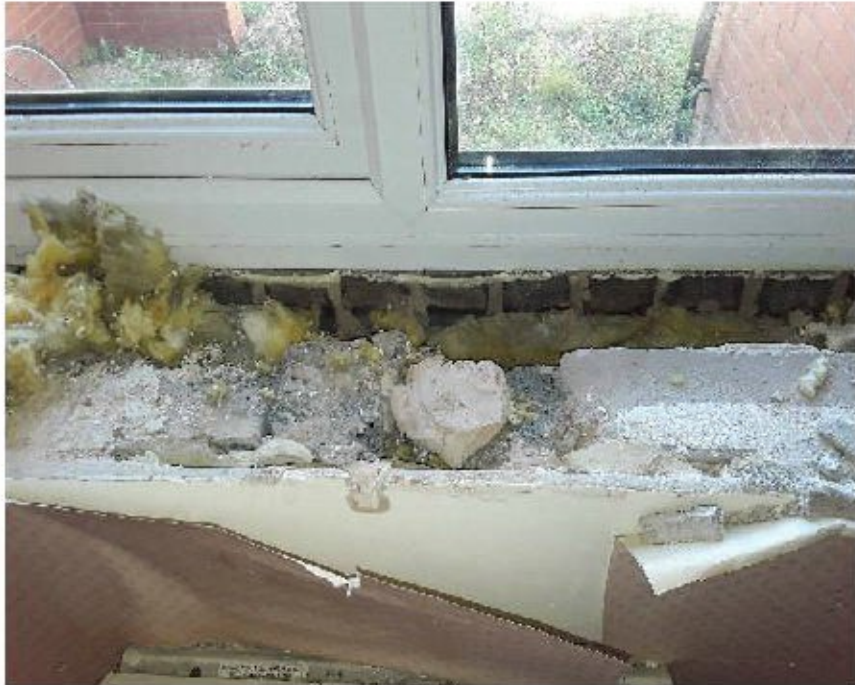
33 (27 Bedroom) Beyond timber window sill

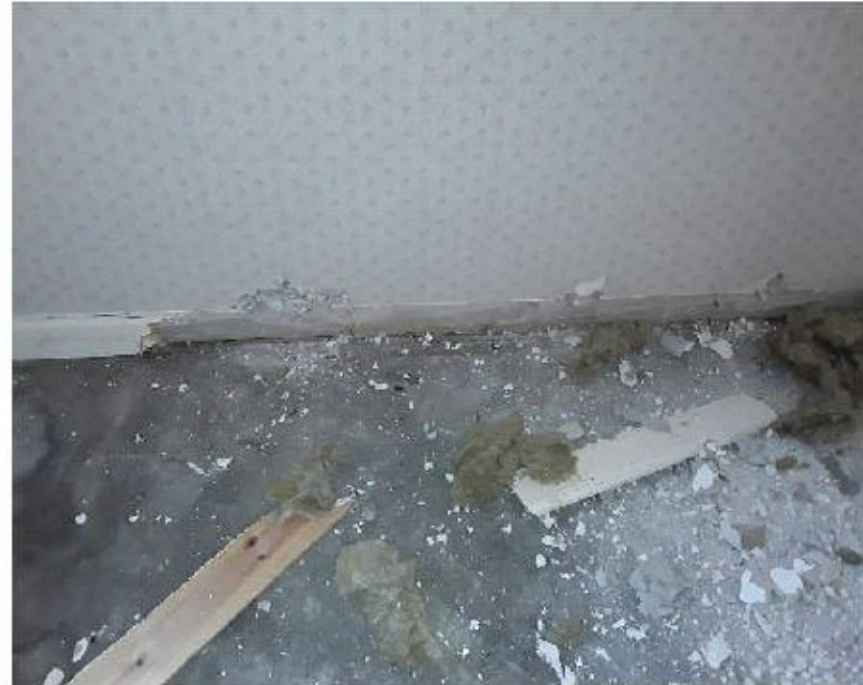
34 (27 Bedroom) Beyond timber skirting boards

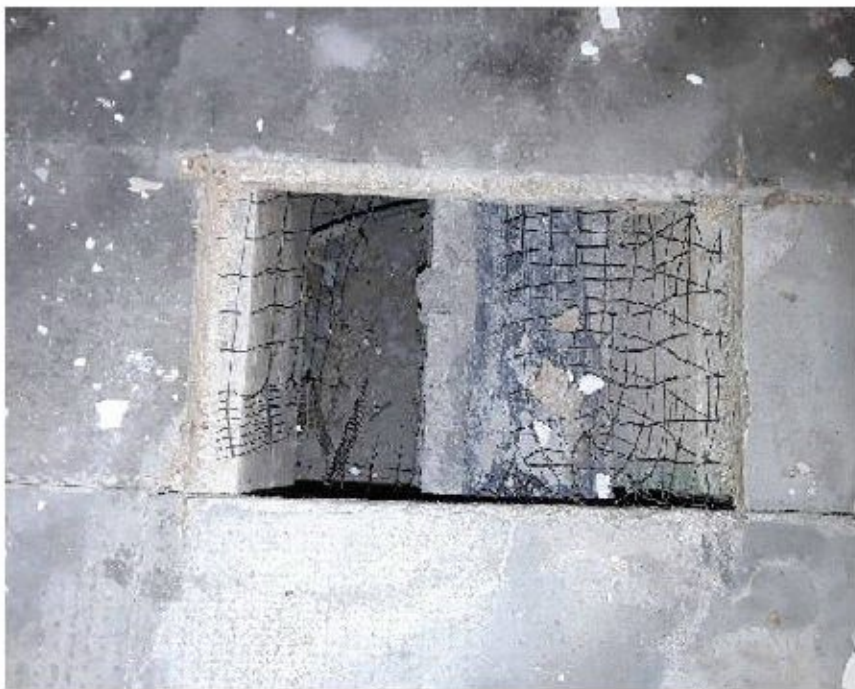
35 (27 Bedroom) Beyond timber floorboards

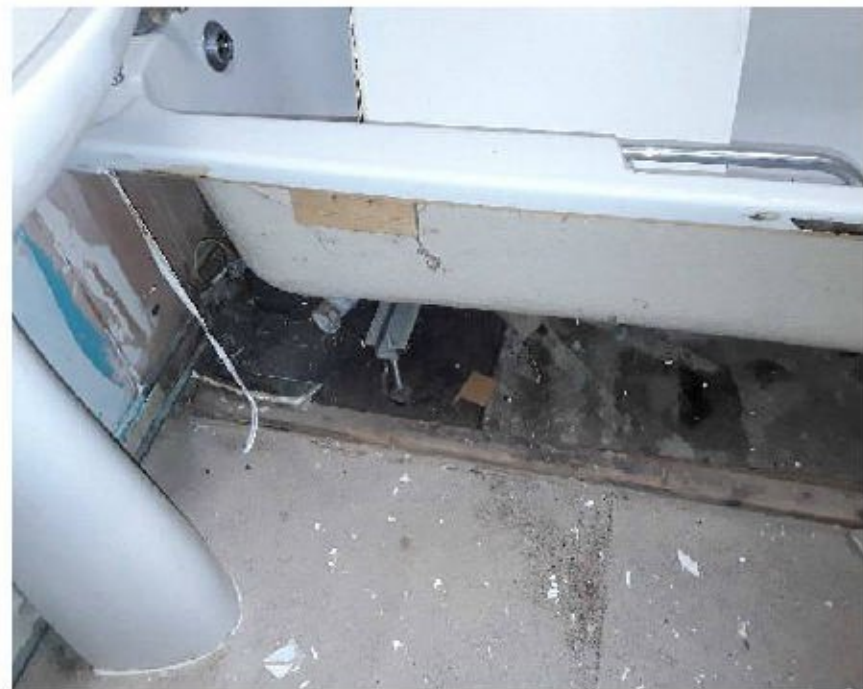
36 (28 Bathroom) Beyond timber bath panel

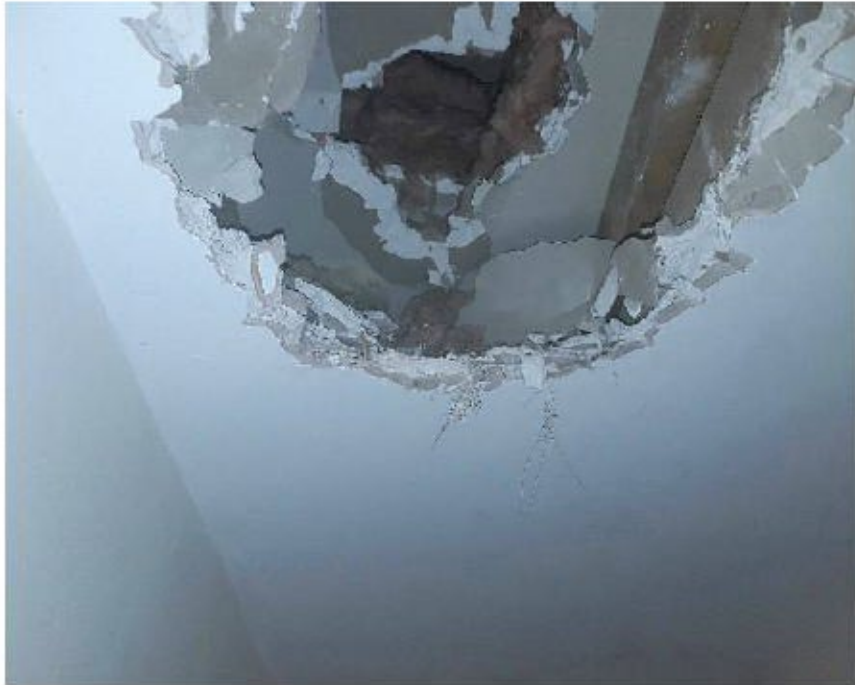
37 (31 Landing) Beyond plasterboard ceiling

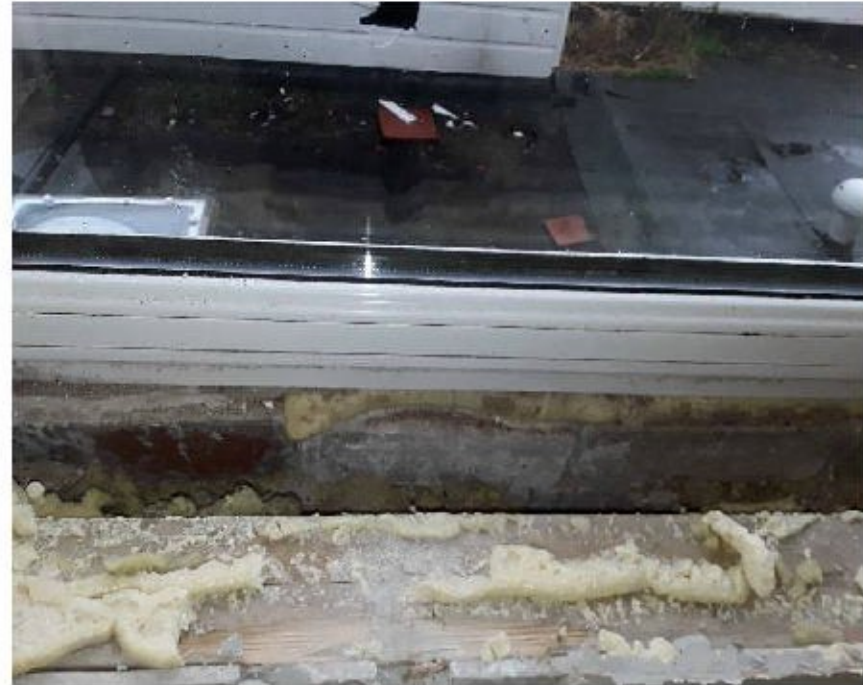
38 (32 Corridor) Beyond timber window sill

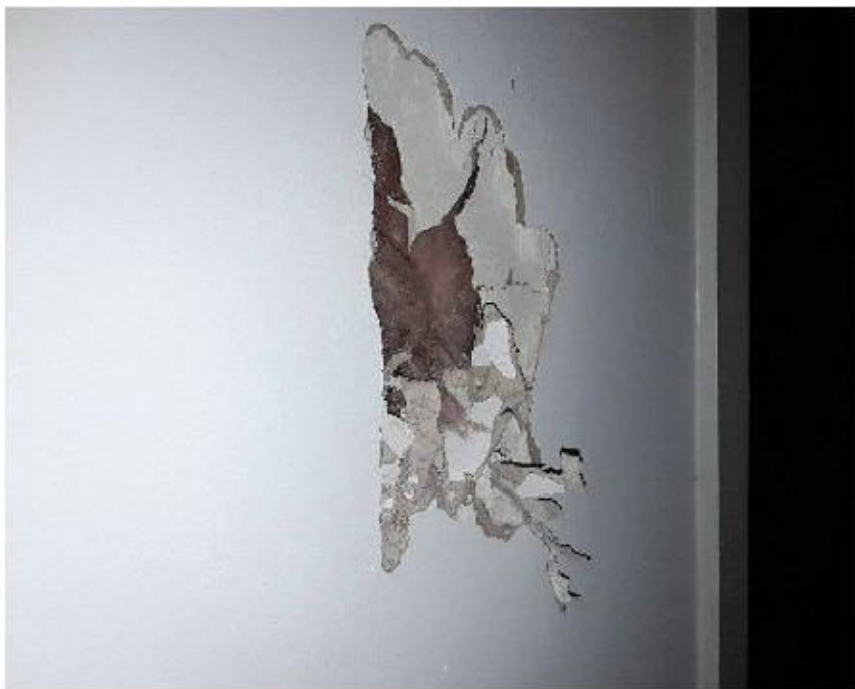
39 (33 Hallway) Beyond plaster to plasterboard wall

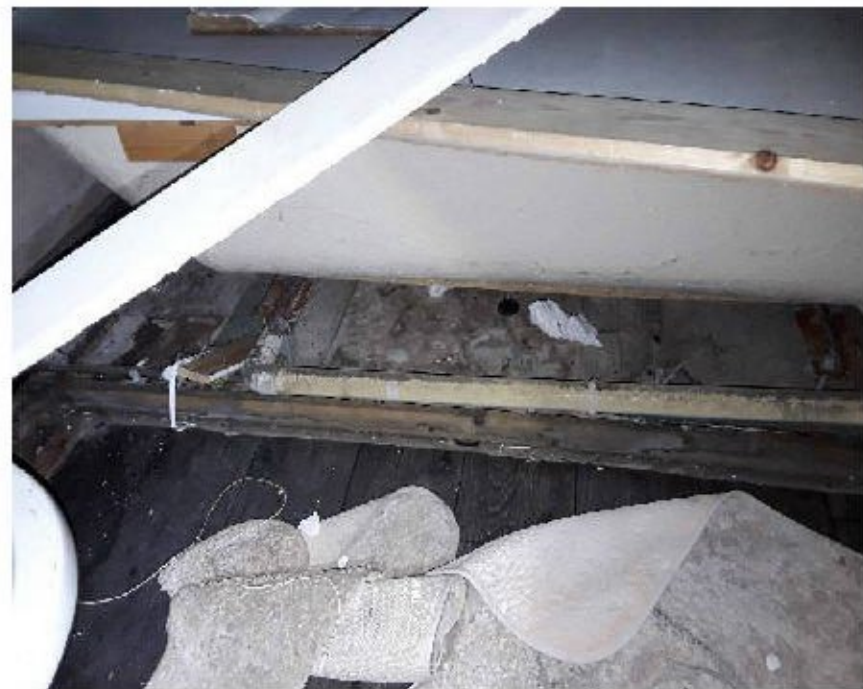
40 (34 Bathroom) Beyond timber bath panel

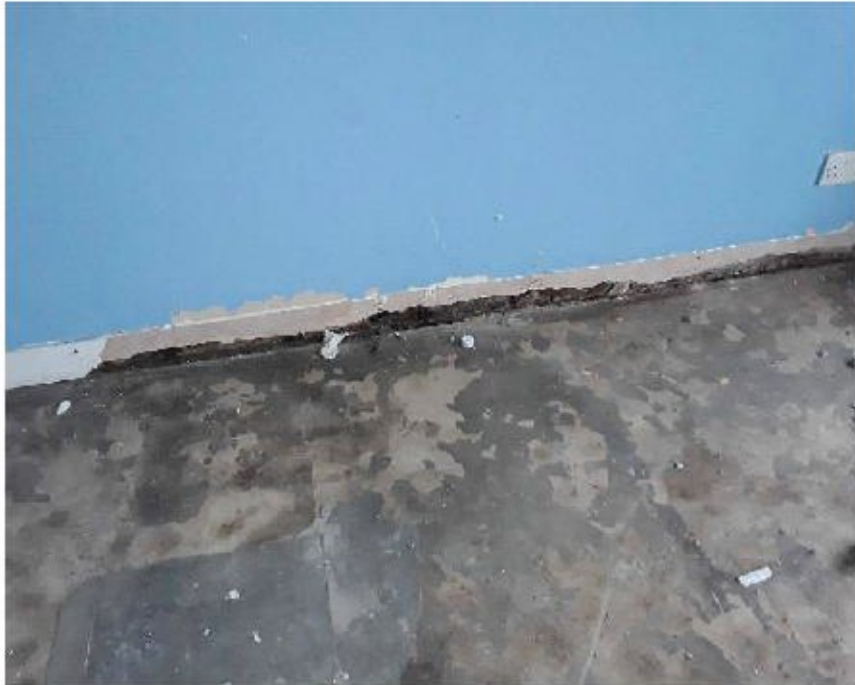
41 (35 Bedroom) Beyond timber skirting boards

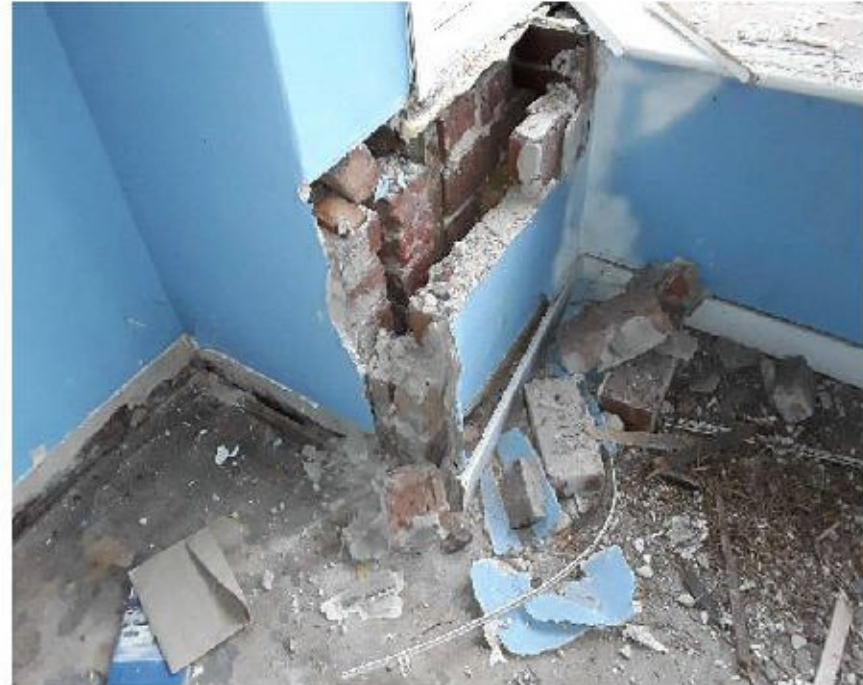
42 (35 Bedroom) Beyond timber window sill

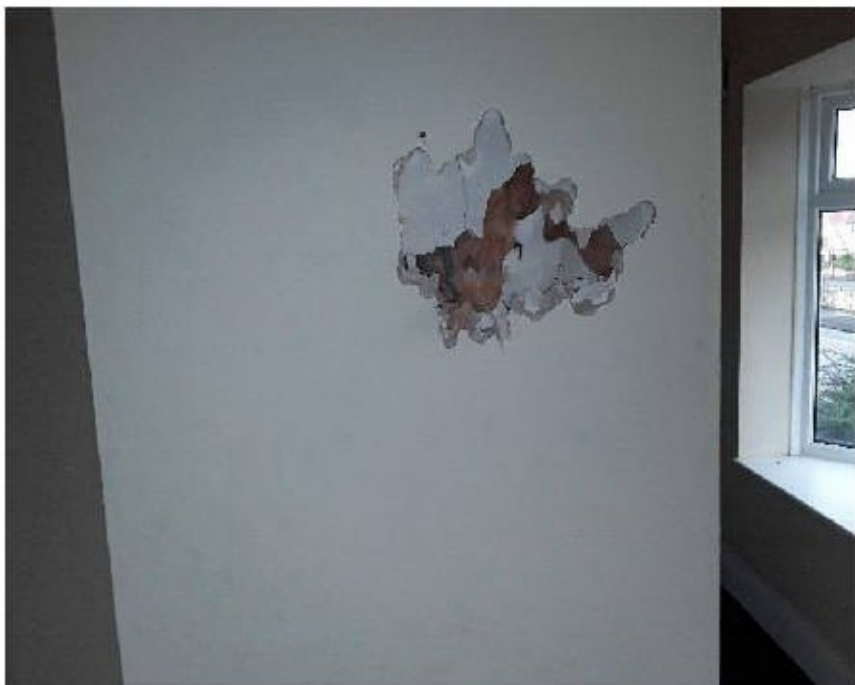
43 (37 Bedroom) Beyond plaster to plasterboard wall

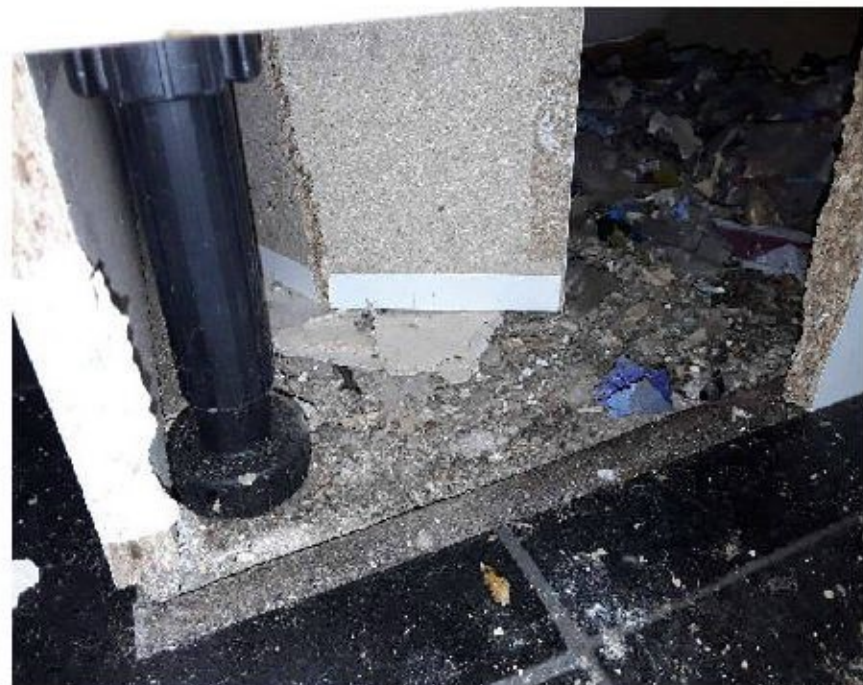
44 (37 Living Room/Kitchen) Beyond kitchen units

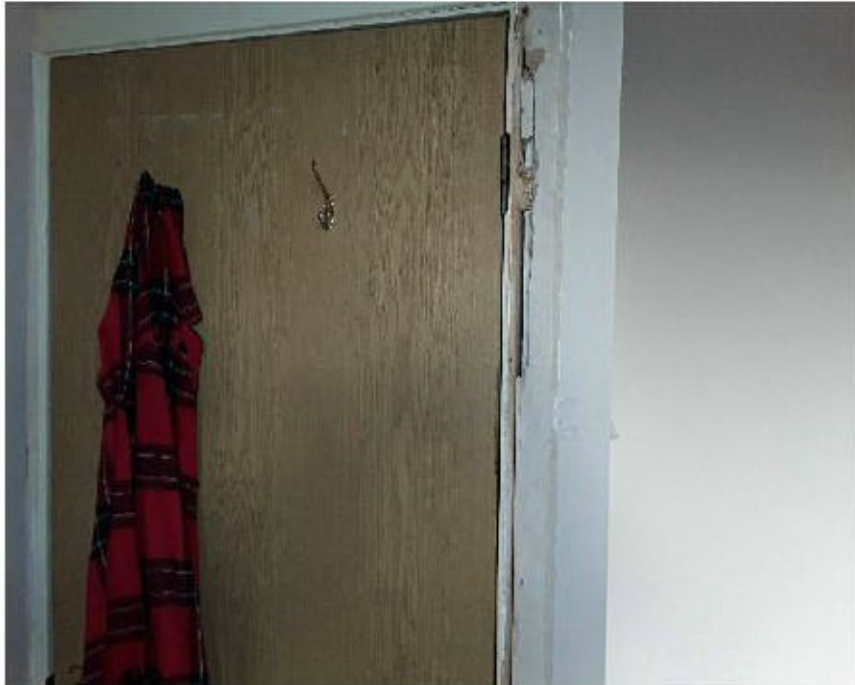
45 (38 Bedroom) Beyond timber door frame

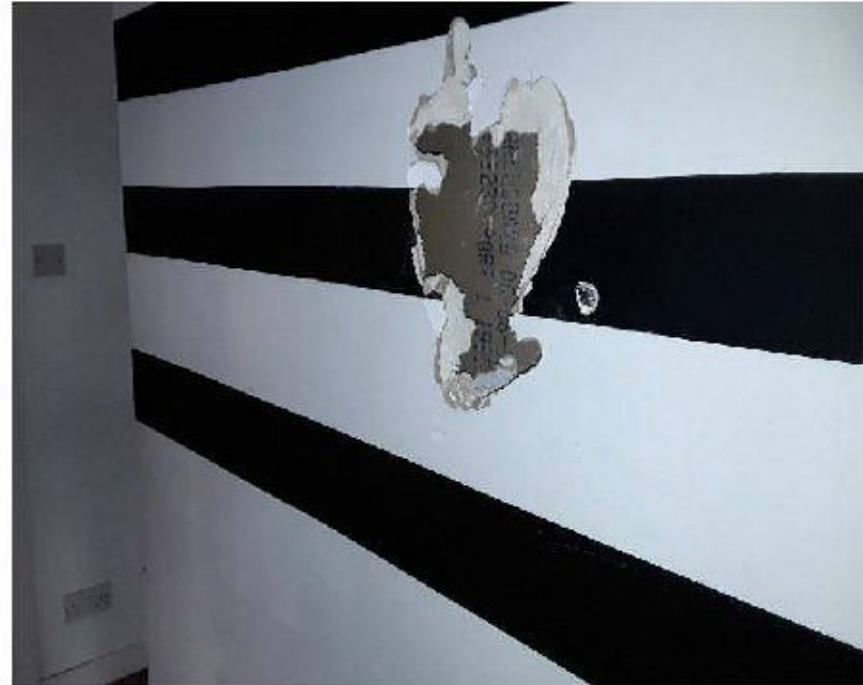
46 (40 Hallway) Beyond plaster to plasterboard wall

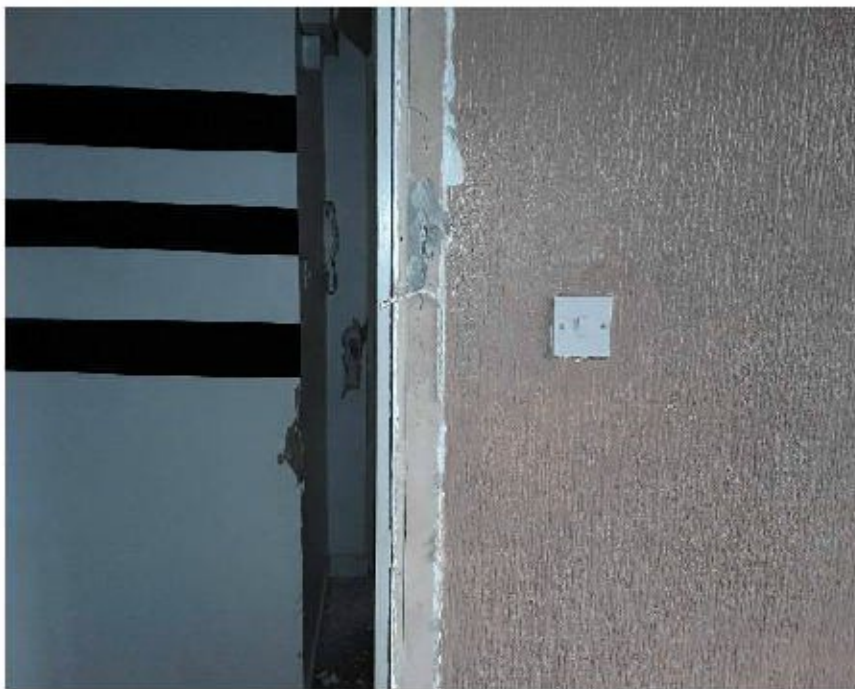
47 (41 Bedroom) Beyond timber door frame

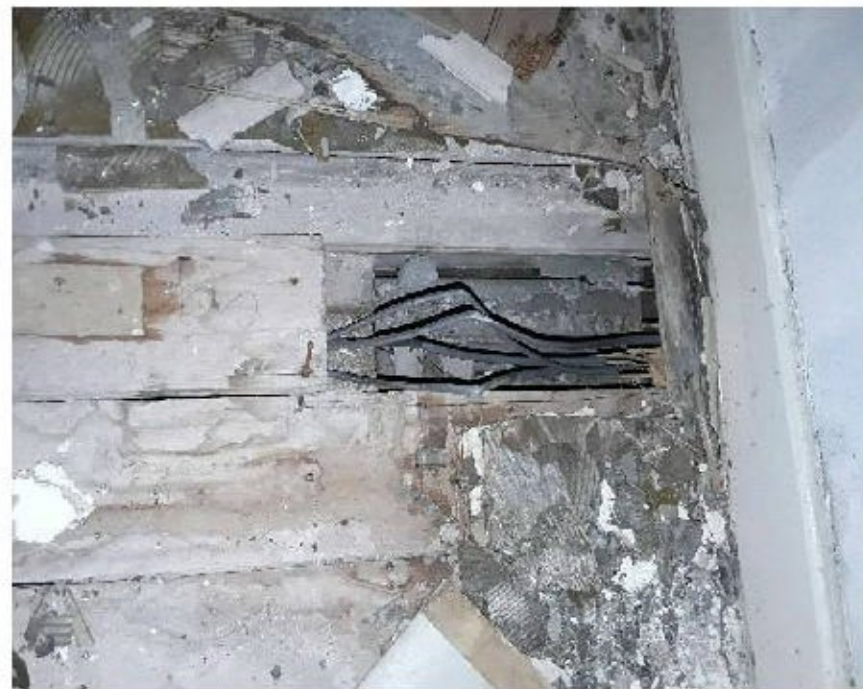
48 (43 Kitchen) Beyond timber floorboards

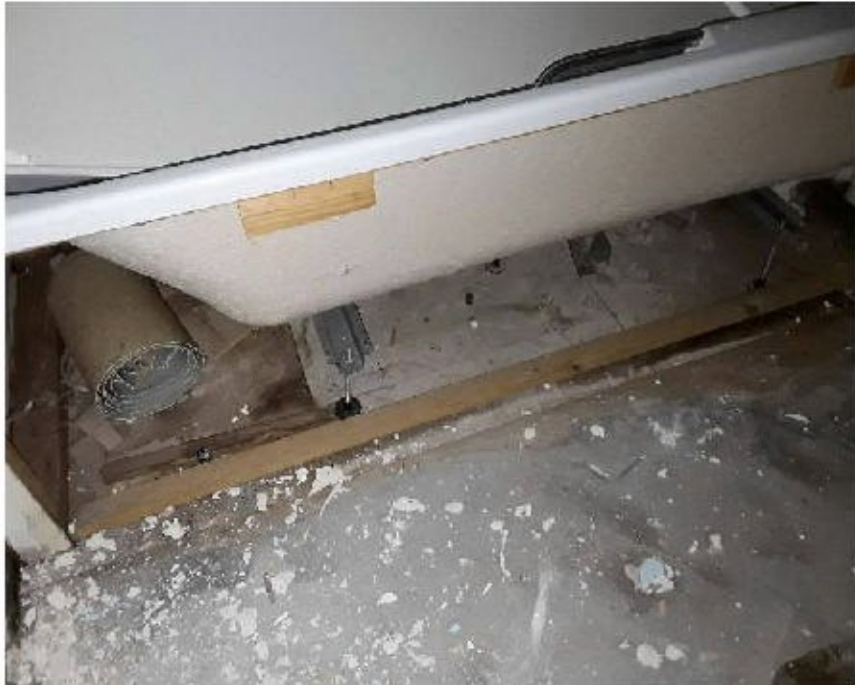
49 (44 Bathroom) Beyond timber bath panel

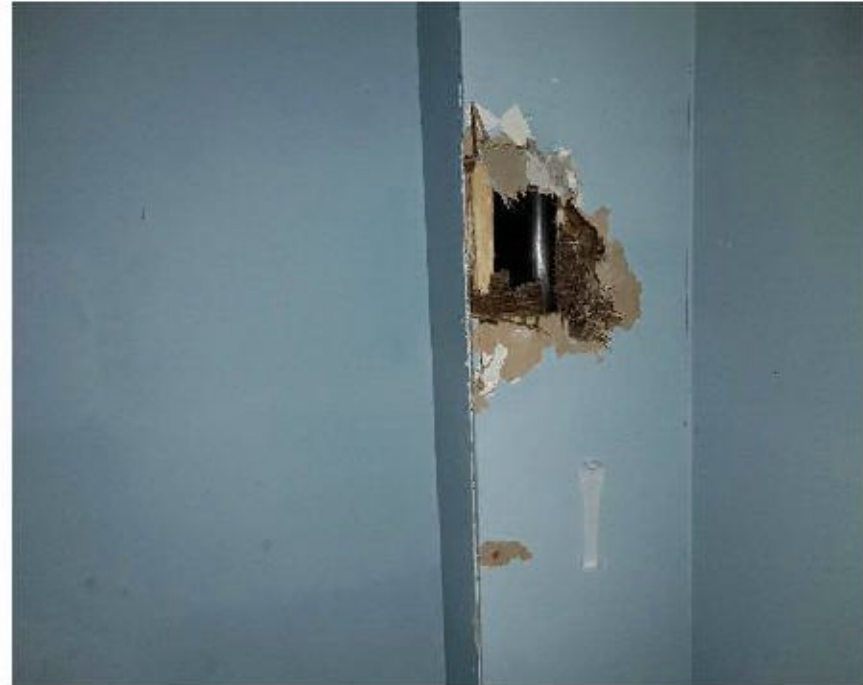
50 (44 Bathroom) Internally to timber boxing

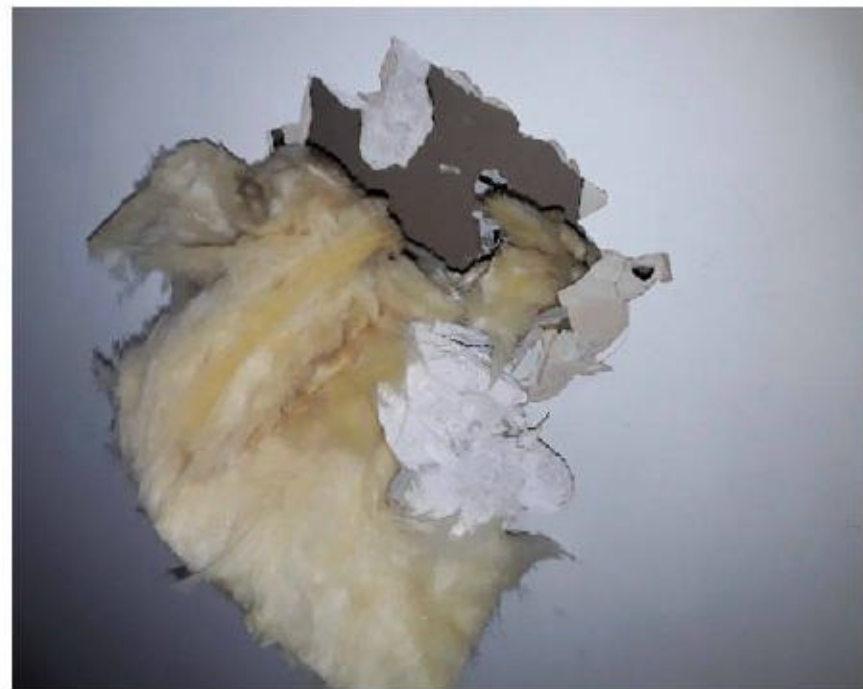
52 (49 Hallway) Beyond plasterboard wall

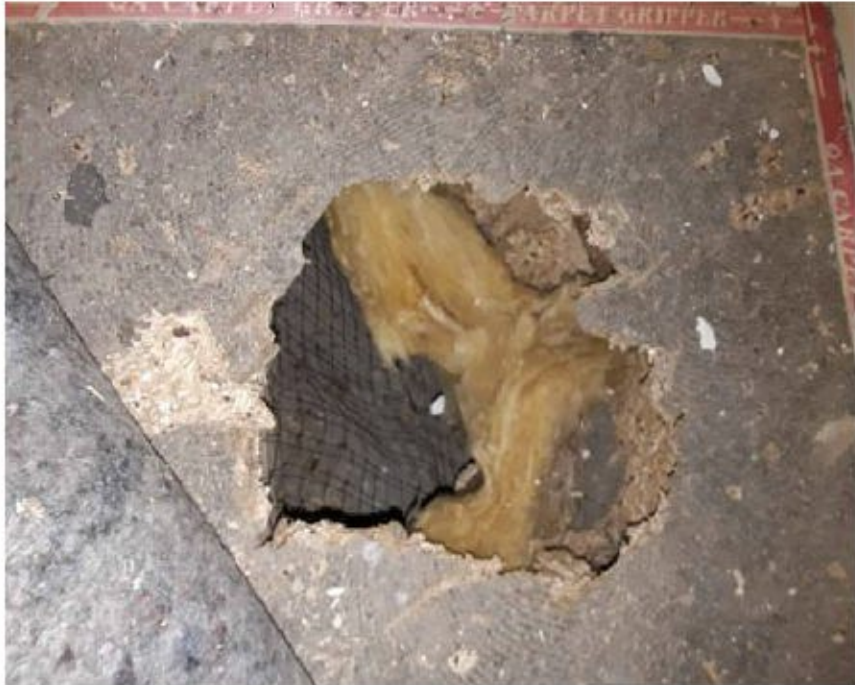
53 (49 Hallway) Beyond timber flooring

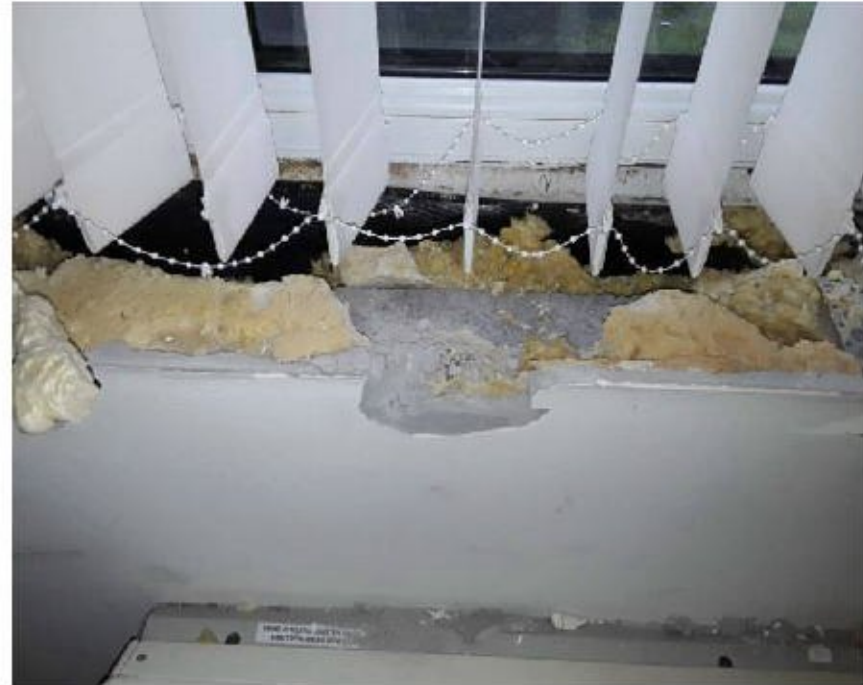
54 (50 Bedroom 1) Beyond timber window sill

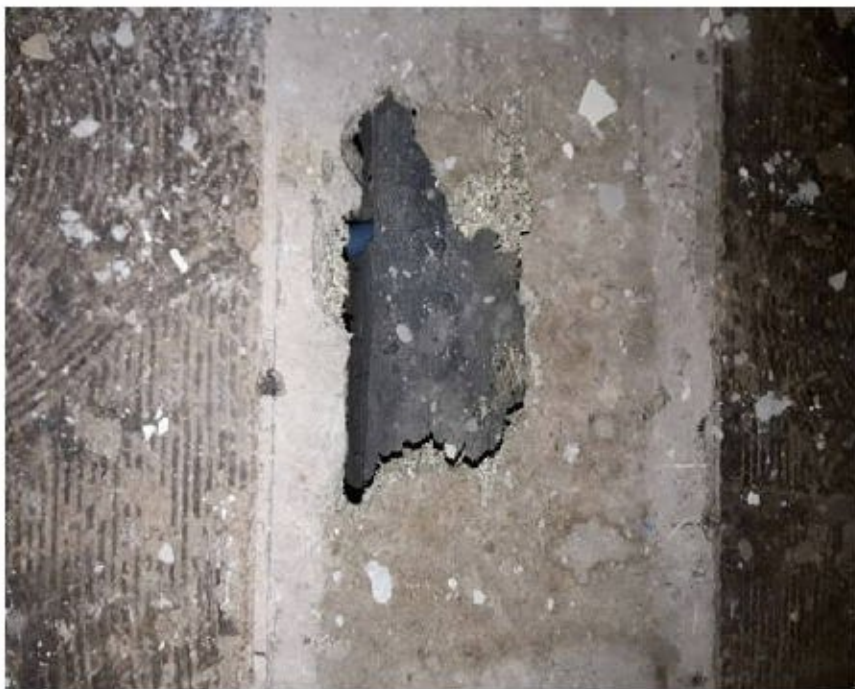
55 (51 Cylinder Cupboard) Beyond timber flooring

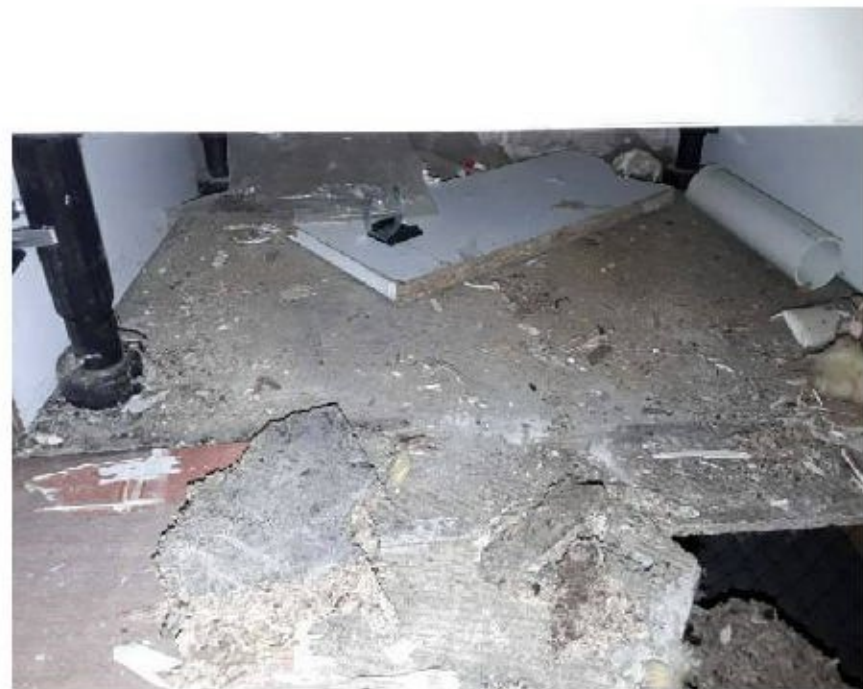
56 (52 Kitchen) Beyond kitchen units

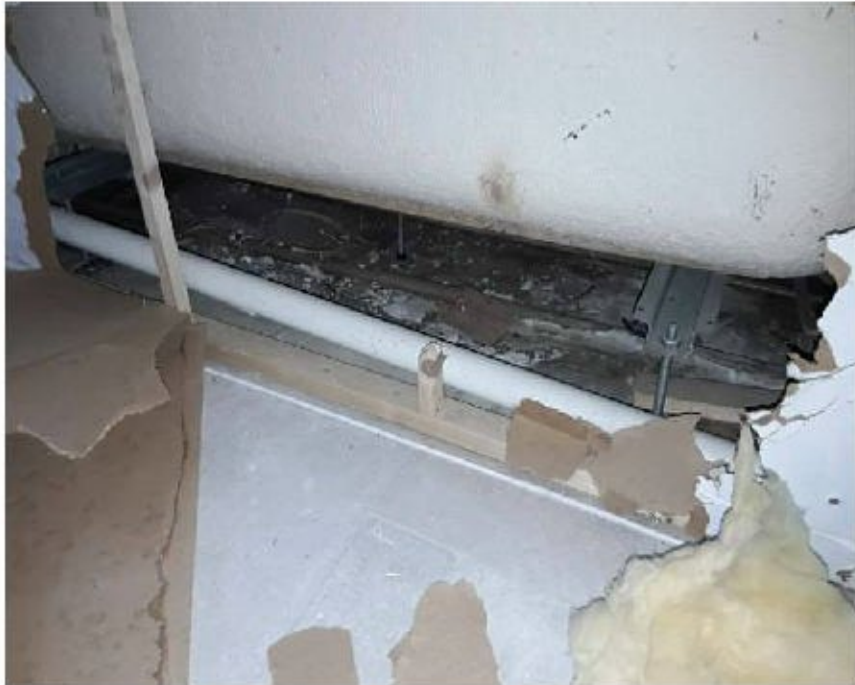
57 (53 Bathroom) Beyond timber bath panel

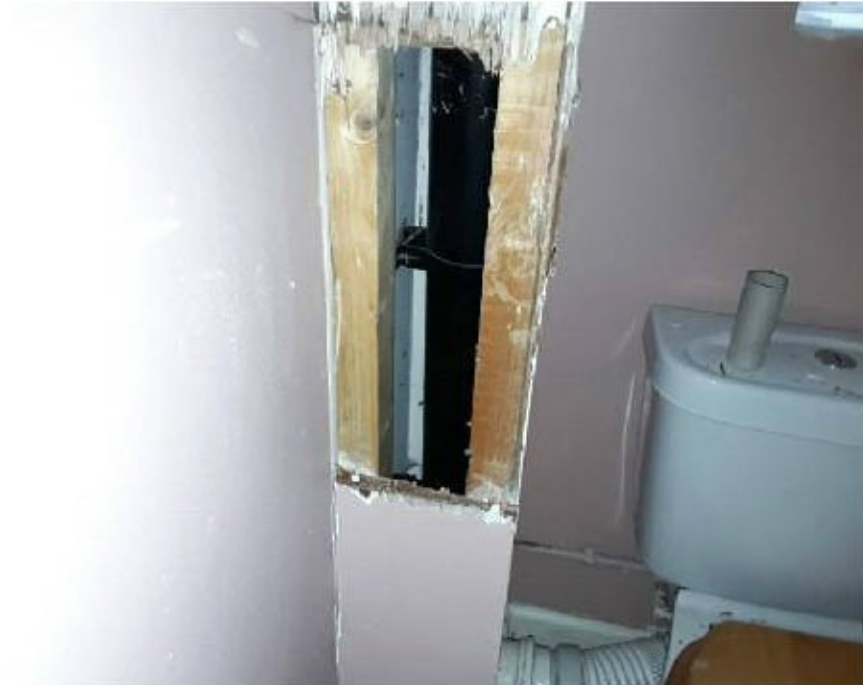
58 (53 Bathroom) Internally to timber boxing

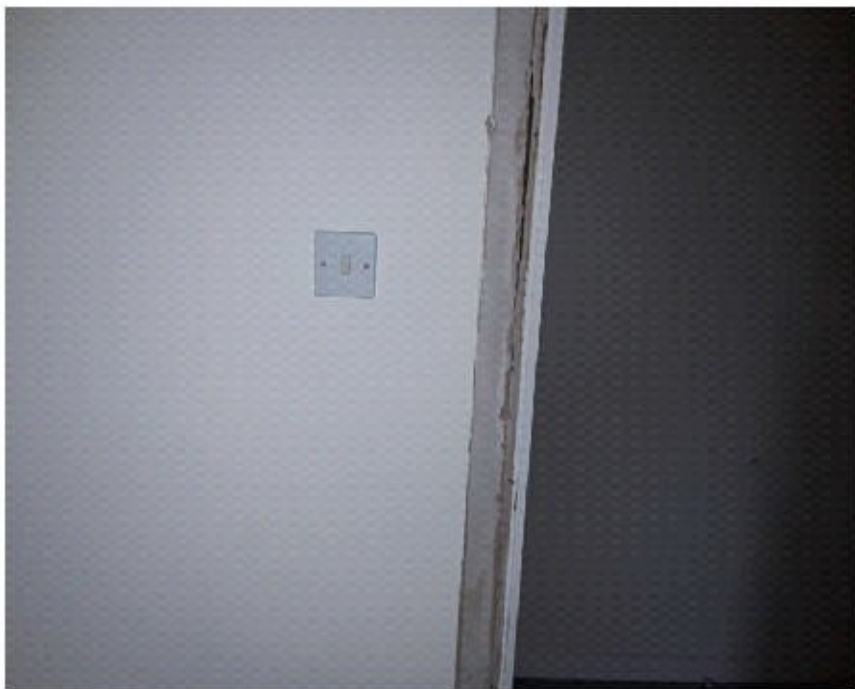
59 (54 Bedroom 2) Beyond timber door frame

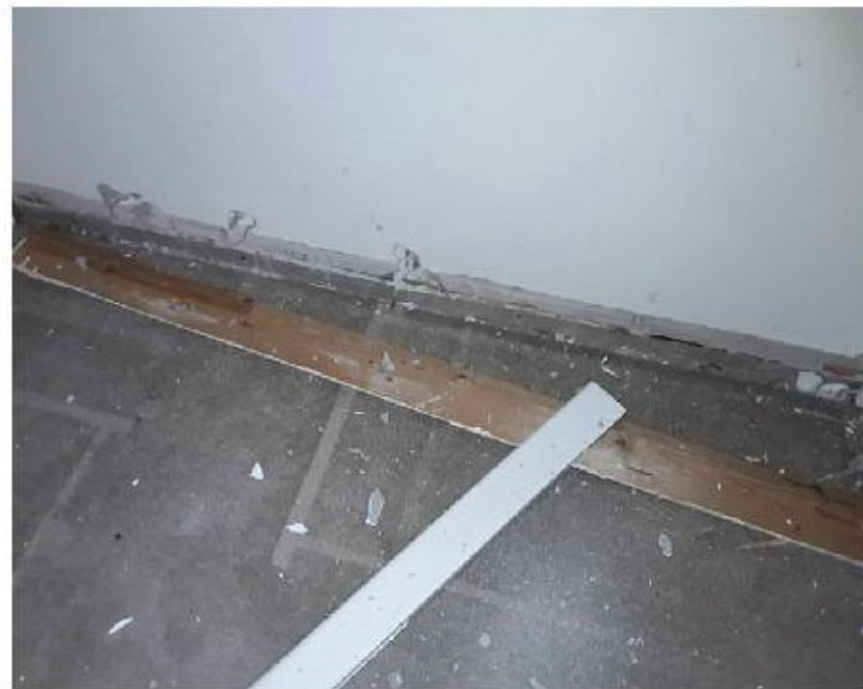
60 (54 Bedroom 2) Beyond timber skirting boards

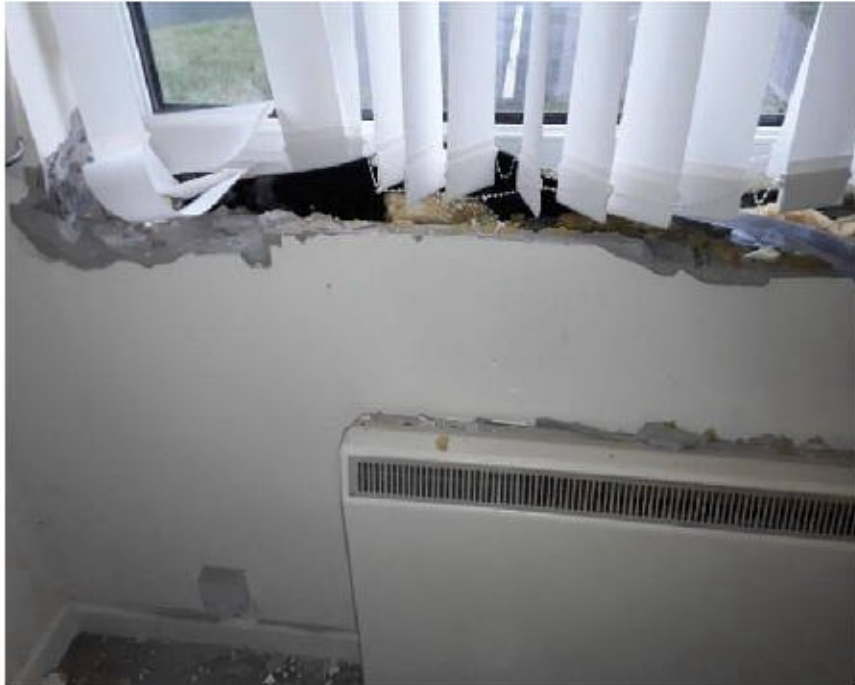
61 (55 Living Room) Beyond timber window sill

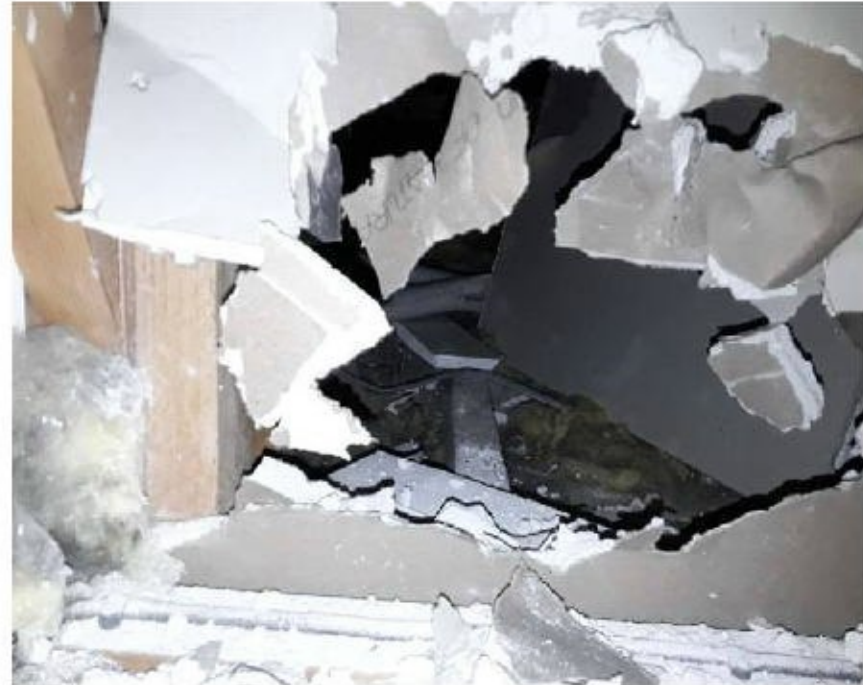
62 (56 Loft Space) Beyond plasterboard wall

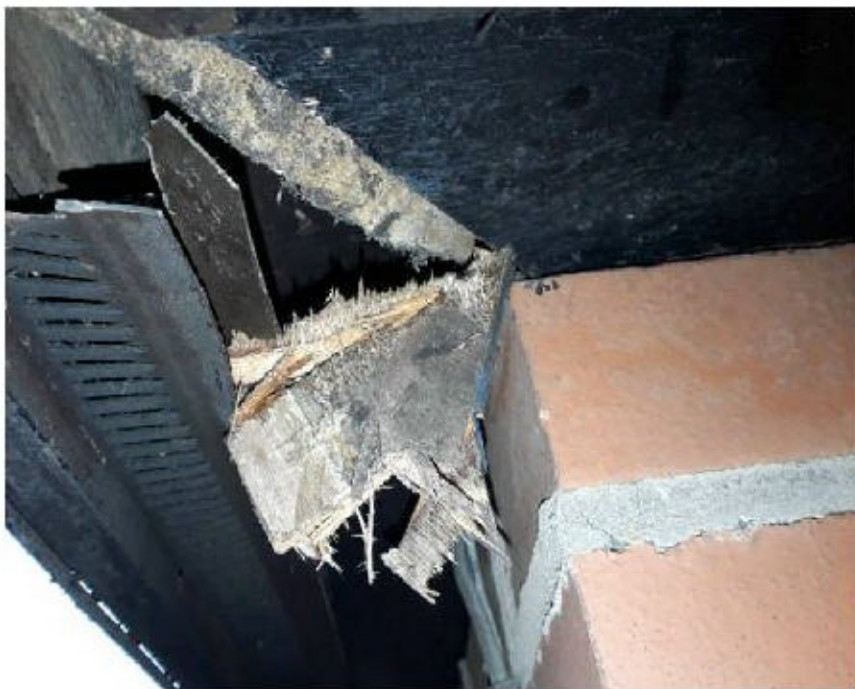
63 (48 External) Beyond timber soffits and fascias
