ASTON HALL - SHROPSHIRE
Aston Munslow - Craven Arms

DESIGN AND ACCESS AND
HERITAGE STATEMENT

Submission to Local Authority

September 2021 - REV 0

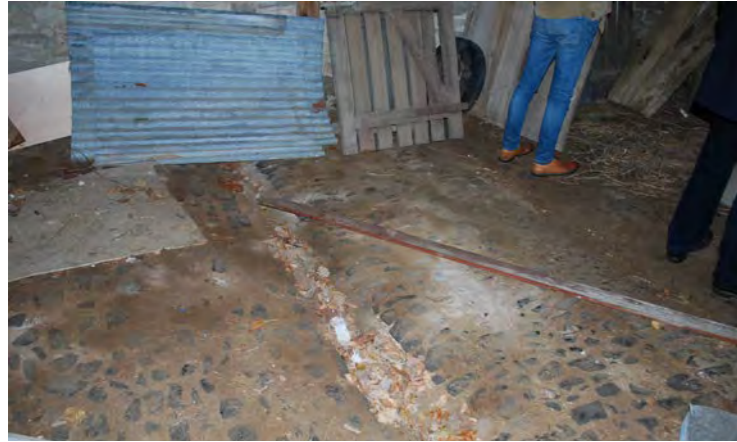
1. TRADITIONAL COBBLED FLOOR

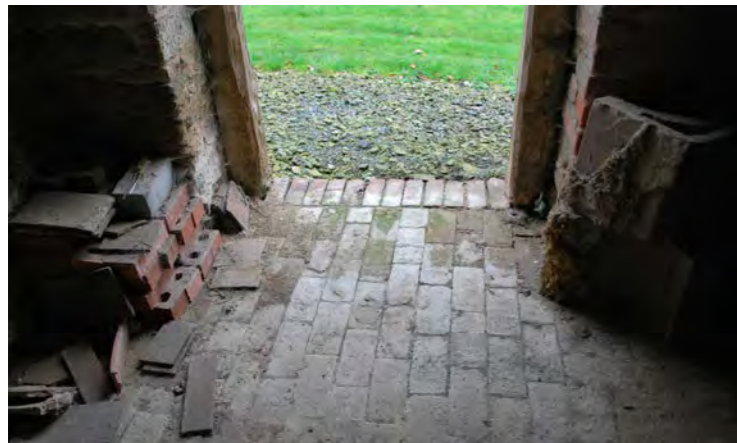
2. TRADITIONAL 'PALMET BRICK' FLOOR

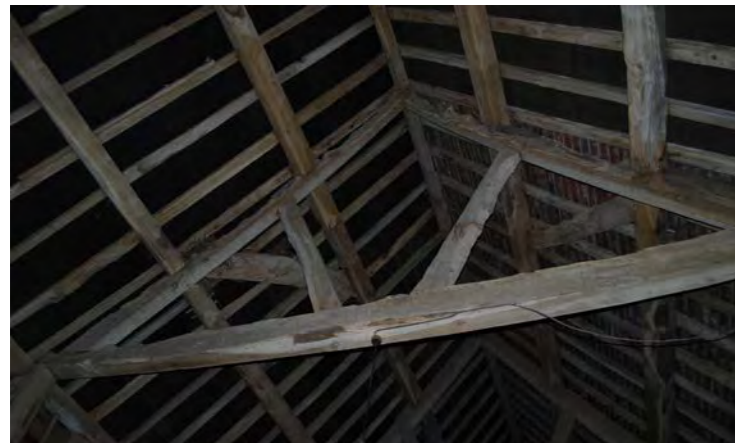
1. SIMPLE TRIANGULAR TRUSS WITH BRACES

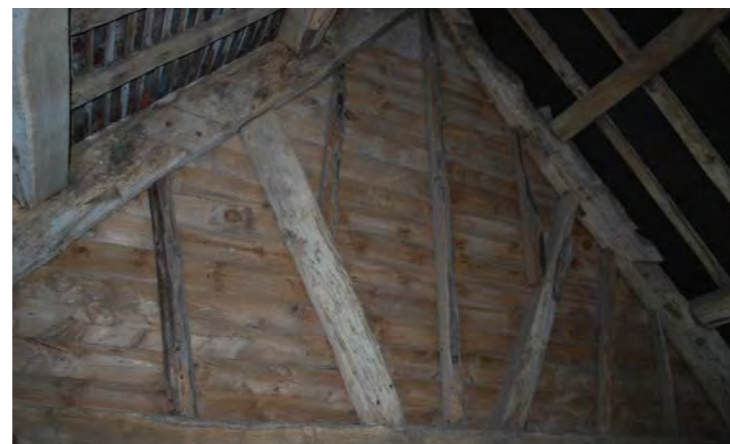
5 & 6. Simple triangular trusses with diagonal braces could be among the oldest on-site. Modern/replacement infilling has been introduced to partition the different rooms. The plasterboard introduced to convert the South-West corner storage room appears particularly detrimental in the context of double height barn space. The proposal is to remove this and regain the space open to the roof as well as some natural light.

5. SIMPLE TRIANGULAR TRUSS WITH BRACES & MODERN BOARDING

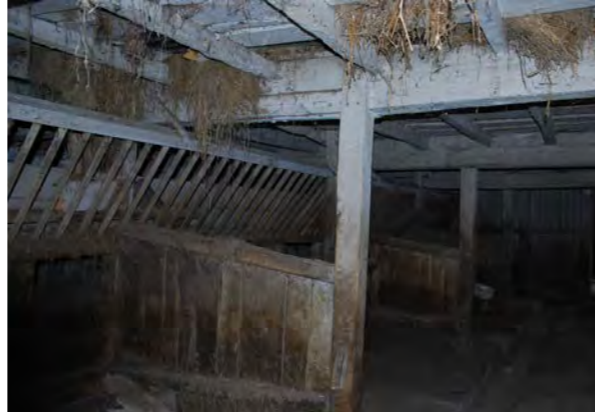
5. CATTLE STALLS AND FODDER HOLDER

5. Cattle stalls and fodder holder: The North Range appears to have been used for over wintering cattle, and fodder holders were replenished from voids in the first floor above. Given their design, they are unlikely to have been used for horses. The stalls and feed holders could be repaired and relocated under the open arcaded barn.
