140 West George Street, Glasgow – 12/05/19

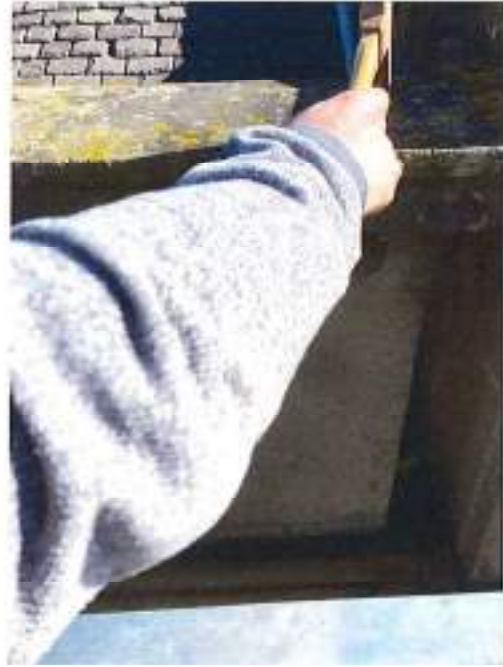
Fig 48: Tap test

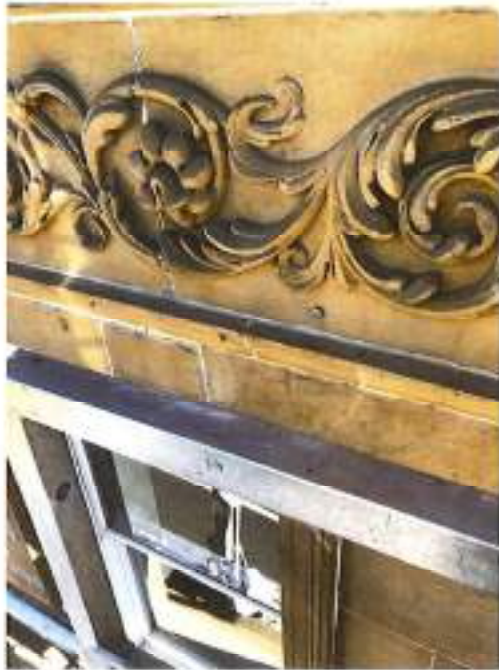
Fig 81: Decorative feature (isolated areas friable)

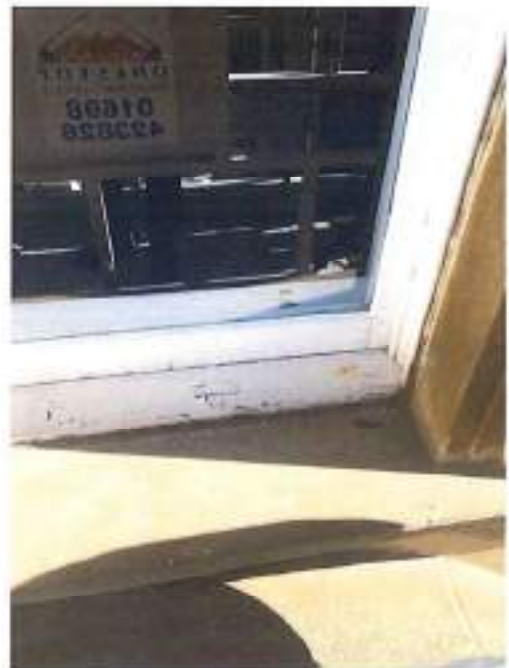
Fig 84: Window require decoration

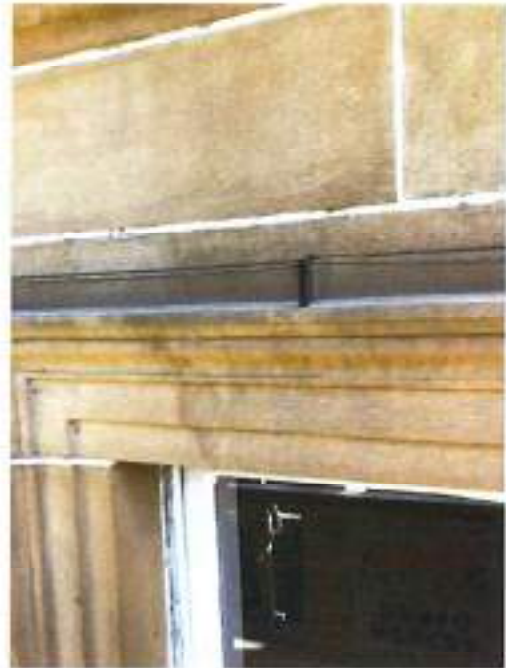
Fig 86: As per Fig 85

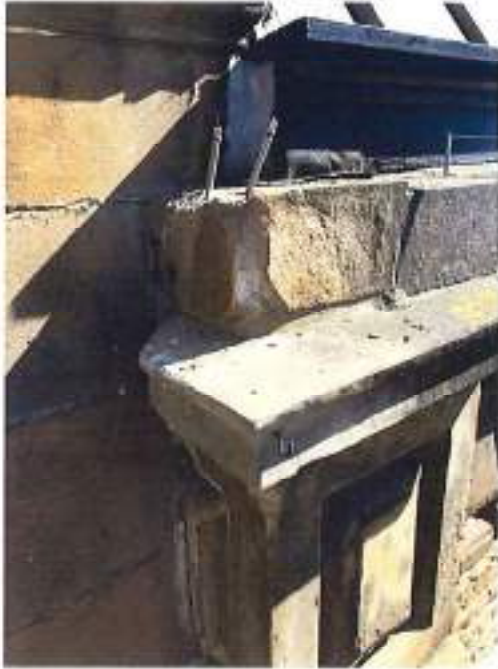
Fig 89: Bird deterrent

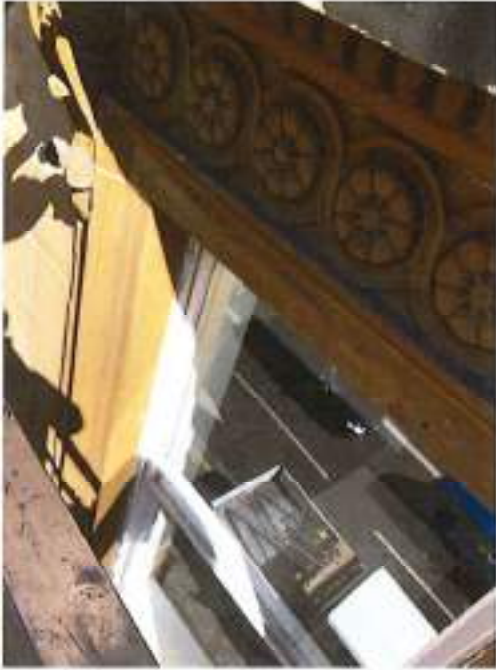
Fig 101: 1st floor decorative lintel

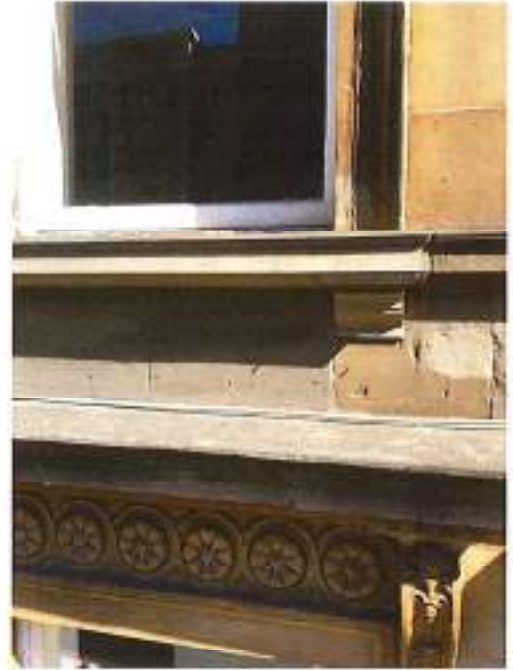
Fig 102: New cill 2nd floor

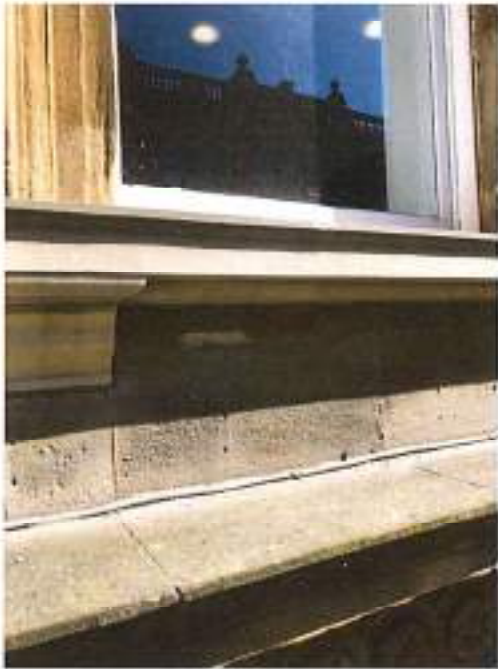
Fig 103: New cill/corbel 2nd floor

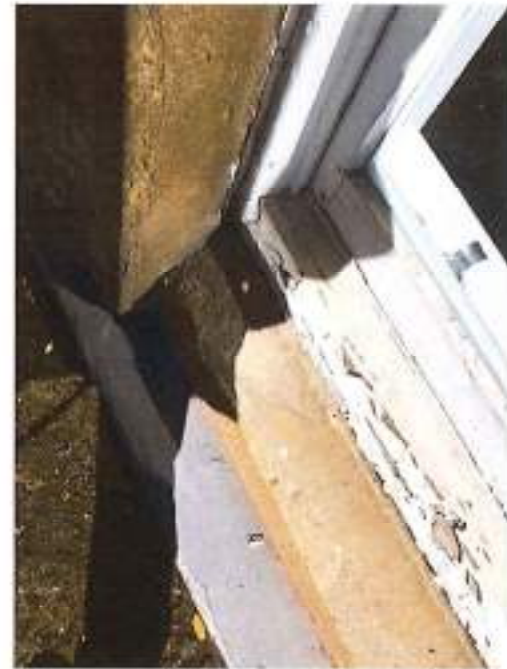
Fig 108: 1st floor window decoration required

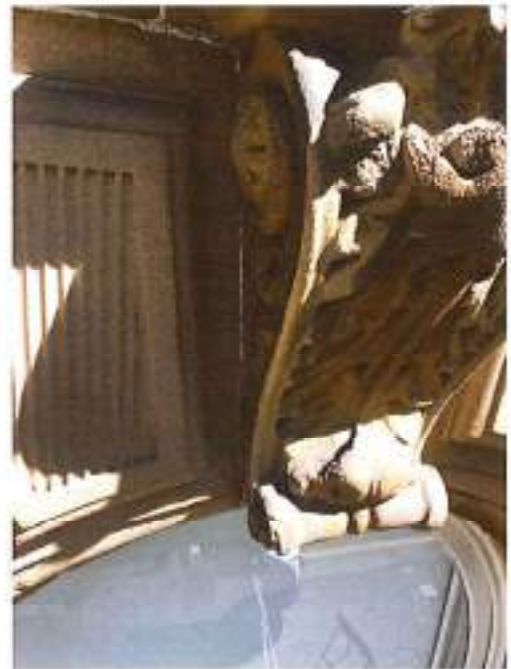
Fig 116: Corbel Ground floor windows

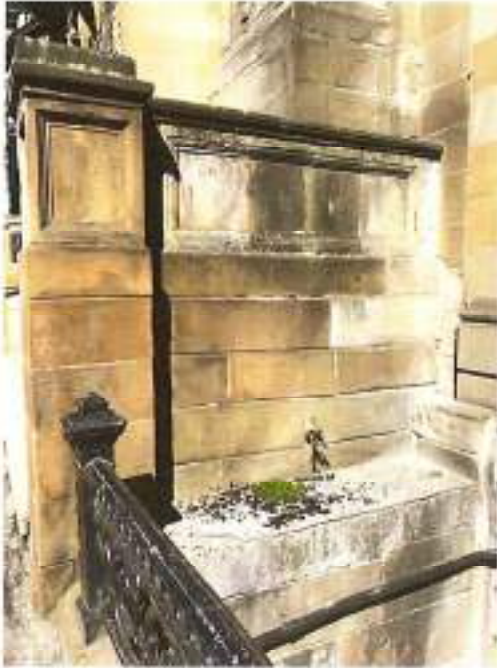
Fig 121: Neighbouring wall

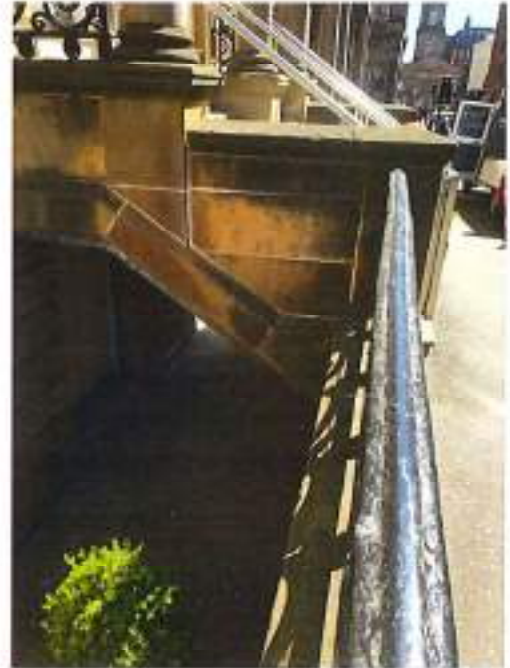
Fig 122: Entrance steps

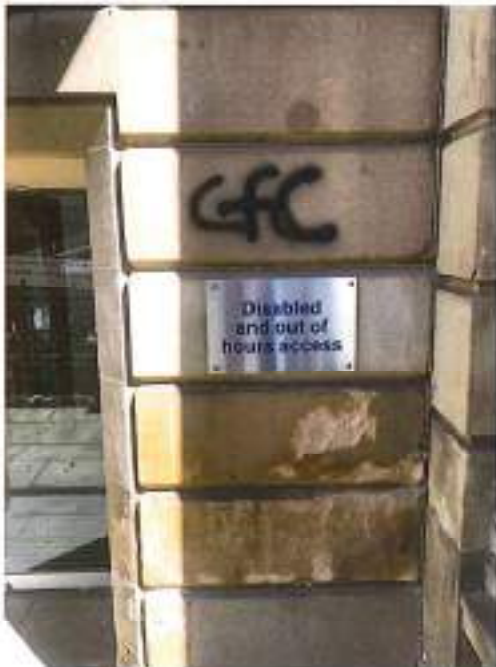
Fig 123: Graffiti at basement entrance
