Drawing Title
**Topographical Survey of Land at:
Barchester Arbour Lodge
Buxton Lane, Marple**

Project Name: 12639 SURVEY OPS ARBO	Project number: 12639	Date: 29/03/2019	Contact: Ian Thompson	
--	--------------------------	---------------------	--------------------------	--

Inspection report

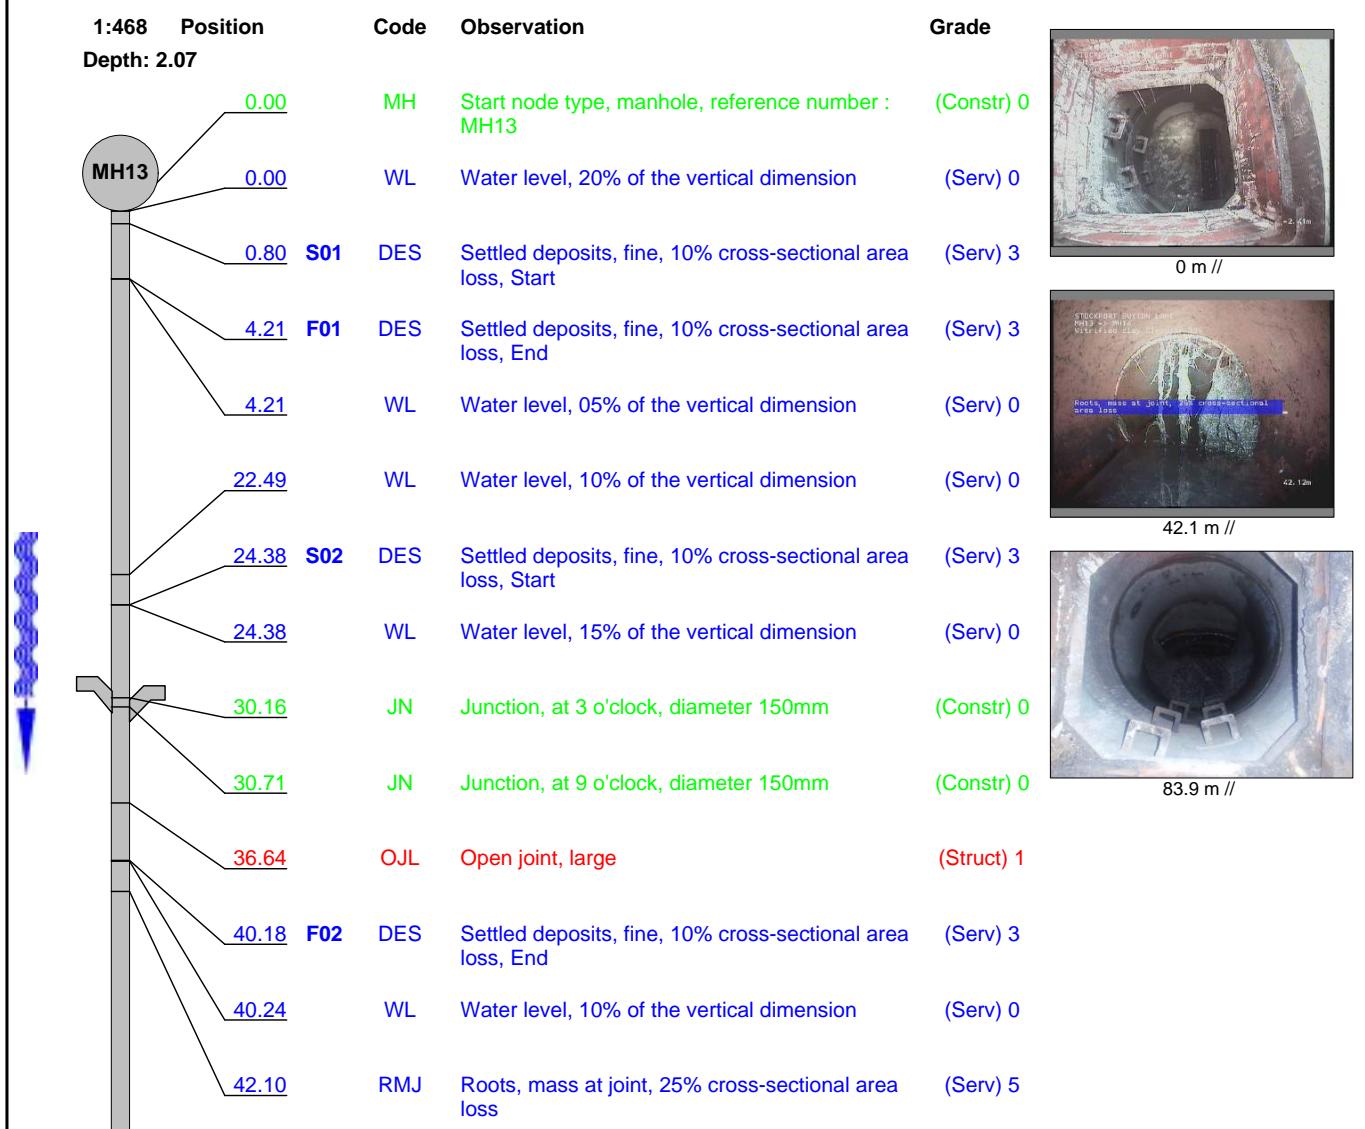
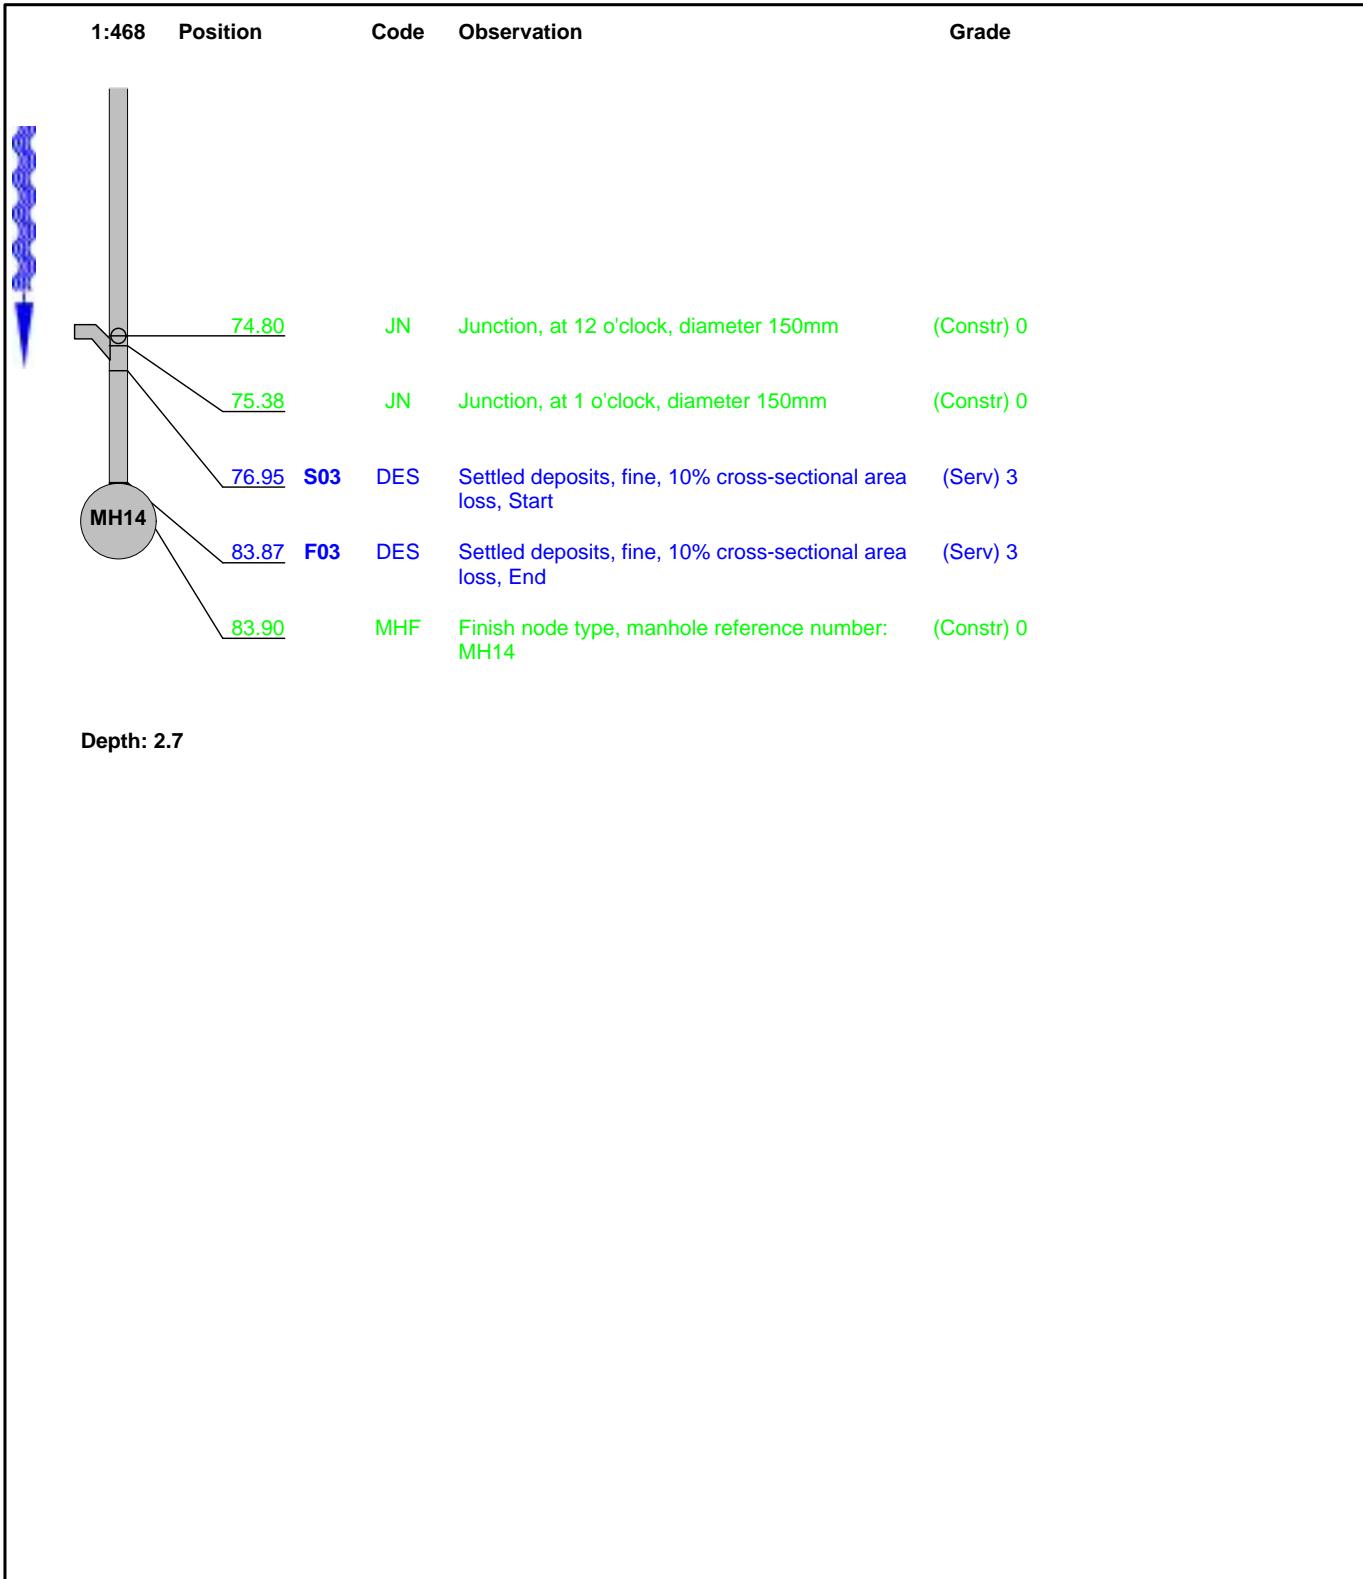
Place : STOCKPORT	Location details: Catchment: Tape number : -	U/S MH : MH13
Road : BUXTON LANE		U/S Depth : 2.07
Location Road		D/S MH : MH14
Inspection MH13 (D/S) MH14	Pipe Length 2.00 m	D/S Depth : 2.7
Use: Combined	Pipe shape : Circular	
Year laid : Z	Pipe size : 225 mm	
Purpose : Sample survey to determine asset condition	Pipe material : Vitrified clay	
Total length : 83.90 m	Lining :	
Comment : CLIENT ON SITE

Structural Defects					Constructional Features				
Service Defects					Miscellaneous Features				
STR no def	STR peak	STR mean	STR total	STR grade	SER no def	SER peak	SER mean	SER total	SER grade
1	2	0.02	2	1	4	7	0.68	57.2	4

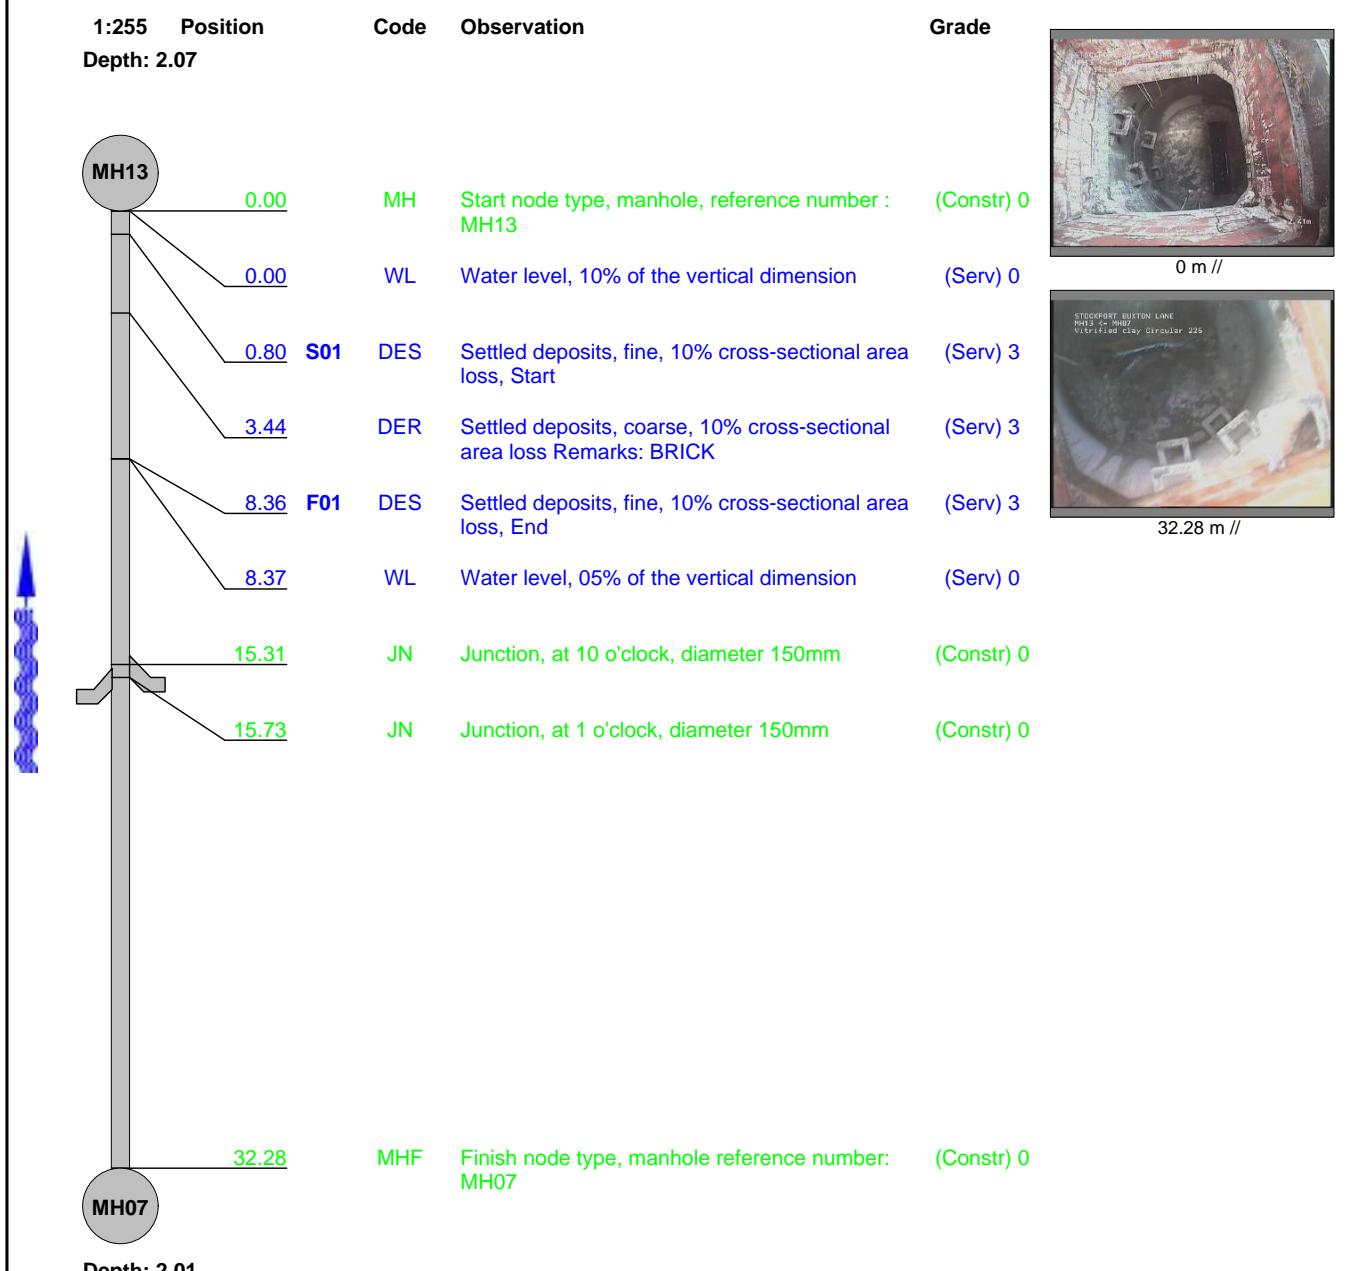
Place : STOCKPORT	Location details:	U/S MH : MH07
Road : BUXTON LANE	Catchment:	U/S Depth : 2.01
Location Road	Tape number : -	D/S MH : MH13
Inspection MH13 (U/S) MH07	Pipe Length 2.00 m	D/S Depth : 2.07
Use: Combined	Pipe shape : Circular	
Year laid : Z	Pipe size : 225 mm	
Purpose : Sample survey to determine asset condition	Pipe material : Vitrified clay	
Total length : 32.28 m	Lining :	
Comment : CLIENT ON SITE

Structural Defects					Constructional Features				
Service Defects					Miscellaneous Features				
STR no def	STR peak	STR mean	STR total	STR grade	SER no def	SER peak	SER mean	SER total	SER grade
0	0	0	0	1	2	4	0.53	17	3

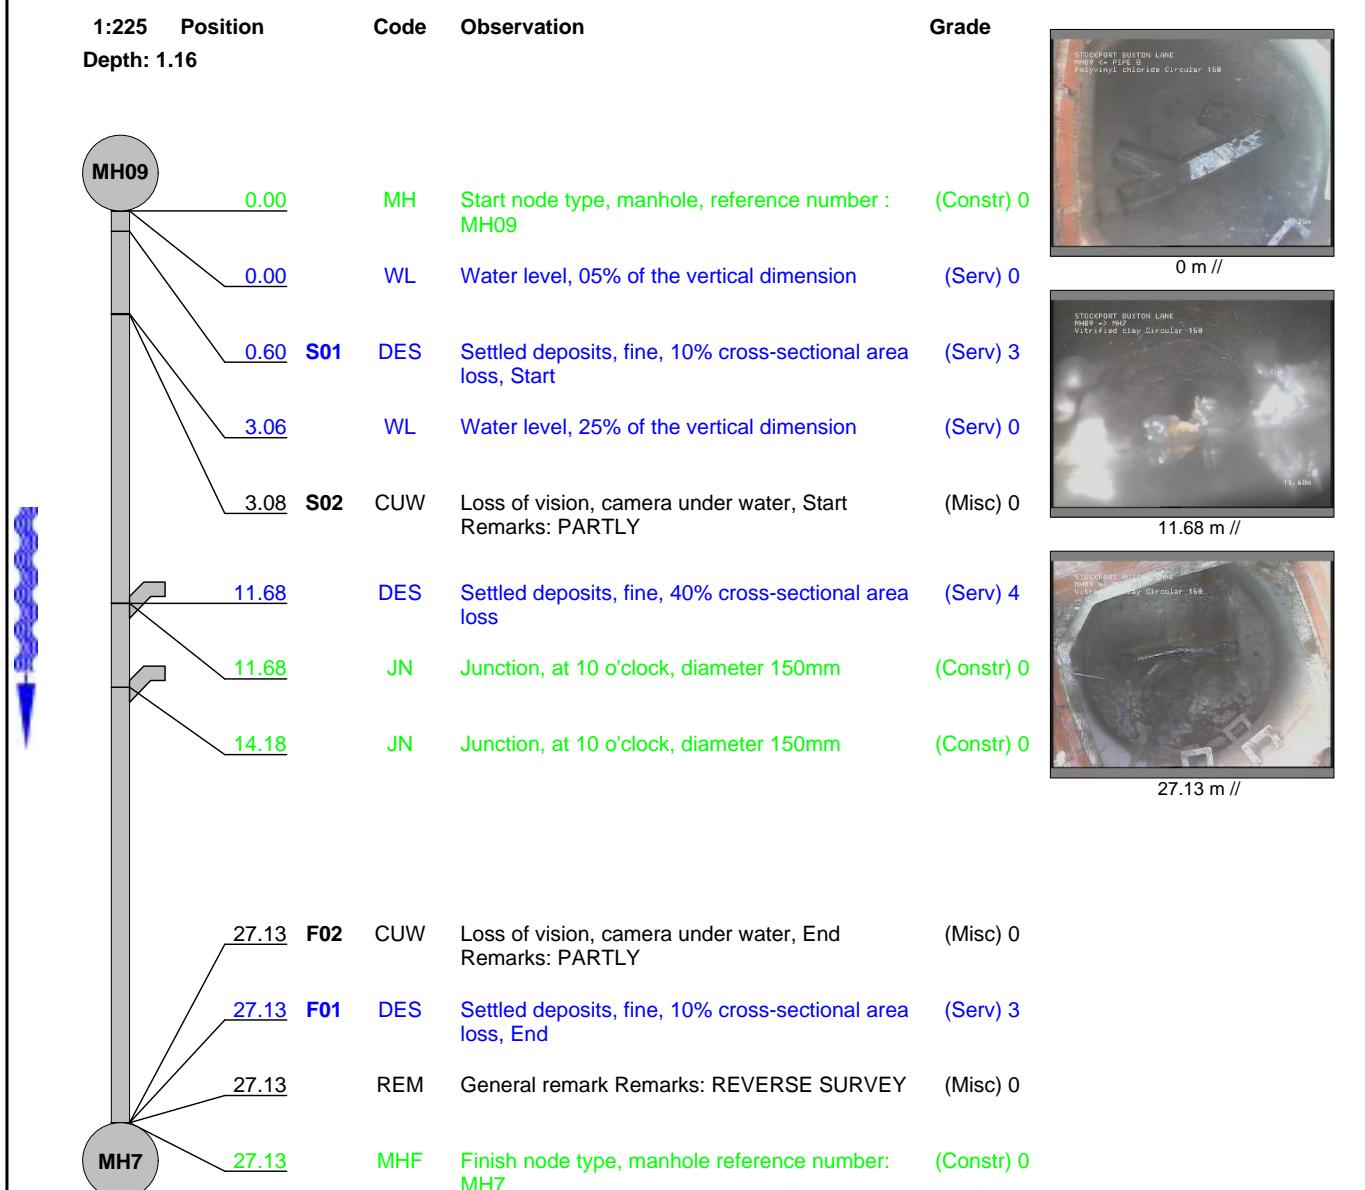
Place : STOCKPORT	Location details:	U/S MH : MH09
Road : BUXTON LANE	Catchment:	U/S Depth : 1.16
Location Road	Tape number : -	D/S MH : MH7
Inspection MH09 (D/S) MH7	Pipe Length 2.00 m	D/S Depth : 2.01
Use: Foul	Pipe shape : Circular	
Year laid : Z	Pipe size : 150 mm	
Purpose : Sample survey to determine asset condition	Pipe material : Vitrified clay	
Total length : 27.13 m	Lining :	
Comment : CLIENT ON SITE

Structural Defects					Constructional Features				
Service Defects					Miscellaneous Features				
STR no def	STR peak	STR mean	STR total	STR grade	SER no def	SER peak	SER mean	SER total	SER grade
0	0	0	0	1	2	7	2.14	58	4

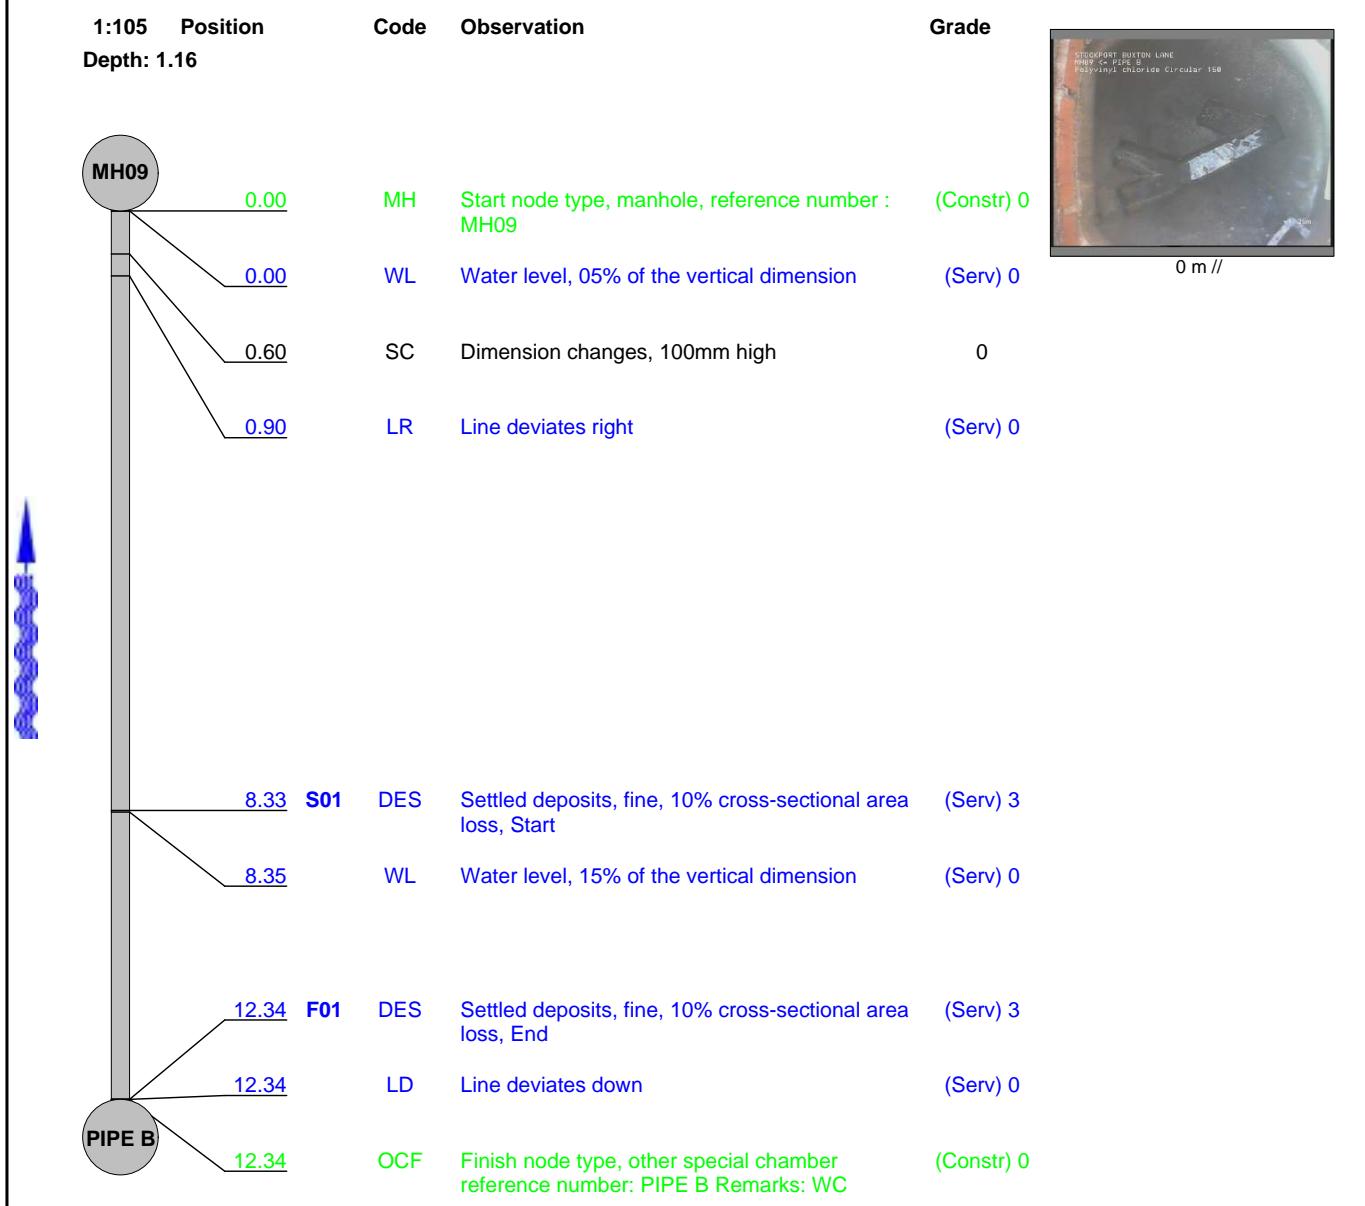
Place : STOCKPORT	Location details: Catchment: Tape number : Pipe Length	U/S MH : PIPE B
Road : BUXTON LANE		U/S Depth : 0
Location Road		D/S MH : MH09
Inspection MH09 (U/S) PIPE B		D/S Depth : 1.16
Use: Foul	Pipe shape : Circular	
Year laid : Z	Pipe size : 150 mm	
Purpose : Sample survey to determine asset condition	Pipe material : Polyvinyl chloride	
Total length : 12.34 m	Lining :	
Comment : CLIENT ON SITE

Structural Defects					Constructional Features				
Service Defects					Miscellaneous Features				
STR no def	STR peak	STR mean	STR total	STR grade	SER no def	SER peak	SER mean	SER total	SER grade
0	0	0	0	1	1	2	0.65	8	3

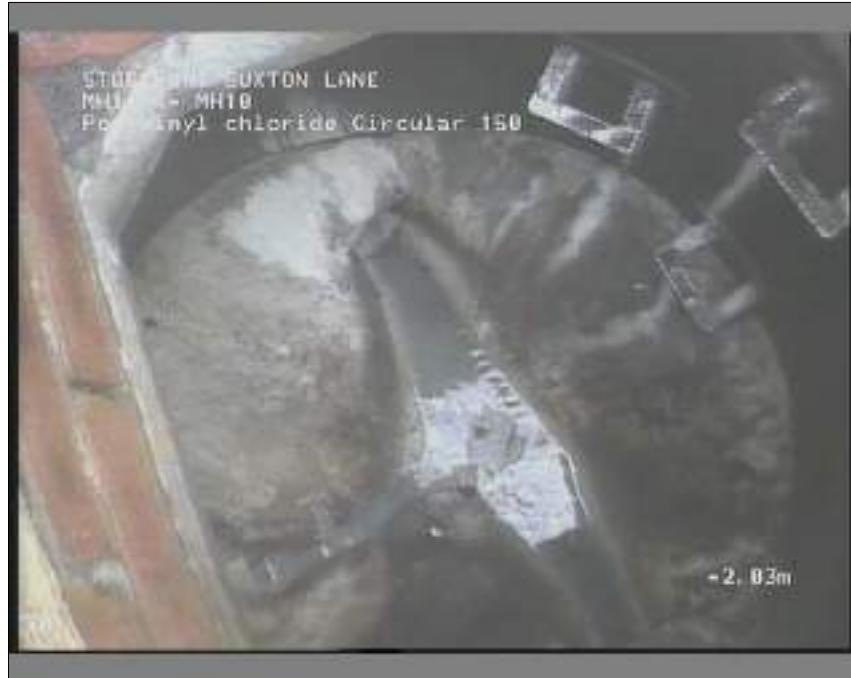
Photo: 021.JPG
0m, Start node type, manhole, reference number : MH11

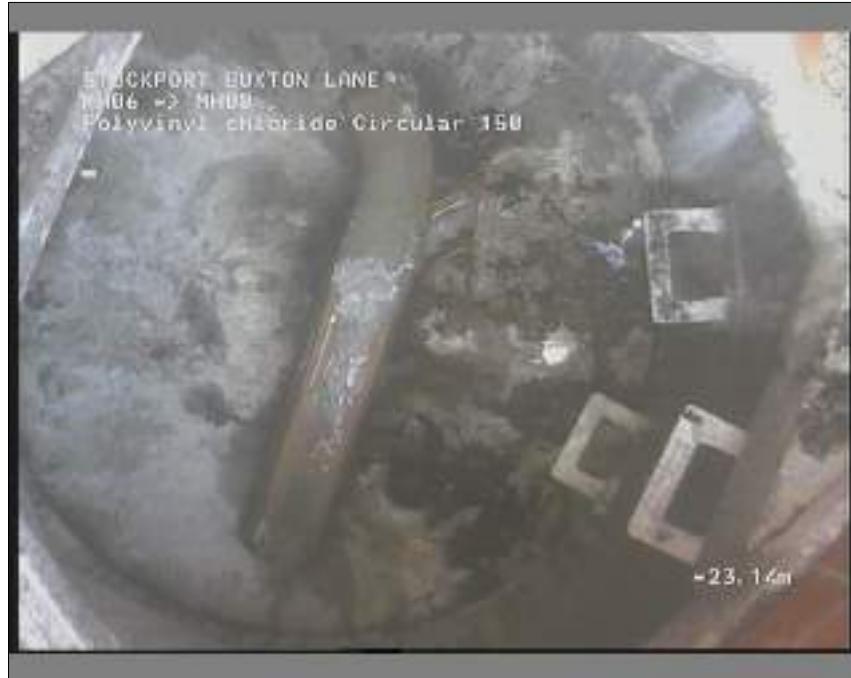
Photo: 022.JPG
0m, Start node type, manhole, reference number : MH06

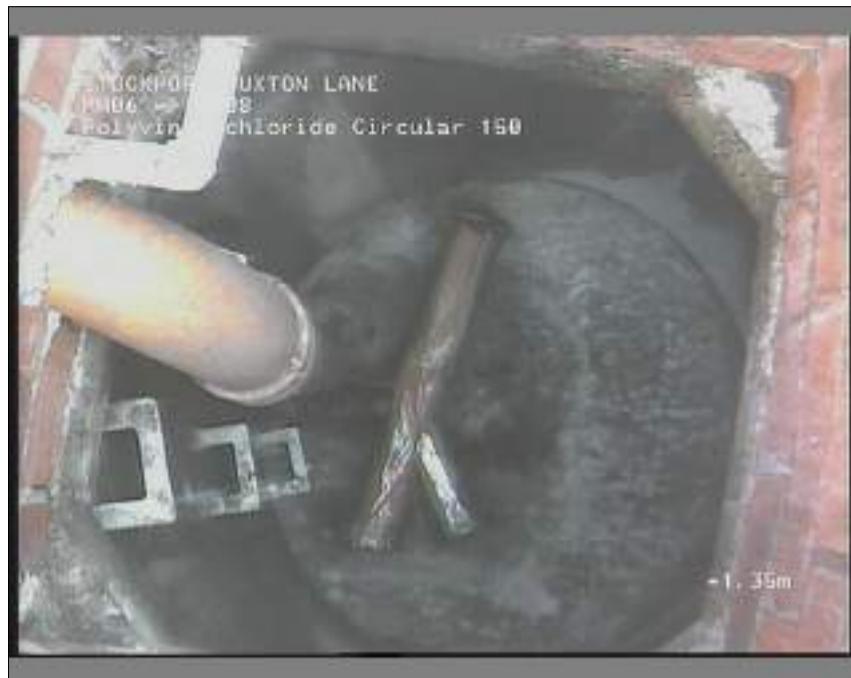
Photo: 023.JPG
17.01m, Finish node type, manhole reference number: MH08

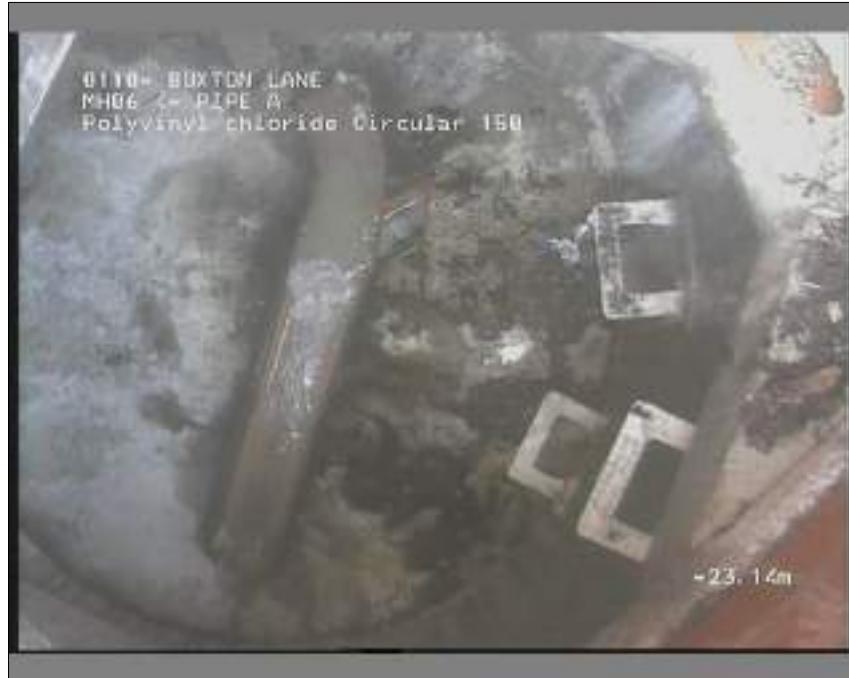
Photo: 024.JPG
0m, Start node type, manhole, reference number : MH06

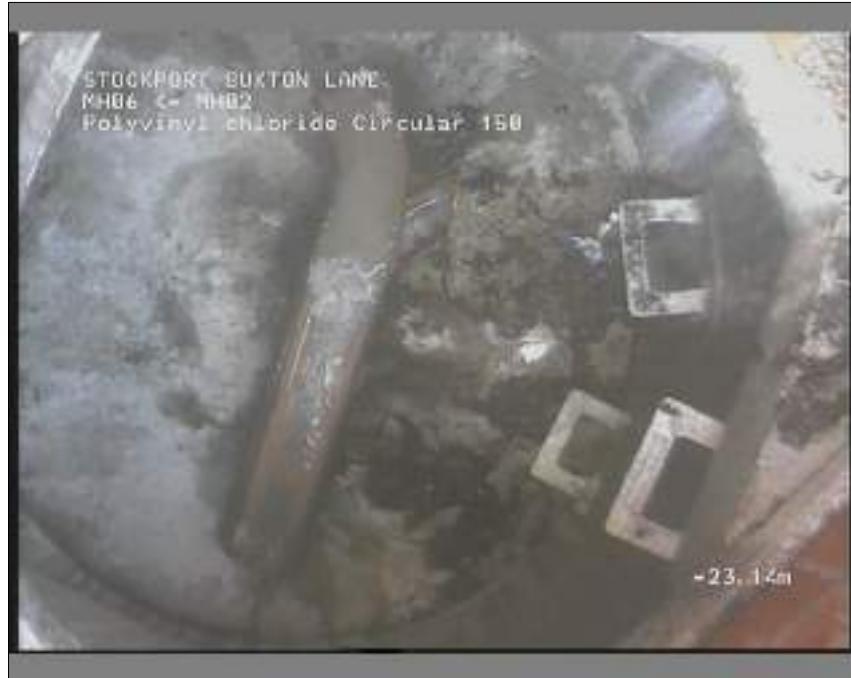
Photo: 026.JPG
0m, Start node type, manhole, reference number : MH06

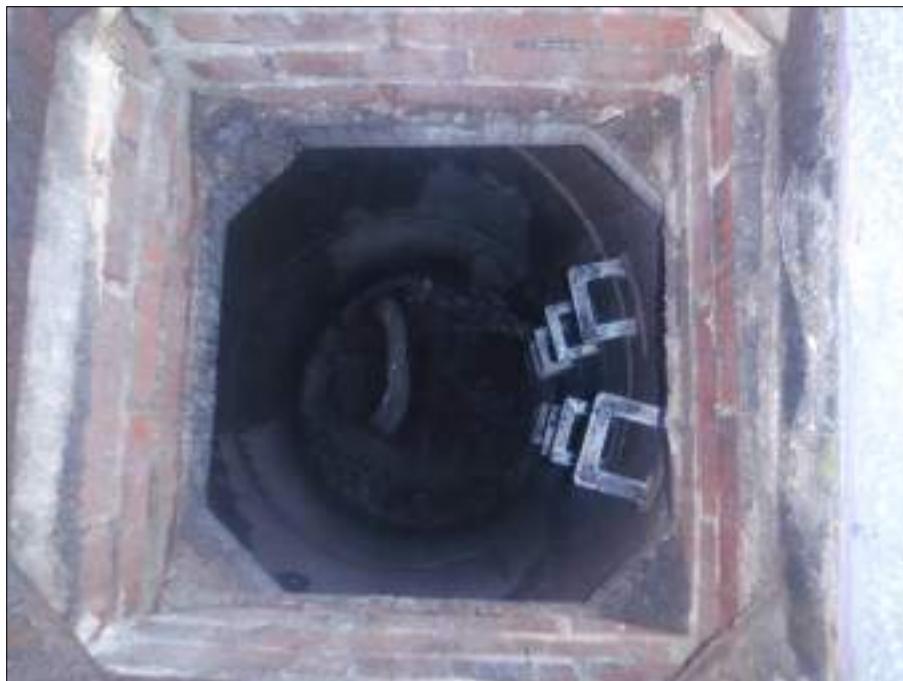
Photo: 027.JPG
22.5m, Finish node type, manhole reference number: MH02

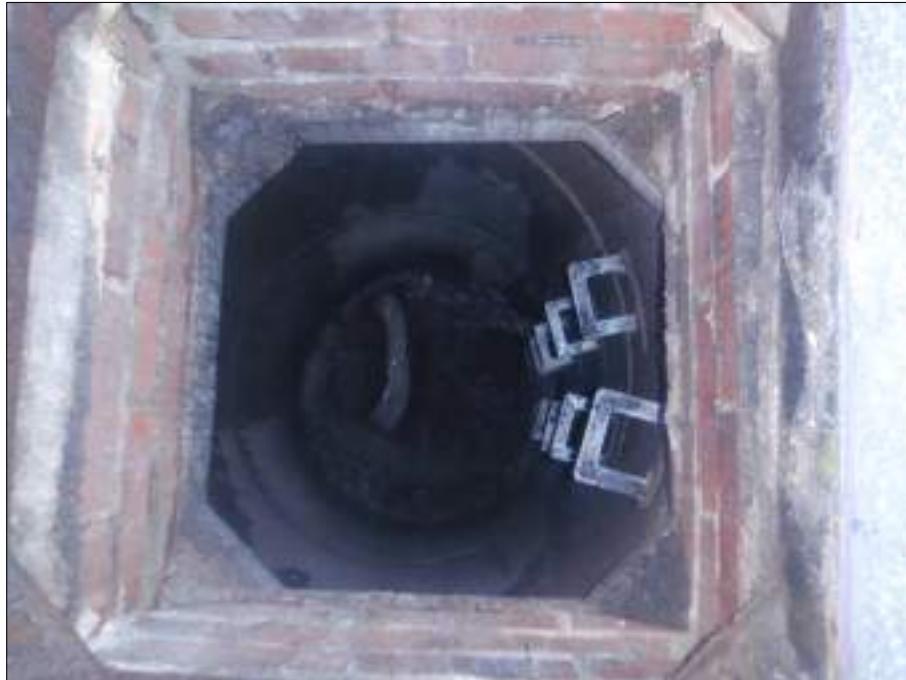
Photo: 028.JPG
0m, Start node type, manhole, reference number : MH02

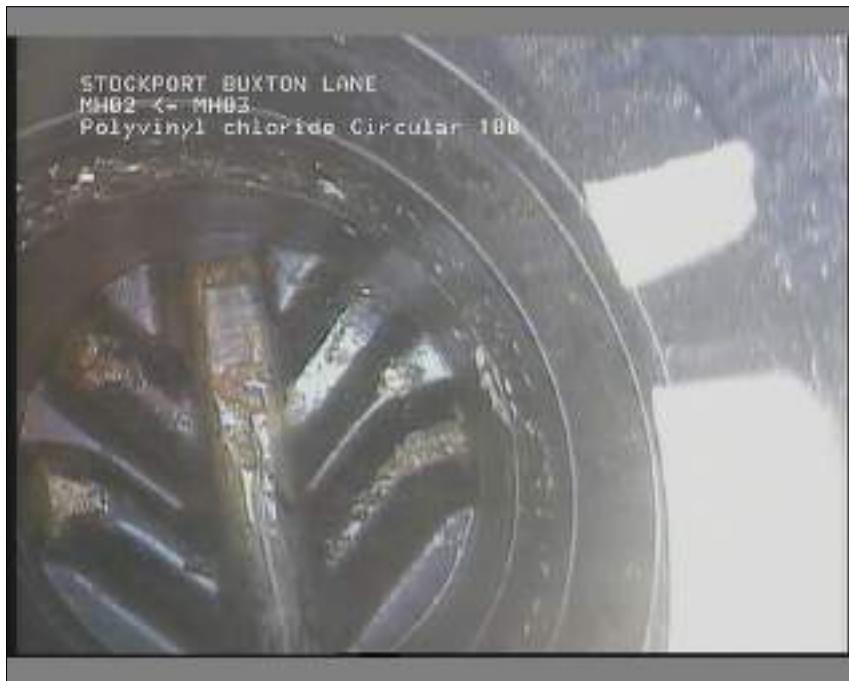
Photo: 029.JPG
10.14m, Finish node type, inspection chamber reference number: MH03

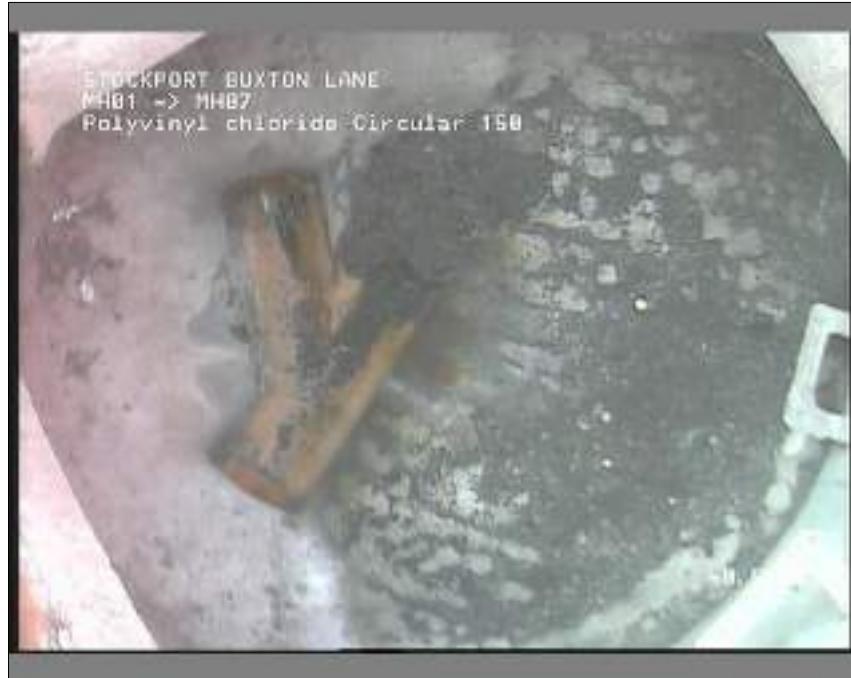
Photo: 030.JPG
0m, Start node type, manhole, reference number : MH01

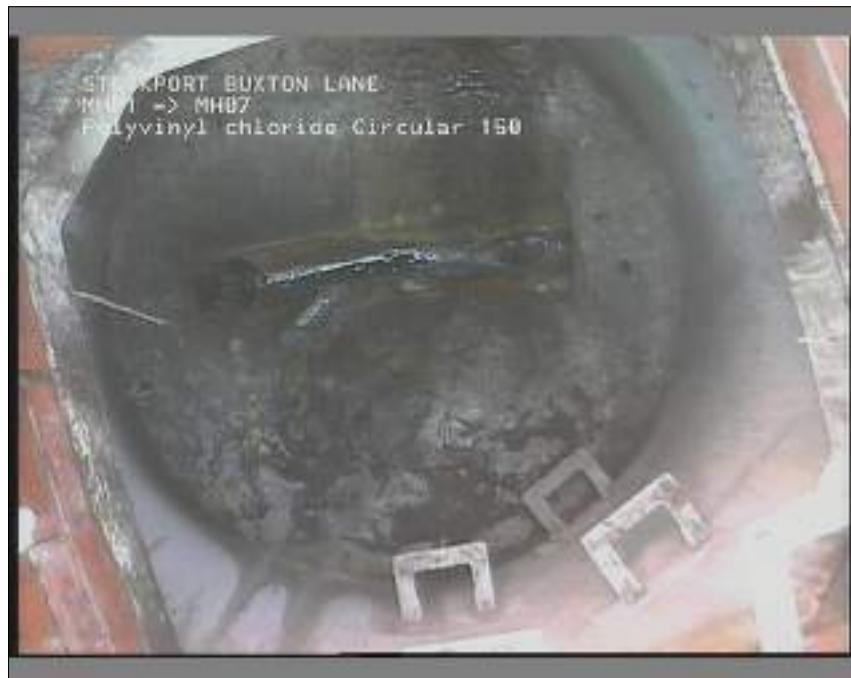
Photo: 031.JPG
34.15m, Finish node type, manhole reference number: MH07

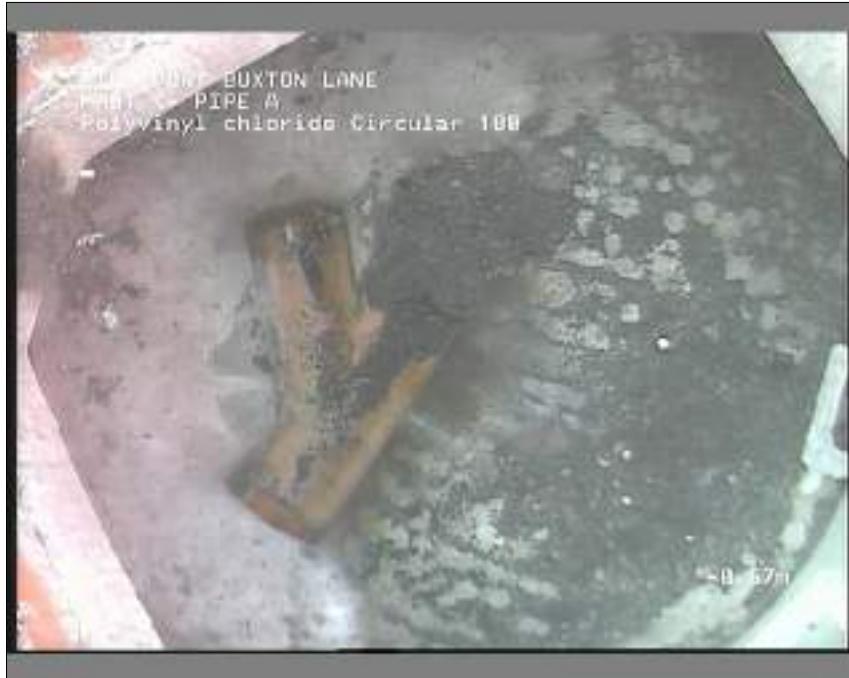
Photo: 032.JPG
0m, Start node type, manhole, reference number : MH01

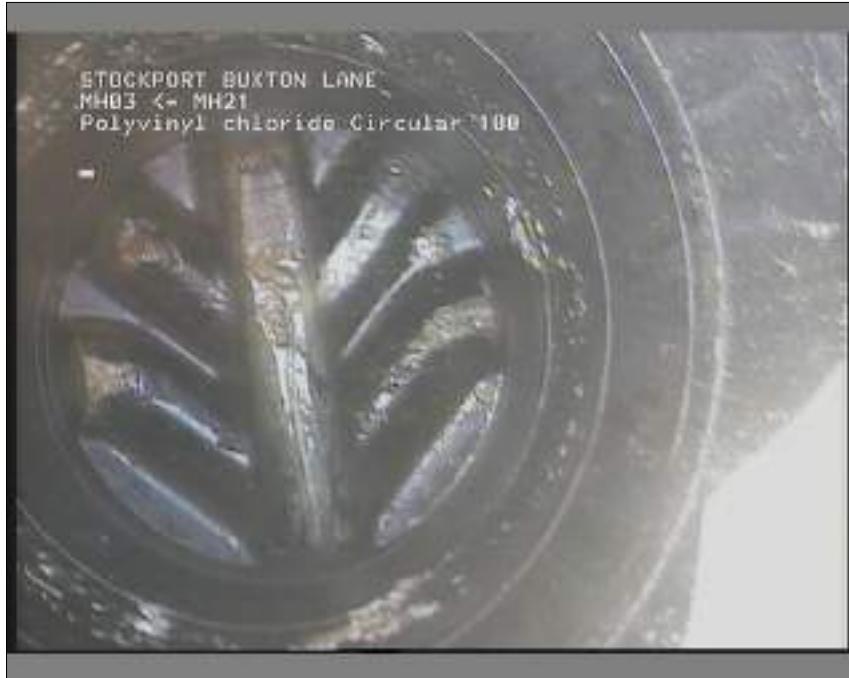
Photo: 033.JPG
0m, Start node type, inspection chamber, reference number : MH03

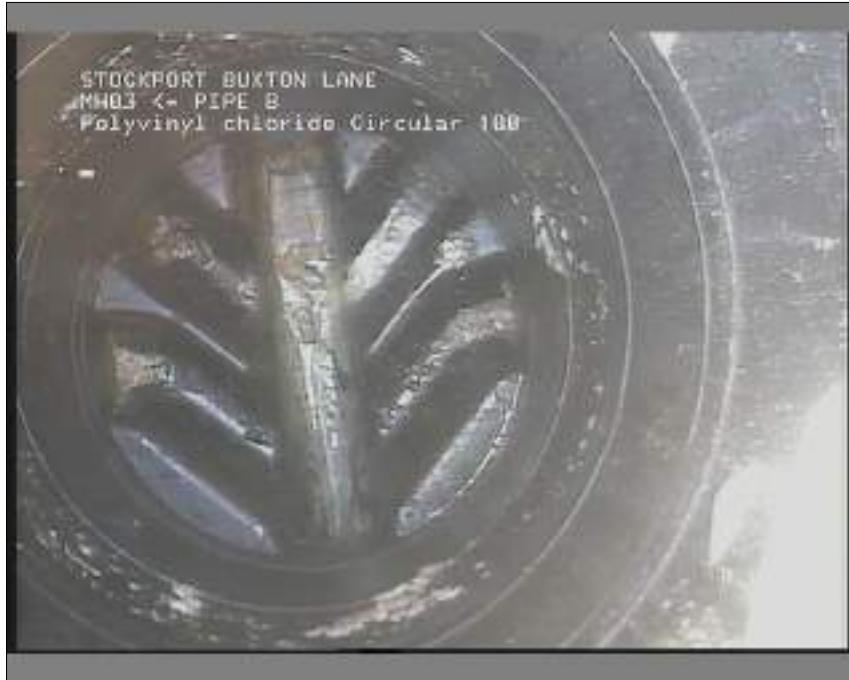
Photo: 034.JPG
0m, Start node type, inspection chamber, reference number : MH03

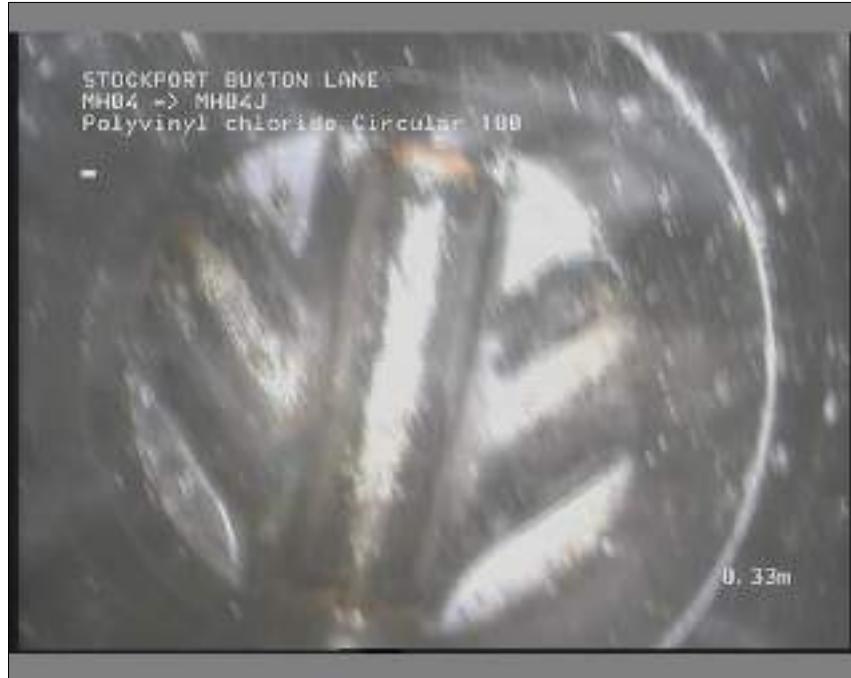
Photo: 035.JPG
0m, Start node type, inspection chamber, reference number : MH04

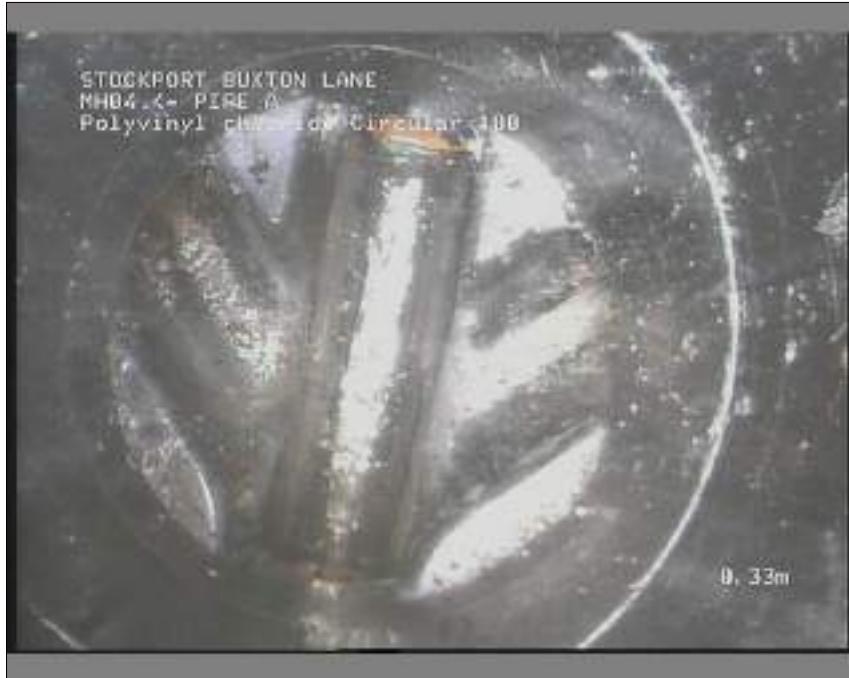
Photo: 036.JPG
0m, Start node type, inspection chamber, reference number : MH04

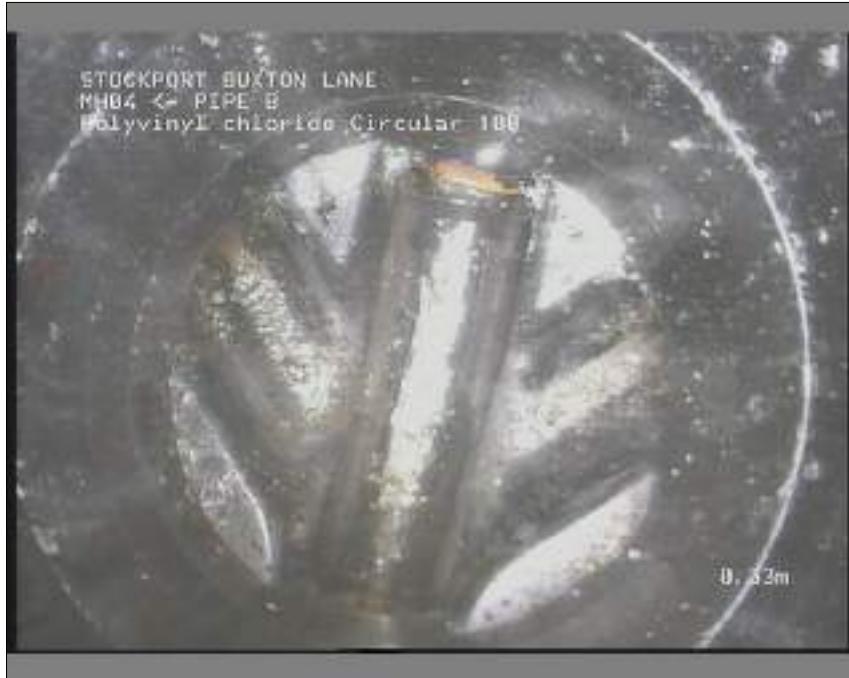
Photo: 037.JPG
0m, Start node type, inspection chamber, reference number : MH04

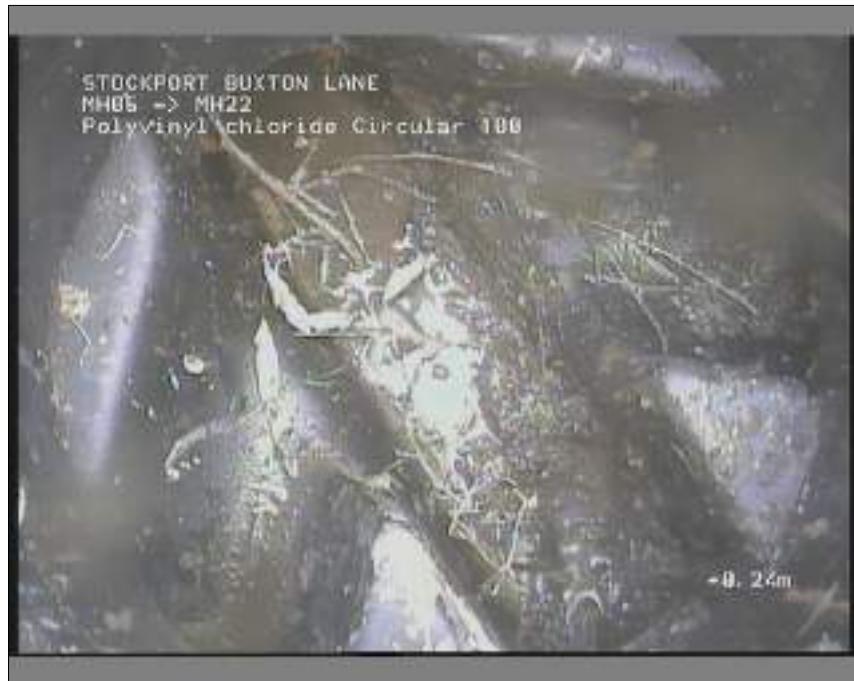
Photo: 038.JPG
0m, Start node type, manhole, reference number : MH05

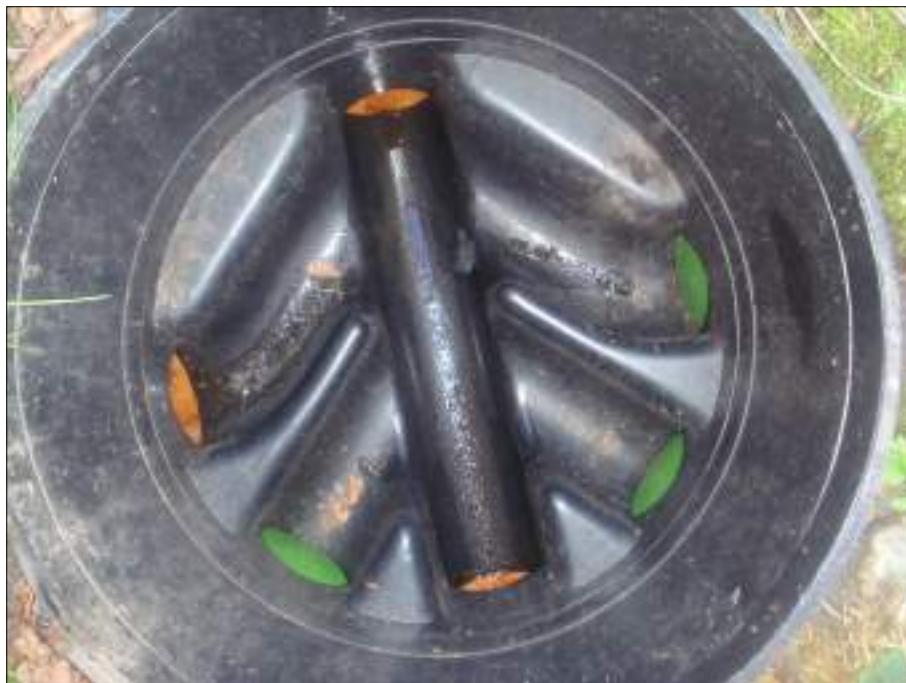
Photo: 039.JPG
19.11m, Finish node type, manhole reference number: MH22

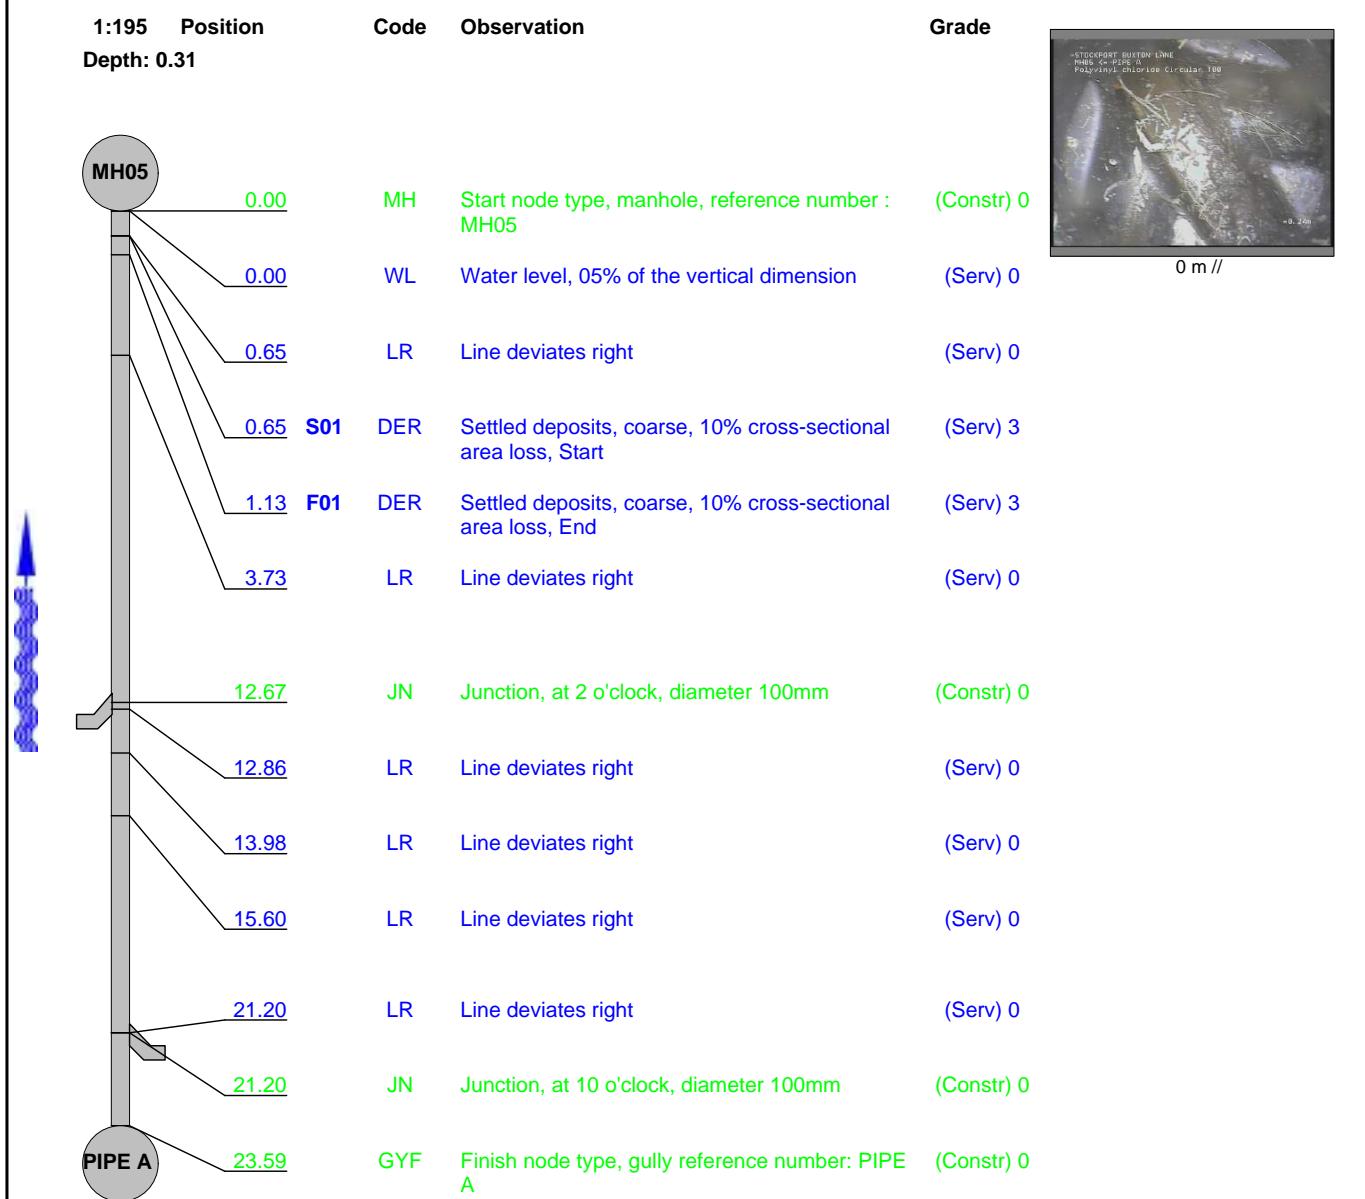
Place : STOCKPORT	Location details:	U/S MH : PIPE A
Road : BUXTON LANE	Catchment:	U/S Depth : 0
Location : Gardens	Tape number : -	D/S MH : MH05
Inspection : MH05 (U/S) PIPE A	Pipe Length 2.00 m	D/S Depth : 0.31
Use: Surface water	Pipe shape : Circular	
Year laid : Z	Pipe size : 100 mm	
Purpose : Sample survey to determine asset condition	Pipe material : Polyvinyl chloride	
Total length : 23.59 m	Lining :	
Comment : CLIENT ON SITE

Structural Defects					Constructional Features				
Service Defects					Miscellaneous Features				
STR no def	STR peak	STR mean	STR total	STR grade	SER no def	SER peak	SER mean	SER total	SER grade
0	0	0	0	1	1	1	0.04	1	2

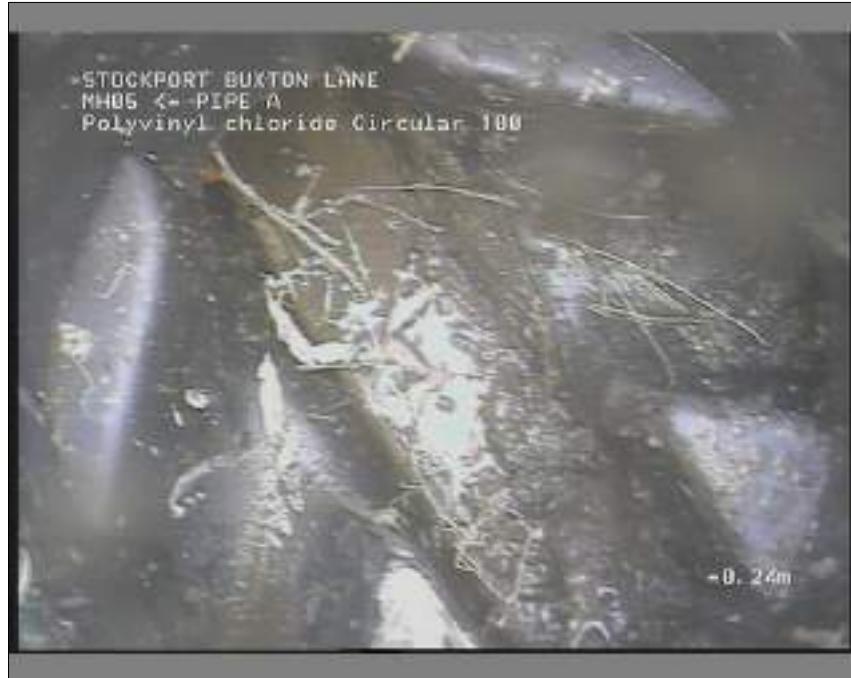
Photo: 040.JPG
0m, Start node type, manhole, reference number : MH05

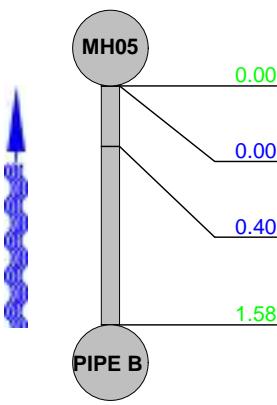
MH05	IC	Start node type, inspection chamber, reference number : MH05	(Constr) 0
0.00	WL	Water level, 05% of the vertical dimension	(Serv) 0
0.40	LR	Line deviates right	(Serv) 0
1.58	GYF	Finish node type, gully reference number: PIPE B	(Constr) 0
Depth: 0
