Drawing Title
**Topographical Survey of Land at:
Barchester Arbour Lodge
Buxton Lane, Marple**

Project Name: 12639 SURVEY OPS ARBO	Project number: 12639	Date: 29/03/2019	Contact: Ian Thompson	
--	--------------------------	---------------------	--------------------------	--

Inspection report

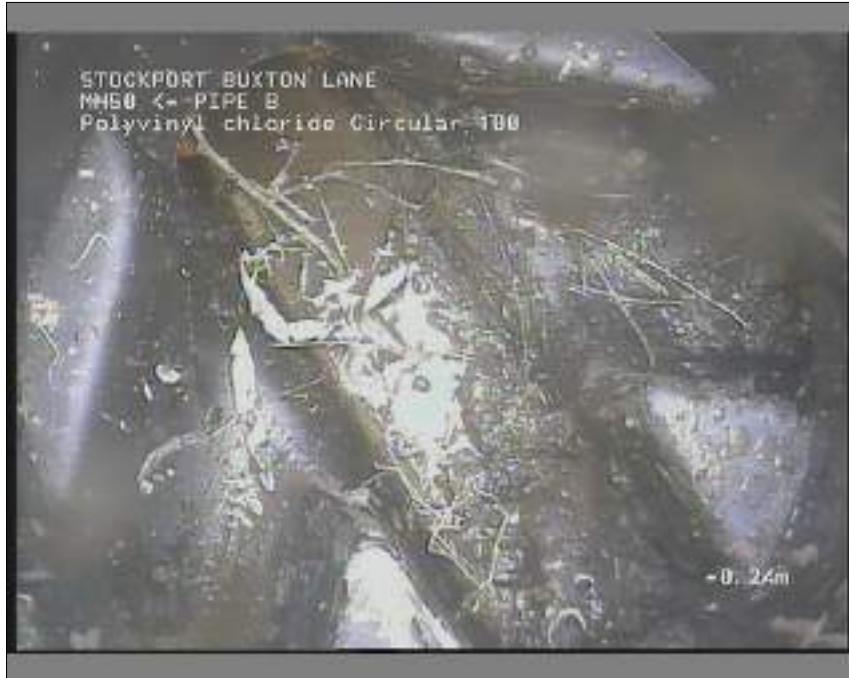
Photo: 041.JPG
0m, Start node type, inspection chamber, reference number : MH05

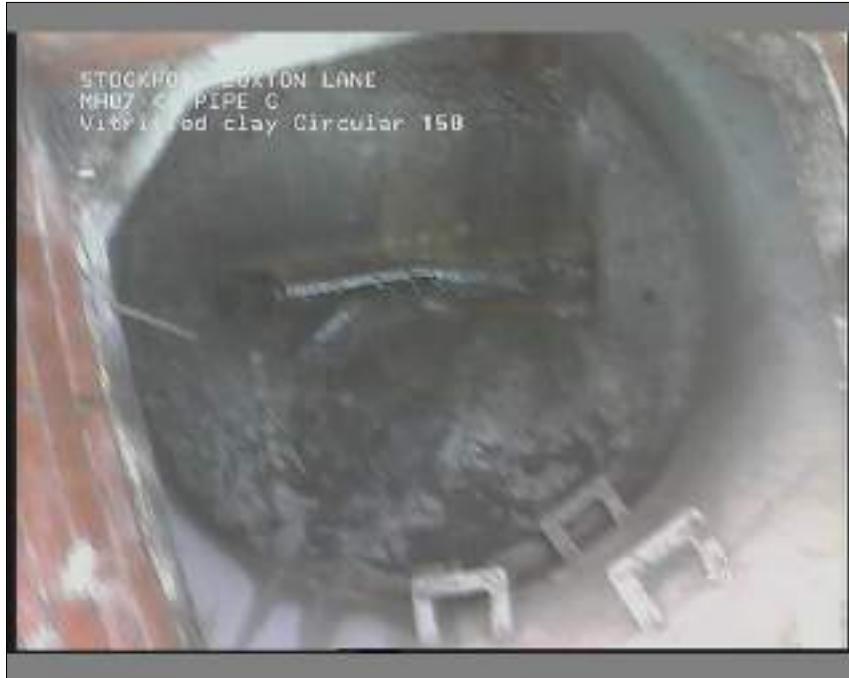
Photo: 042.JPG
0m, Start node type, manhole, reference number : MH07

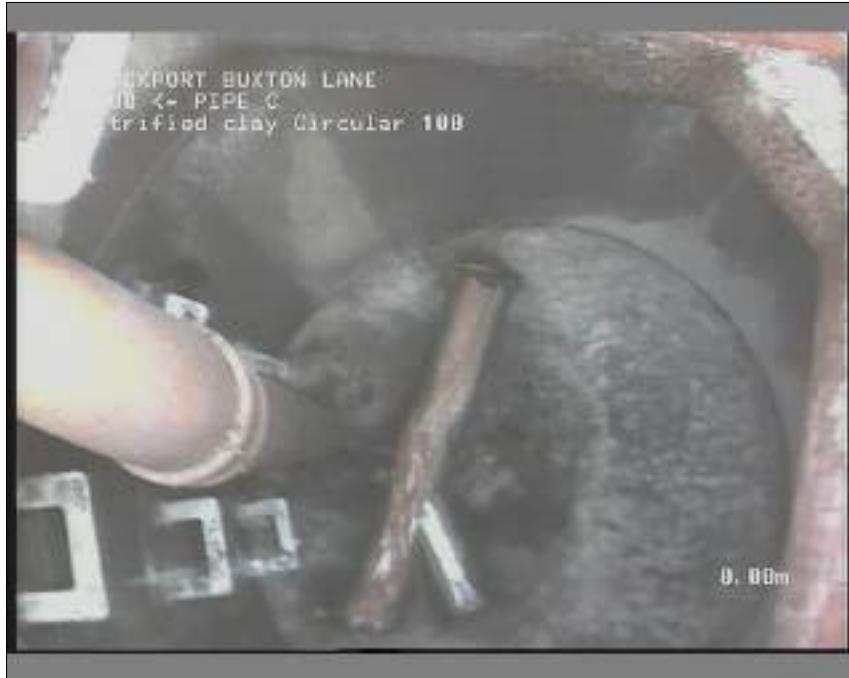
Photo: 043.JPG
0m, Start node type, manhole, reference number : MH08

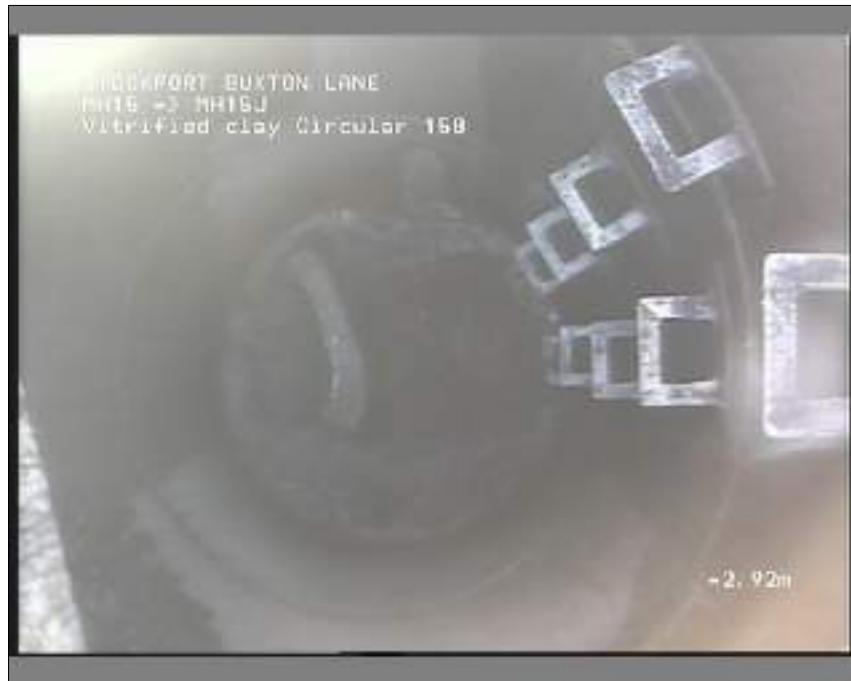
Photo: 044.JPG
0m, Start node type, manhole, reference number : MH15
