Buildings at East Field House
Mickleton
Co Durham

archaeological building recording

report 5173
October 2019

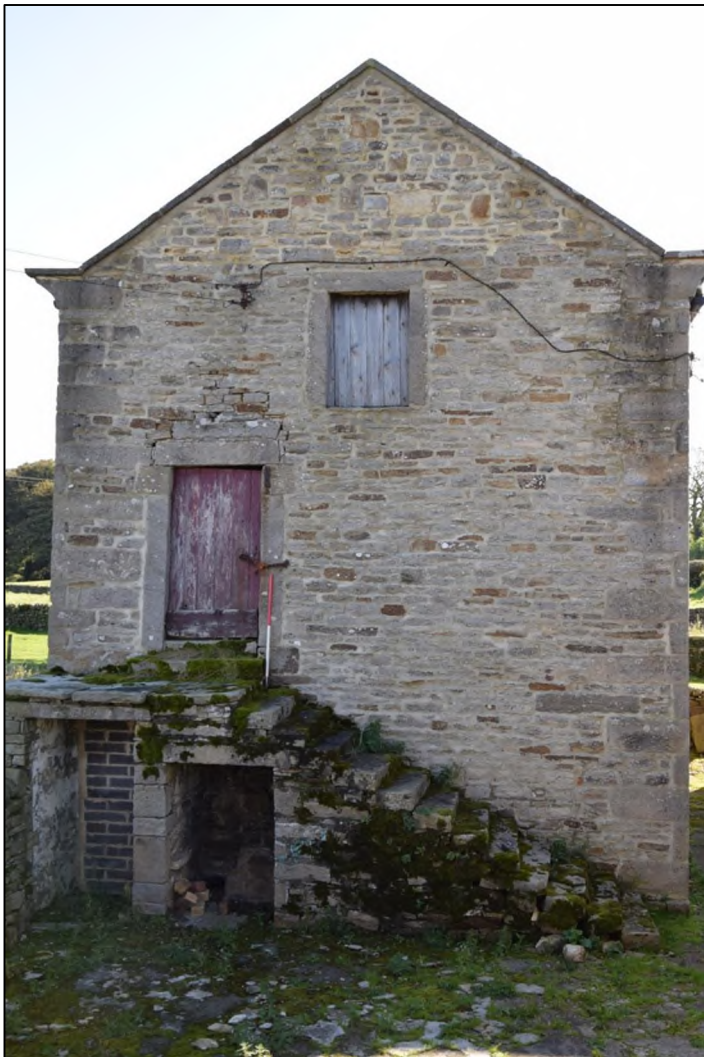
external stair runs across the west end, under a central loading door. The gable above this has been repaired recently (Photograph 8). Beneath the stone platform outside the upper door is a small door to the ground floor, now closed up with concrete blocks.

Photograph 8 (left): The west end of building 1, with a loading door and stone staircase. The concrete blocks, bottom left, block a later door into the byre. The top of the gable has been rebuilt

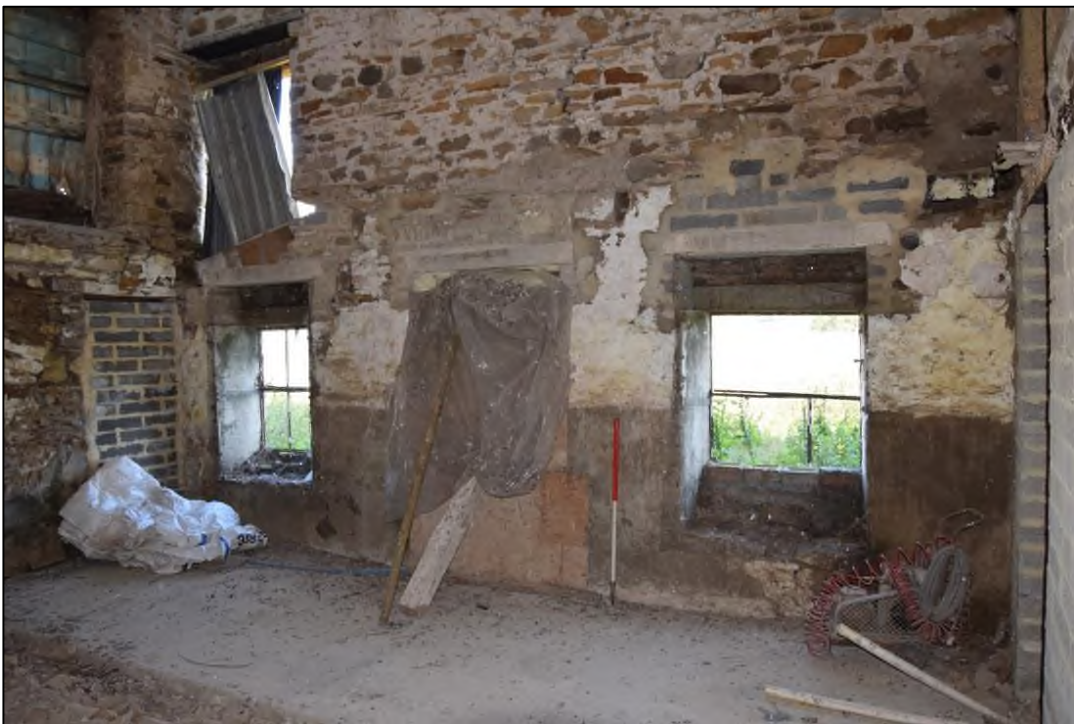
Photograph 25 (above): Settlement cracks can be seen in the north wall of the hay loft at the west end of building 1

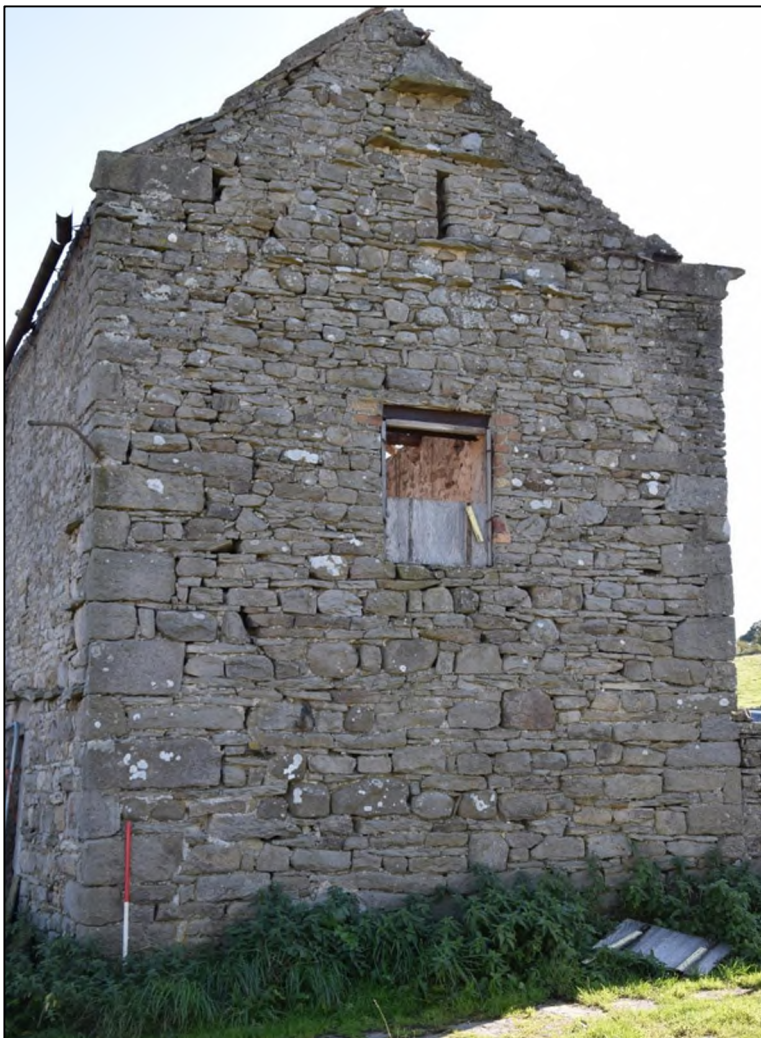
- 5.9 Like building 1, this was a byre and hay store; and like building 1 it has been substantially altered. It abuts the west end of the house in the manner of longhouses of the upper dale. Its roof slabs have been removed but the trusses and rafters remain; a small lean-to shed stands at the junction of this building and an outshut extension behind the house (Photograph 27). The north wall is dominated by a large modern door at the centre of the face (Photograph 28). There is a smaller door to the west under a course of projecting through stones and there are breather slits higher up in the face. The quoins at the north-west corner of the building are like those in the older part of building 1, but these disappear at a point about 4.2m above ground level (Photograph 29). From here the stonework is much smaller; this change coincides with a break in the masonry of the building. This is most clearly visible in the south face but the difference in the size of the stones can be seen in the west end; the change in the quoins can be seen in the south-west corner as well (Photograph 30).

Photograph 30 (left):
The change from large
angle quoins can be
seen at both corners of
the building in this
view of the west end.
The character of the
masonry is different
above and below the
window

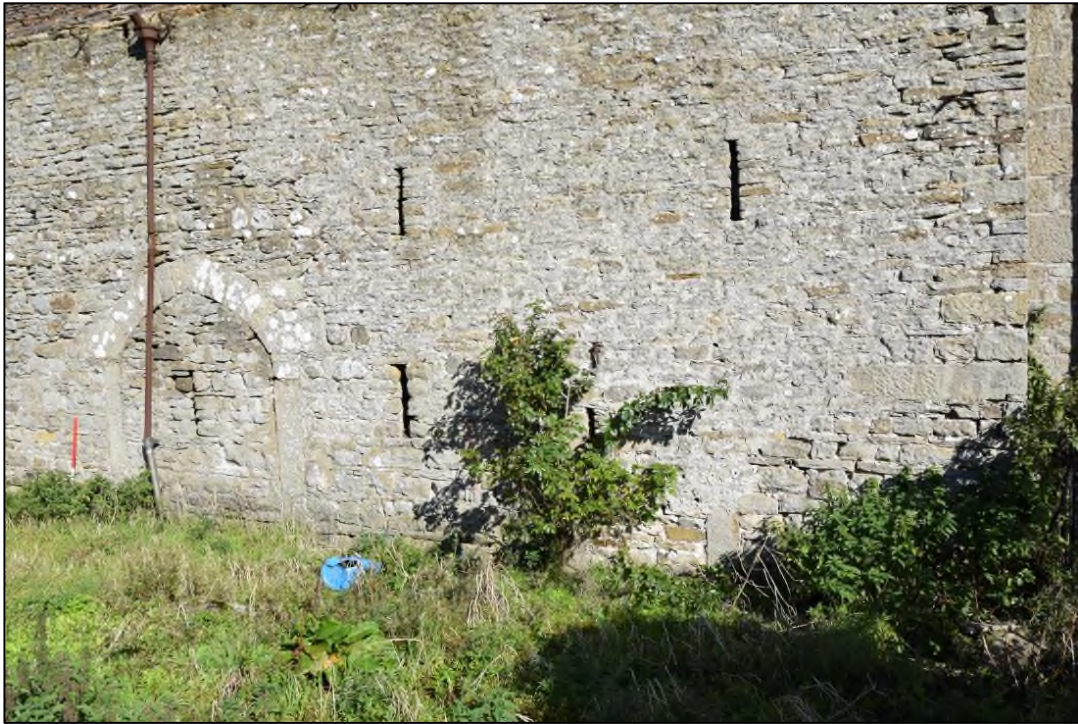
Photograph 35 (above):
The wall at the east end
of the south face is
almost wholly rebuilt.
The door jambs can be
seen as in Photo 32

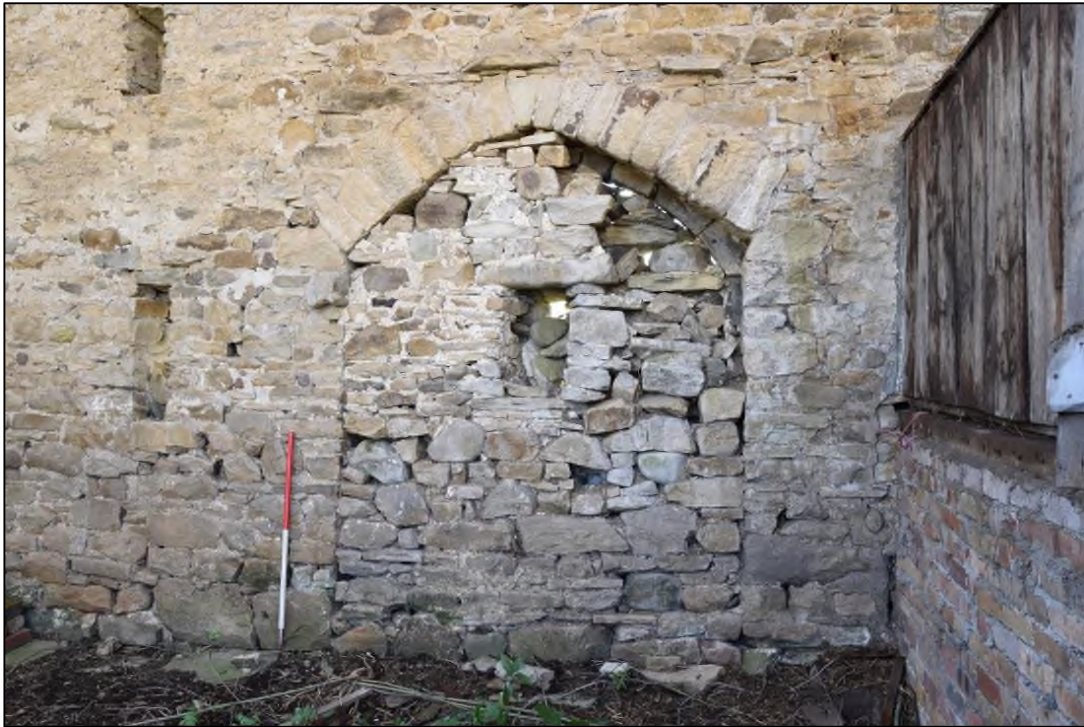
Photograph 41: Detail of the central door, showing the rebate and hinge pin

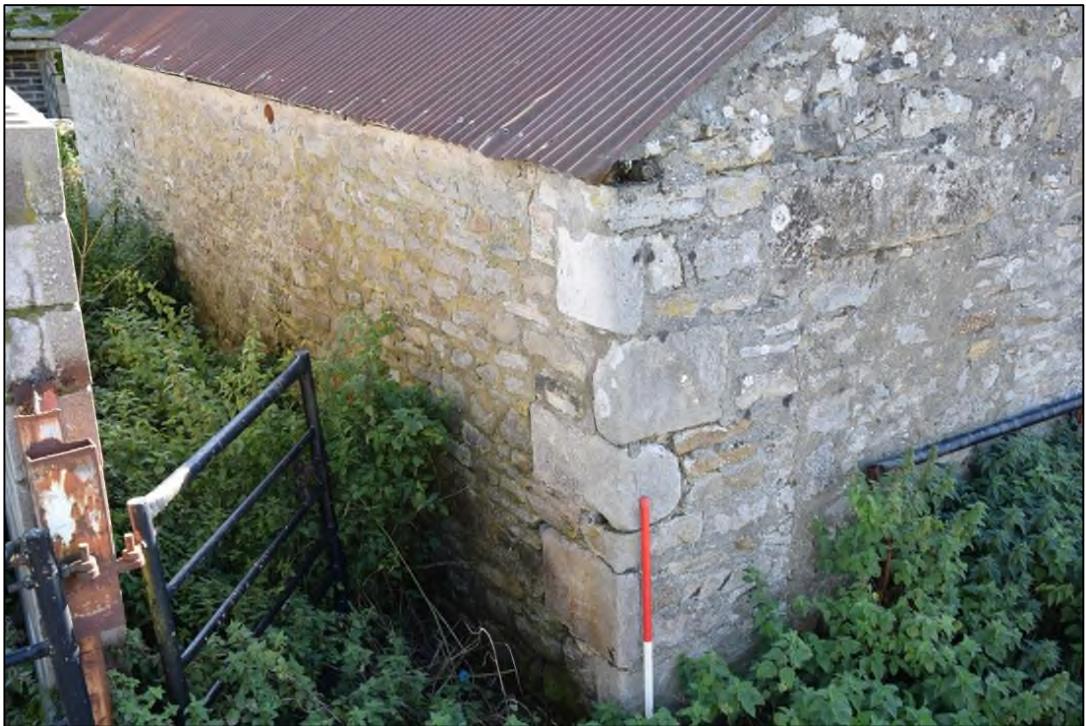
blocked door in the west end (Photographs 65, 66). Inside, the two store rooms are bare. The internal wall has a bricked-up door at its north end (Photograph 67). The east room has a matchboard ceiling (Photograph 68). Though it is more than a century younger than the other buildings at the farmstead, the construction of this small shed is very similar to that of other structures on the site (Photograph 70). This emphasises the difficulty of providing firm dates for simple farm buildings like these.

Photograph 65: The west end of the shed. A blocked door is faintly visible near the right-hand end

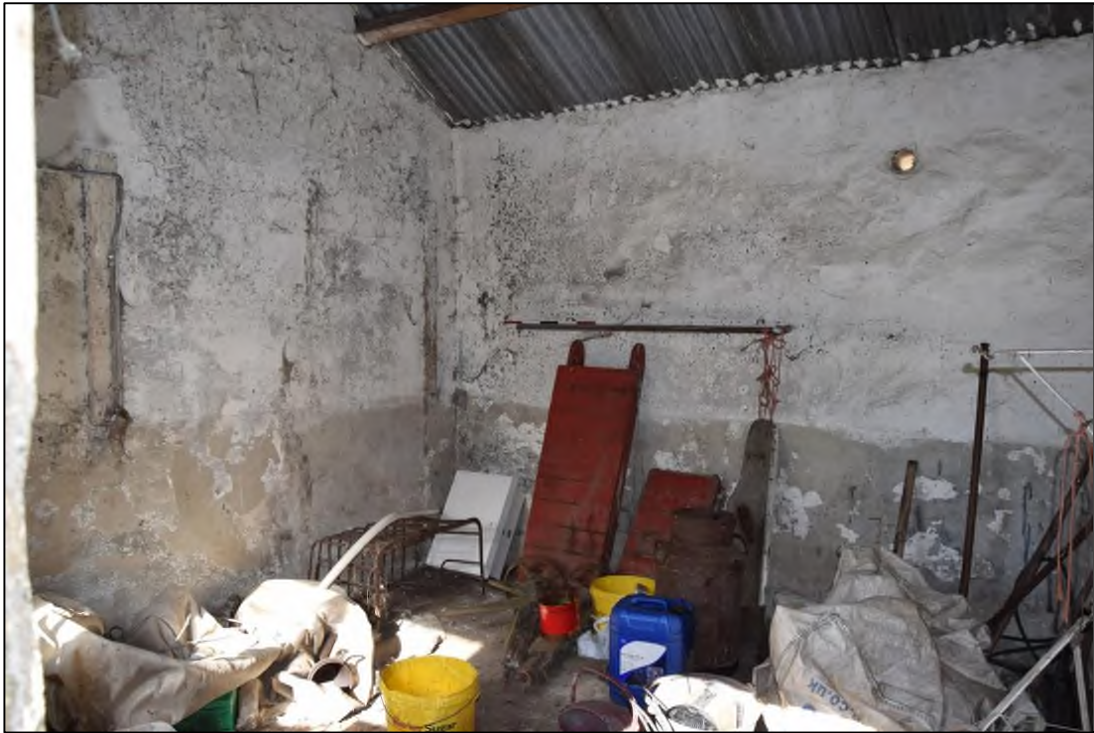
Photograph 66: The north-west corner of the shed, showing the blocked door (right of the scale) and the windowless north face

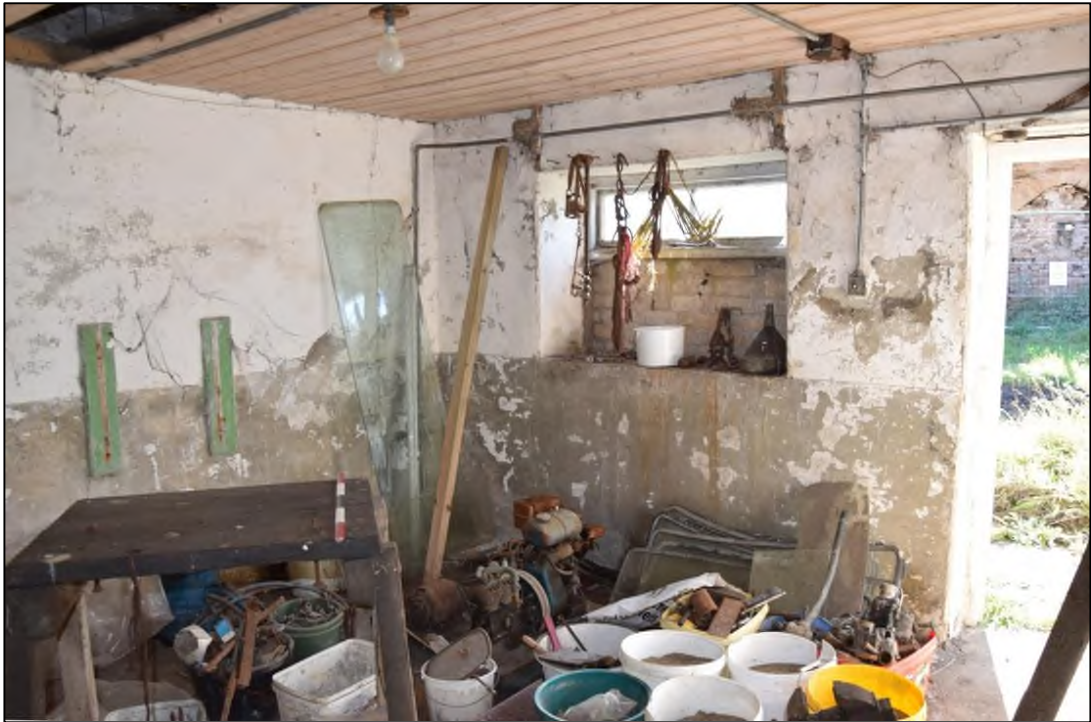
Photograph 68: A view looking north-west in the east room, with the blocked internal door
