Phase I Geo-Environmental Site Assessment

Rookery Farm, Rookery Farm Lane, Basingstoke, RG26 5HW

March 2023

Omnia ref: A11764/1.1

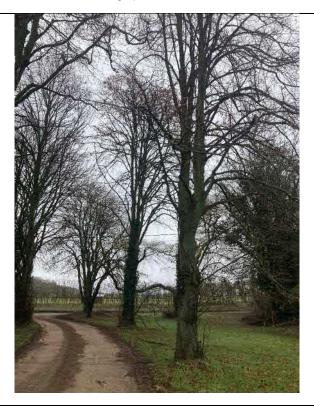
Photograph 2 – View of trees at site entrance

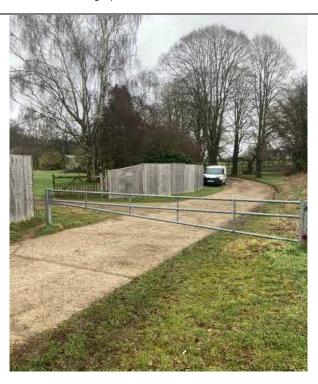
Photograph 4 –Gate located on driveway into site

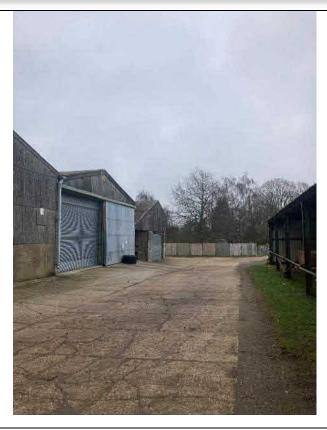
At the time of site walkover, the access route comprised a private concrete road off Rookery Farm Lane to the east (Photographs 1-3). This was noted from superficial visual inspection to be in good condition. The road was also an access point for a residential property adjacent to the east of the site. The Rookery Farm entrance was marked by a metal gate with pedestrian access either side of the gate (Photograph 4). The access route led onto a yard area, which contained 5 main barns and a stable block (Photograph 5, Figure 3.0 within Appendix III).

Photograph 5 – Overview of yard area

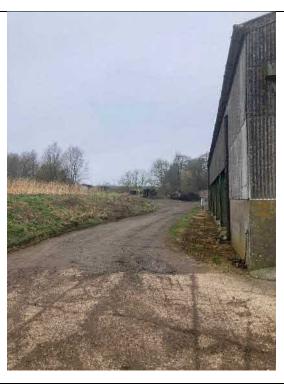
Photograph 6 –Road that ran north-south on the western side of site

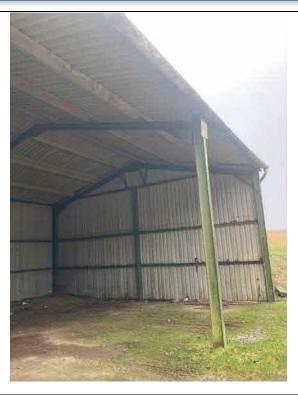
Photograph 7 –Western side of Barn 1

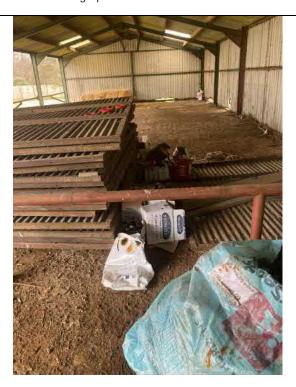
Barn 1 was located on the southwestern corner and was approximately 28m x 10m in size (I x w) with the long axis aligned east to west. The barn was of metal frame construction with walls of corrugated metal cladding, concrete blockwork and a roof of corrugated cement sheeting considered to be Potential Asbestos containing Material (PACM). The northern elevation of the barn was open (Photograph 7). In the centre of the barn were approximately fifteen (15no.) 2x2m metal and wooden fencing panels with some waste materials (approximately thirty (30no.) 0.20m empty glass bottles, nine (9no.) cardboard boxes ranging in sizes 0.20m-0.40m, two (2no.) animal feed plastic packaging 1mx1m) scattered on the ground (Photograph 8). To the south and southeast of the barn were two (2no.) approximately 3m tall elder trees.

Photograph 8 –Internal area of Barn 1

It is recommended that an asbestos survey is undertaken in accordance with the Control of Asbestos Regulations (2012) prior to the commencement of any refurbishment or demolition works.

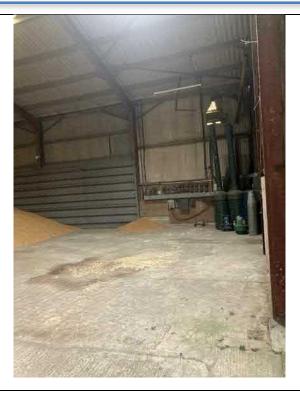
Barn 2 was located at the western side of site (Figure 3.0 Appendix III) and was approximately 28m x 18m (I x w), with the long axis aligned north to south. The entrance to this barn was through the south elevation. The barn was of metal frame construction with walls of corrugated metal cladding, concrete blockwork and a roof of corrugated cement sheeting considered to be PACM. Barn 2 contained harvested grain on over 60% of the internal space (Photograph 10), with agricultural equipment and an electricity circuit board within the southeast corner (Photograph 9 and Photograph 11).

Photograph 9 –South-eastern corner of Barn 2 including circuit board and agricultural equipment

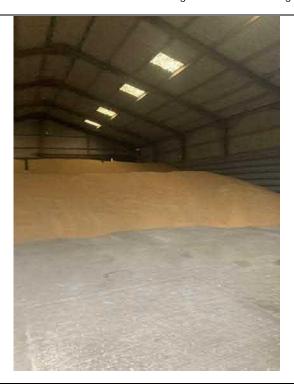
Photograph 10 –Inside of Barn 2

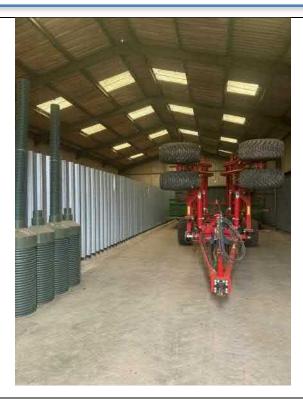
corrugated cement sheeting considered to be PACM. Internally Barn 3 contained grain storage on the western side (Photograph 12) and agricultural equipment within the eastern side (Photograph 11).

Photograph 11 –Eastern side of Barn 3

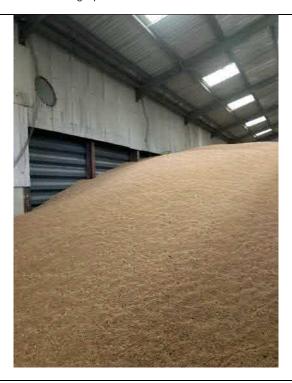
Photograph 12 –Western side of Barn 3

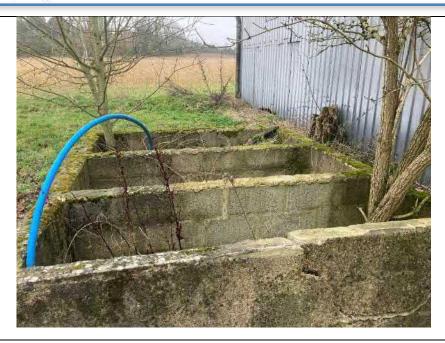
Photograph 13 –Concrete troughs to the east of Barn 1

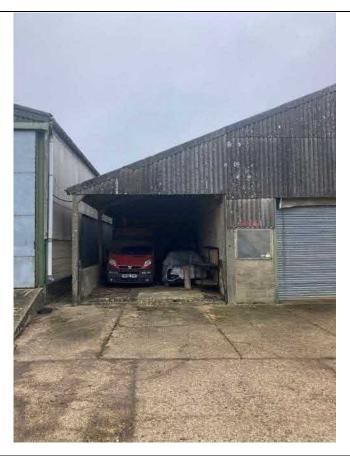
Photograph 14 –Garage area of Barn 5

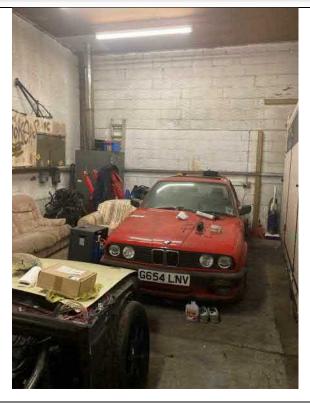
Photograph 17 –North-western corner of the private storage area of Barn 5

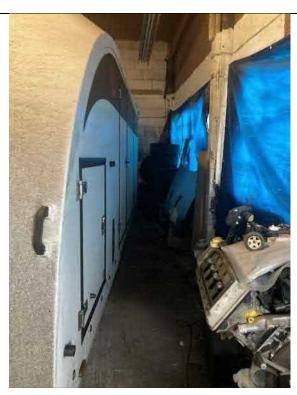
Photograph 18 –Eastern edge of the private storage area of Barn 5

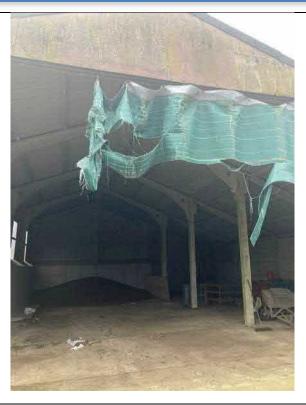
Photograph 19 –Southern facing view of the inside of Barn 4

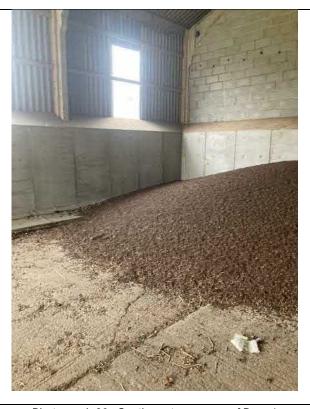
Photograph 20 – South-eastern corner of Barn 4

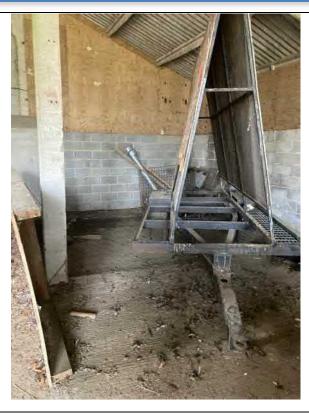
Photograph 21 –South-western corner of Barn 4 of signage

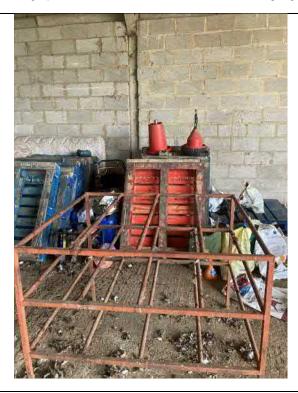
Photograph 22 – Materials on the western side of Barn 4

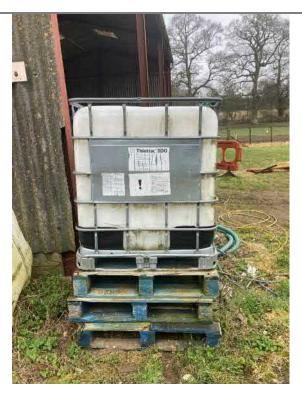
Photograph 24 –Tank 4

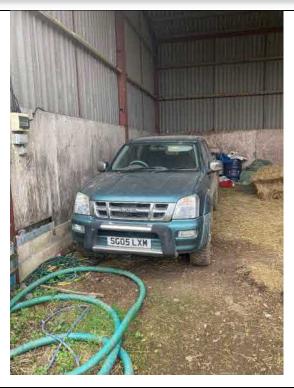
North of Barn 4 was a stable block, which contained four (4no.) wooden-built stables (Photograph 27). It was approximately 18m x 10m in size (I x w) with the long axis aligned north to south. Within the stable block was a locked metal container, assumed to contain equestrian-related materials (Photograph 28). The barn was of metal frame construction with walls of corrugated metal cladding and a roof of corrugated cement sheeting considered to be Potential Asbestos containing Material (PACM). The eastern elevation of the barn was open (Photograph 27). However, an internal inspection was not undertaken. A vehicle was parked south of the stable block with scattered general waste materials (including plastic tarpaulin, empty plastic bottles, string and wood) behind the car (Photographs 25-26).

Photograph 25 – Southern side of the stables

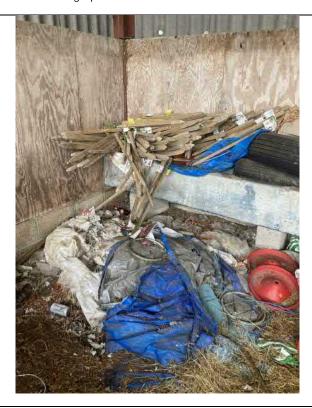
Photograph 26 – Southwestern corner of the stables

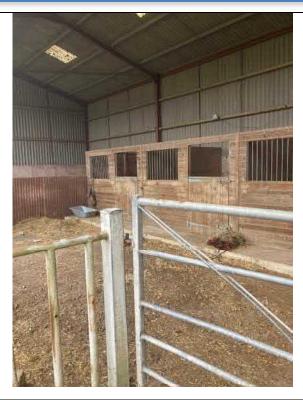
Photograph 27 –Western side of the stables

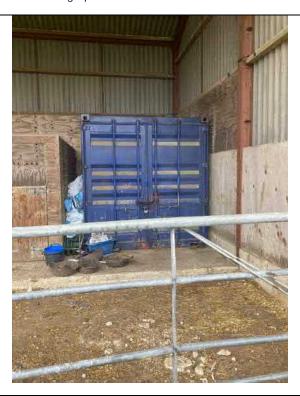
Photograph 28 –Northern side of the stables

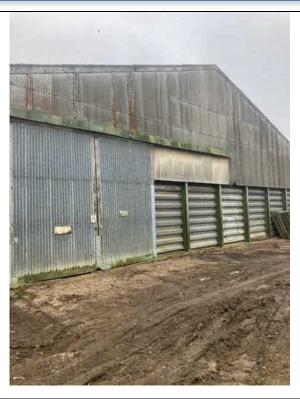
Photograph 32 –Northern side of Barn 2

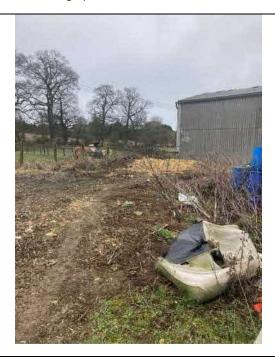
Photograph 33 –Land north of the container containing general waste

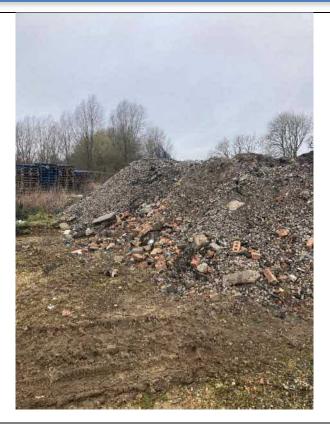
Photograph 34 –Stockpile in the northwest corner of site
