The Head Of The River
Folly Bridge
St Aldates
Oxford
OX1 4LB

Safety Survey

Prepared for Fuller's

July 2023

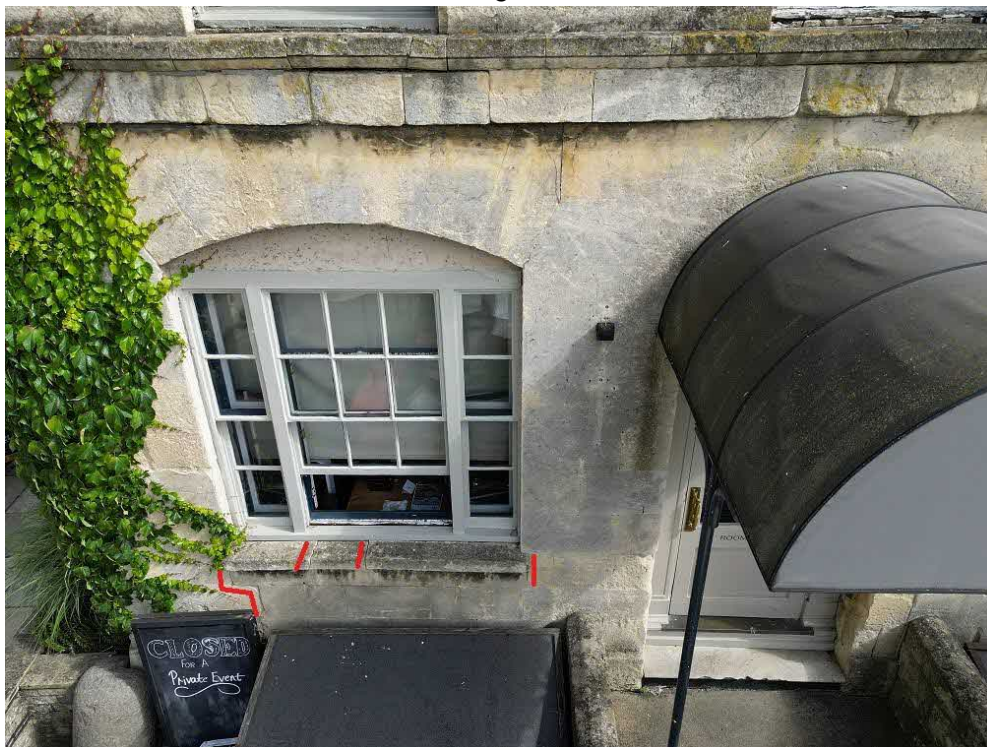
5

Open joints

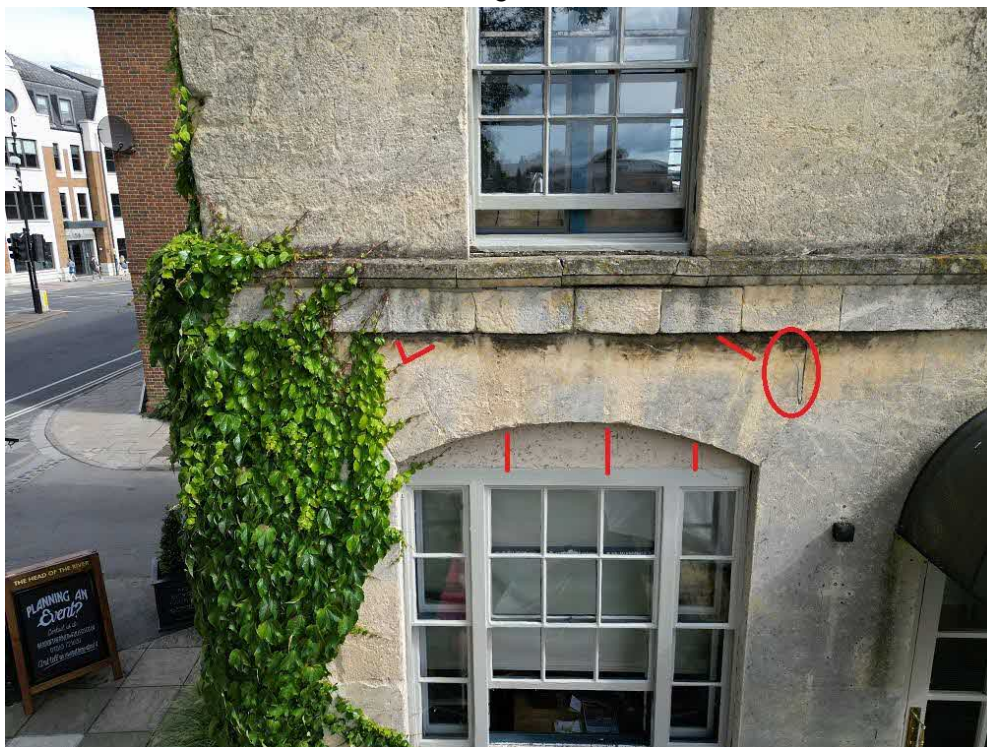
5

Open joints

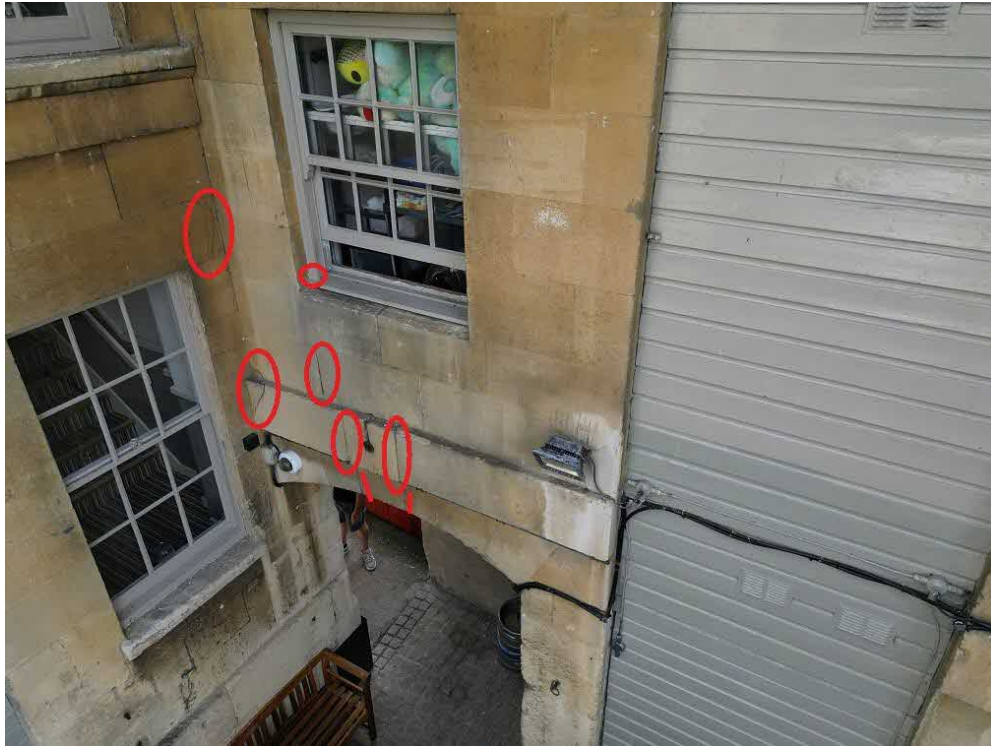
19

Open joints

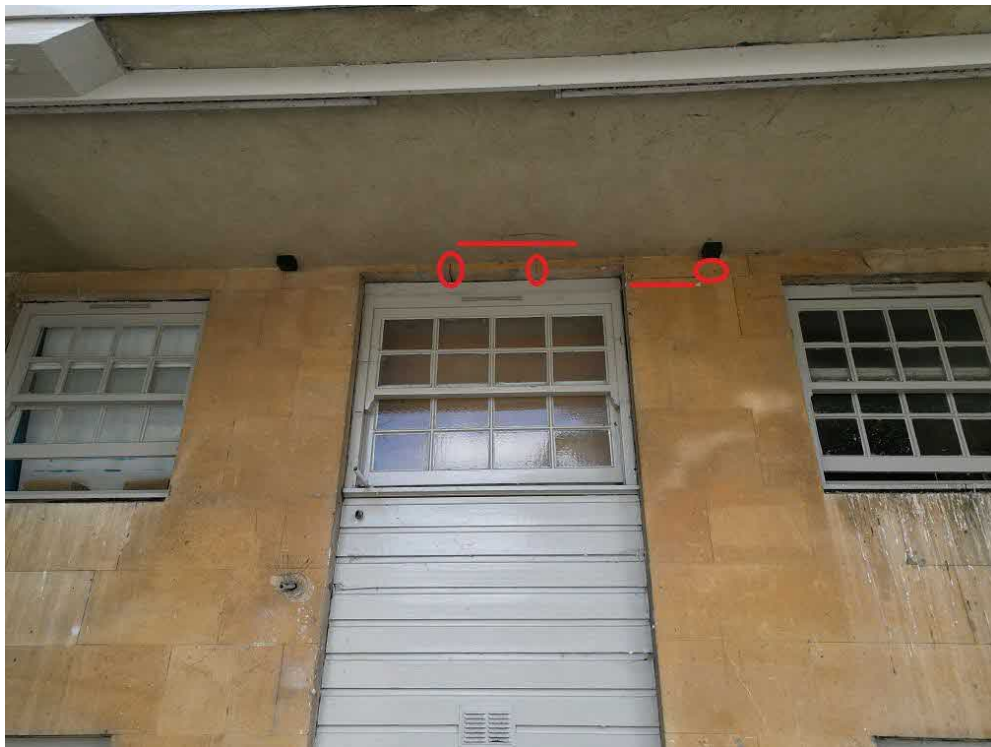
20

Open joints

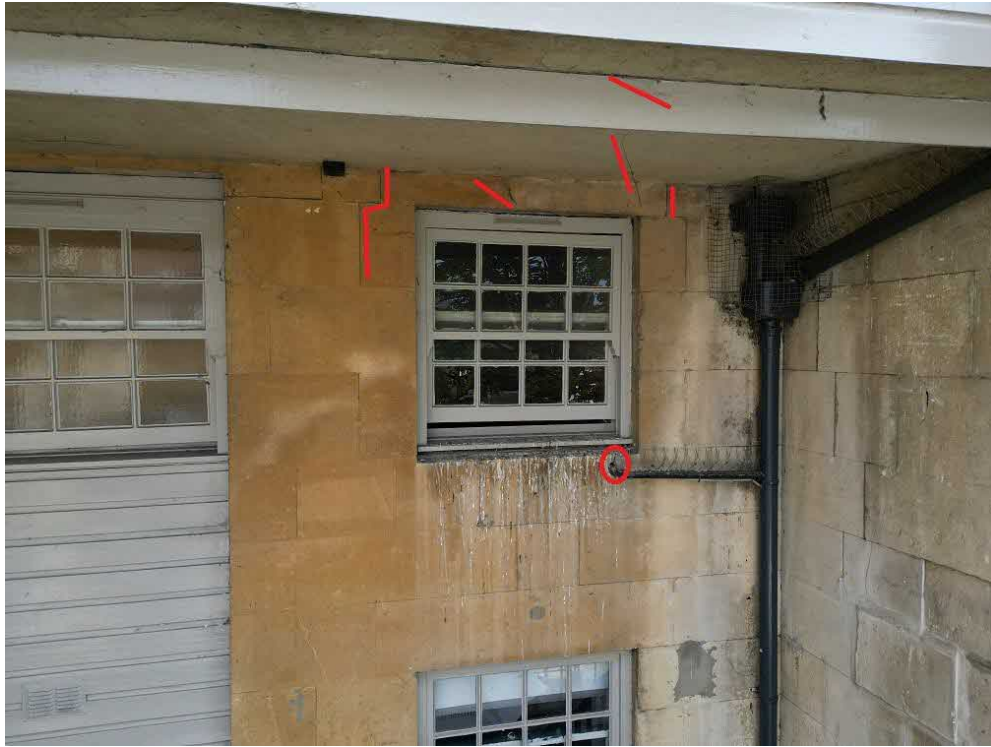
21

Open joints

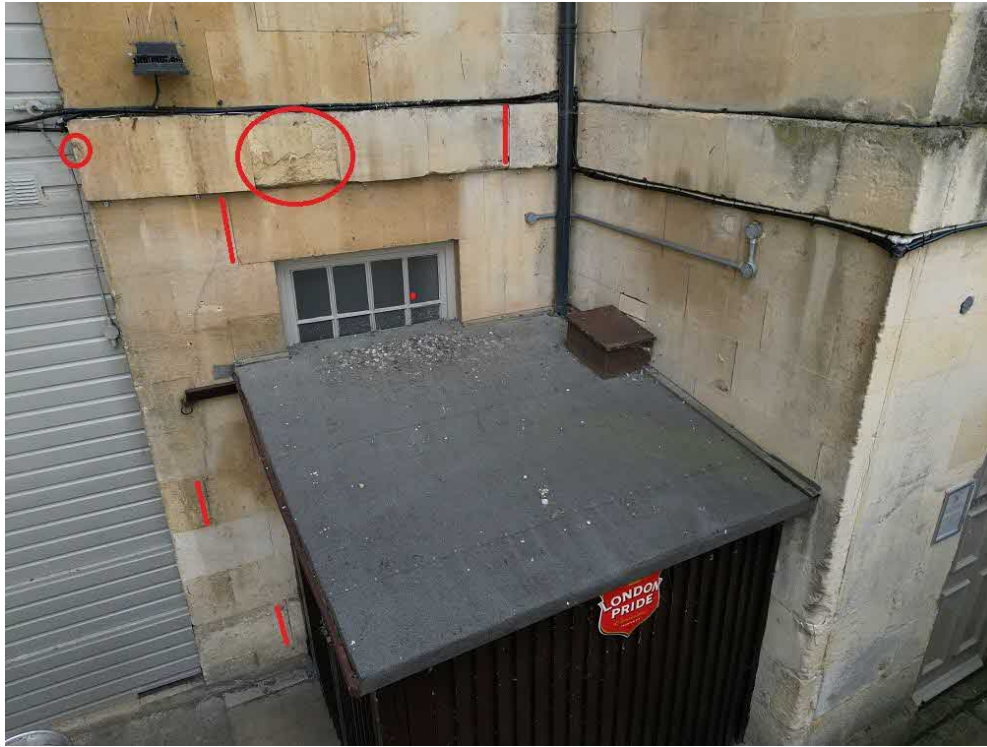
23

Open joints and friable stonework

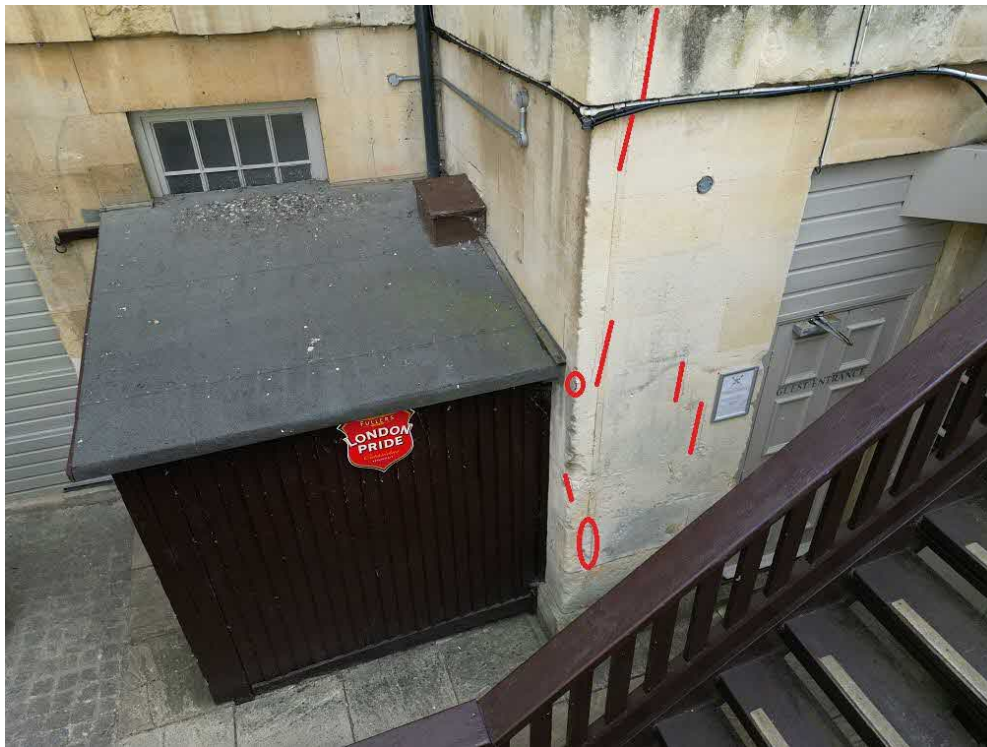
26

Open joints

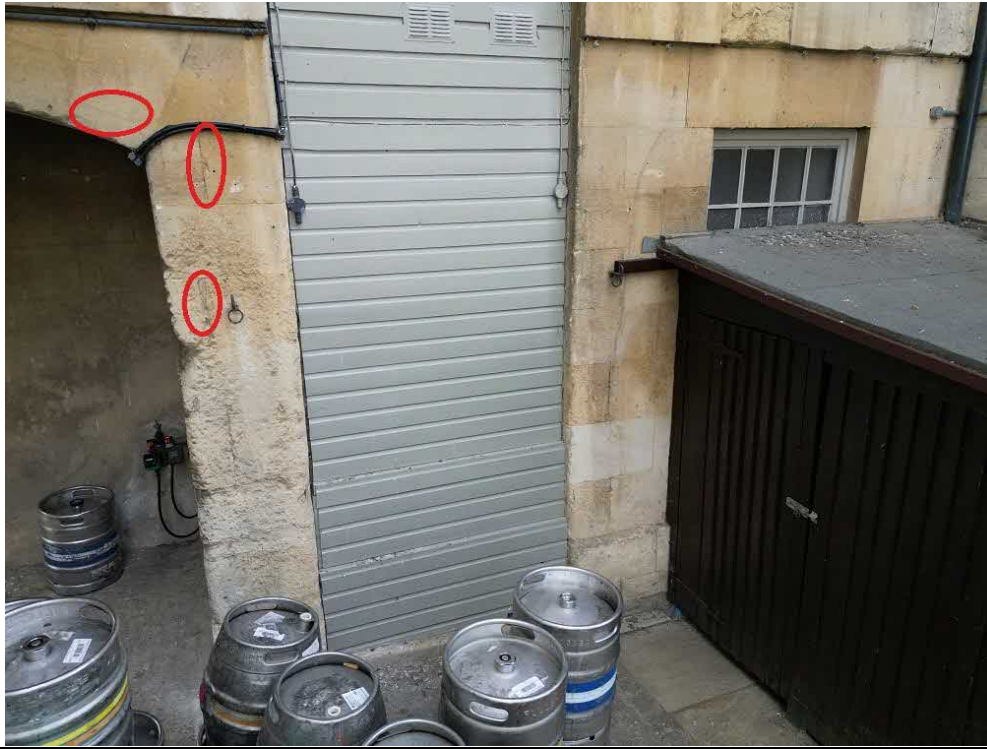
26

Open joints

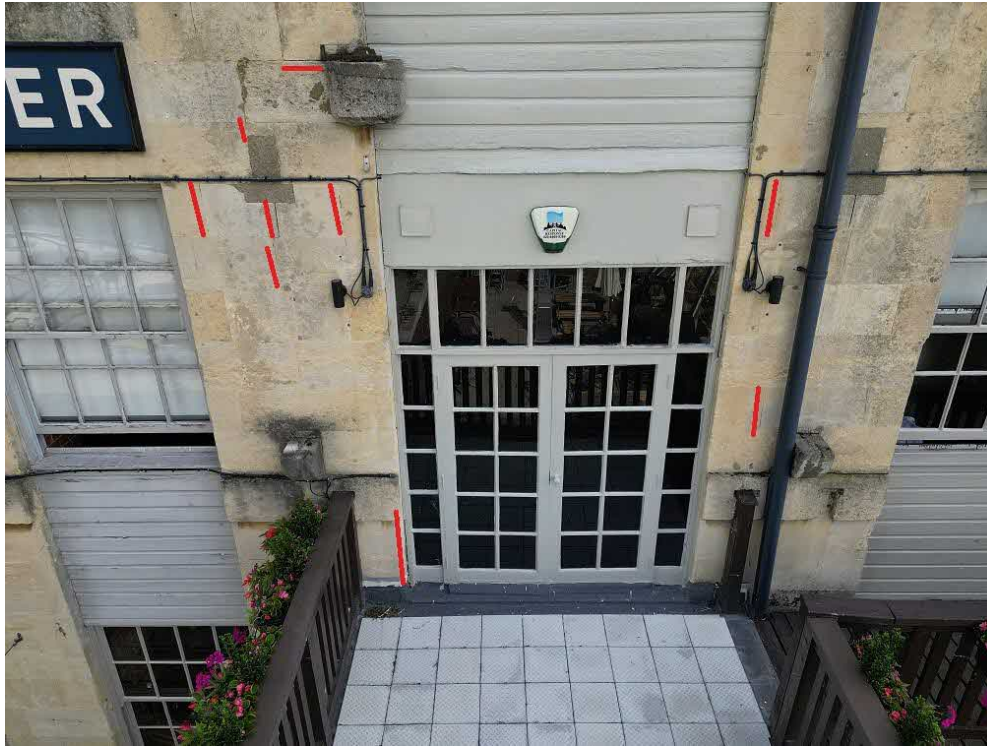
42

Open joints

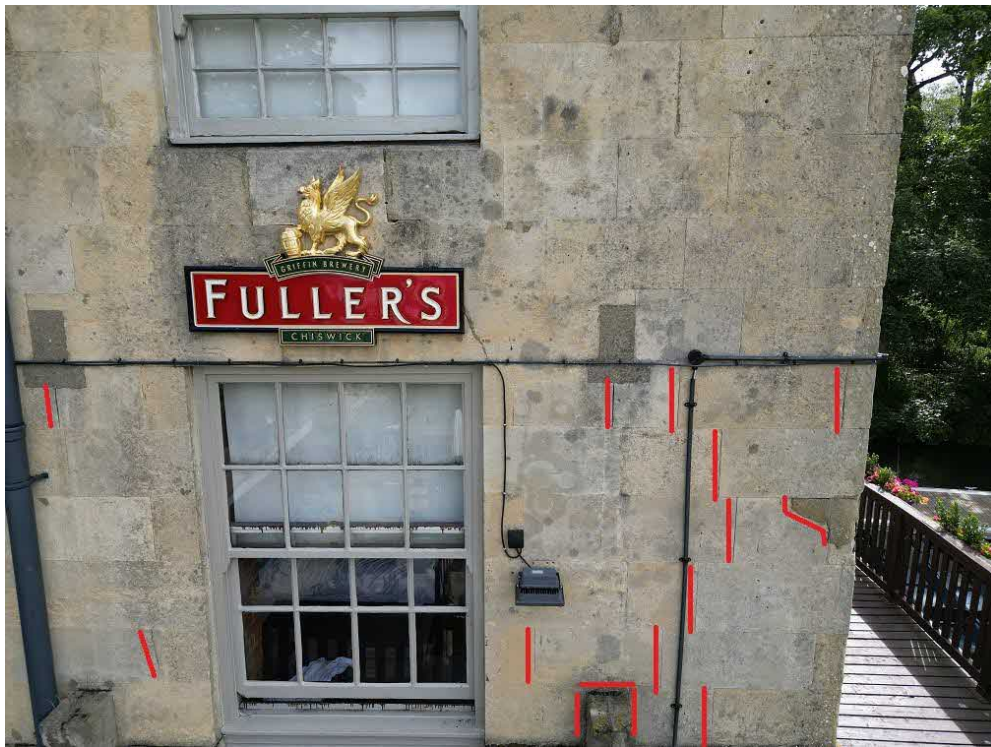
45

Open joints

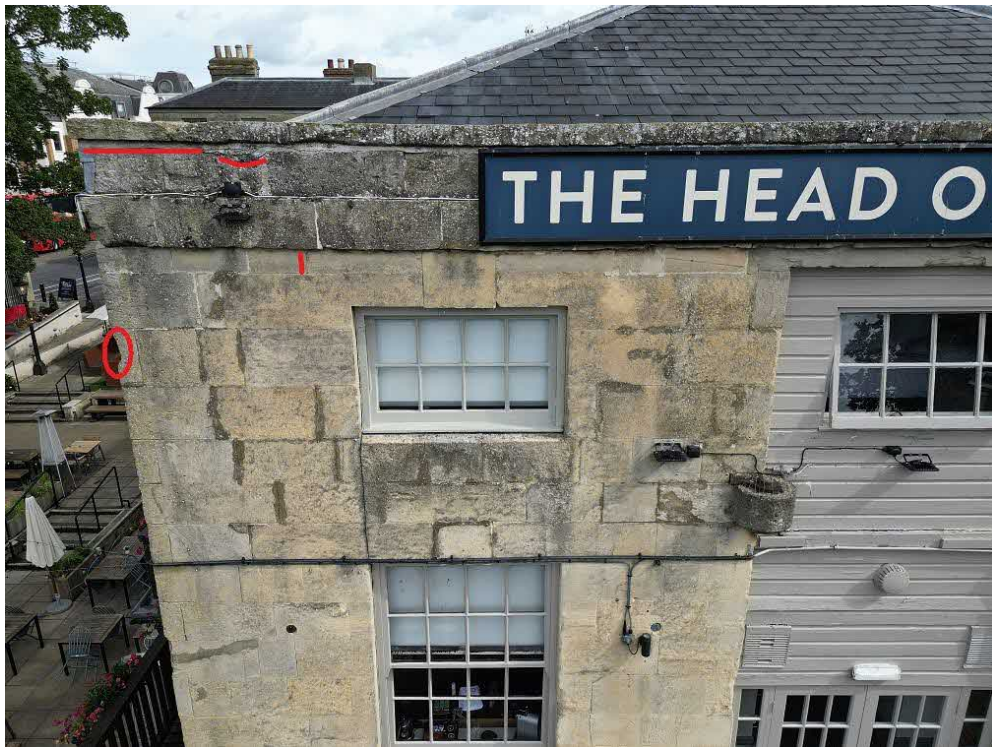
48

Open joints and
indent to
corner

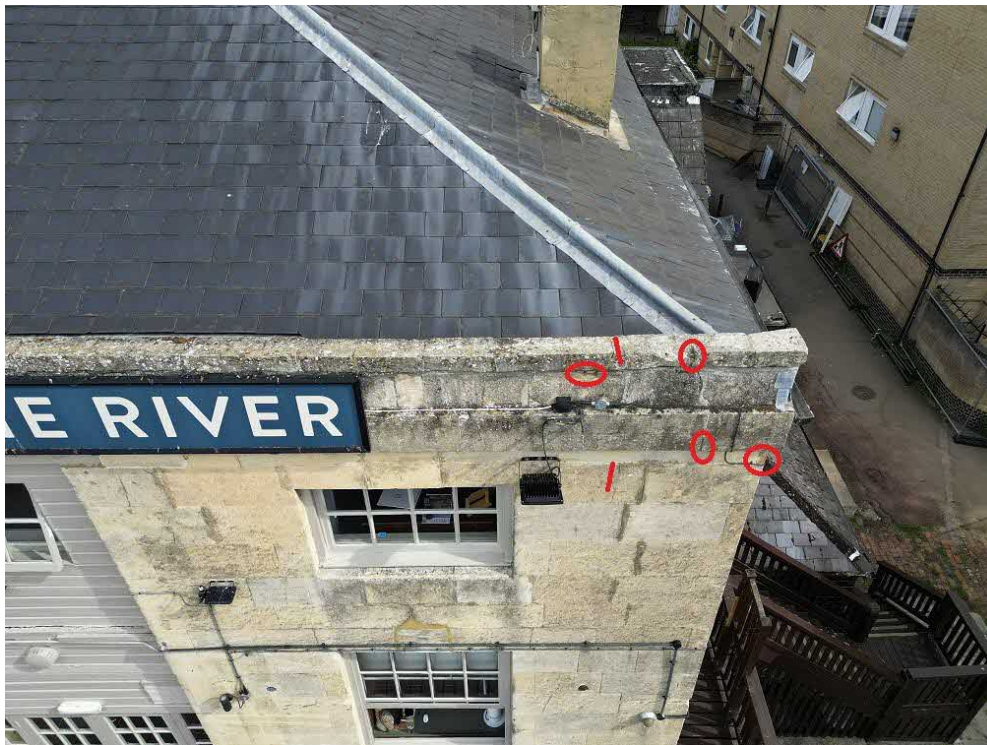
54

Open joints

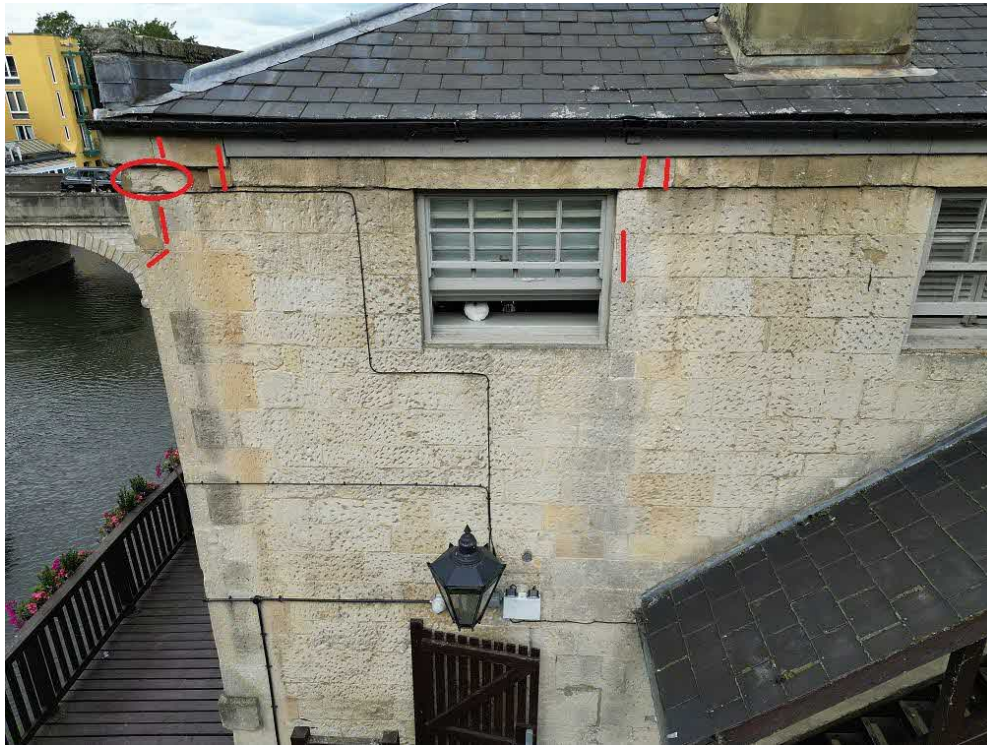
1

Open joints

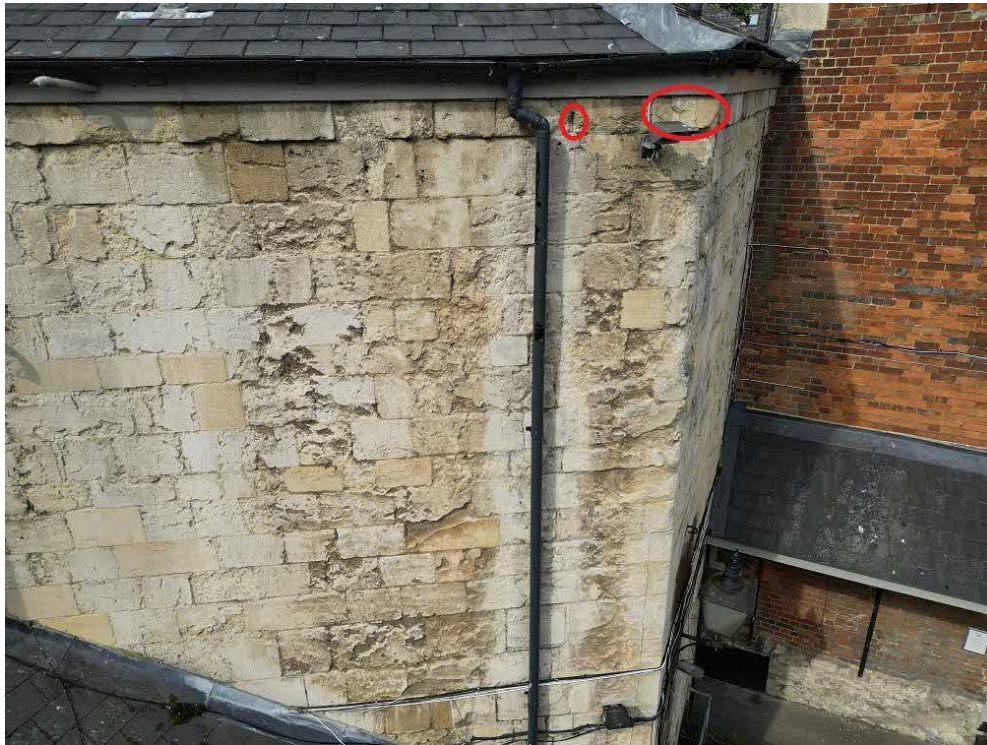
0

Open joints

Friable stonework generally
