Appendix F – Existing Building CCTV Drainage Survey

Project Name: 67C Camlet Way, Barnet, EN4 0NL
Project Description: Pre-build
Project Date: 02/11/2022

Survey Comments & Recommendations

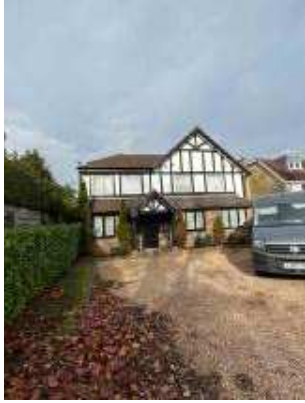
Front of property

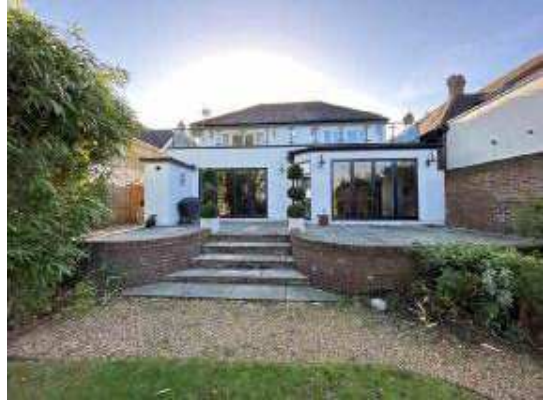
Back of property,

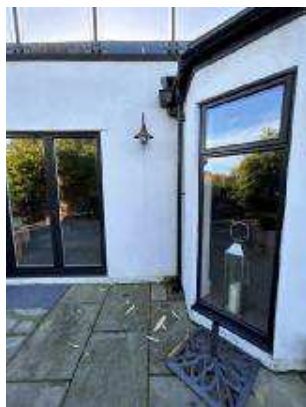
RWG1 unknown discharge

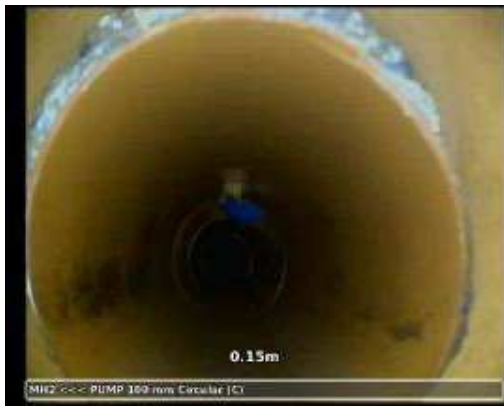
20221102-090846-snap0001.jpg, 00:00:11, 0.15 m
Material changes to polyvinyl chloride, 110

Town or Village:	Barnet	Inspection Direction:	Upstream	Upstream Node:	PUMP
Road:	67C Camlet Way	Inspected Length:	4.14 m	Upstream Pipe Depth:	0.000 m
Location:	Other (state in comments)	Total Length:	4.14 m	Downstream Node:	MH2
Surface Type:		Joint Length:		Downstream Pipe Depth:	0.550 m
Use:	Combined	Pipe Shape:	Circular		
Type of Pipe:	Gravity drain/sewer	Dia/Height:	100 mm		
Flow Control:	No flow control	Pipe Material:	Vitrified clay pipe (i.e. all clayware)		
Year Constructed:	Not Specified	Lining Type:	No Lining		
Inspection Purpose:	Sample survey to determine asset condition	Lining Material:	No Lining		
Comments:	Pump station discharges to MH2 - Large displacement and redundant connection noted.				
Recommendations:	Install 1m x 100mm Silicate Patch Liner

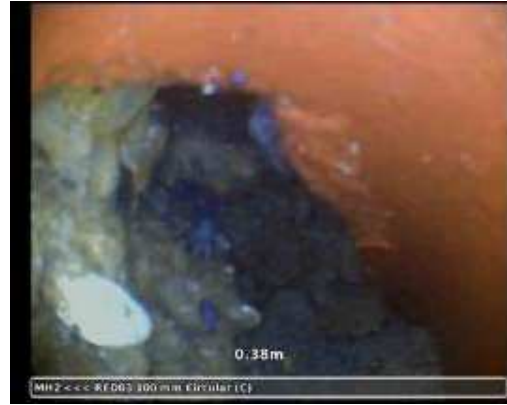
20221102-091424-snap0001.jpg, 00:00:09, 0.38 m
 Finish node, major connection without manhole, reference: RED03

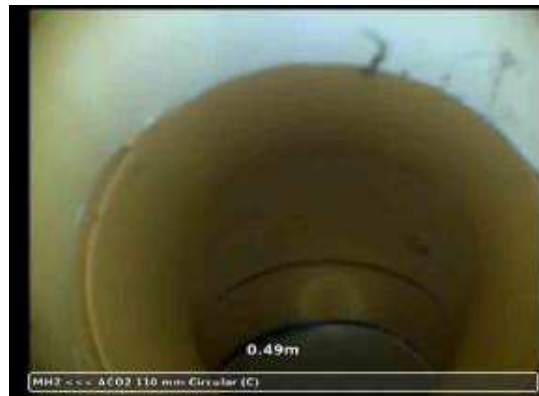
ACO2X_7dc139ce-aeb6-4b22-838a-7008bf17a777_20221103_102550_845.jpg, 00:00:10, 0.49 m
 Line deviates down

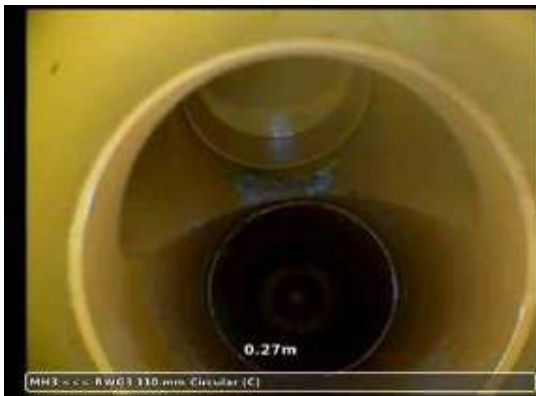
RWG3X_cf47935a-85fd-4da2-a48d-ed589d96b3f2_20221103_103426_234.jpg, 00:00:06, 0,27 m
 Junction at 12 o'clock, diameter: 110mm, Capped

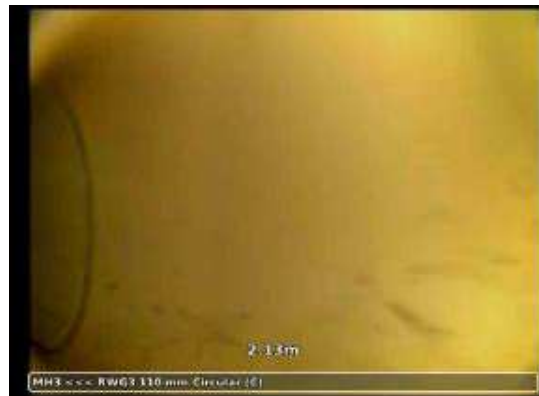
RWG3X_5cb0c9bf-0b0f-48bd-9de4-727545d8e9e1_20221103_103442_854.jpg, 00:00:13, 2,13 m
 Line deviates left
