FAIRFIELD ROAD, DROYLSDEN

SITE COMPLETION REPORT

Job: Number: LKC 20 1761
Date: 1st December 2023
Client: J Greenwood (Builders) Ltd

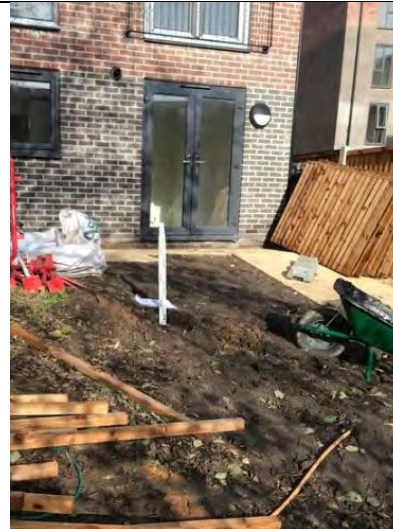
Photograph 4: View of rear (N) garden in Plot 37.

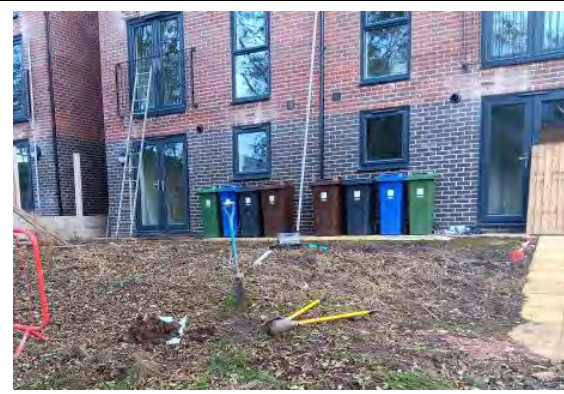
Photograph 7: View of rear (S) garden in Plot 37.

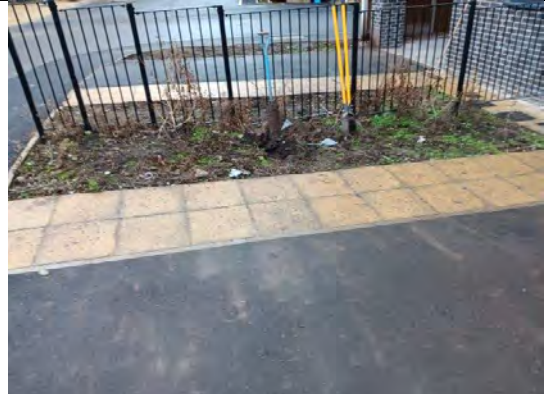
Photograph 10: View of front garden in Plot 38.

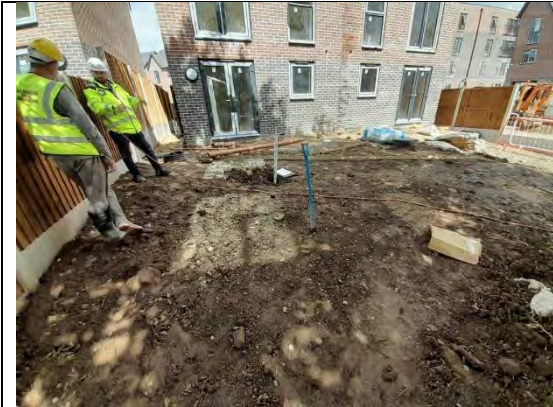
Photograph 13: View of rear (N) garden in Plot 38.

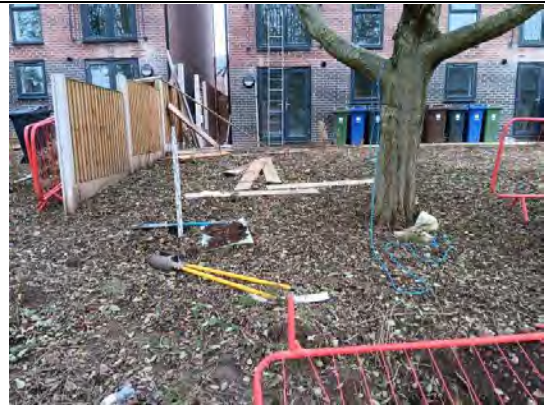
Photograph 16: View of rear (S) garden in Plot 38.

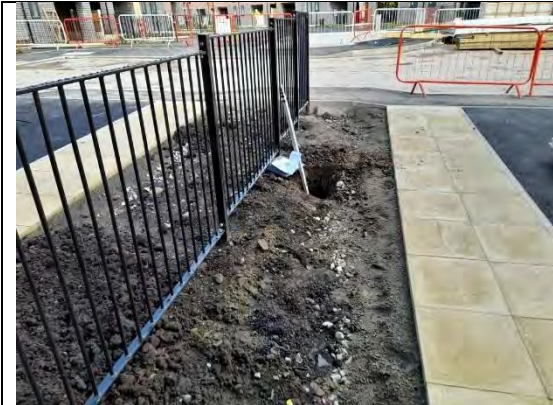
Photograph 19: View of front garden in Plot 39.

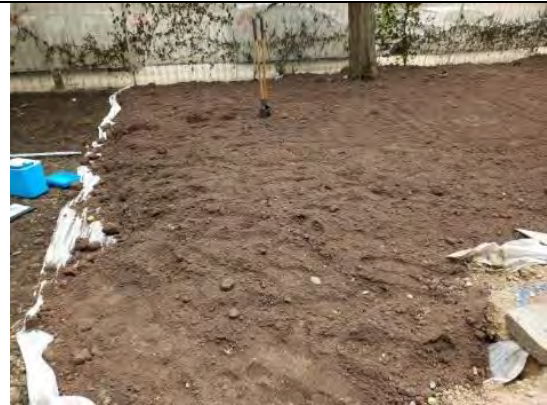
Photograph 22: View of rear (S) garden in Plot 39.

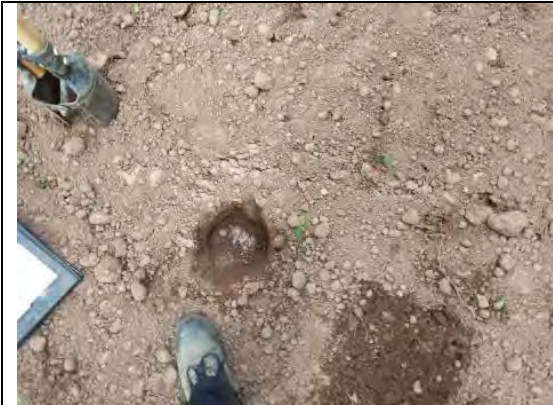
Photograph 25: View of rear (N) garden in Plot 39.

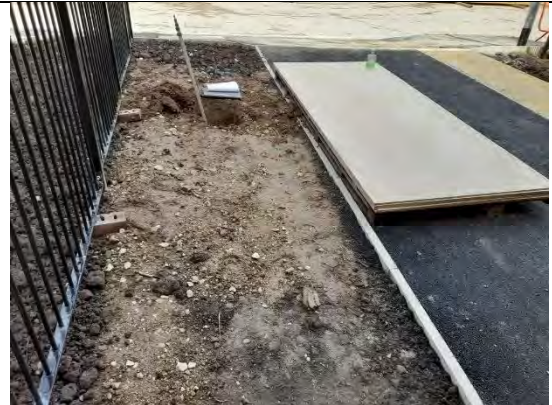
Photograph 28: View of front garden in Plot 40.

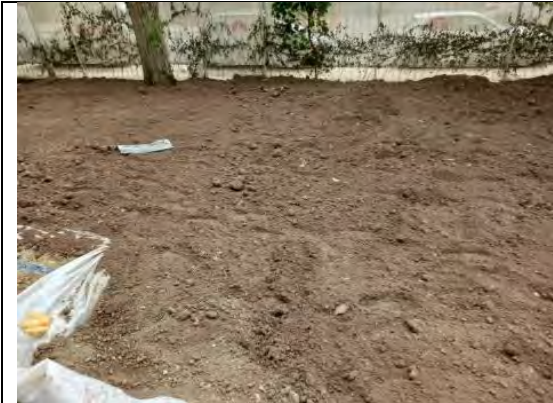
Photograph 31: View of rear (N) garden in Plot 40.

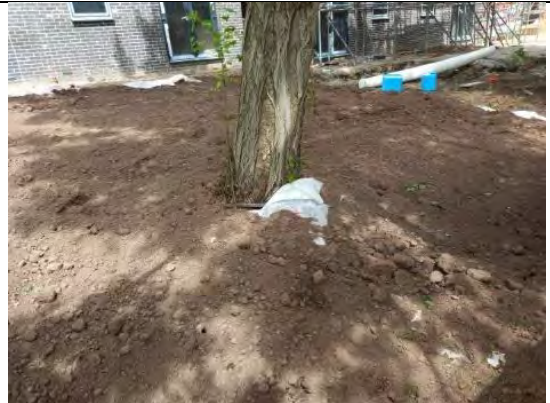
Photograph 34: View of rear (S) garden in Plot 40.

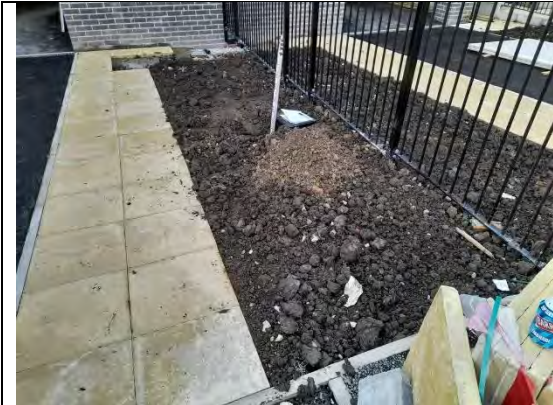
Photograph 37: View of front garden in Plot 41.

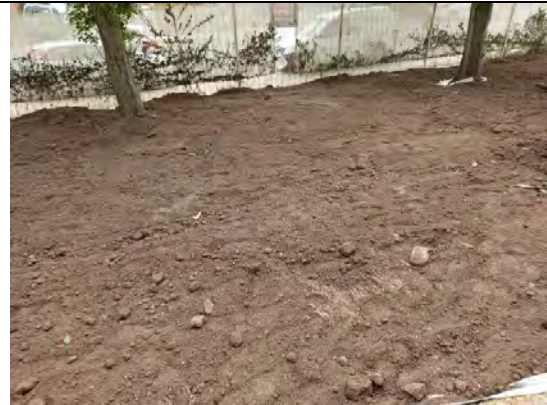
Photograph 40: View of rear (N) garden in Plot 41.

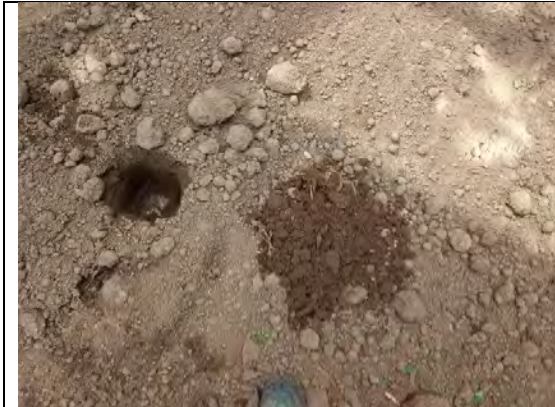
Photograph 42: View of soil within cover system and geotextile at base in rear (N) of Plot 41.

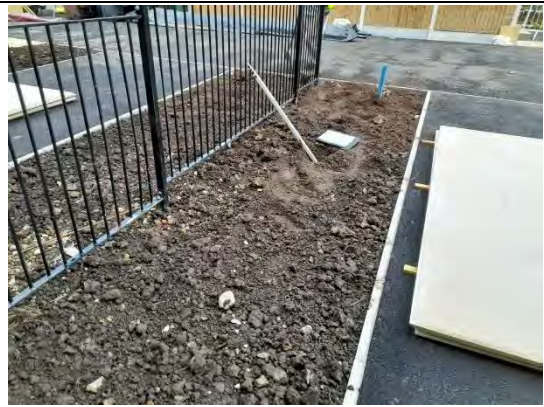
Photograph 43: View of rear (S) garden in Plot 41.

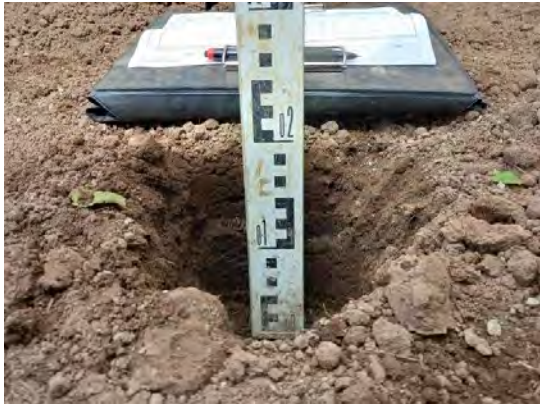
Photograph 46: View of front garden in Plot 42.

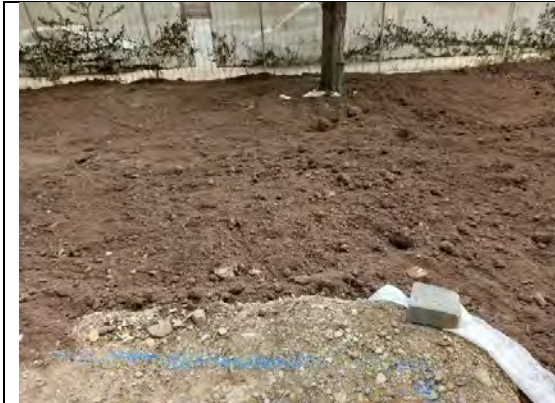
Photograph 48: View of soil within cover system and geotextile at base in front of Plot 42.

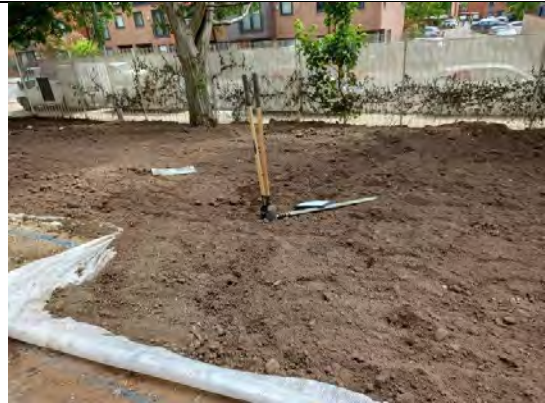
Photograph 49: View of rear (N) garden in Plot 42.

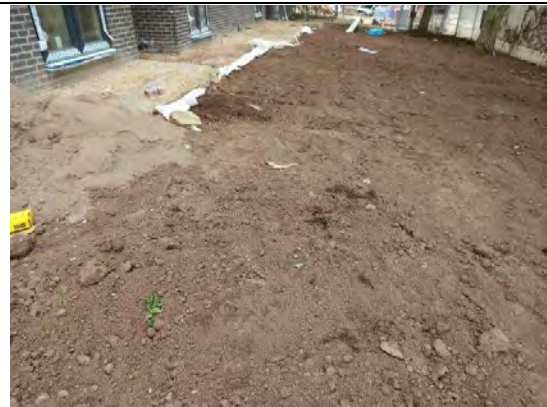
Photograph 55: View of front garden in Plot 43.

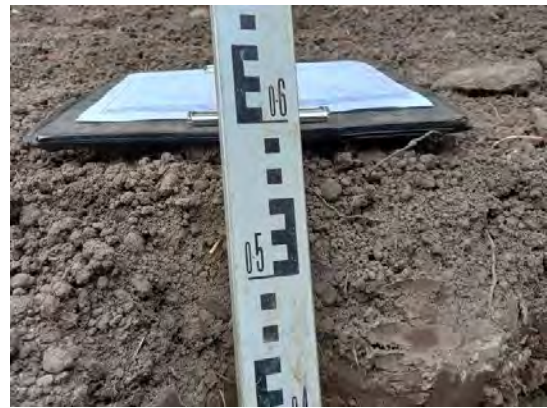
Photograph 56: View of depth of soil within the front garden of Plot 43.

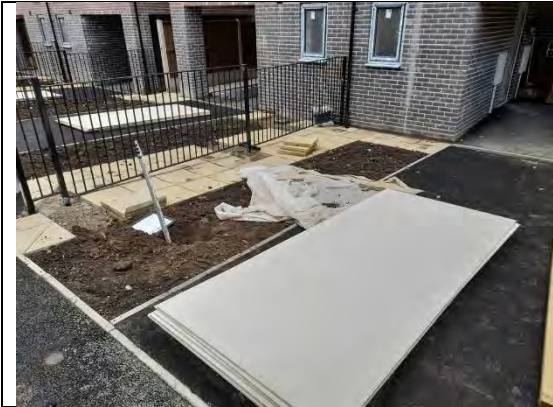
Photograph 60: View of soil within cover system and geotextile at base in rear of Plot 43.

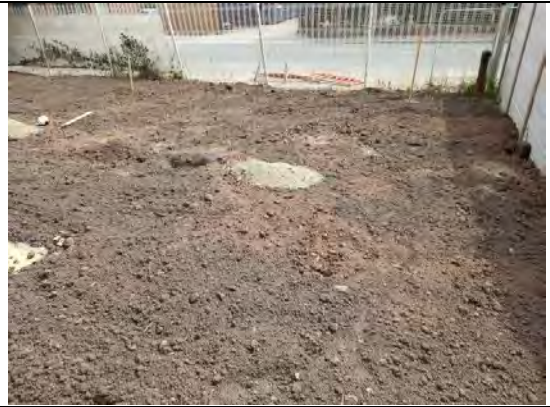
Photograph 61: View of front garden in Plot 44.

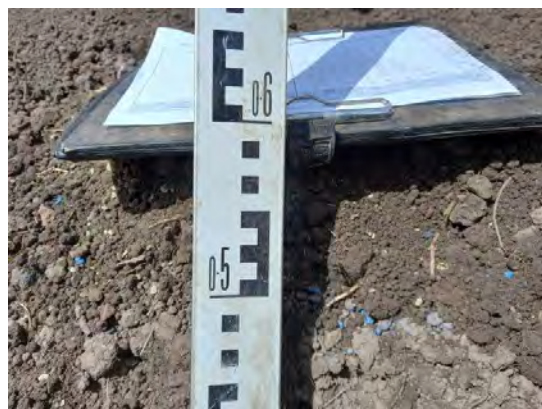
Photograph 62: View of depth of soil within the front garden of Plot 44.

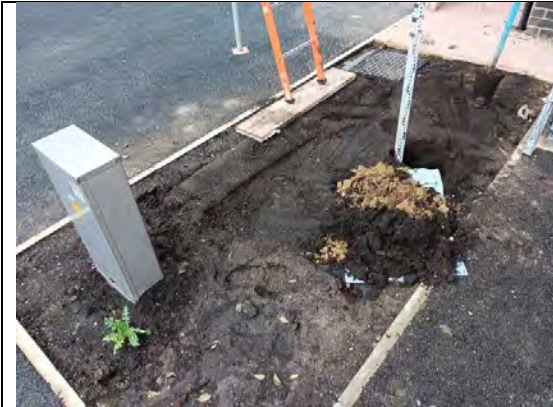
Photograph 66: View of soil within cover system and geotextile at base in rear of Plot 44.

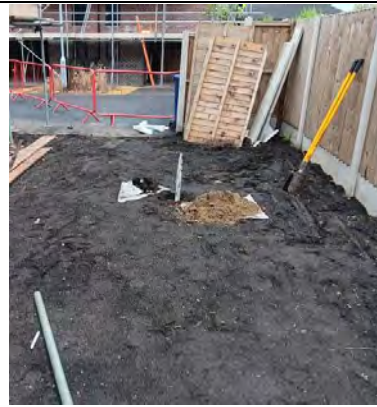
Photograph 67: View of front garden in Plot 45.

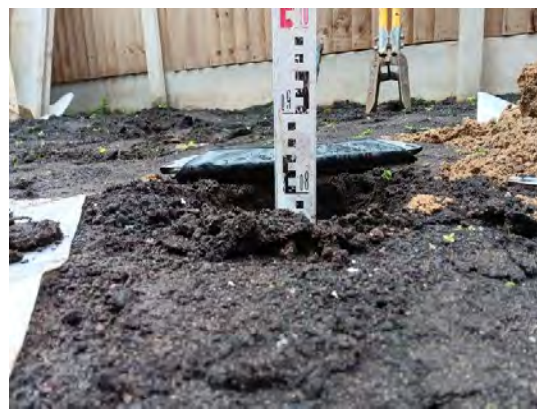
Photograph 68: View of depth of soil within the front garden of Plot 45.

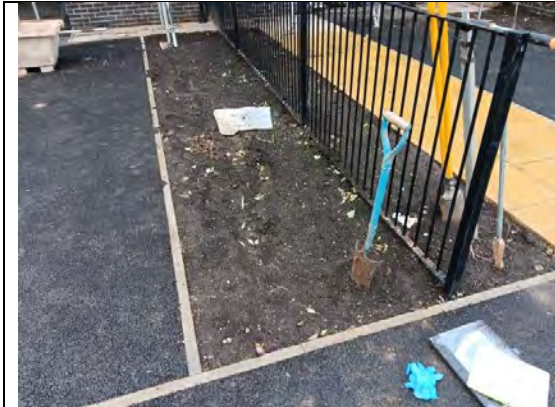
Photograph 72: View of soil within cover system and geotextile at base in rear of Plot 45.

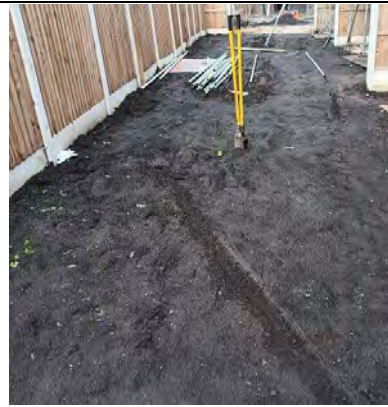
Photograph 73: View of front garden in Plot 46.

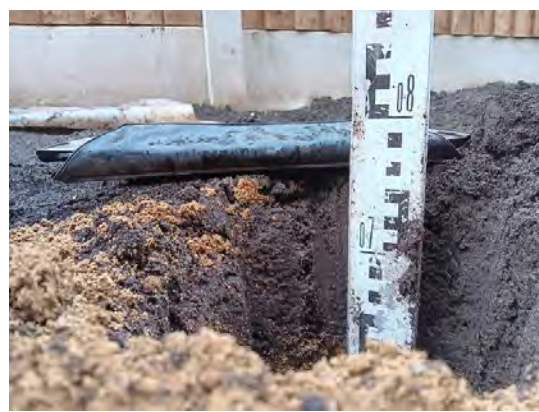
Photograph 74: View of depth of soil within the front garden of Plot 46.

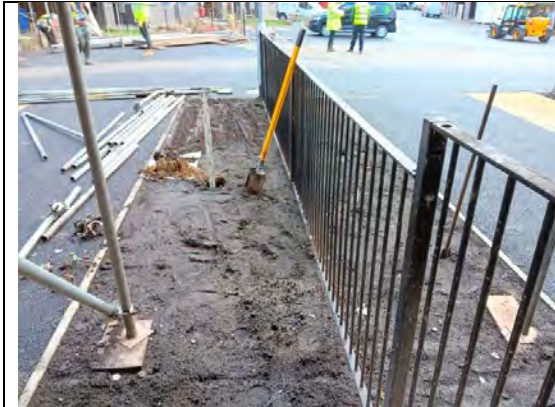
Photograph 78: View of soil within cover system and geotextile at base in rear of Plot 46.

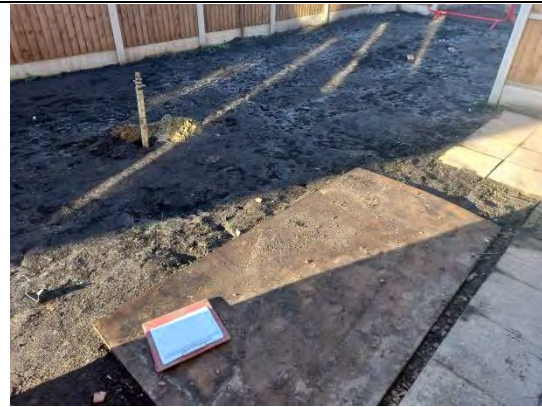
Photograph 79: View of front garden in Plot 47.

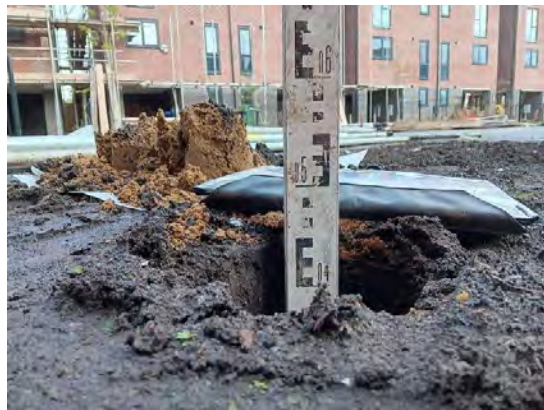
Photograph 80: View of depth of soil within the front garden of Plot 47.

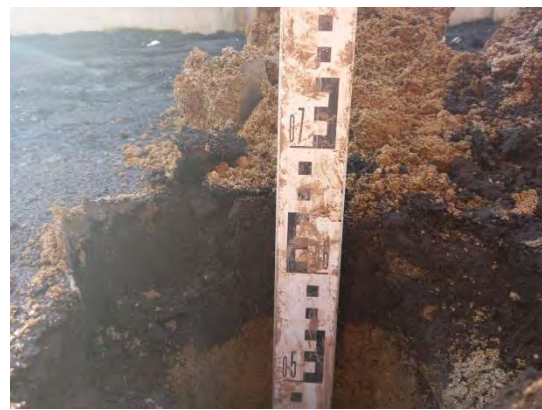
Photograph 83: View of depth of soil within the rear garden of Plot 47.

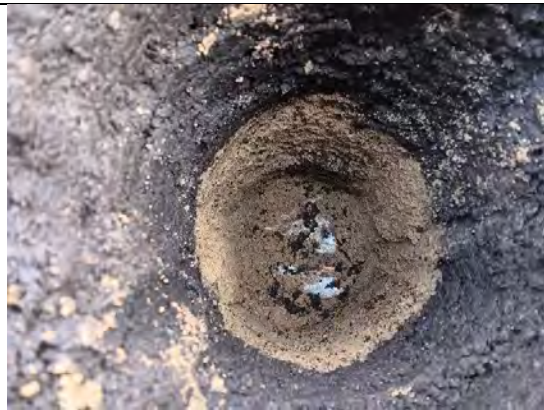
Photograph 81: View of soil within cover system and geotextile at base in front of Plot 47.

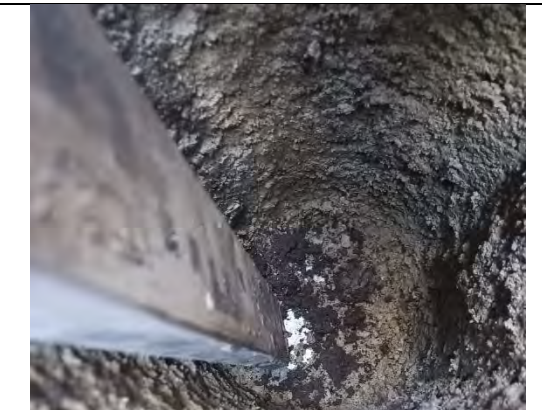
Photograph 84: View of soil within cover system and geotextile at base in rear of Plot 47.

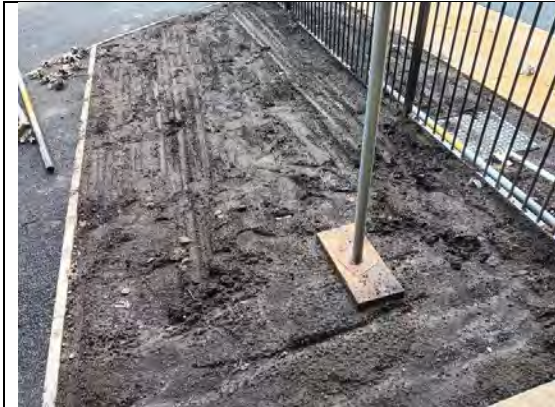
Photograph 85: View of front garden in Plot 48.

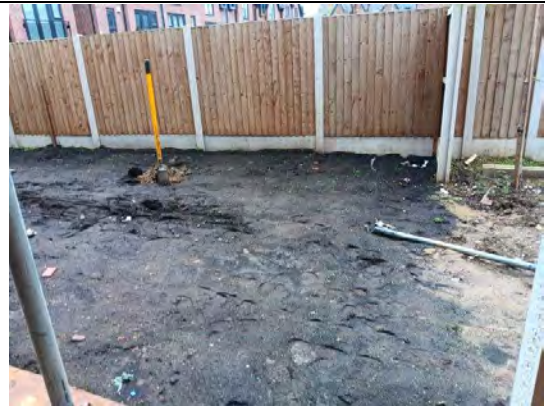
Photograph 88: View of rear garden in Plot 48.

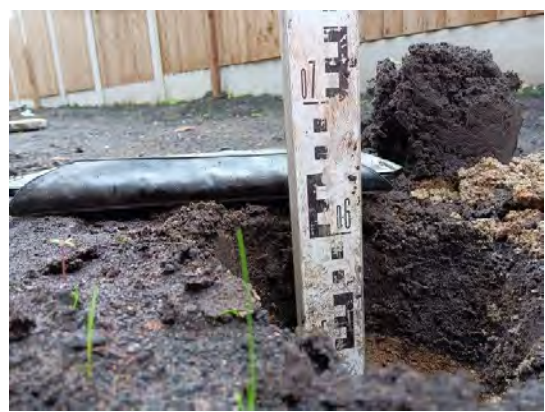
Photograph 89: View of depth of soil within the rear garden of Plot 48.

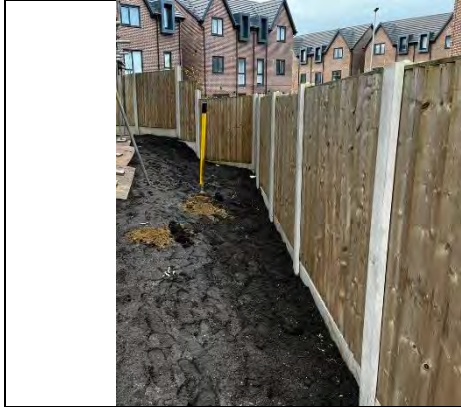
Photograph 91: View of side garden in Plot 49.

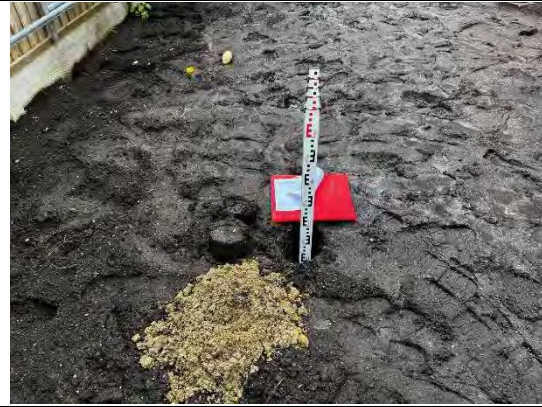
Photograph 94: View of rear garden in Plot 49.

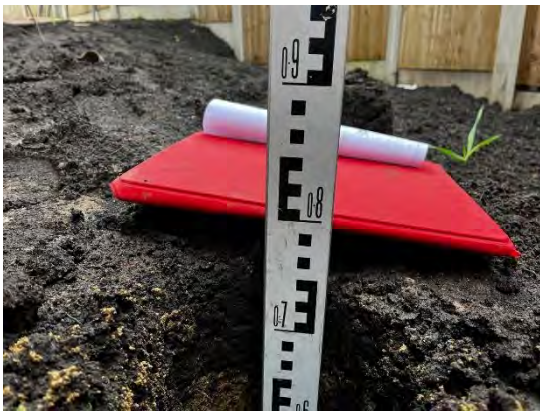
Photograph 92: View of depth of soil within the side garden of Plot 49.

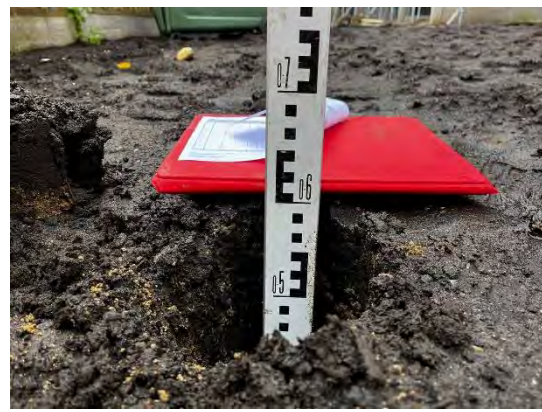
Photograph 95: View of depth of soil within the rear garden of Plot 49.

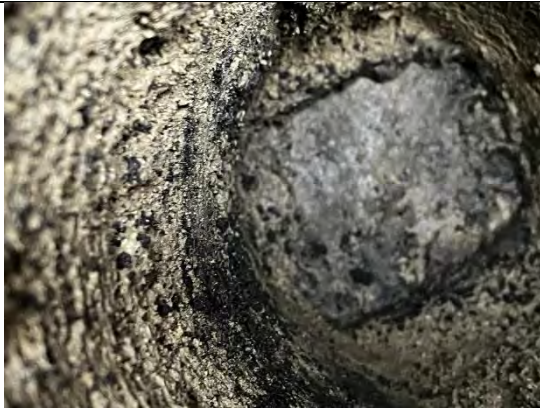
Photograph 93: View of soil within cover system and geotextile at base in side of Plot 49.

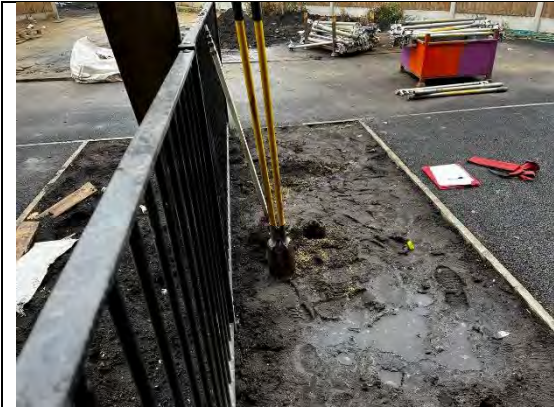
Photograph 97: View of front garden in Plot 50.

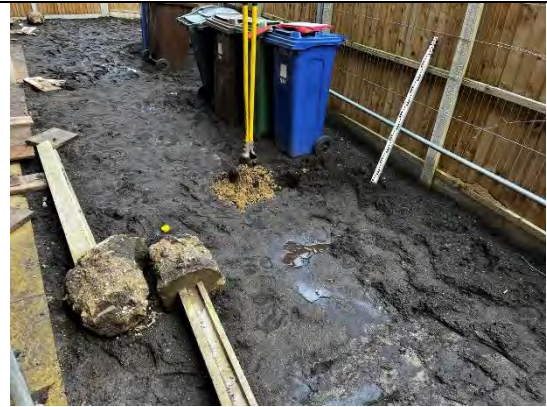
Photograph 100: View of rear garden in Plot 50.

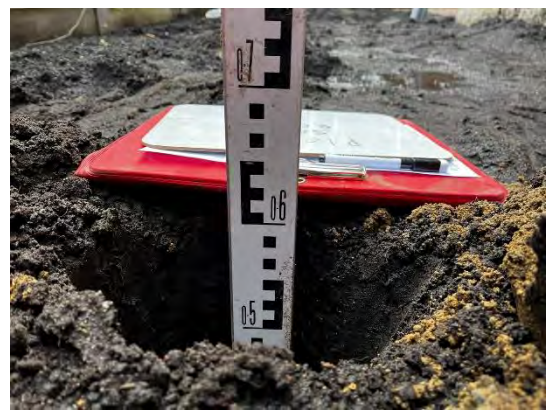
Photograph 101: View of depth of soil within the rear garden of Plot 50.

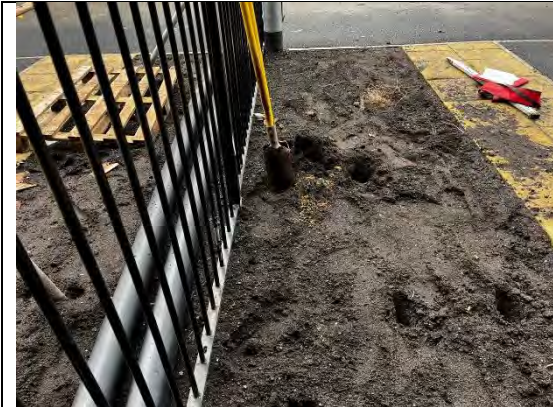
Photograph 103: View of front garden in Plot 51.

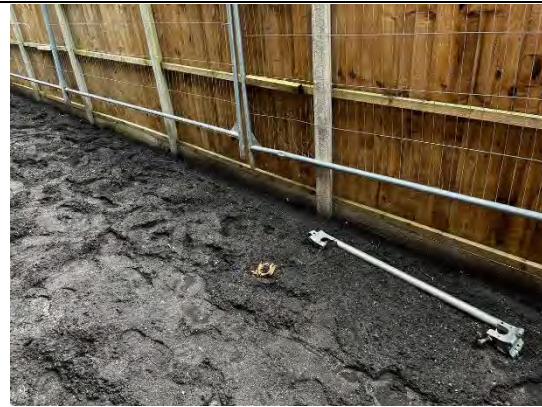
Photograph 106: View of rear garden in Plot 51.

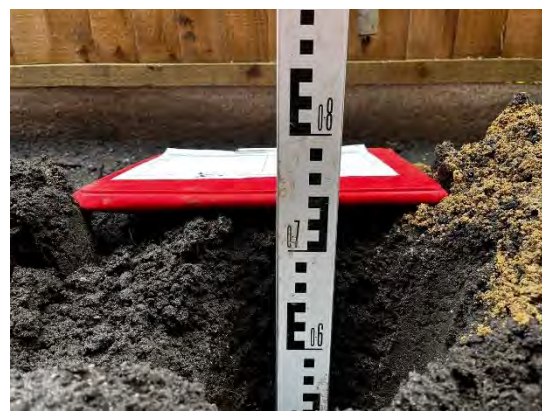
Photograph 107: View of depth of soil within the rear garden of Plot 51.

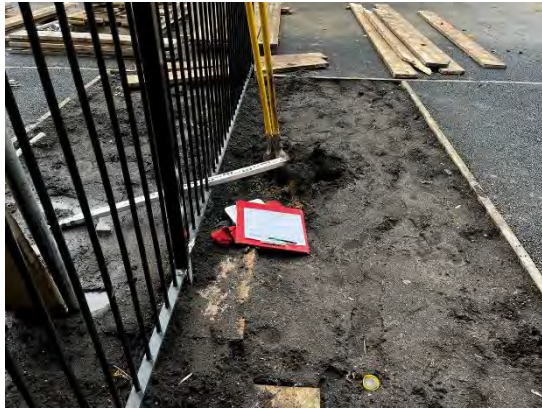
Photograph 109: View of front garden in Plot 52.

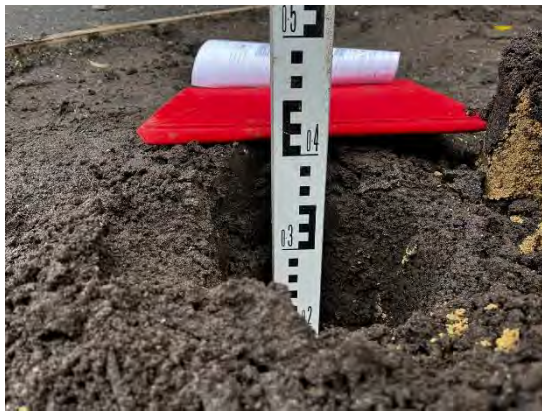
Photograph 110: View of depth of soil within the front garden of Plot 52.

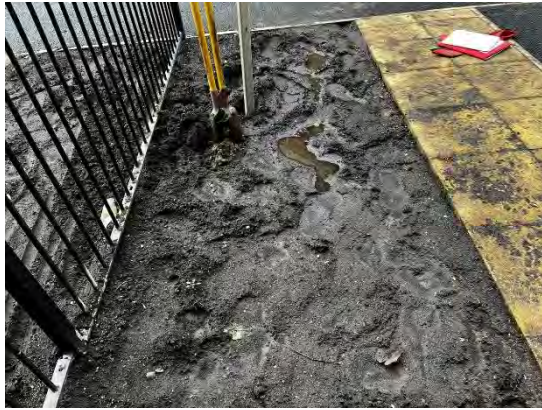
Photograph 113: View of front garden in Plot 53.

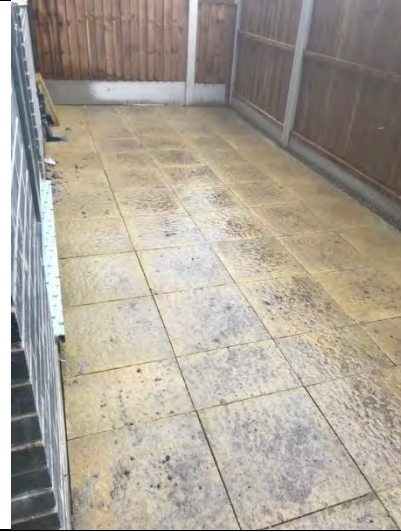
Photograph 116: View of rear garden in Plot 53.

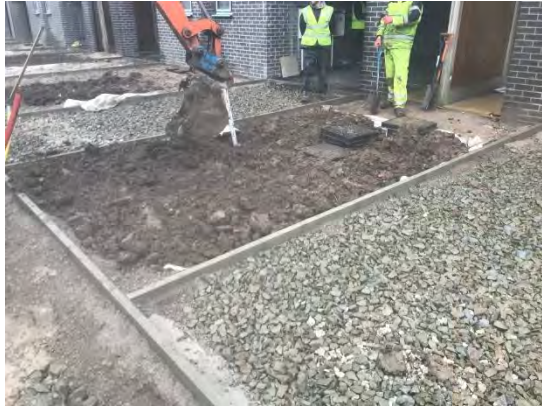
Photograph 118: View of shared front garden in Plots 54/55.

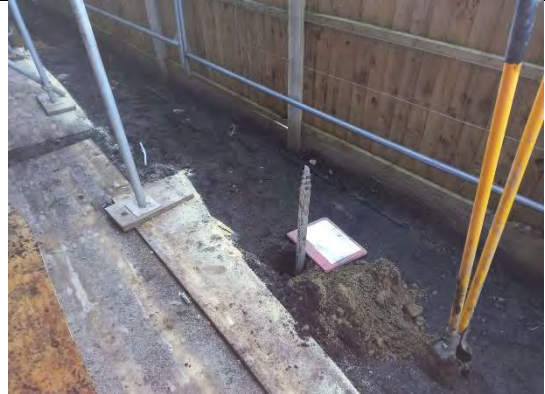
Photograph 125: View of rear garden in Plot 55.

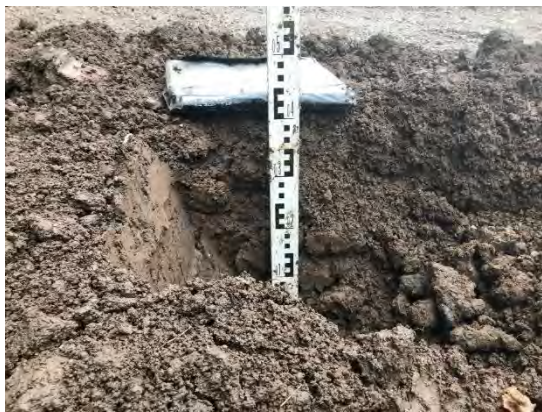
Photograph 123: View of depth of soil within the front gardens of Plot 55/56.

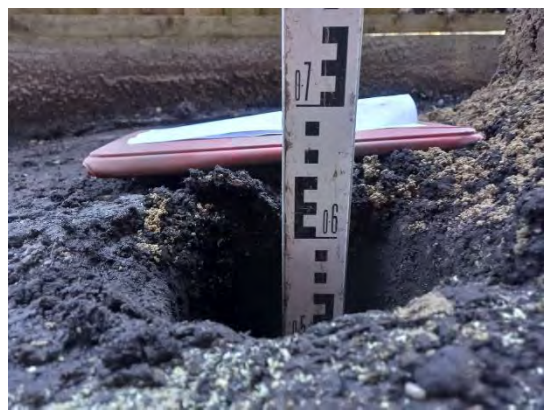
Photograph 126: View of depth of soil within the rear garden of Plot 55.

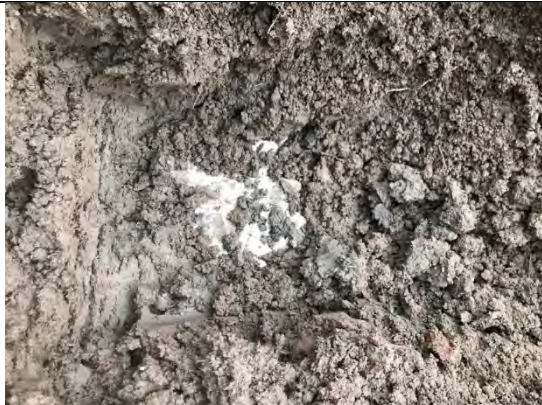
Photograph 124: View of soil within cover system and geotextile at base in front of Plots 55/56.

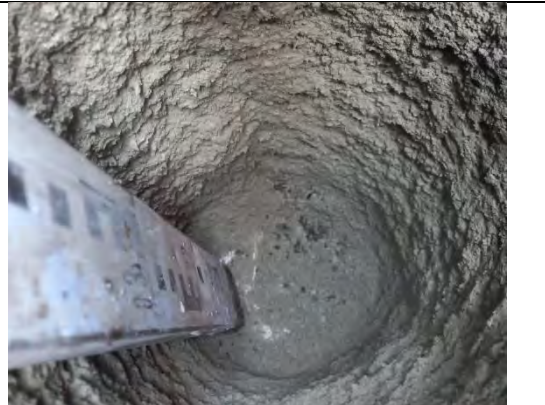
Photograph 127: View of soil within cover system and geotextile at base in rear of Plot 55.

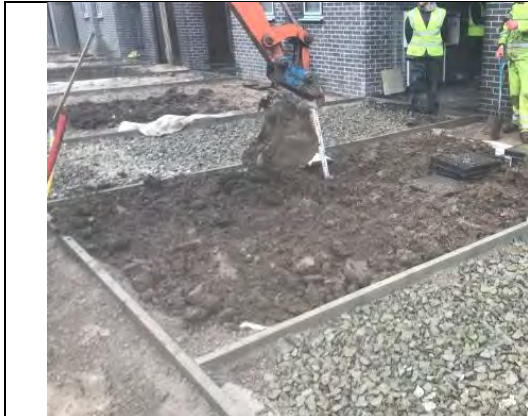
Photograph 128: View of shared front garden in Plots 56/57.

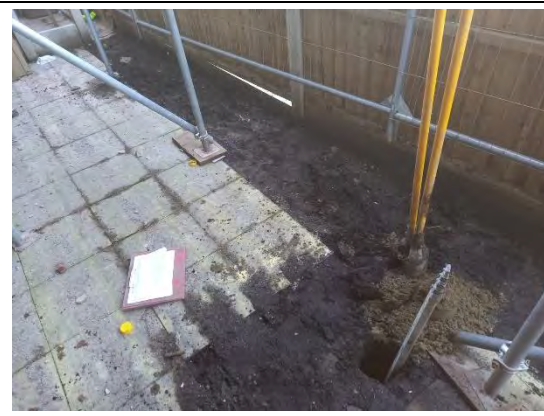
Photograph 131: View of rear garden in Plot 56.

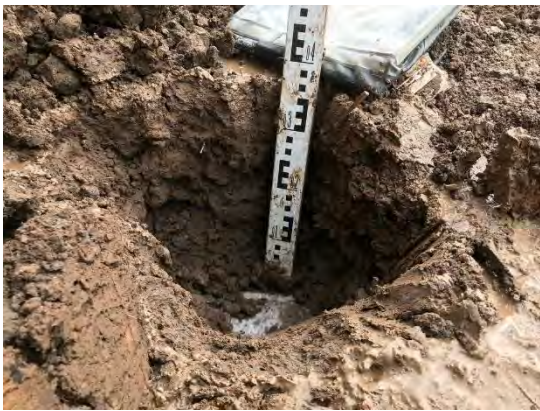
Photograph 129: View of depth of soil within the front garden of Plots 56/57.

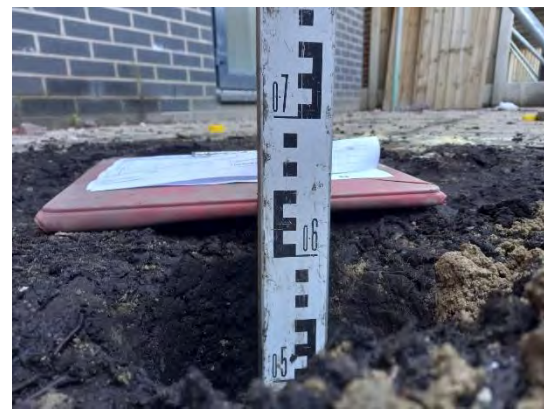
Photograph 132: View of depth of soil within the rear garden of Plot 56.

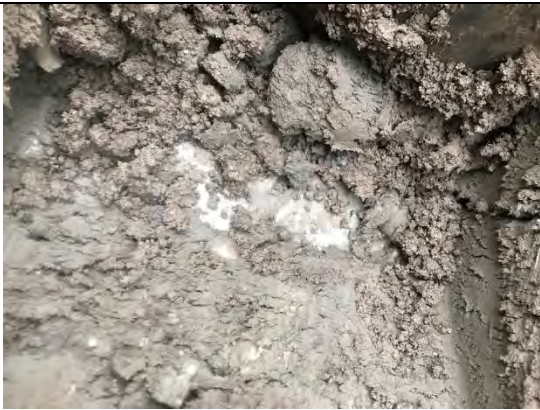
Photograph 130: View of soil within cover system and geotextile at base in front of Plots 56/57.

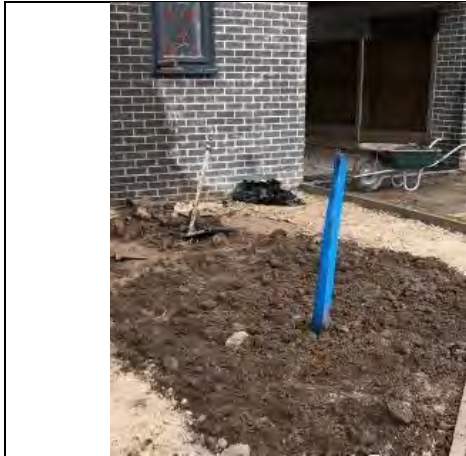
Photograph 134: View of shared front garden in Plots 57/58.

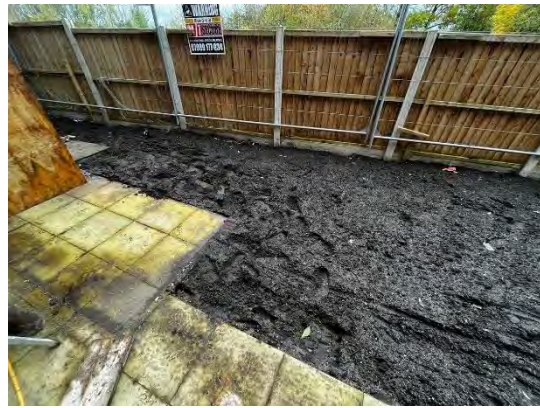
Photograph 137: View of rear garden in Plot 57.

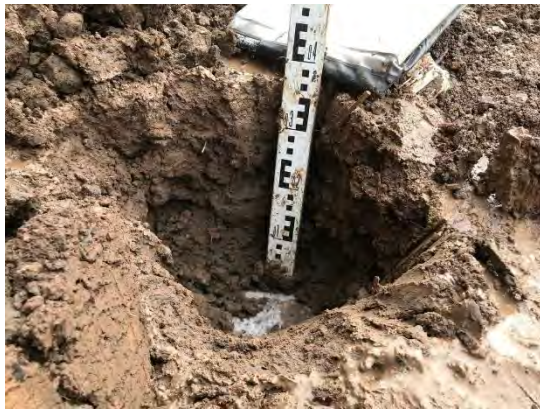
Photograph 135: View of depth of soil within the front garden of Plots 57/58.

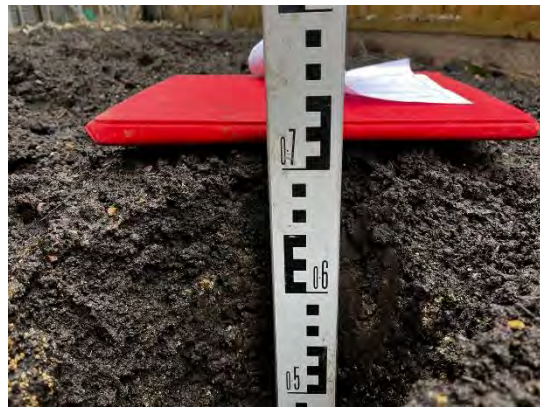
Photograph 138: View of depth of soil within the rear garden of Plot 57.

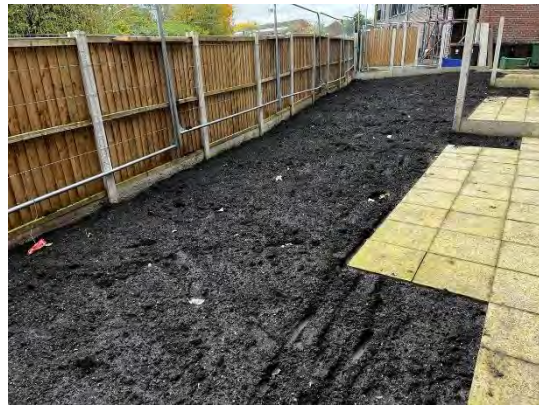
Photograph 143: View of rear garden in Plot 58.

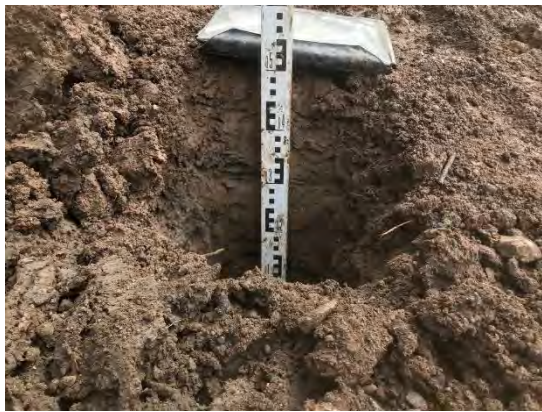
Photograph 141: View of depth of soil within the front garden of Plots 58/59.

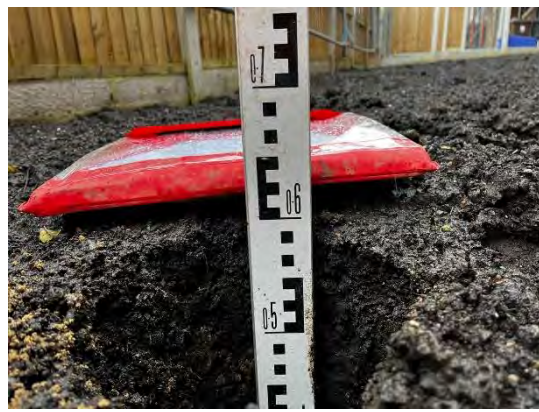
Photograph 144: View of depth of soil within the rear garden of Plot 58.

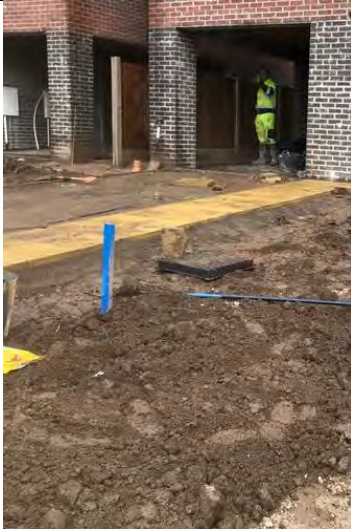
Photograph 146: View of shared front garden in Plots 59/60.

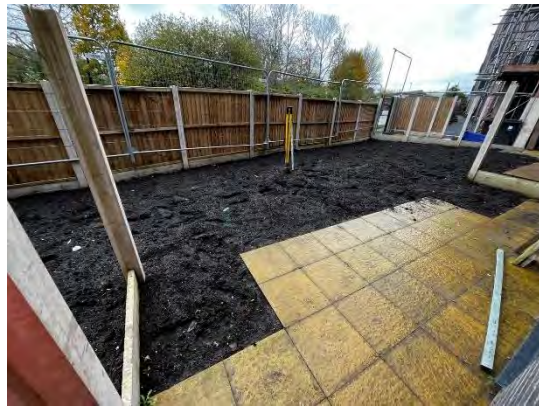
Photograph 149: View of rear garden in Plot 59.

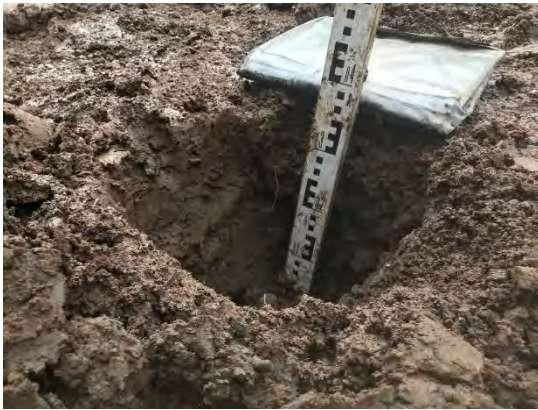
Photograph 147: View of depth of soil within the front garden of Plots 59/60.

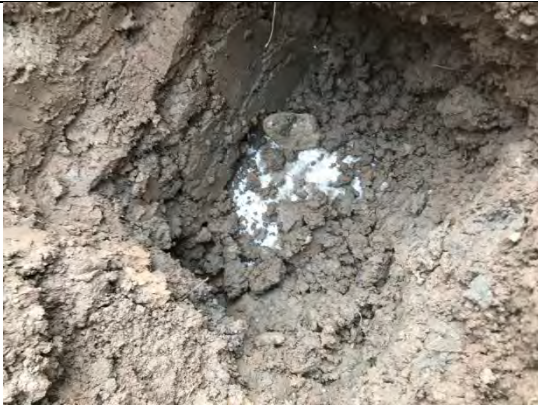
Photograph 148: View of soil within cover system and geotextile at base in front of Plots 59/60.

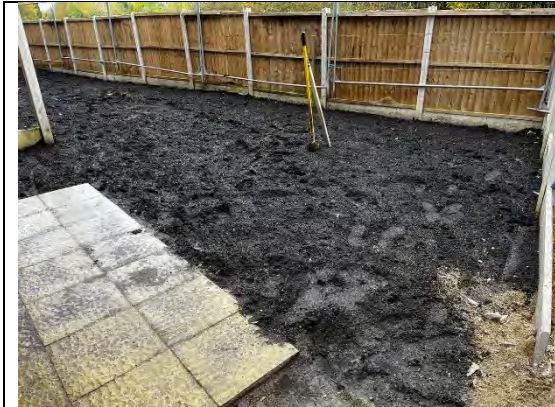
Photograph 152: View of rear garden in Plot 60.

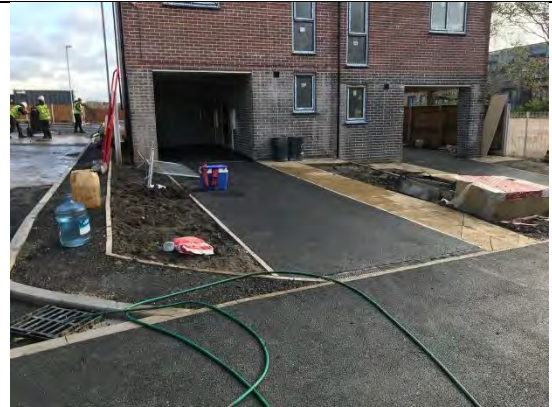
Photograph 155: View of front garden in Plot 61.

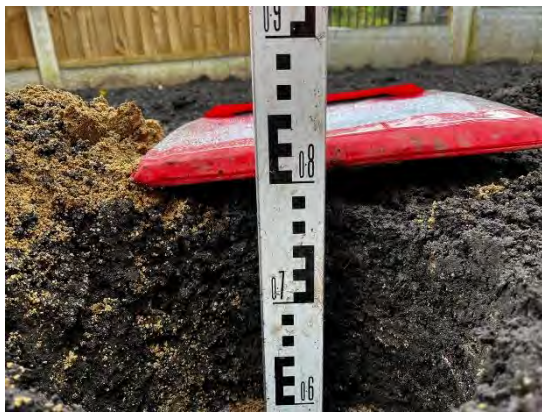
Photograph 153: View of depth of soil within the rear garden of Plot 60.

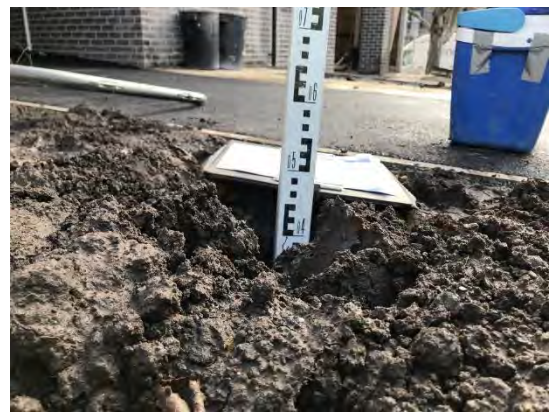
Photograph 156: View of depth of soil within the front garden of Plot 61.

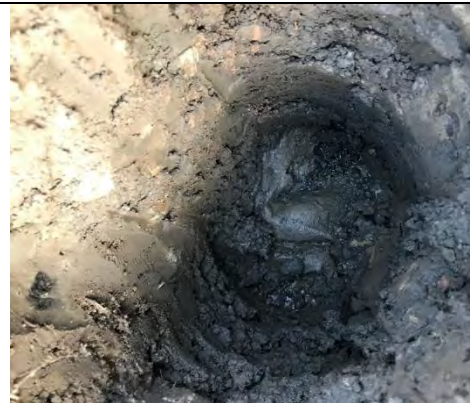
Photograph 157: View of soil within cover system and geotextile at base in front of Plot 61.

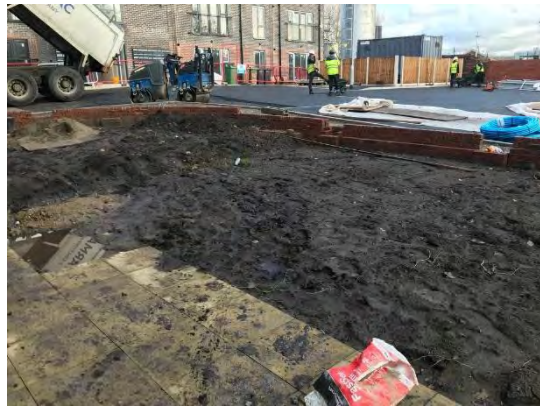
Photograph 158: View of rear garden in Plot 61.

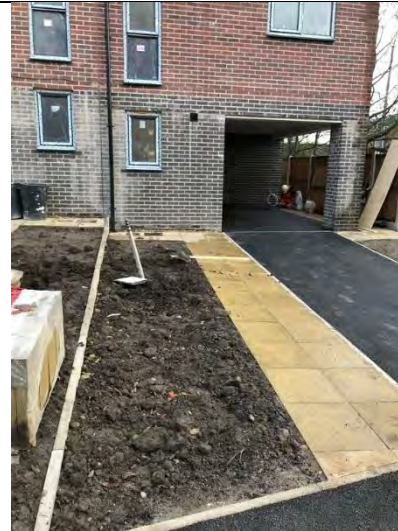
Photograph 161: View of front garden in Plot 62.

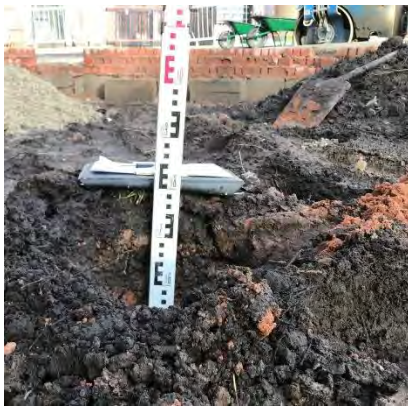
Photograph 159: View of depth of soil within the rear garden of Plot 61

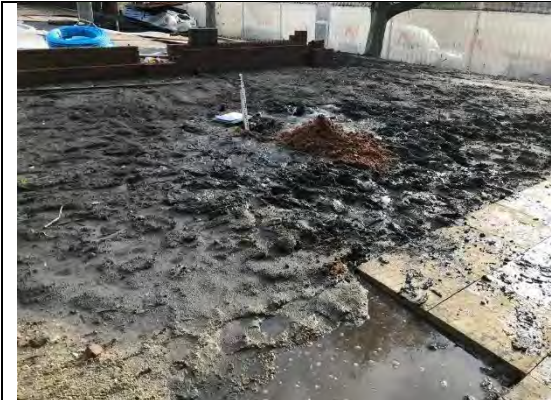
Photograph 164: View of rear garden (N) in Plot 62.

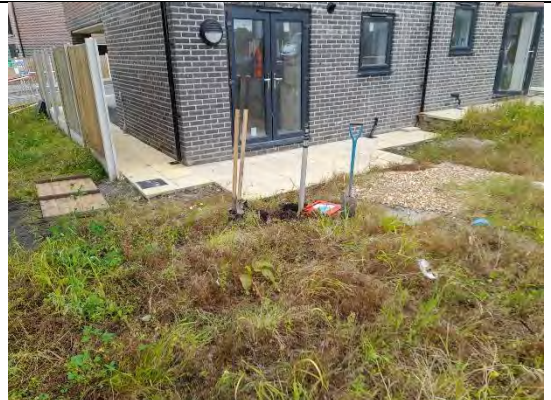
Photograph 167: View of rear garden (S) in Plot 62.

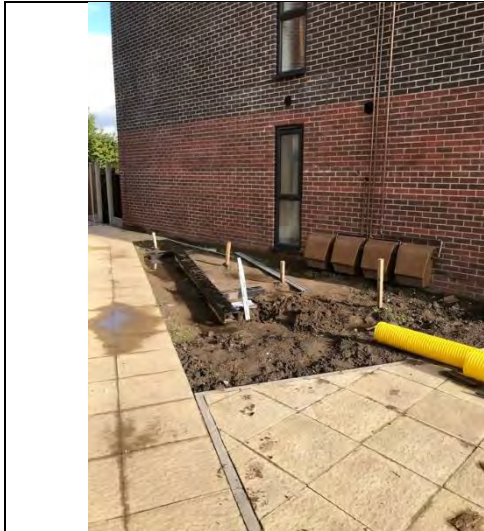
Photograph 170: View of shared soft landscaping A1.

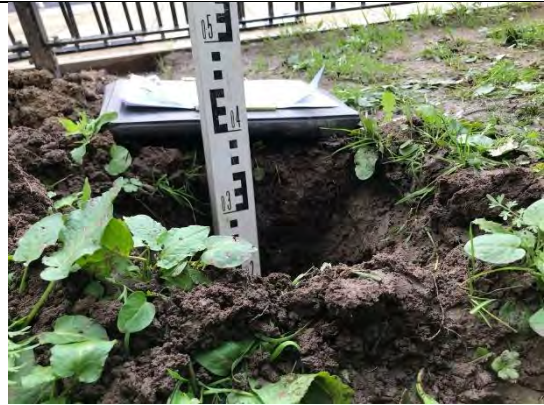
Photograph 173: View of shared soft landscaping A2.

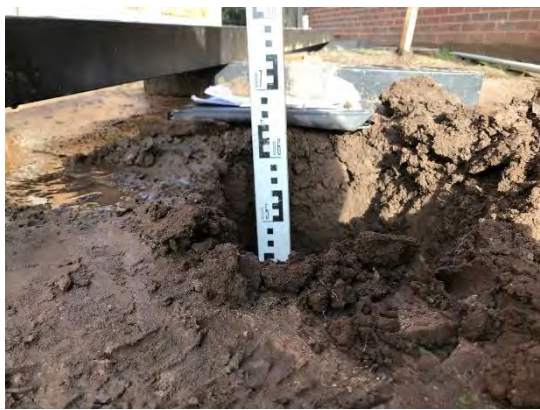
Photograph 171: View of depth of soil within the shared soft landscaping A1.

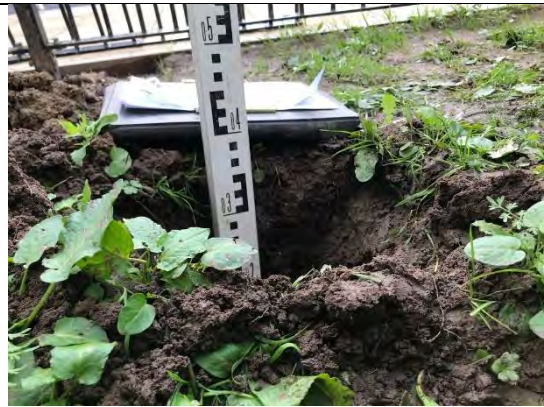
Photograph 174: View of depth of soil within the shared soft landscaping A2.

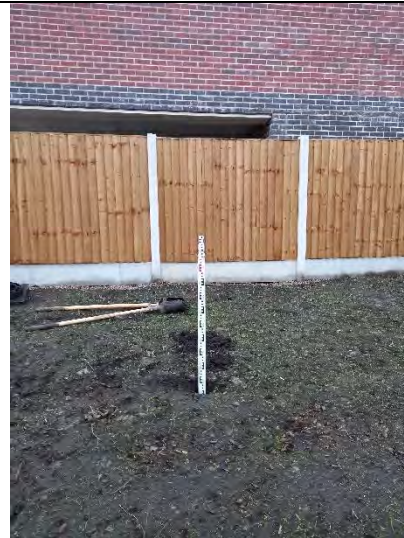
Photograph 178: View of shared soft landscaping B1.

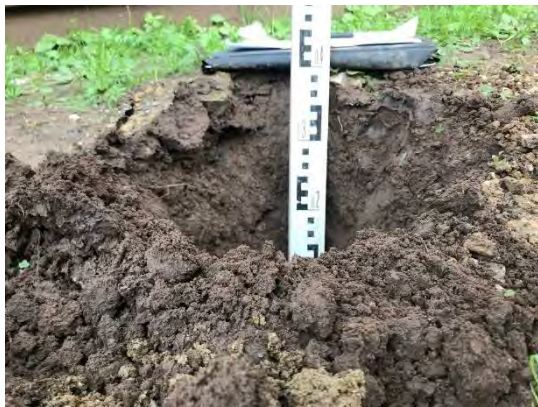
Photograph 176: View of depth of soil within the shared soft landscaping A3.

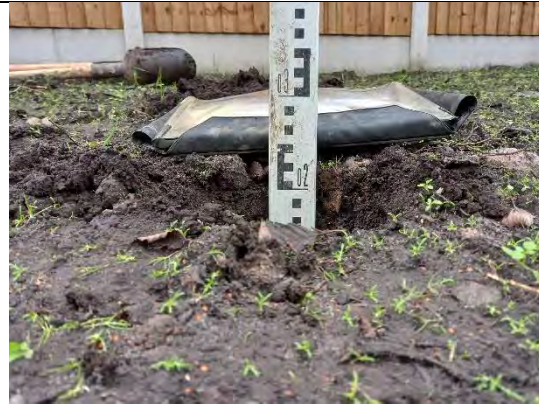
Photograph 179: View of depth of soil within the shared soft landscaping B1.

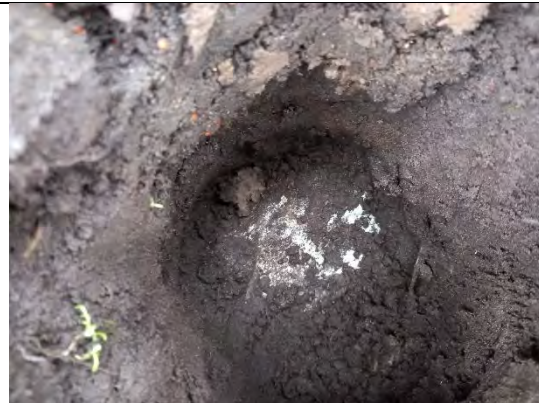
Photograph 180: View of soil within cover system and geotextile at base of shared soft landscaping B1.

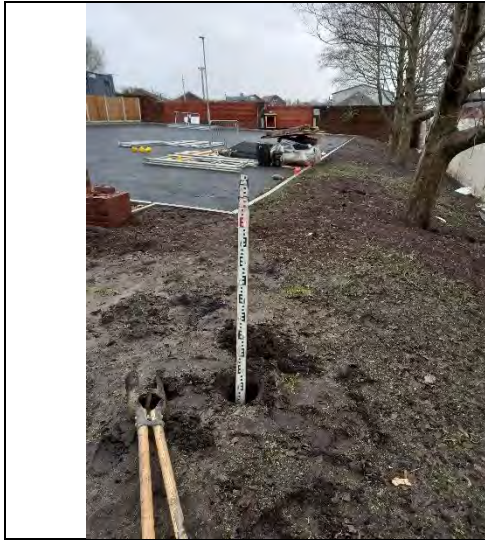
Photograph 181: View of shared soft landscaping B2.

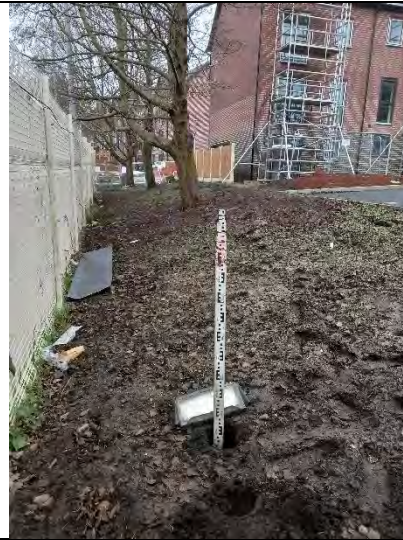
Photograph 184: View of shared soft landscaping B3.

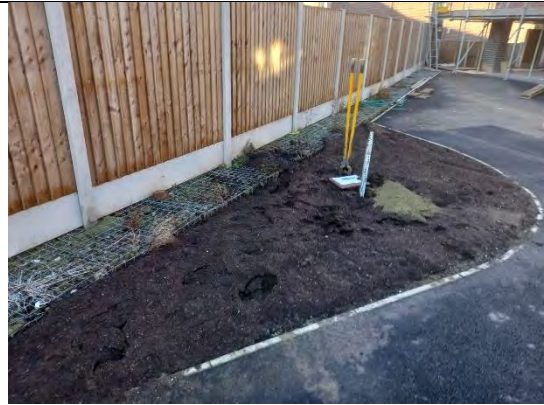
Photograph 190: View of shared soft landscaping C1.

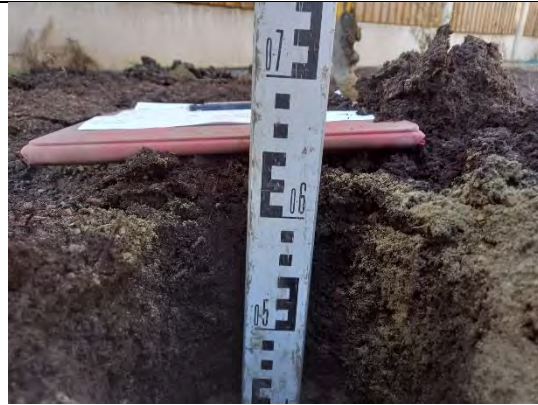
Photograph 191: View of depth of soil within the shared soft landscaping C1.
