FAIRFIELD ROAD, DROYLSDEN

SITE COMPLETION REPORT

Job: Number: LKC 20 1761
Date: 1st December 2023
Client: J Greenwood (Builders) Ltd

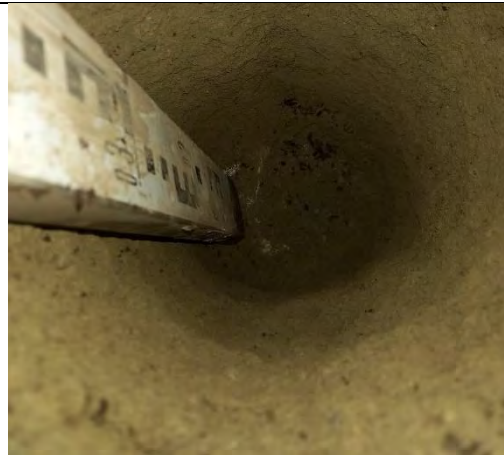
Photograph 192: View of soil within cover system and geotextile at base of shared soft landscaping C1.

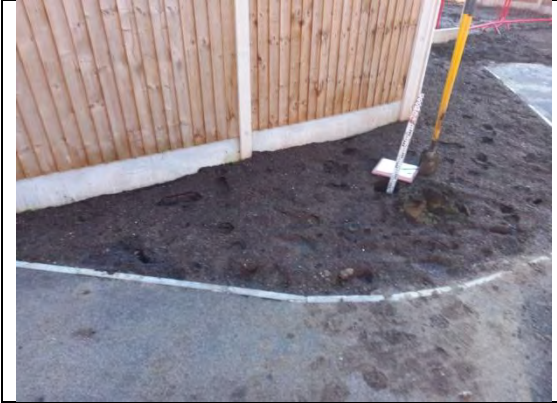
Photograph 193: View of shared soft landscaping C2.
