Site: Fairfield Road, Droylsden
Plots: Ground Floor of Apartment Block (Plots 1-9) & Plots 37-62
Date: 23rd November 2023
LKC Ref.: CL-602-LKC 20 1791-02 Plots 1-9 & 37-62 R1

GAS MEMBRANE VALIDATION REPORT

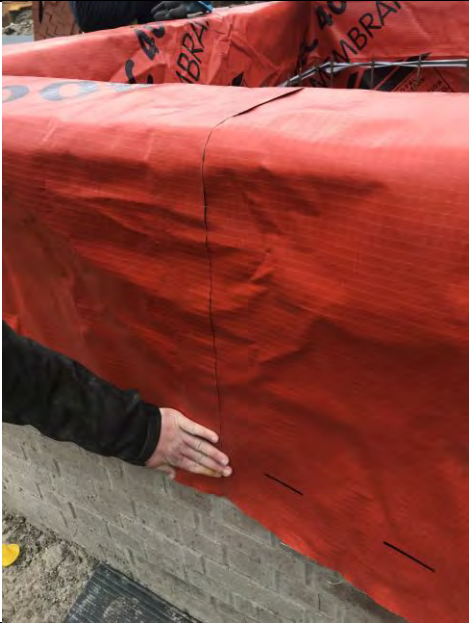
<p>Photograph 1: Evidence of gas membrane coverage in lift pit.</p>	<p>Photograph 2: Evidence of appropriate sealing and overlap.</p>

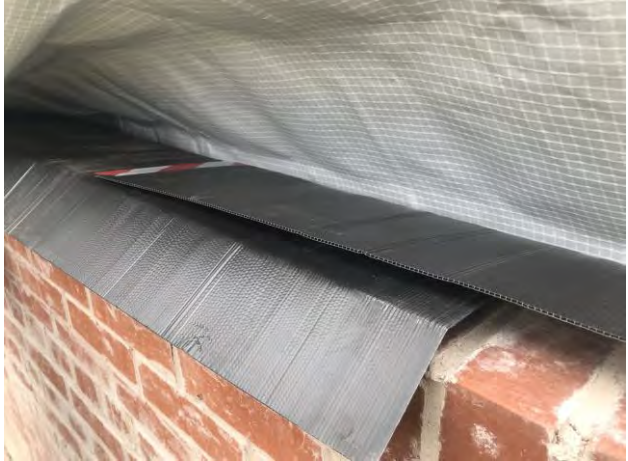
<p>Photograph 3: Evidence of appropriate sealing and overlap.</p>	<p>Photograph 4: Evidence of appropriate overlap of the membrane.</p>

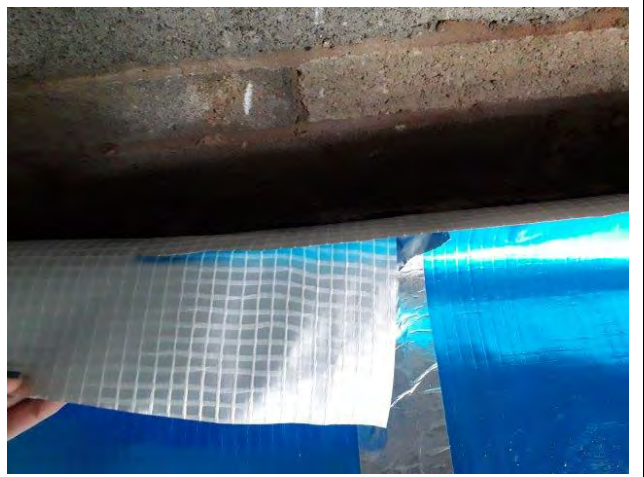
Photograph 4:
Evidence of appropriate overlap of the membrane for Plot 4.

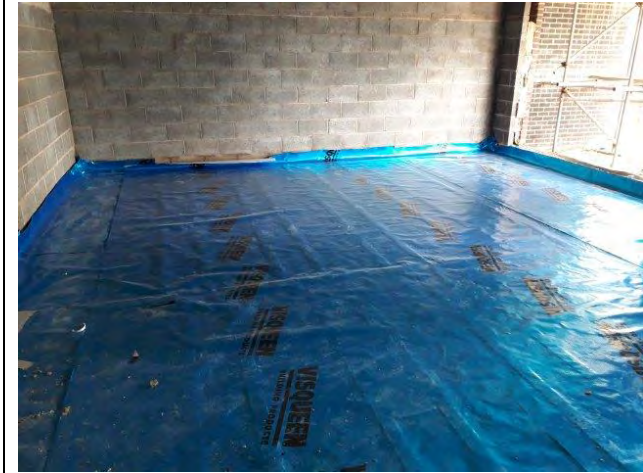
<p>Photograph 1: Evidence of gas membrane coverage across Plot 5.</p>	<p>Photograph 2: Evidence of appropriate sealing around services for Plot 5.</p>

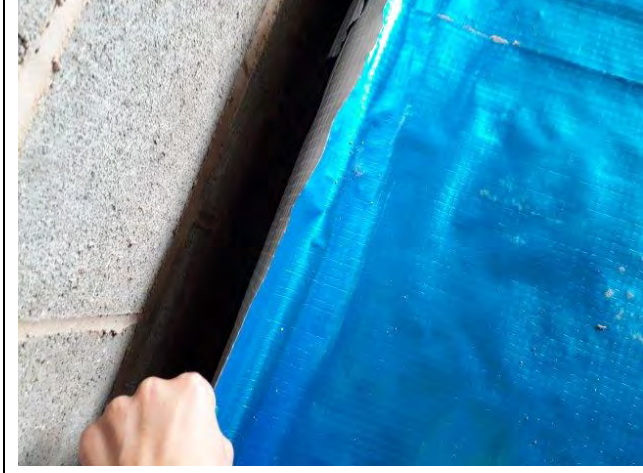
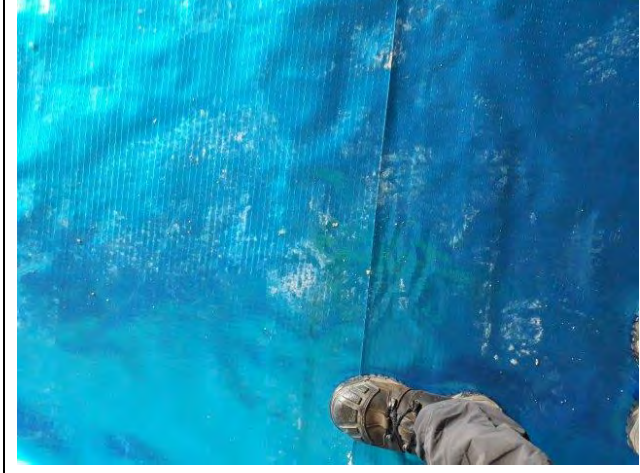
<p>Photograph 3: Evidence of appropriate sealing of membrane to DPC with appropriate overlap for Plot 5.</p>	<p>Photograph 4: Evidence of appropriate overlap of the membrane for Plot 5.</p>

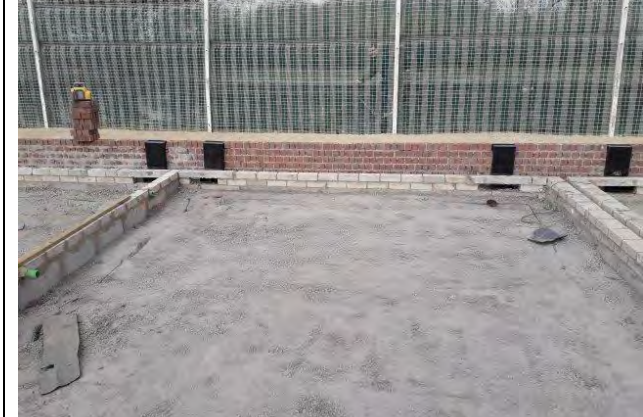
<p>Photograph 5: Evidence of sub-floor void in Plot 5.</p>

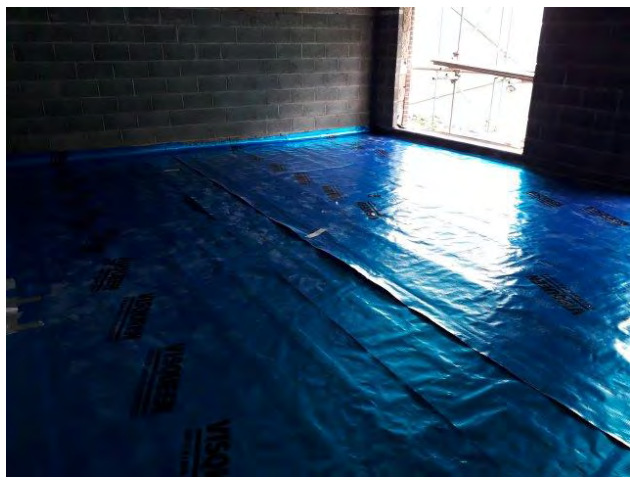
<p>Photograph 1: Evidence of gas membrane coverage across Plot 6.</p>	<p>Photograph 2: Evidence of appropriate sealing around services for Plot 6.</p>

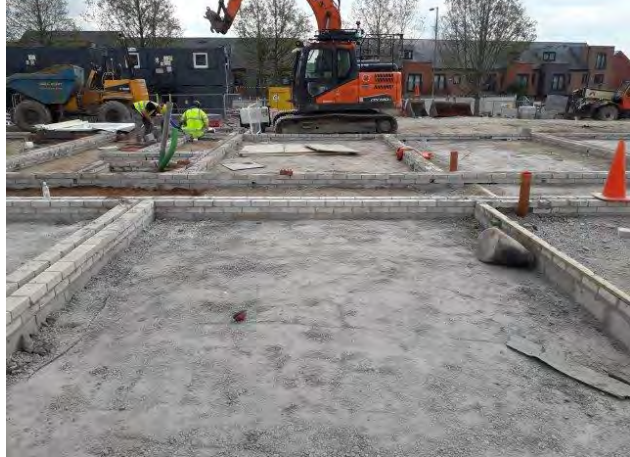
<p>Photograph 5: Evidence of sub-floor void in Plot 6.</p>

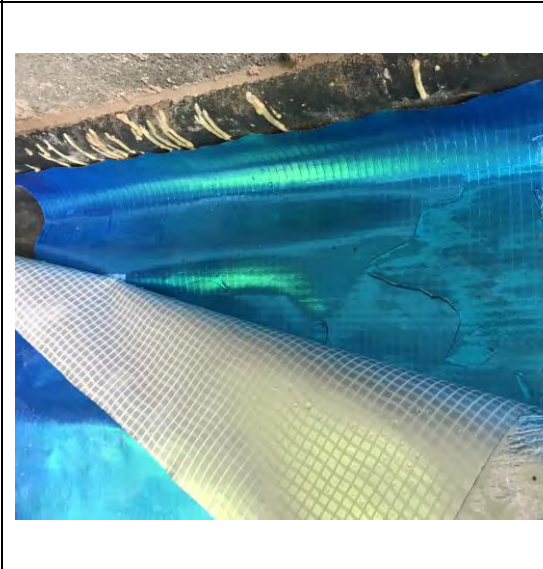
Photograph 4:
Evidence of appropriate overlap of the membrane for Plot 51.

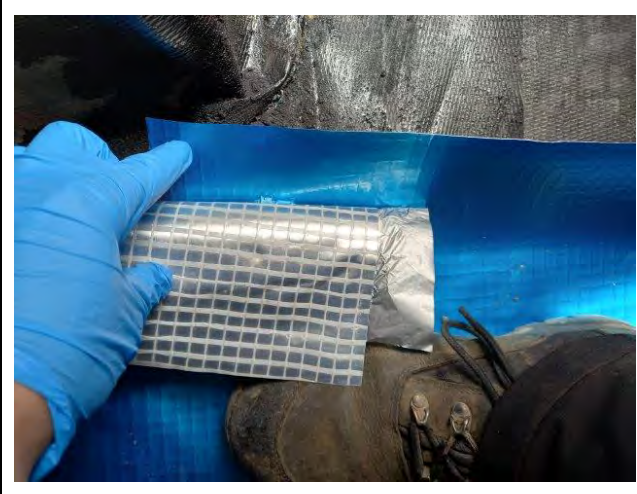
Photograph 4:
Evidence of appropriate overlap of the membrane for Plot 62.
