CCTV Inspection Report

**MILLFIELD HOUSE
LINLEY AVENUE
HAXBY
YORK
YO32 3NF**

20/04/2023

Job Number: 7663

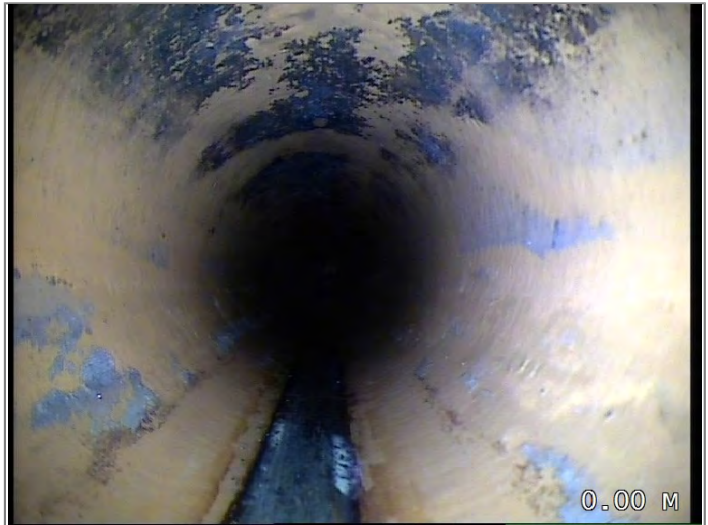
Water level 0% height/diameter

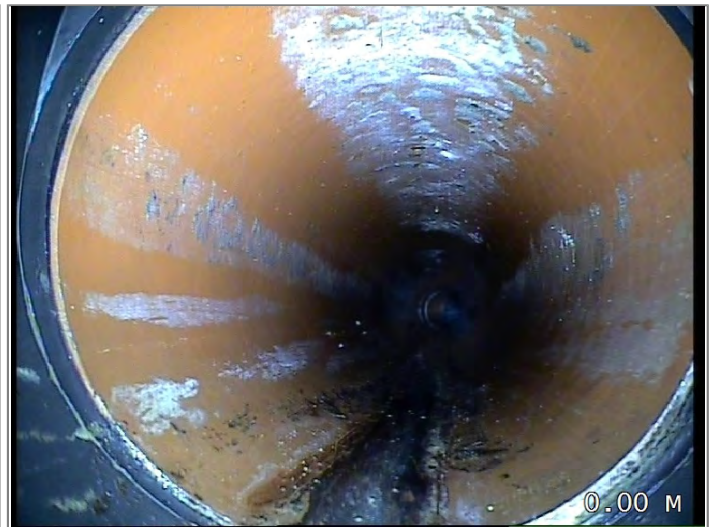
Water level 0% height/diameter

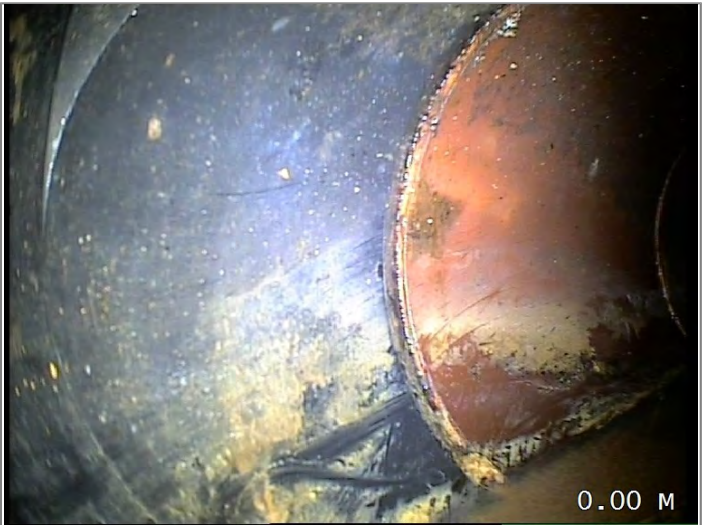
Water level 0% height/diameter

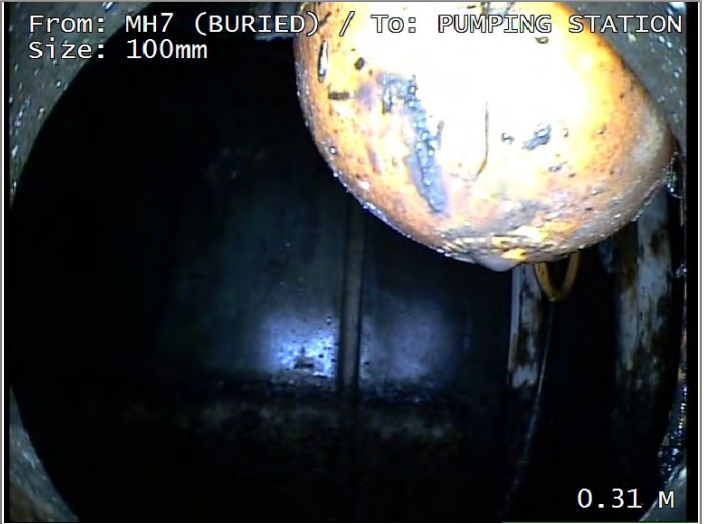
Finish node type, other special chamber, reference PUMPING STATION

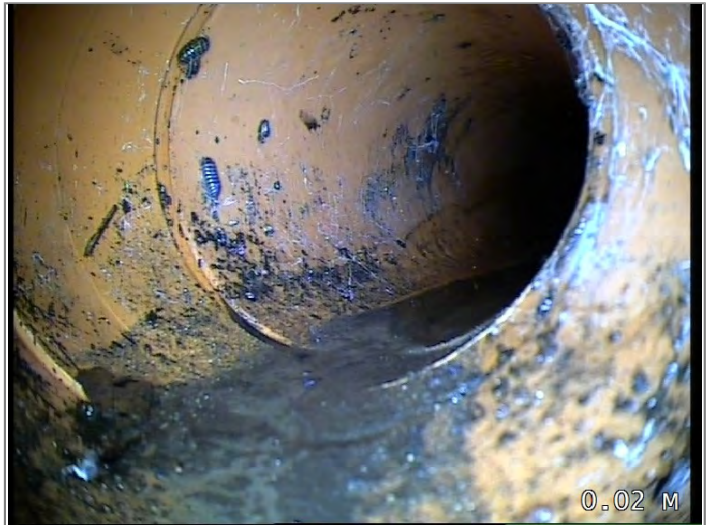
Water level 0% height/diameter

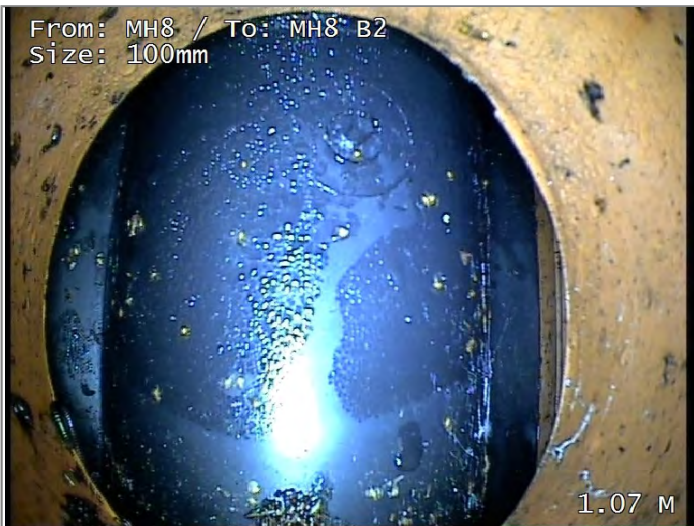
Finish node type, gully, reference MH8 B2

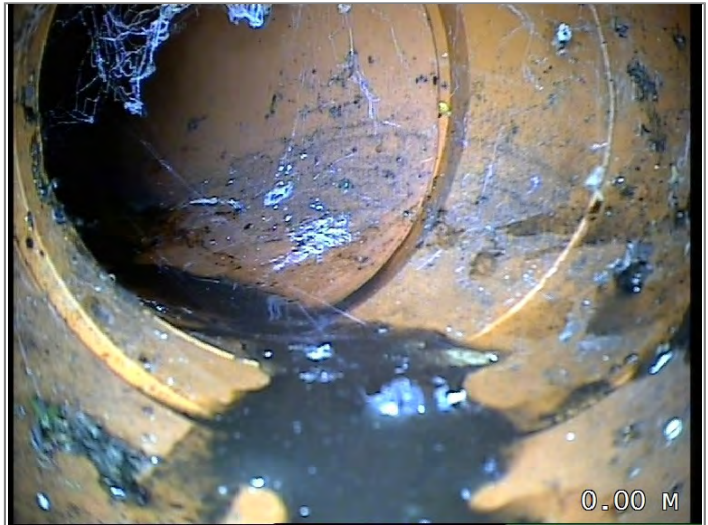
Water level 0% height/diameter

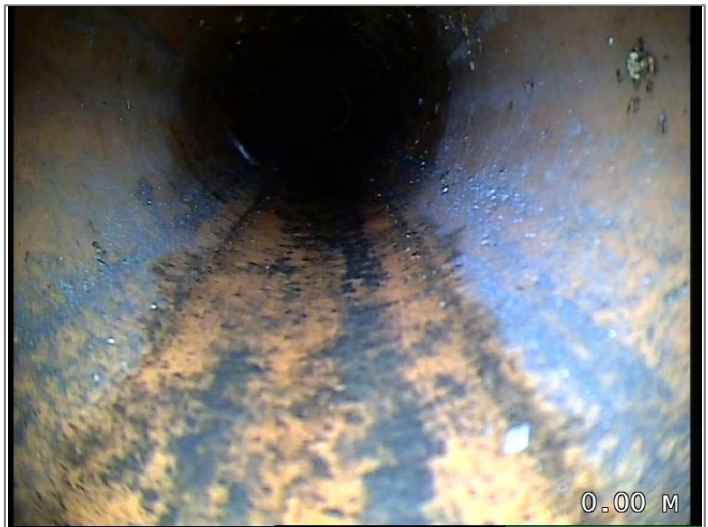
Water level 0% height/diameter

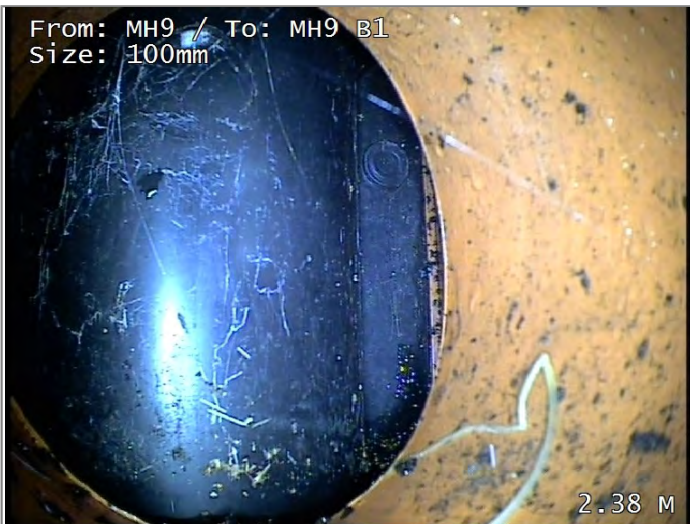
Finish node type, gully, reference MH9 B1

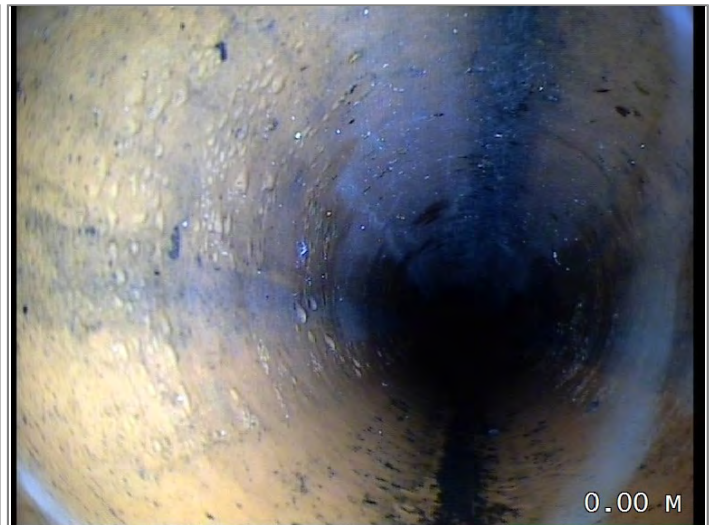
Water level 0% height/diameter

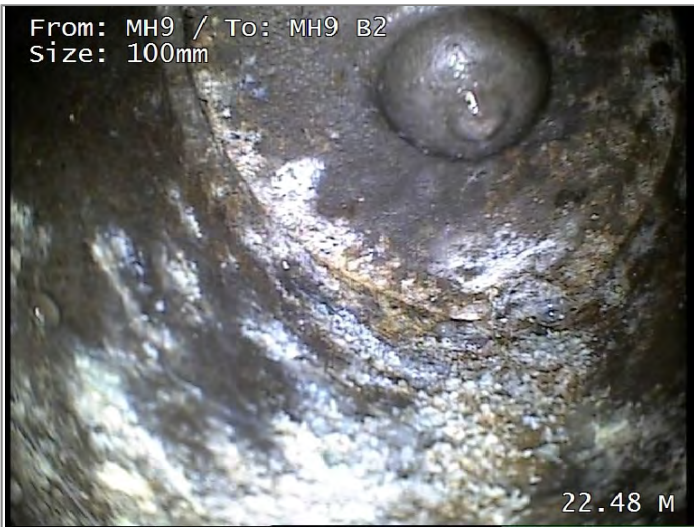
Finish node type, rodding eye, reference MH9 B2

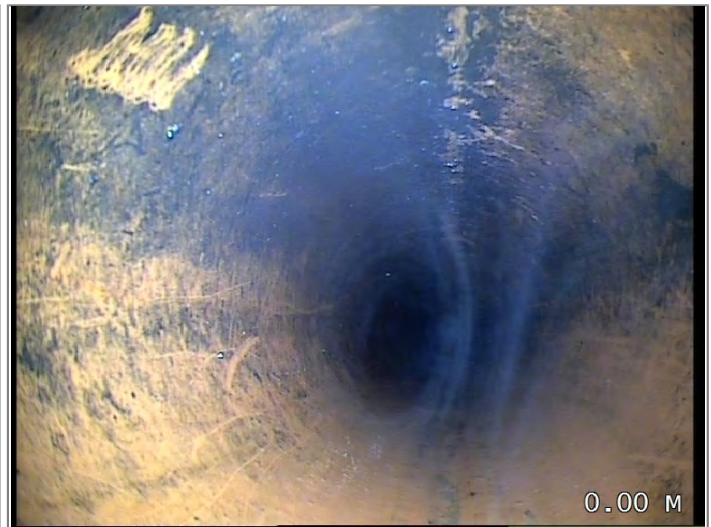
Water level 0% height/diameter

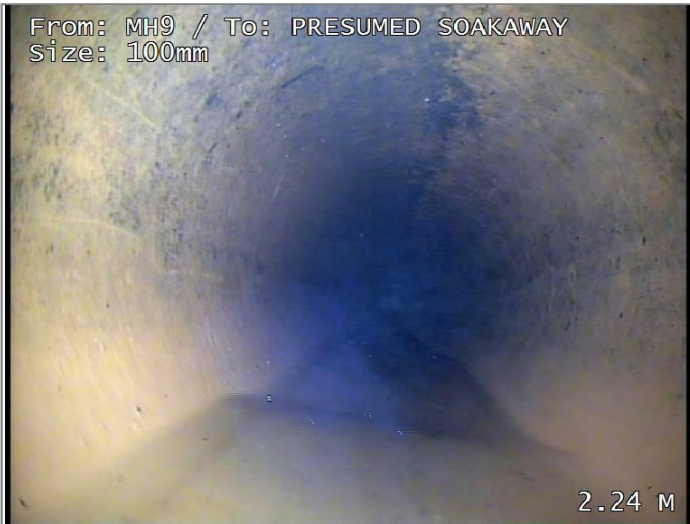
Water level 10% height/diameter

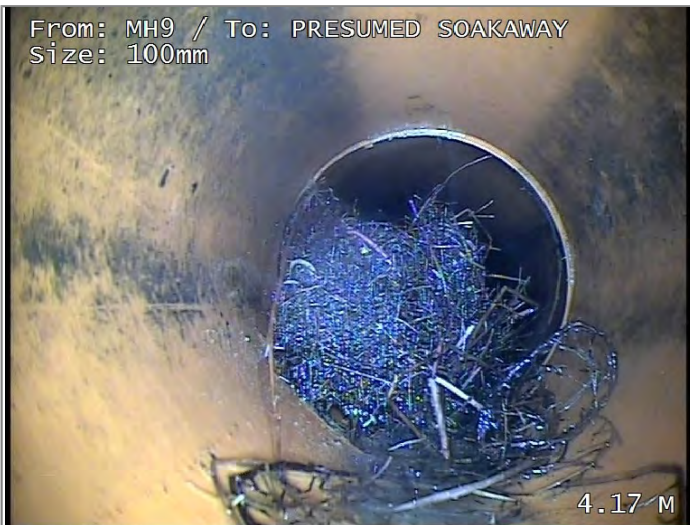
Open joint 10mm

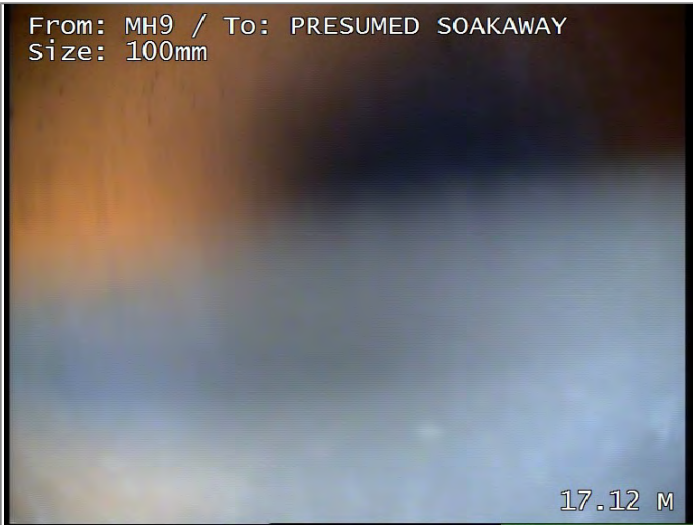
Water level 30% height/diameter
