THE BARN  
CANAGLAZE  
ALTARNUN  
CORNWALL

Heritage Assessment

South West Archaeology Ltd. report no. 230516

South West Archaeology Ltd. was commissioned to undertake a heritage assessment for the Barn at Canaglaze, Altarnun, Cornwall to inform plans to consolidate and convert the barn to a dwelling. This work was carried out in consultation with HEP(Arch) and in accordance with the relevant guidance.

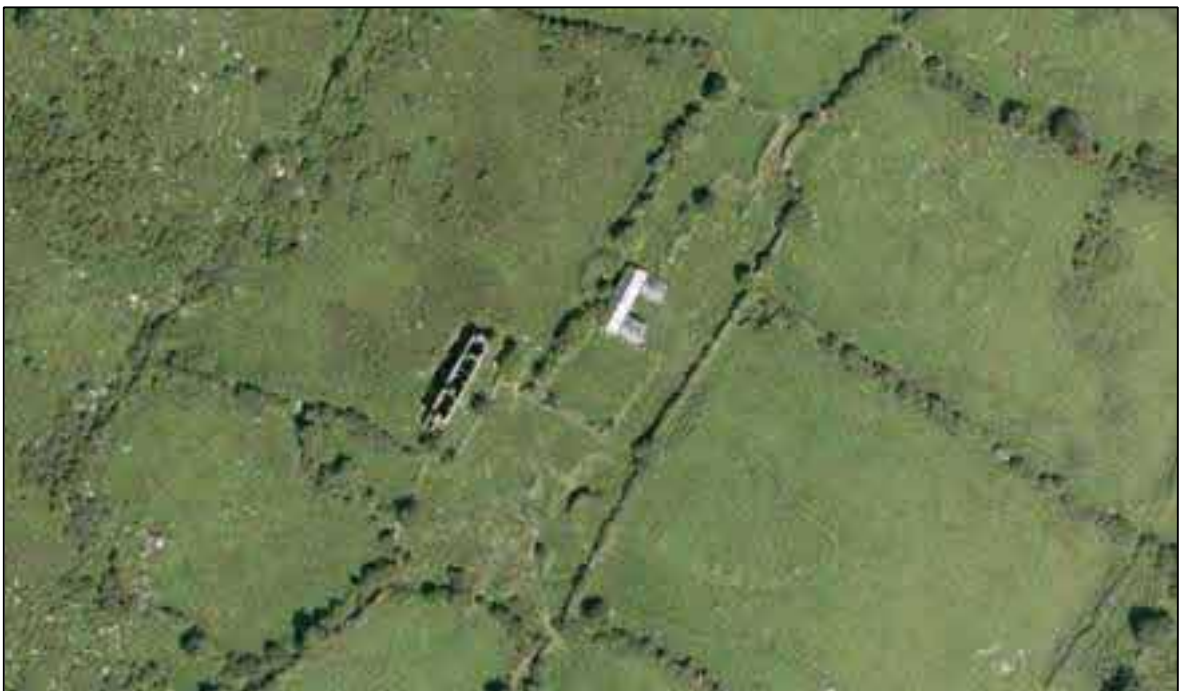
FIGURE 8: AERIAL VIEW OF THE SITE IN 2001 (© INFOTERRA AND BLUESKY 2023).

Aerial photography for the site shows that by 2001 (Figure 8) the house at Canaglaze had fallen into disrepair and was completely roofless and partly overgrown. The Barn was still roofed, although the northern end appears compromised. By 2009, the southern end of the barn, most likely the historic part, had lost its roof. By 2018 (Figure 9) most of the barn was roofless and overgrown.

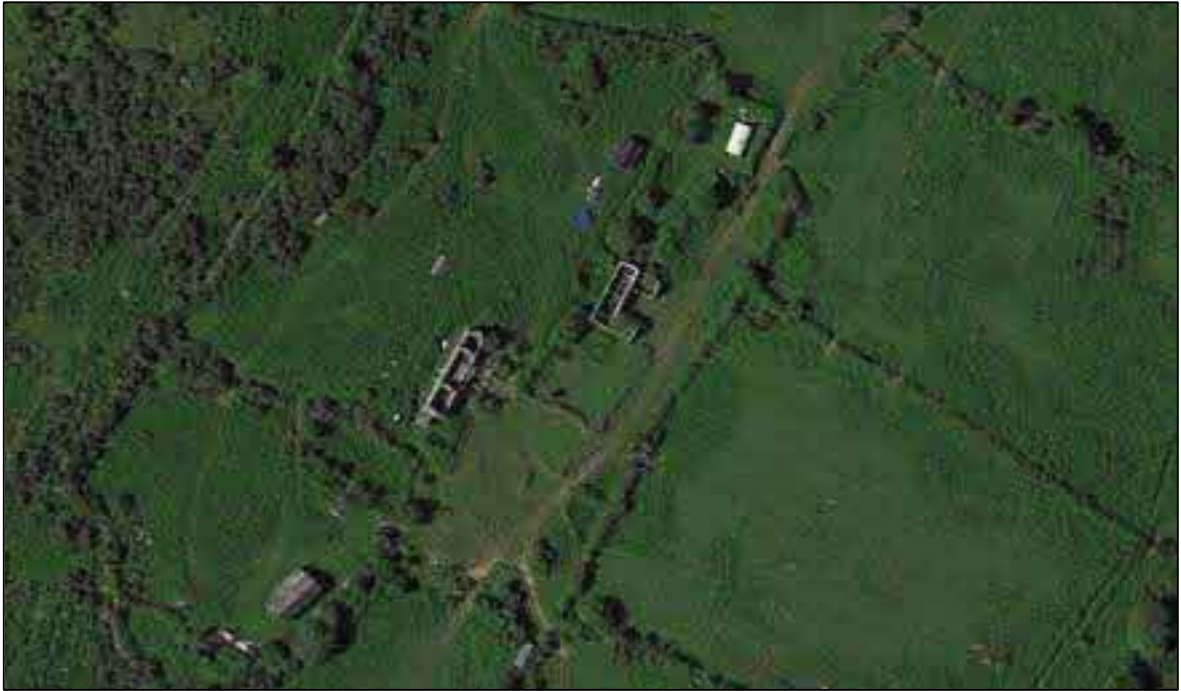
FIGURE 9: AERIAL VIEW OF THE SITE IN 2018 (© GOOGLE EARTH 2023).

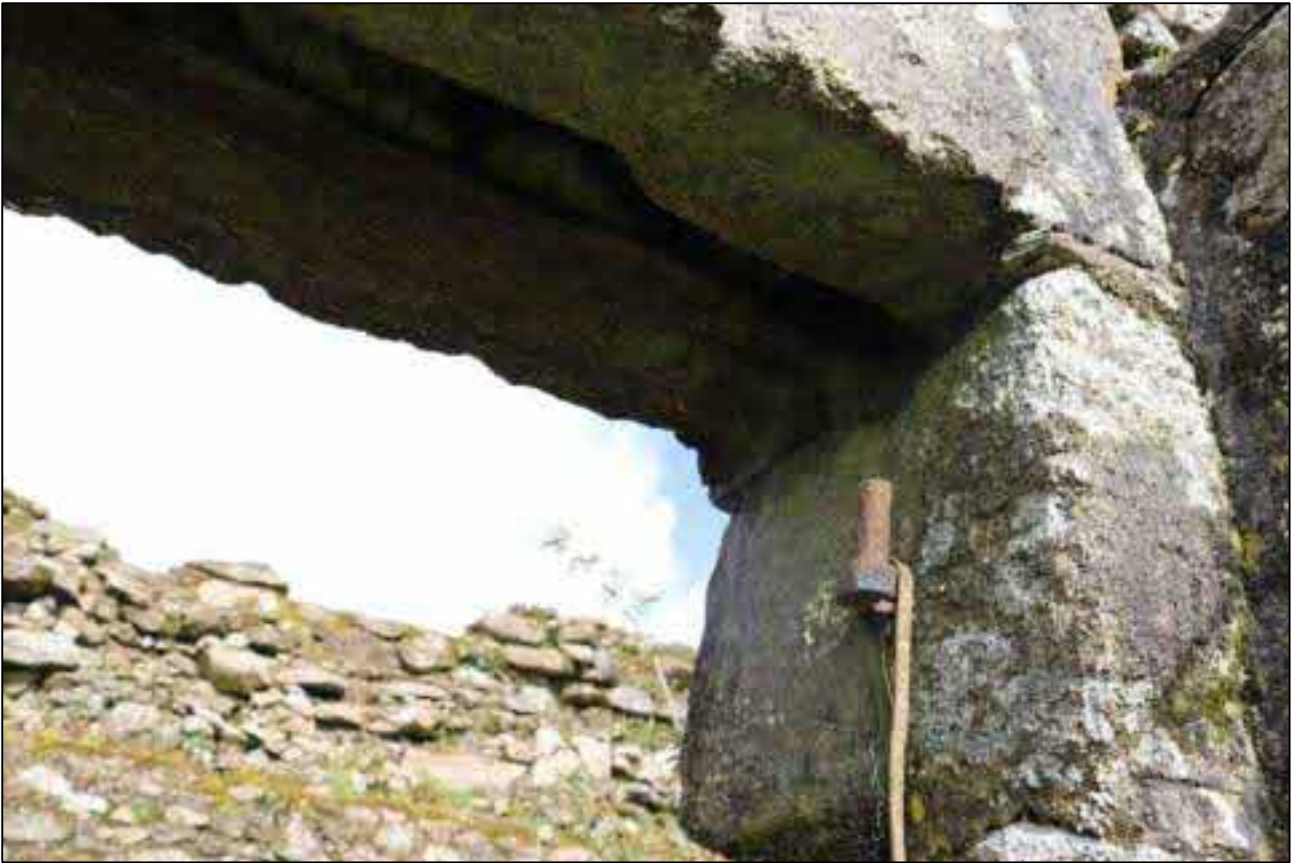
5. LINTEL AND IRON BRACE SEEN TO D2 WITH HEAVY PINTLE SURVIVING TO NORTH SIDE.

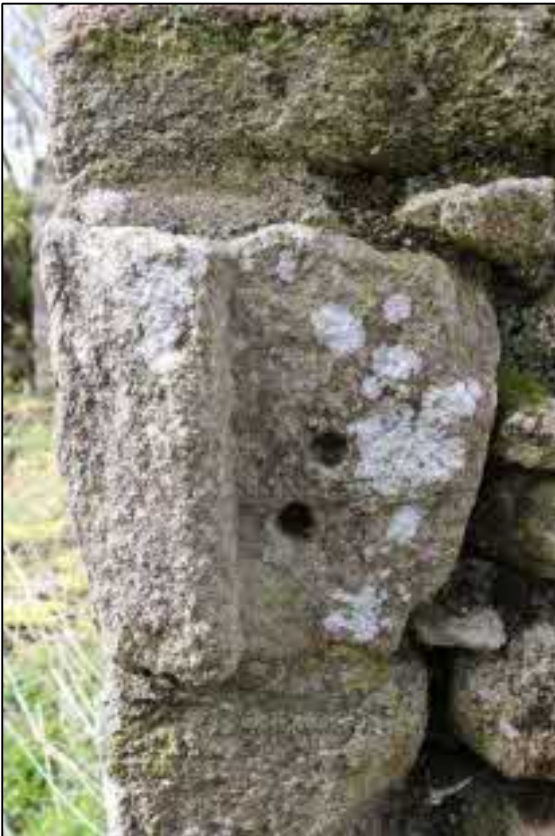
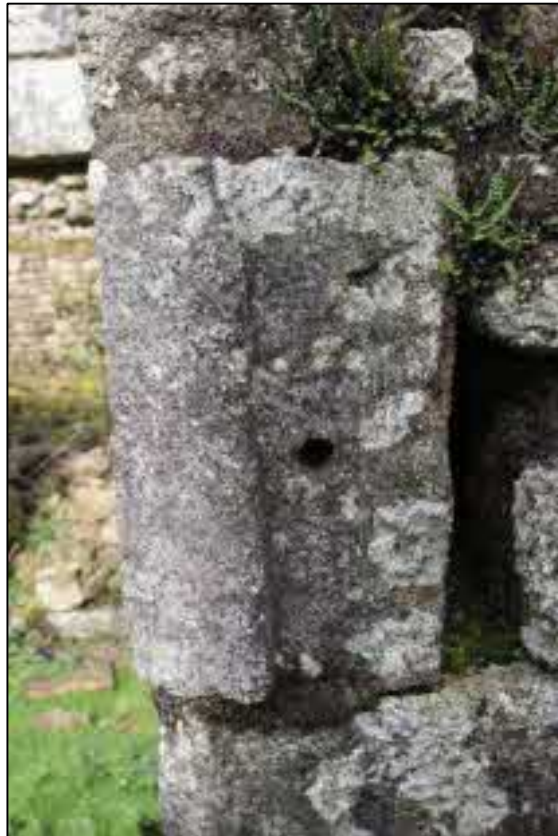
6. THE CARVED GRANITE LIPS SEEN TO D2 AND D3.

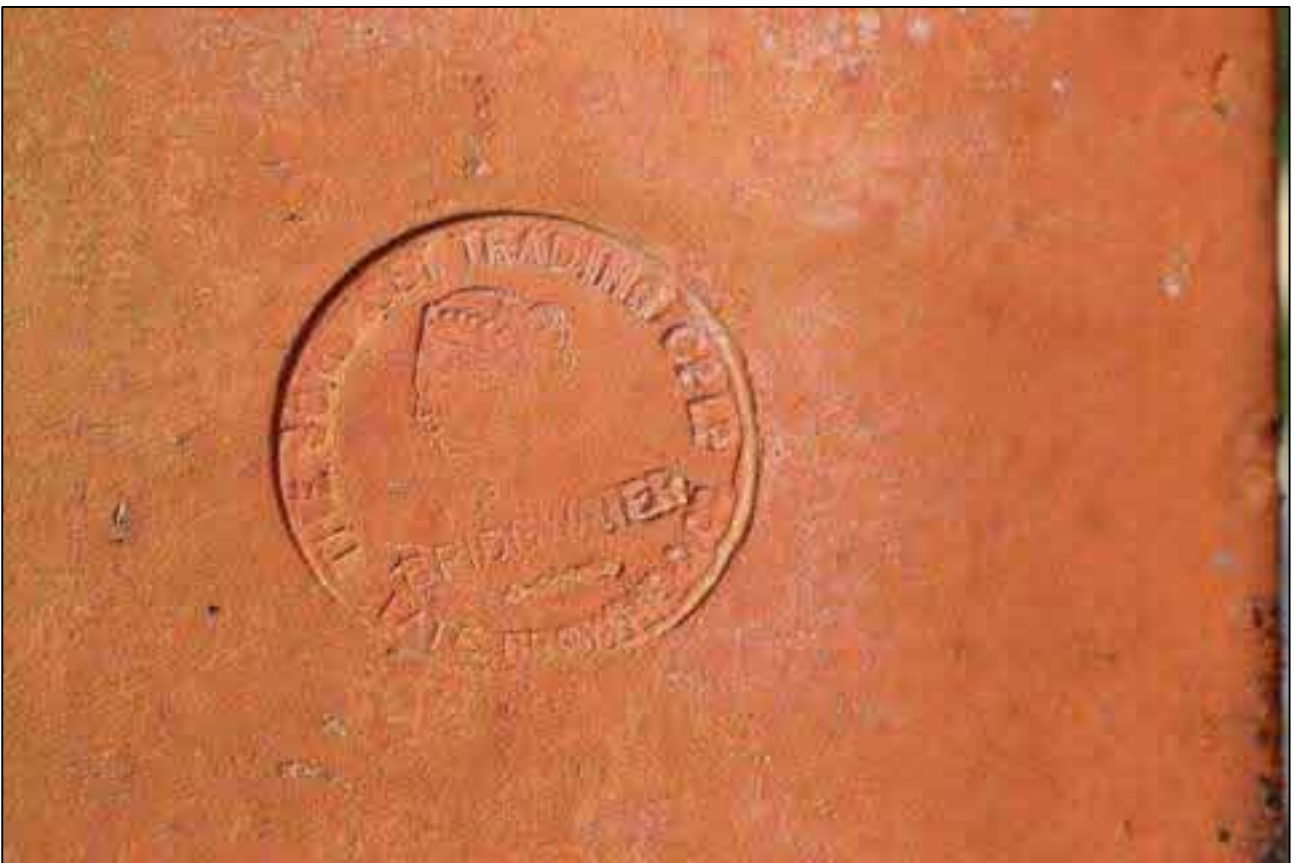
58. THE STAMP FOR FORMER RIDGE TILES.

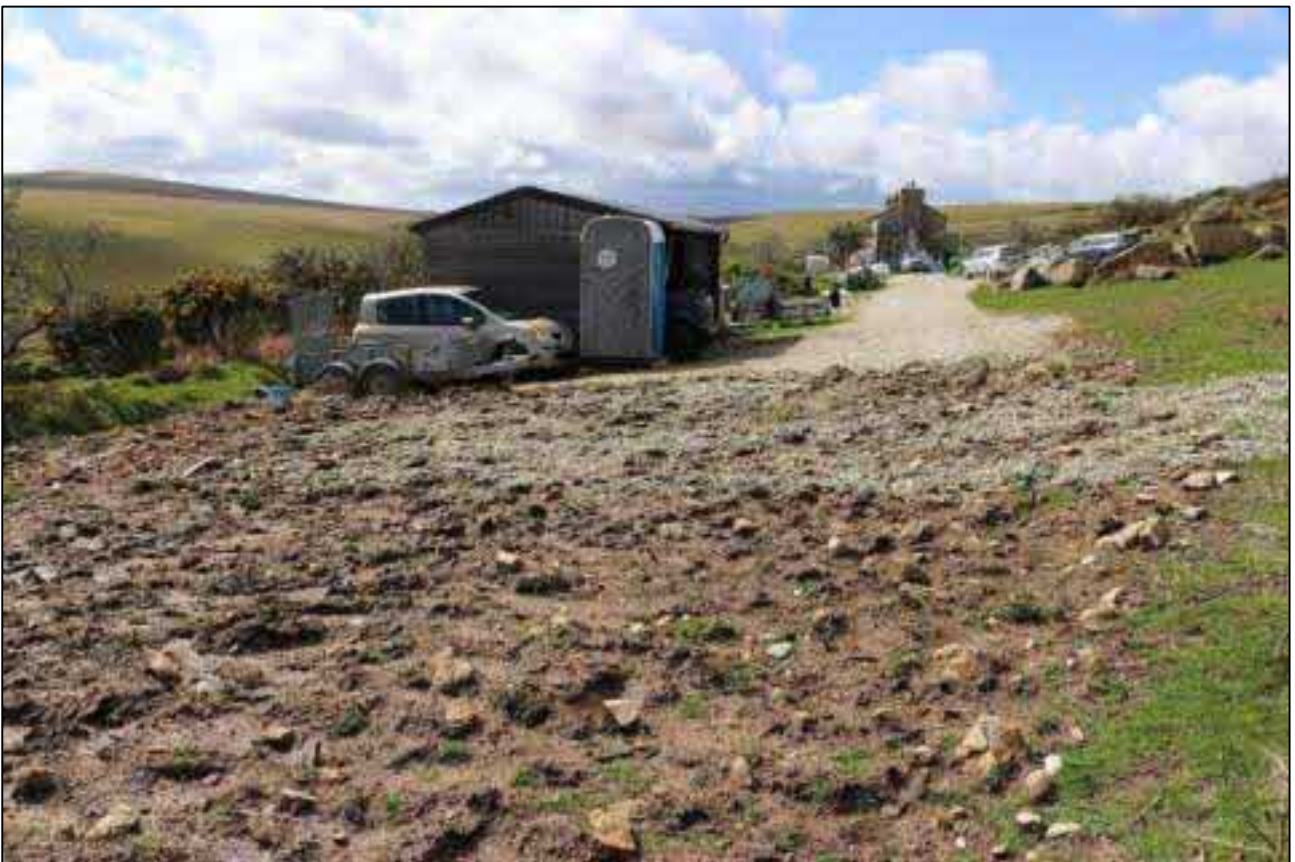
61. THE LANDSCAPED YARD LOOKING TO CARNE DOWN; VIEWED FROM THE WEST.

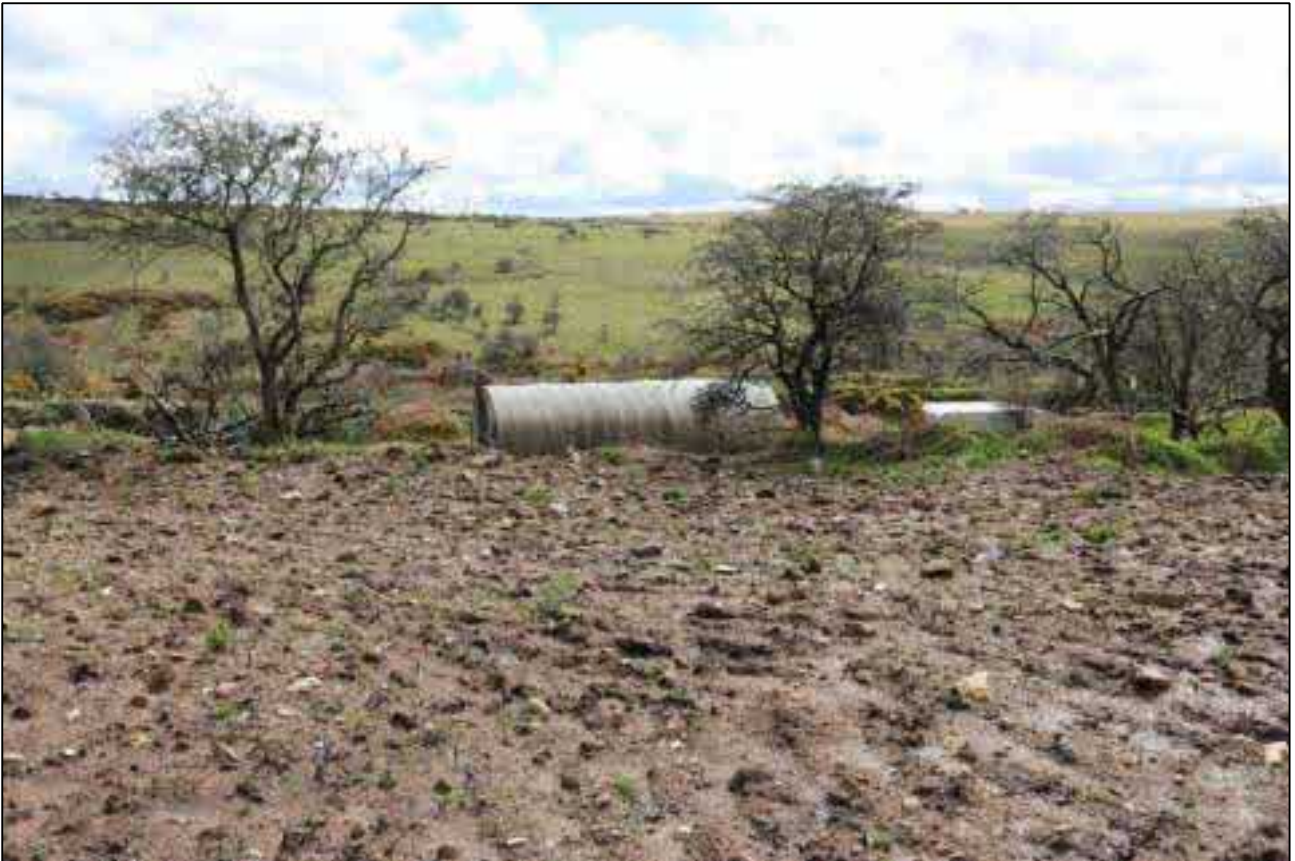
62. THE TERRACING/ HEDGE BANKS IDENTIFIED JUST NORTH OF BARN; VIEWED FROM THE NORTH.
