**APPENDIX B**  
**CK CONSULTING AND GEOTECHNICAL LIMITED**  
**GEOTECHNICAL REPORT ON GROUND CONDITIONS**  
**NOVEMBER 2022**

The subject site is located at 15 Gordon Close, Sandown, Isle of Wight and comprises a detached bungalow with garden areas to the north and south of the property. The building has undergone movement causing cracking of external and internal walls, over the entire property, of varying magnitude. A ground investigation was requested by the appointed consultant engineer, Frankham Consultancy Group Ltd, to provide information on the ground conditions underlying the site, existing foundation type and likely cause(s) of building movement.

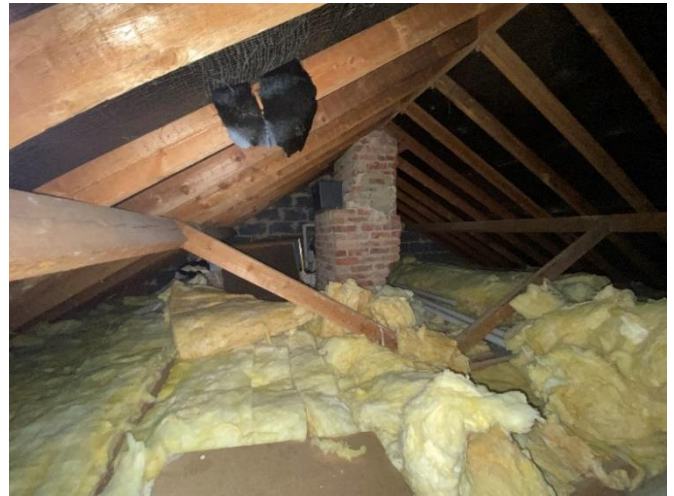
*Photo 86: Roof space above the main property*

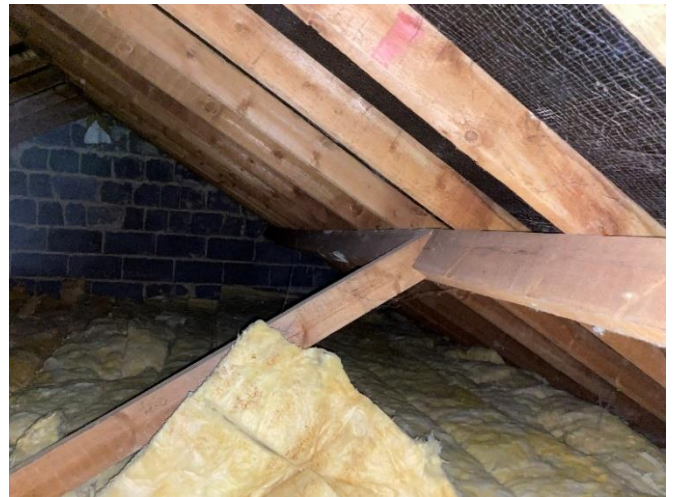
*Photo 88: Roof space above the main property*
