Validation Letter

Date: 6 October 2023

Our Ref: M41977-JNP-XX-XX-RP-G-0020-P01

Re: Former Sunninghill Gas Works – Validation of Capping Layer for Plots 13 - 26 (Block C)

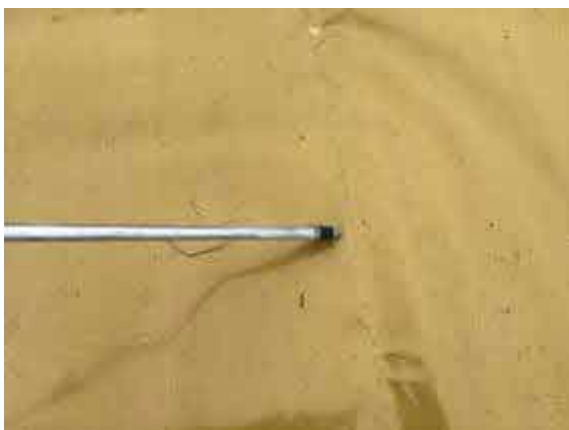
Air lancing all weld laps and SAGM detailing.

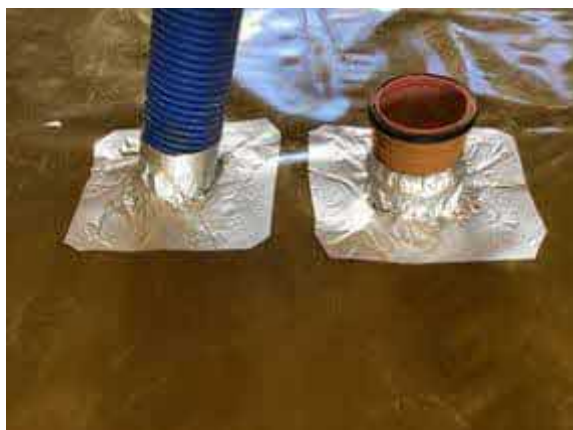
Plot 3 typical double pipe penetration seal using SAGM.

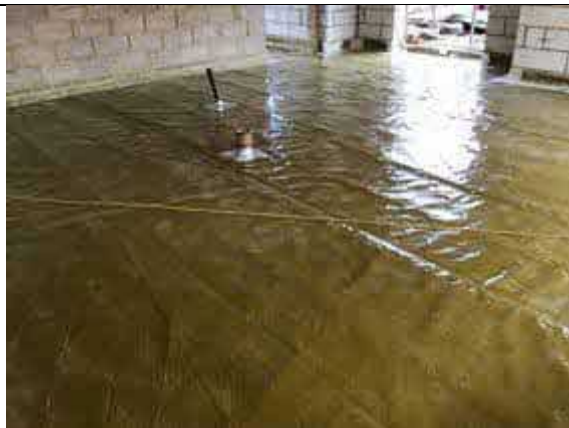
Plot 75 overview of installed membrane.

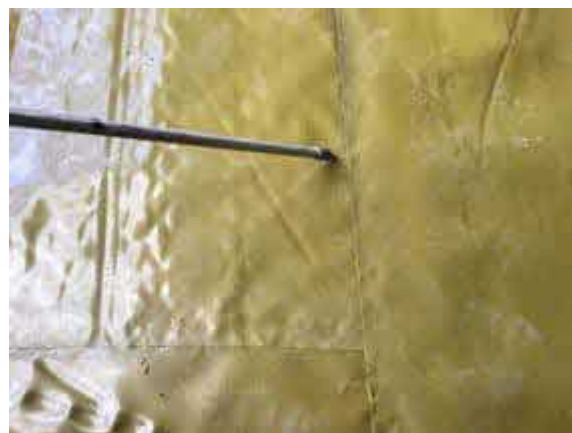
Plot 75 air lancing all weld laps and SAGM detailing.

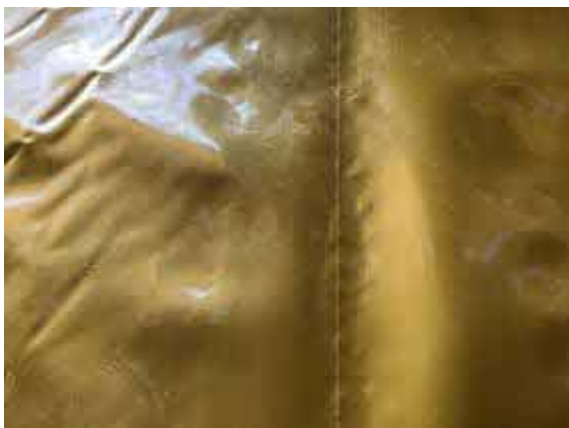
Plot 4 hand welded membrane lap.

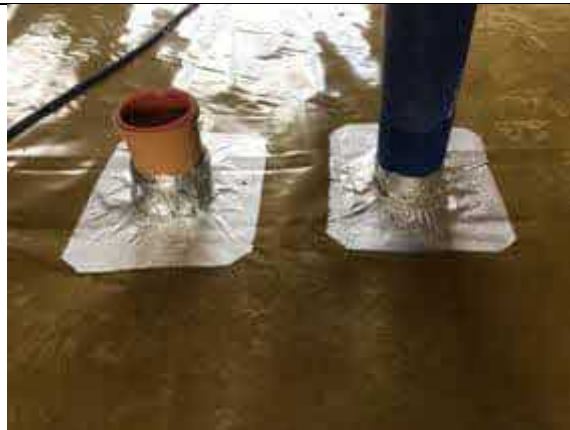
Plot 7 typical double pipe penetration seal using SAGM.

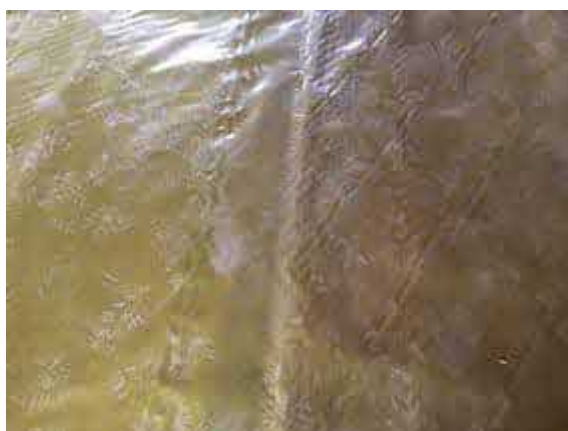
Plot 35 hand welded membrane laps.

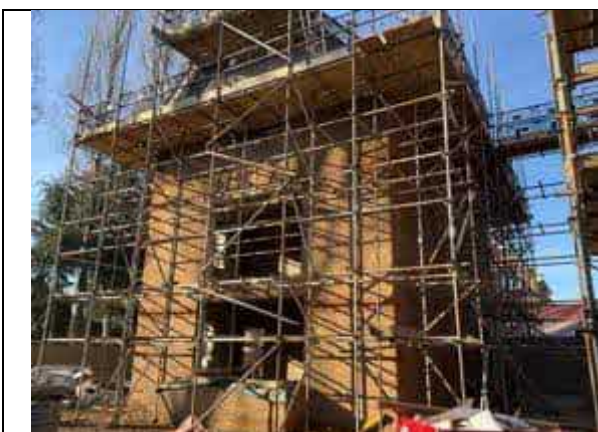
Plot 73 Overview where Visqueen HC Blok was installed.

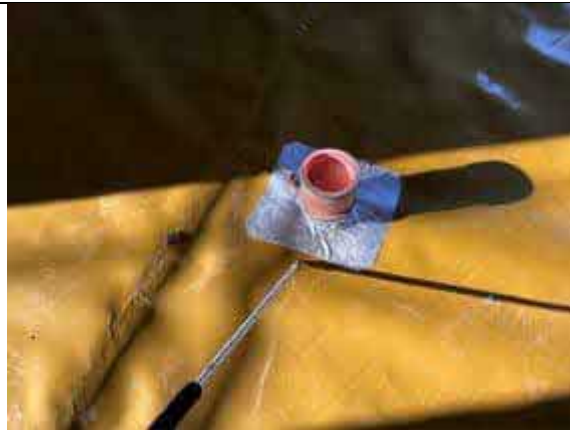
Plot 74. Air lance integrity test conducted upon sealed pipe penetration.

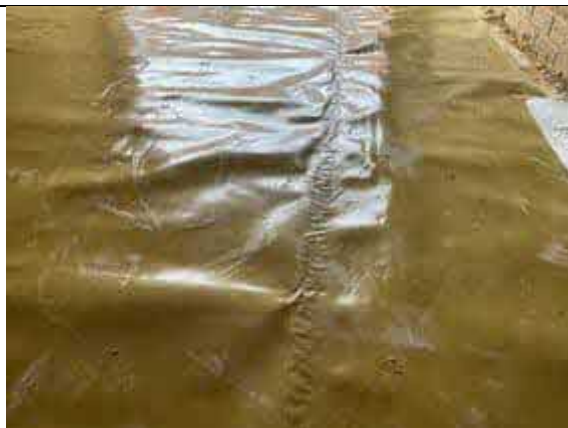
Plot 30 garage. Overview of a hand welded membrane lap joint.

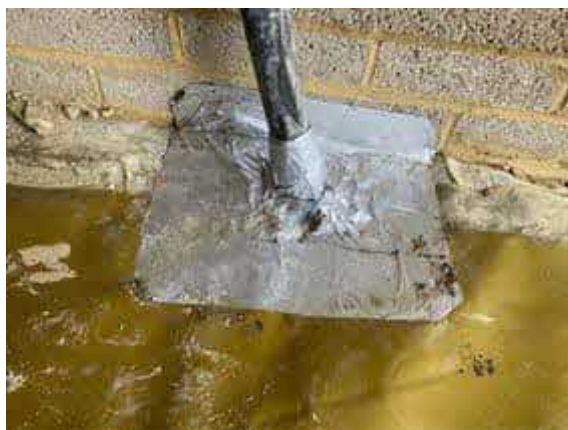
Plot 32 garage. Typical pipe penetration sealed using SAGM.

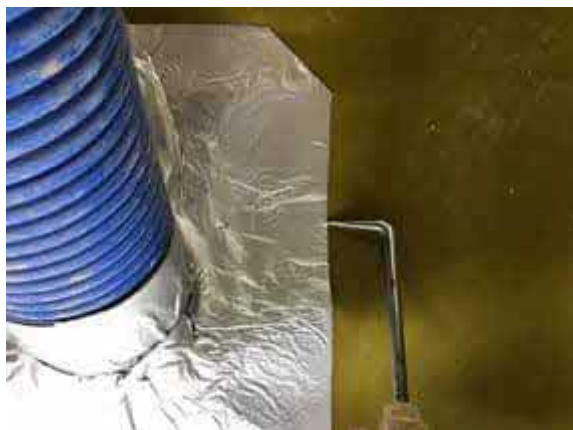
Pick testing all SAGM detailing in plot 50.

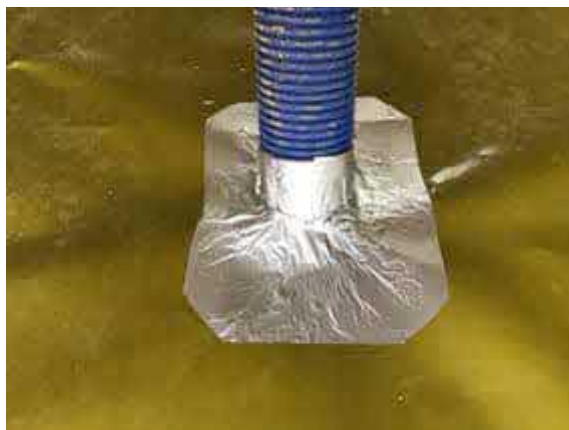
Typical pipe penetration seal using SAGM to plot 50.

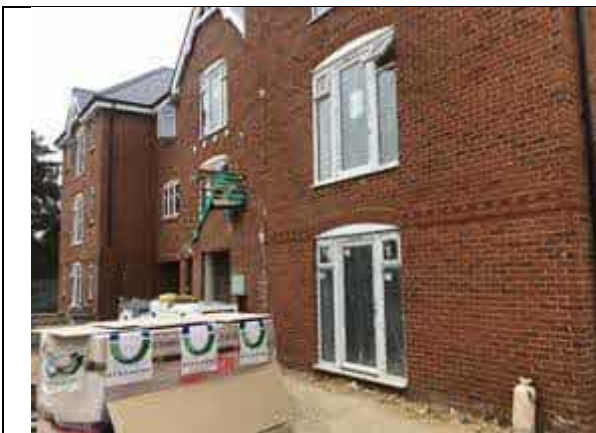
Overview of Apartment Block C.

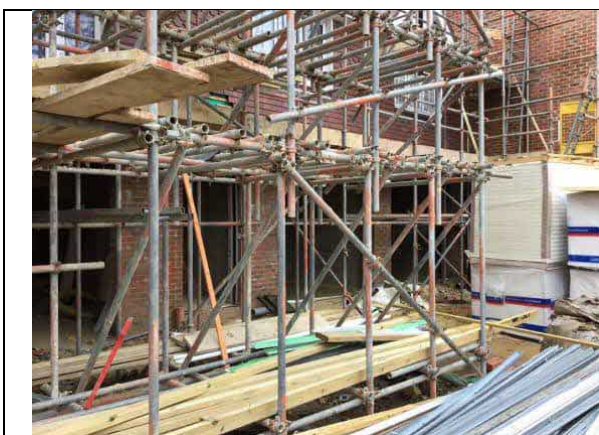
Overview of plots 63 & 64.

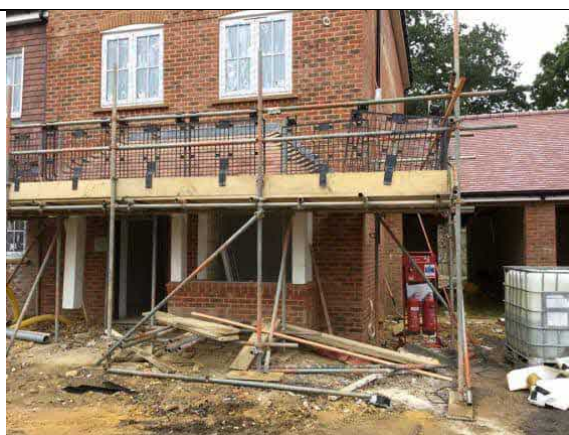
Overview of plot 67.

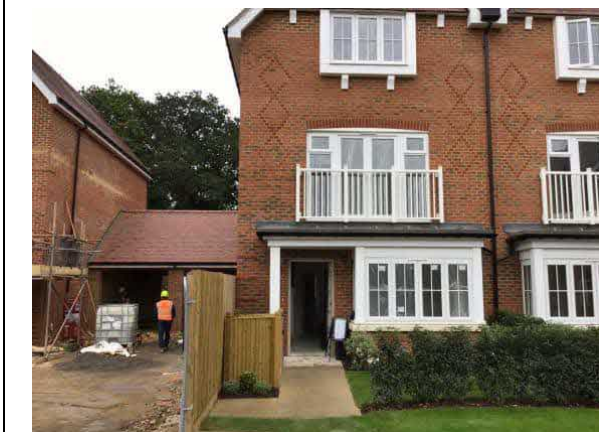
Overview of plot 68.
