Validation Letter

Our Ref: M41977-JNP-XX-XX-RP-G-0026-P01

Re: Former Sunninghill Gas Works – Validation of Capping Layer for Plots 54- 63 inclusive (Block H - Apartments)

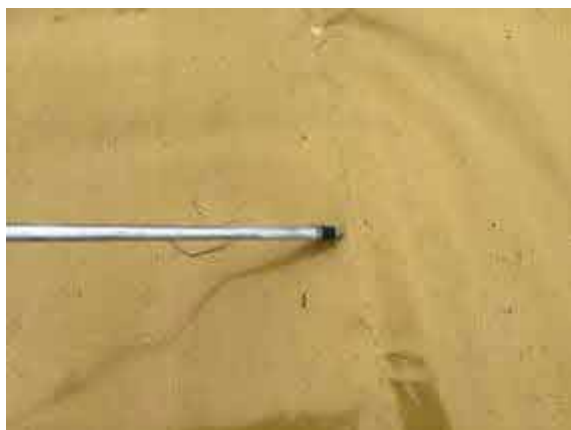
Air lancing all weld laps and SAGM detailing.

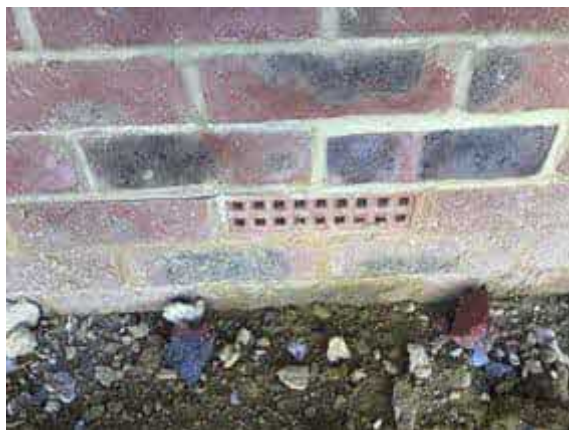
Air brick in place at the time of our inspection.

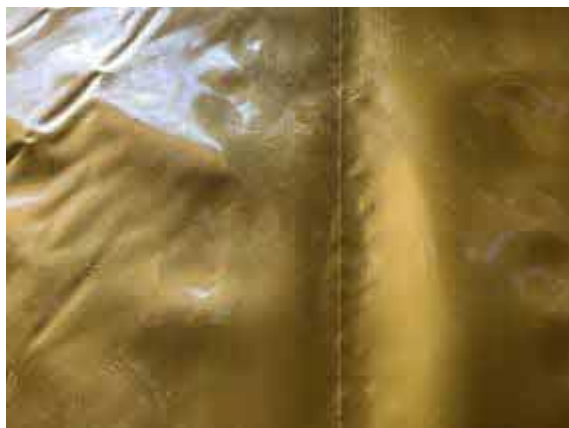
Plot 4 hand welded membrane lap.

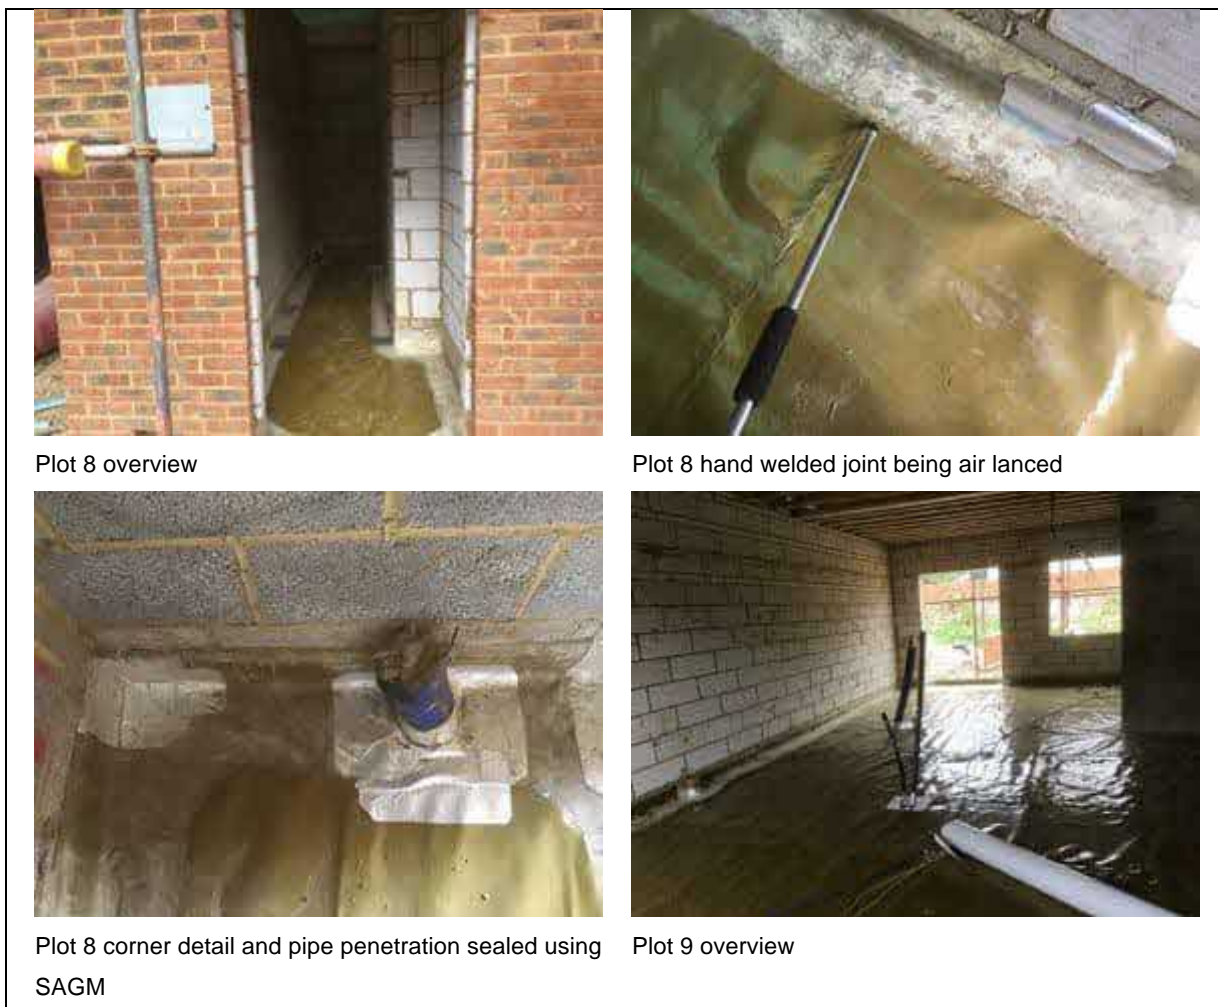
Plot 8 overview

Plot 8 hand welded joint being air lanced

Plot 8 corner detail and pipe penetration sealed using SAGM

Plot 9 overview

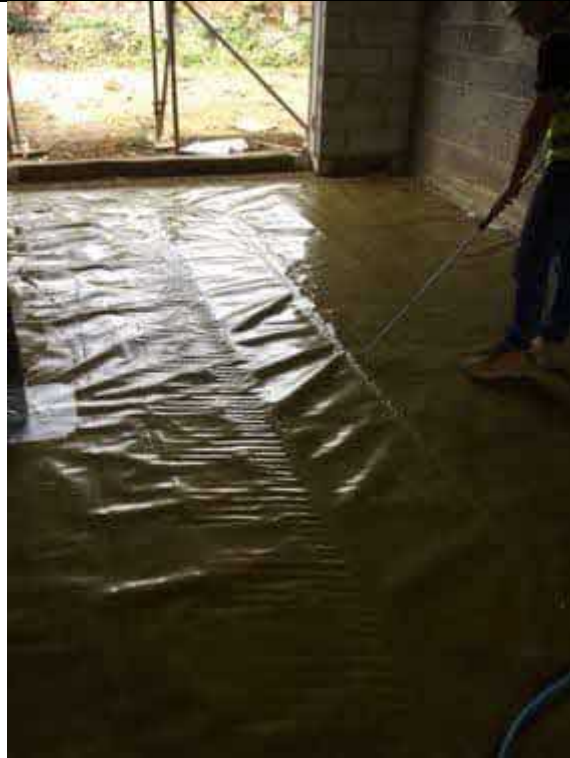
Overview to the air lance test in process to Plot 11.

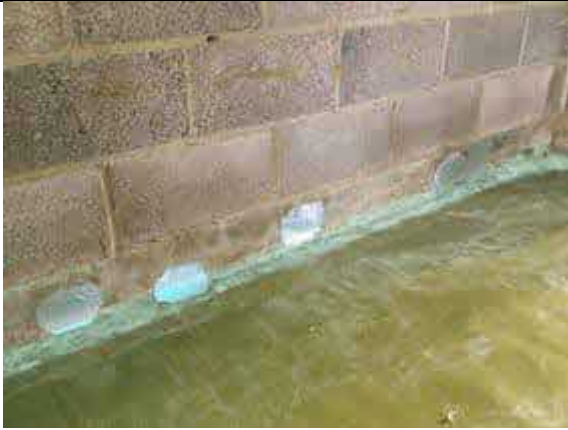
SAGM patches applied prior to inspection to the perimeter membrane within Plot 10.

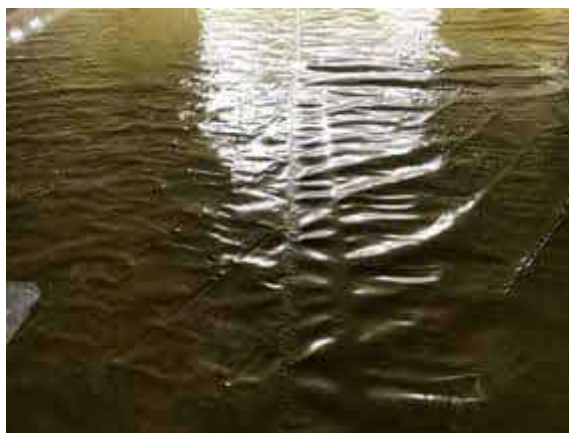
Plot 33 hand welded membrane lap.

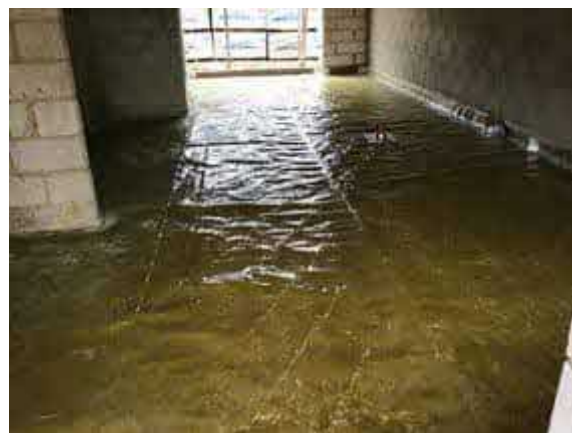
Plot 34 overview of installed Visqueen HC Blok Gas Barrier.

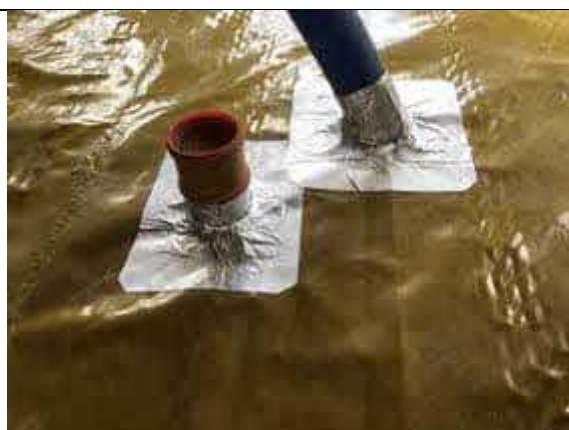
Plot 35 typical double pipe penetration seal using SAGM.

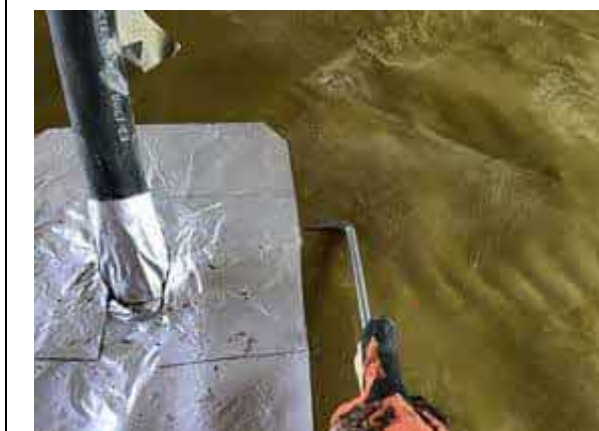
Plot 35 pick testing all SAGM detailing.

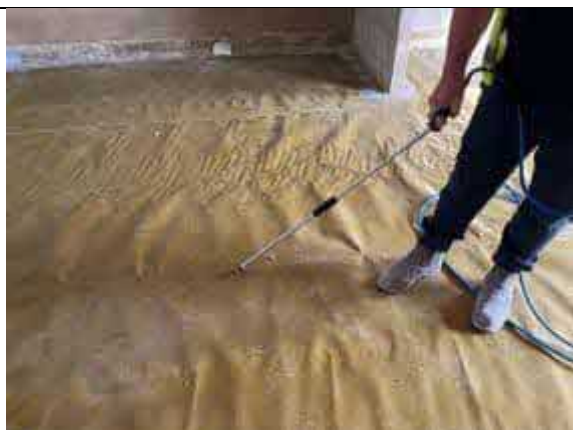
Plot 30 - Air lance test conducted upon all membrane lap joints.

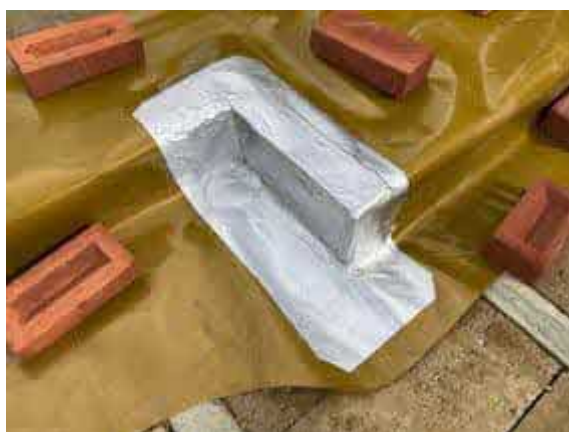
Plot 63 FOG Unit - Typical threshold detail sealed using SAGM.

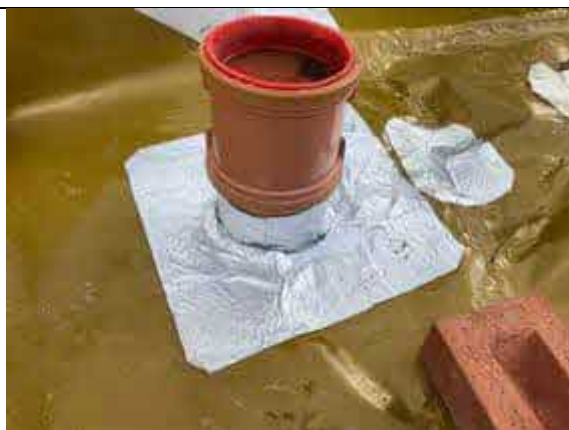
Plot 63 FOG Unit - Typical pipe penetration sealed using SAGM.

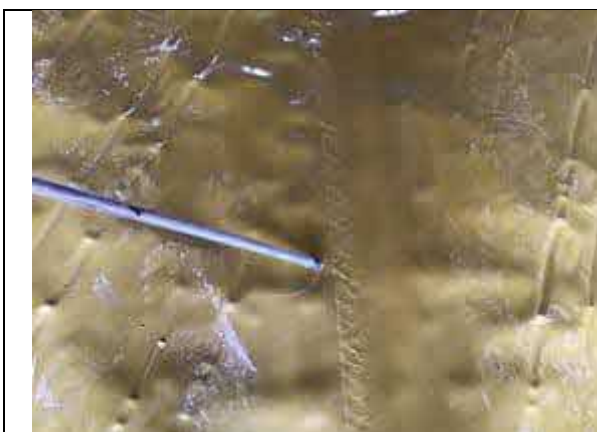
Plot 27 air lancing all weld laps.

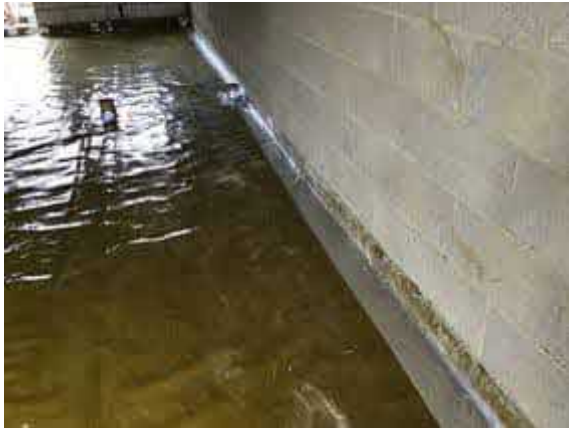
Plot 28 retro fit detail using SAGM.

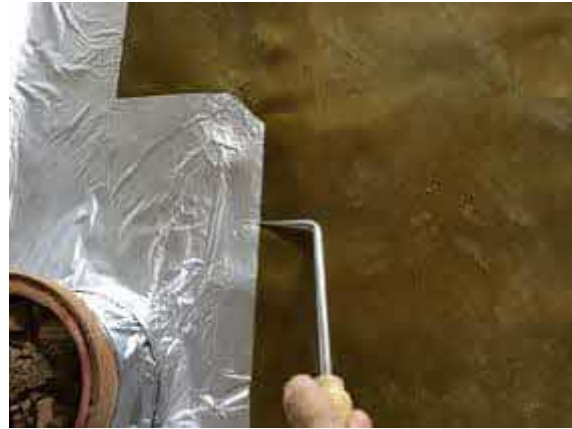
Plot 28 pick testing all SAGM detailing.

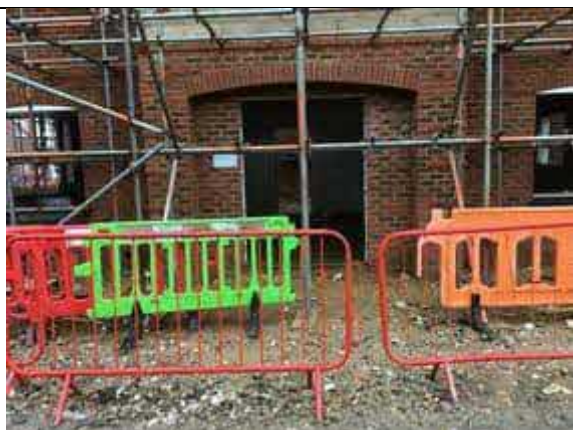
Overview of plot 41.

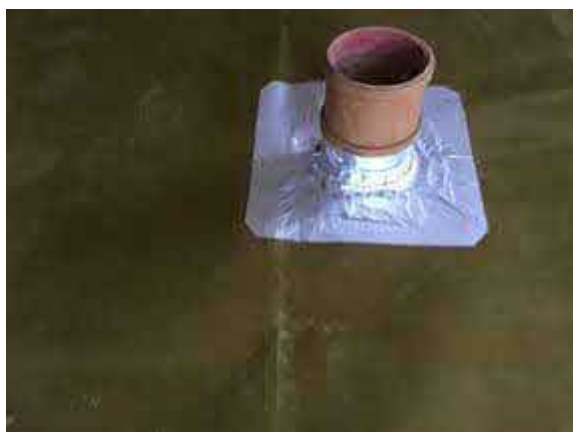
Typical pipe penetration seal using SAGM to plot 36.

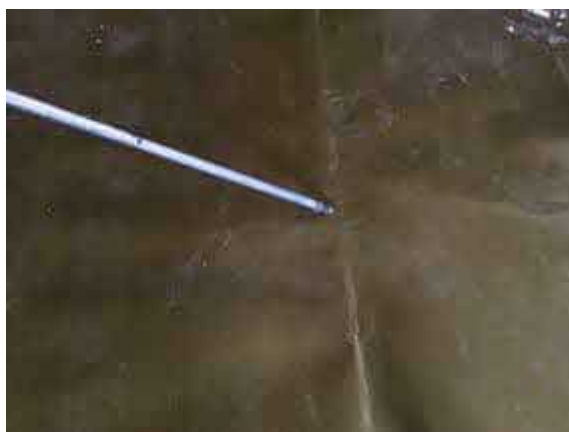
Air lancing all welded membrane laps to plot 37.

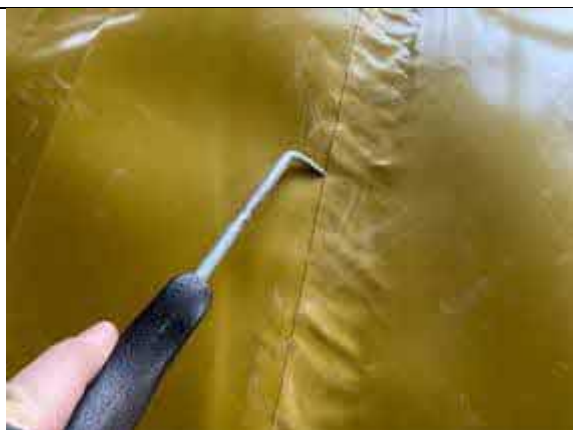
Plot 74. Pick test upon hand welded membrane lap joint.

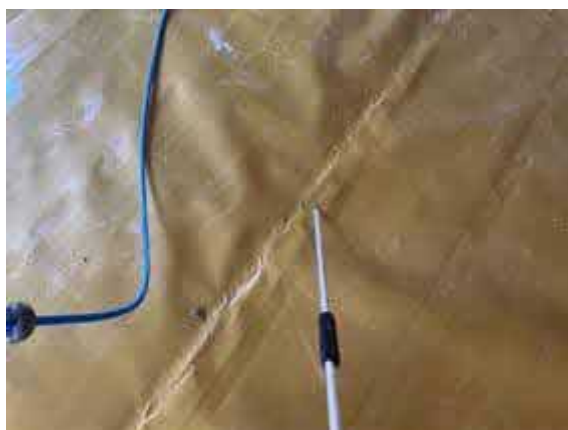
Plot 40. Air lance integrity conducted upon all welded membrane lap joints.

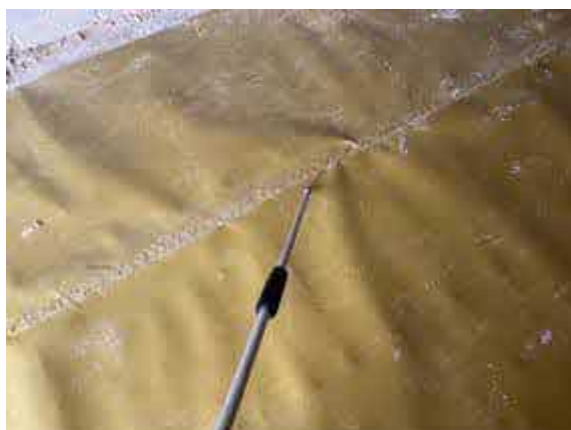
Plot 30 garage. Air lance integrity test upon welded lap joint.

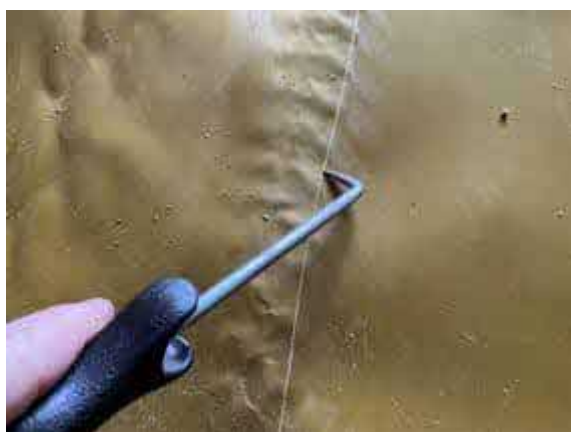
Plot 32 garage. Pick testing along hand welded lap joint.

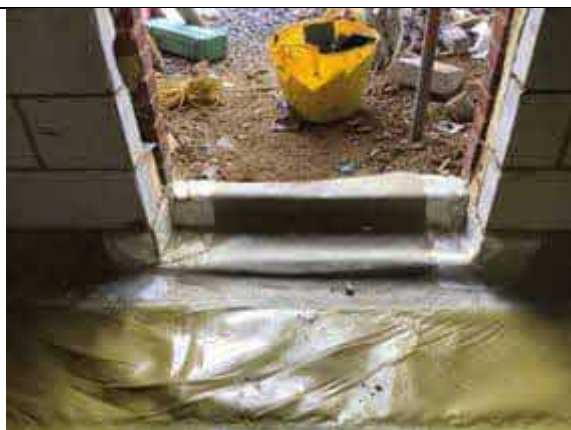
Typical door threshold seal using SAGM to plot 47.

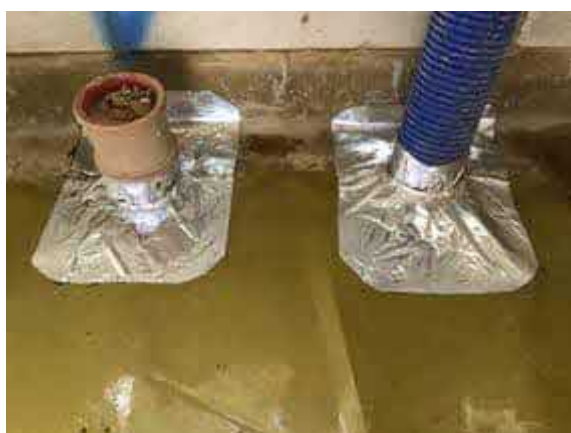
Typical double pipe penetration seal using SAGM to plot 48.

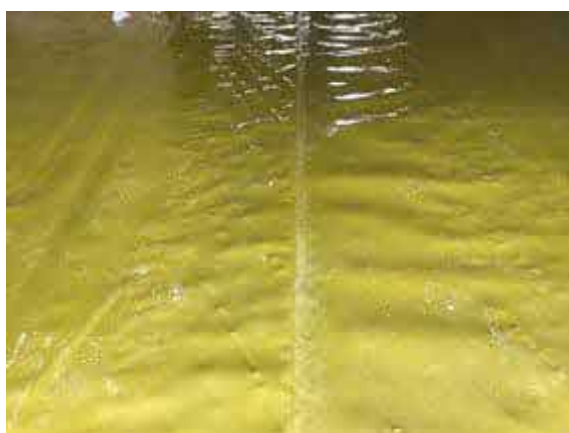
Hand welded membrane lap to plot 48.

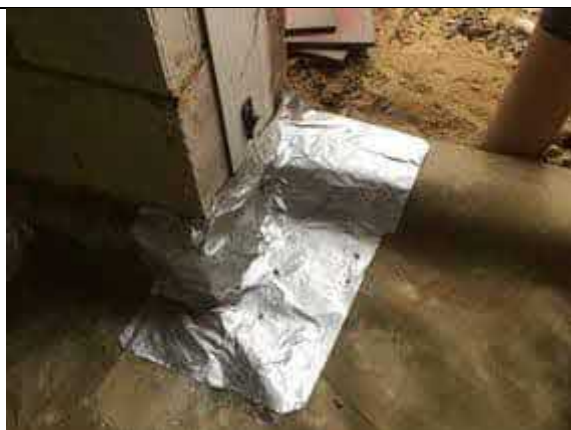
Sealed door threshold detail using SAGM to plot 64.

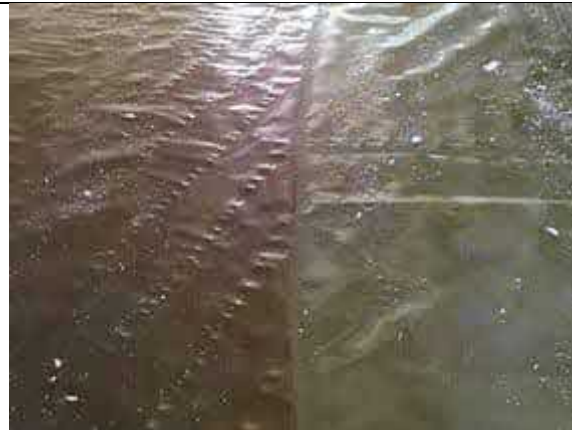
Hand welded membrane lap to plot 65.

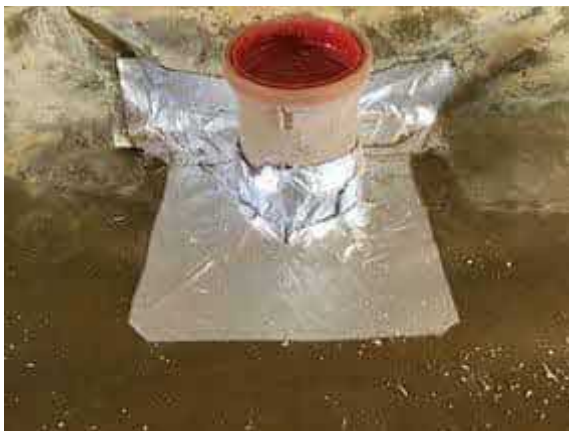
Typical pipe penetration seal using SAGM to plot 65.

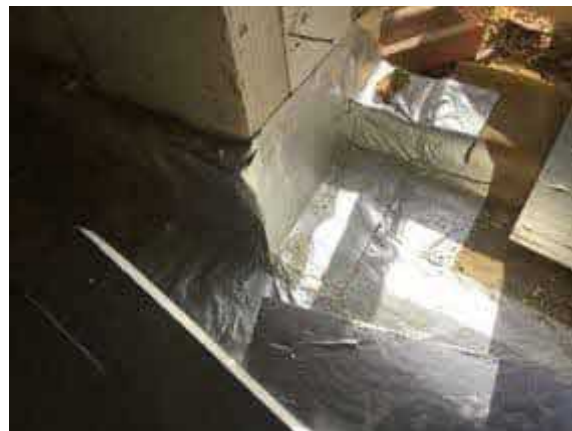
Re sealed door threshold detail using SAGM to plot 65.

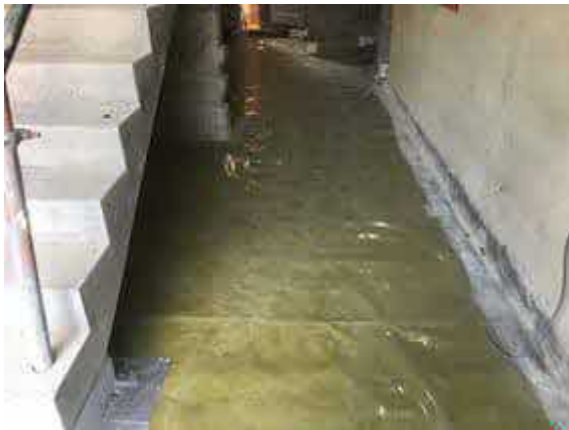
Over of installed membrane to apartment block c entrance lobby.

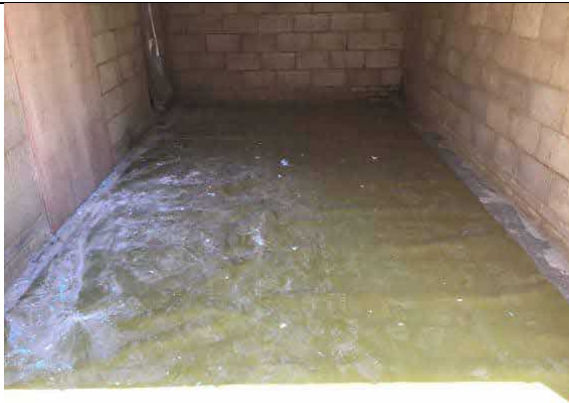
Overview of installed membrane to the garage, as an infill to plot 40.

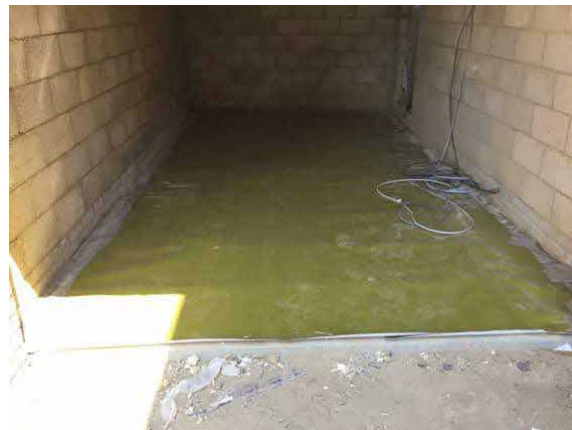
Overview of installed membrane to the garage in plot 41.

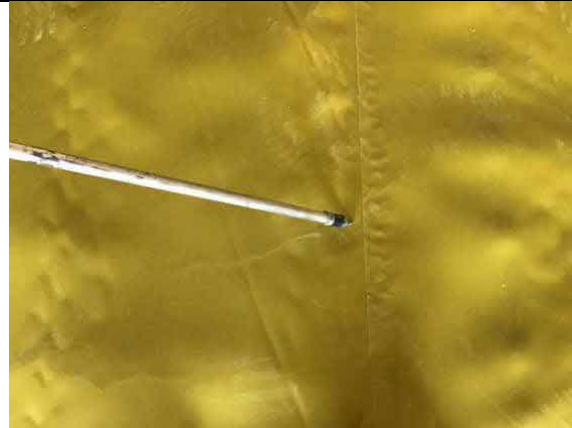
Air lancing all hand welded membrane laps in apartment block H.

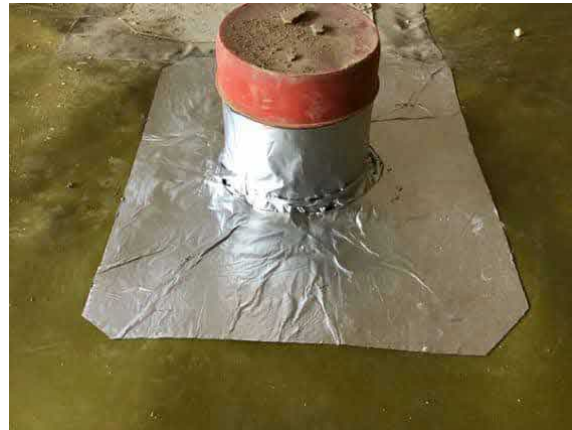
Typical pipe penetration seal using SAGM in apartment block H.

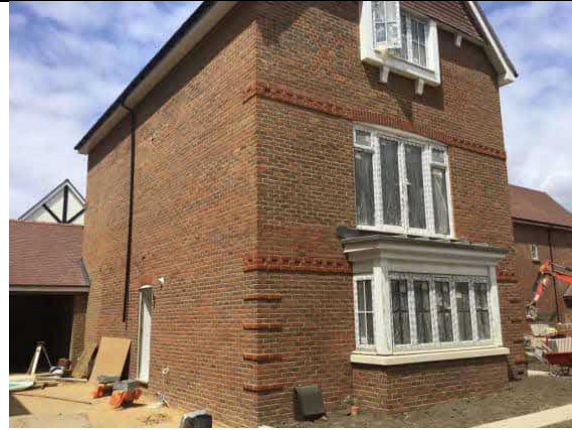
Overview of plot 74.

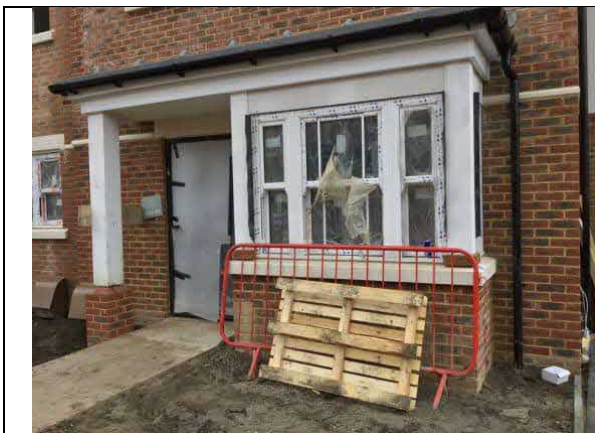
Overview of plot 45.

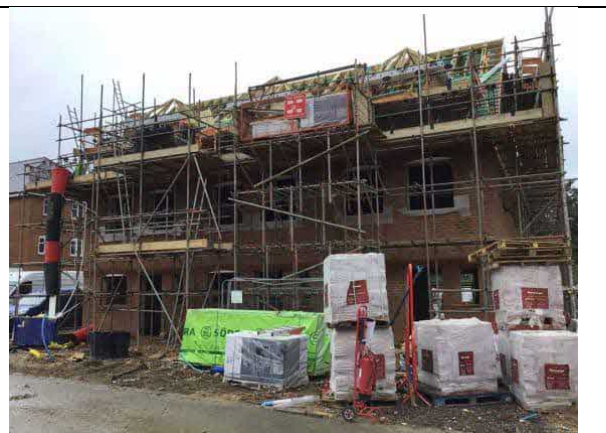
Overview of plots 51-53.

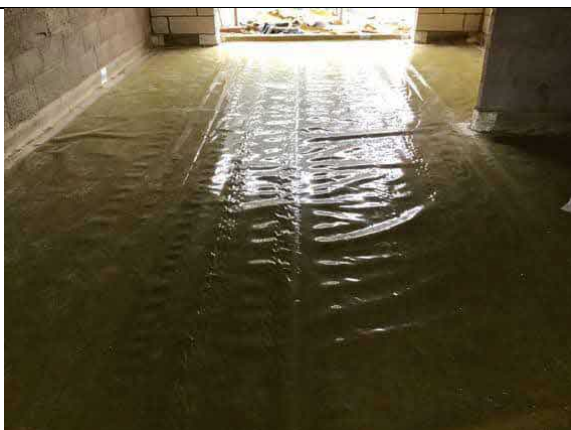
Hand welded membrane lap in plot 51.

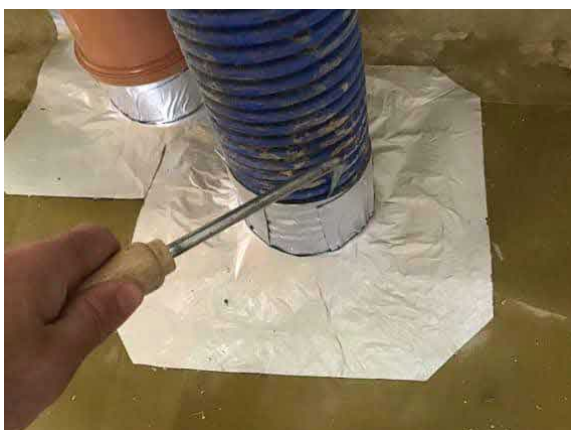
Pick testing all SAGM detailing in plot 52.
