Validation Letter

Date: 18 October 2023

Our Ref: M41977-JNP-XX-XX-RP-G-0021-P01

Re: Former Sunninghill Gas Works – Validation of Capping Layer for Plot 42 (Block C)

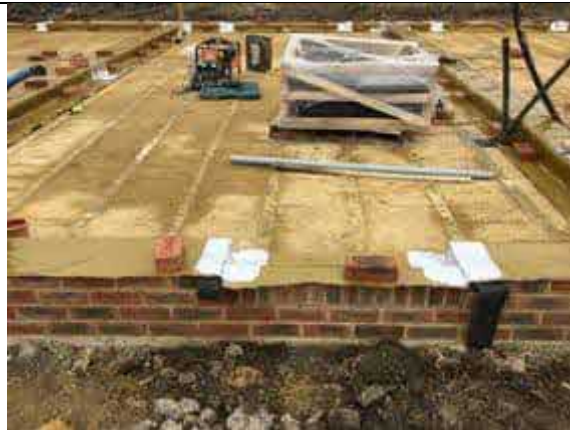
Plot 5 overview of installed membrane to the perimeter and party walls.

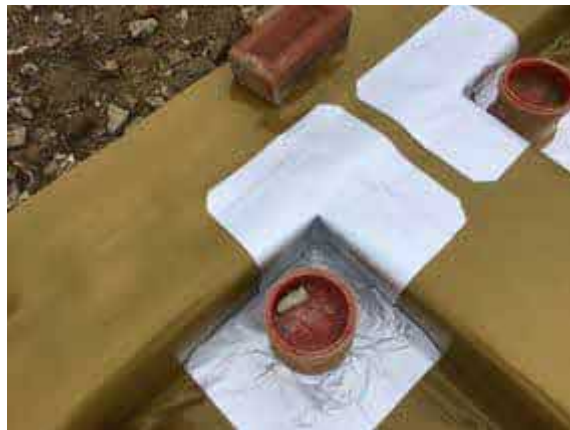
Plot 5 typical corner and pipe penetration seal using SAGM.

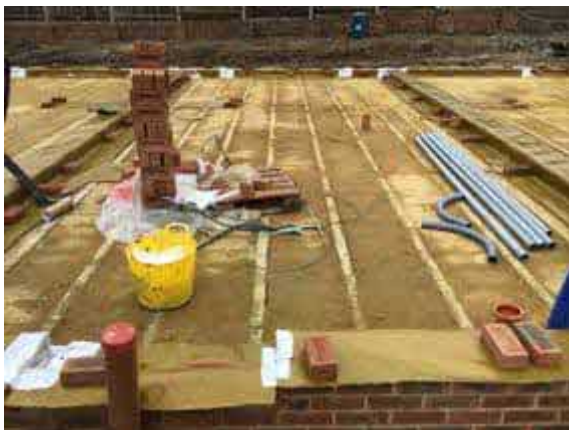
Plot 6 overview of installed membrane.

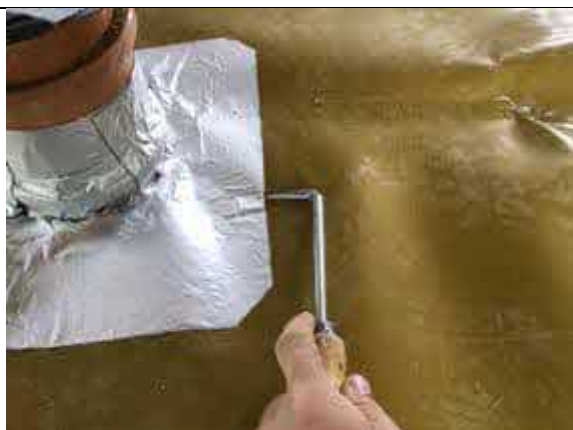
Pick testing all SAGM detailing.

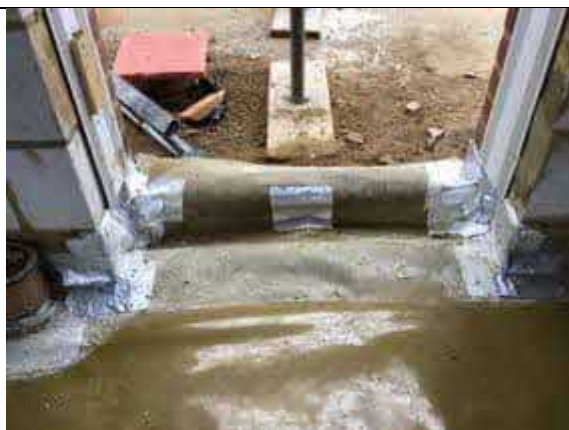
Door threshold seal using SAGM.

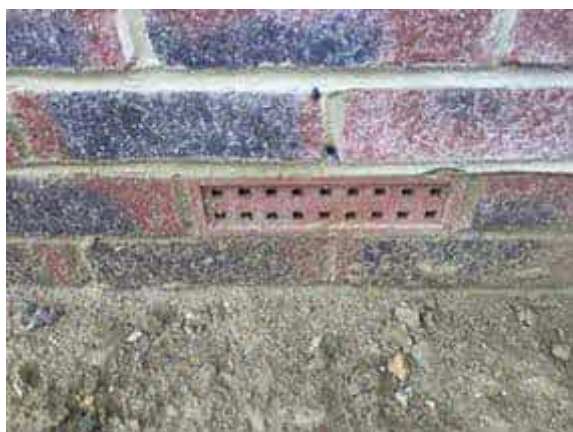
Air brick in place at the time of our inspection.

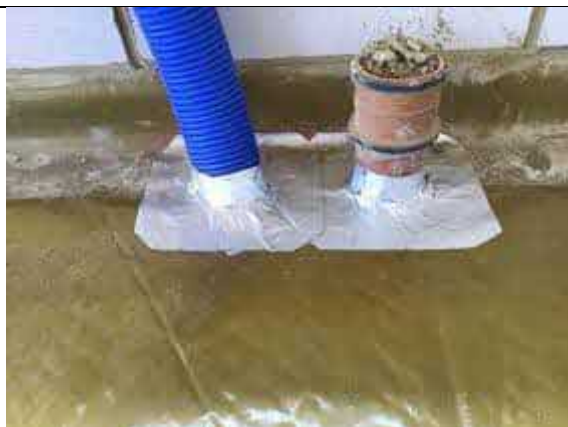
Plot 75 typical double pipe penetration seal using SAGM.

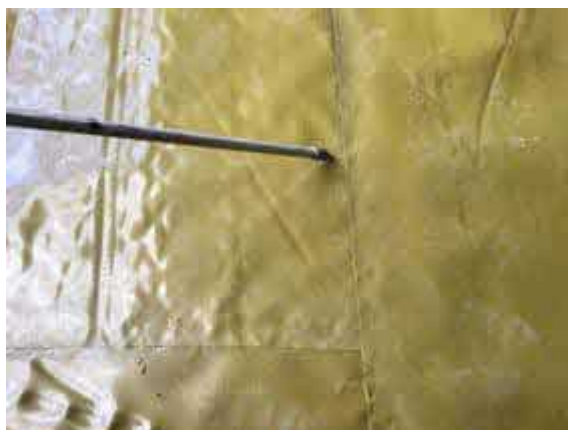
Plot 75 air lancing all weld laps and SAGM detailing.

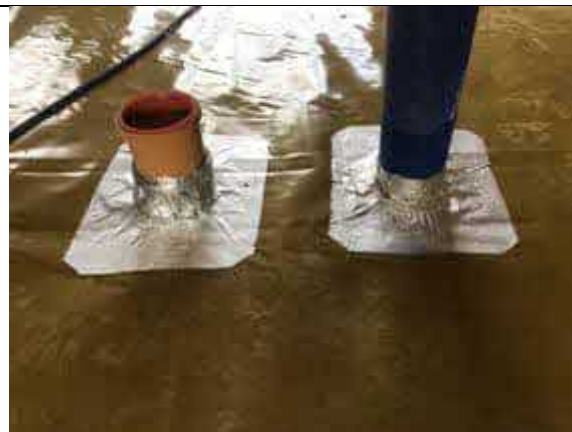
Plot 7 typical double pipe penetration seal using SAGM.

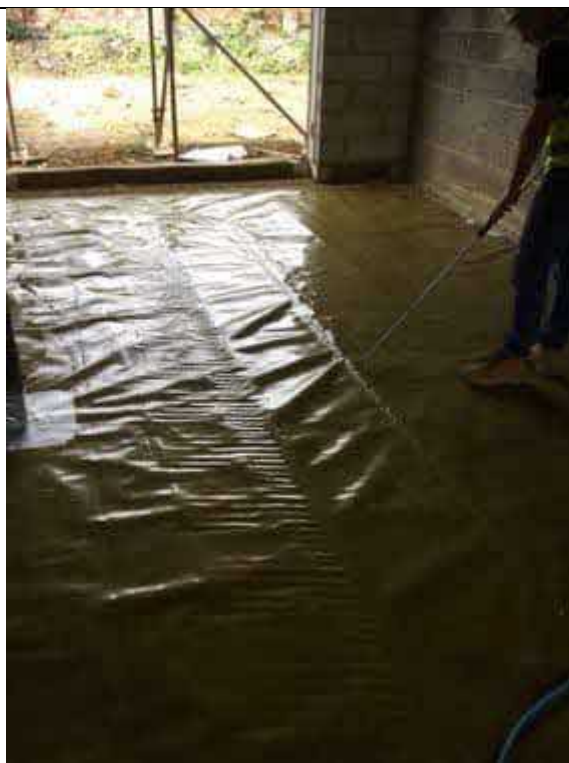
Overview to the air lance test in process to Plot 11.

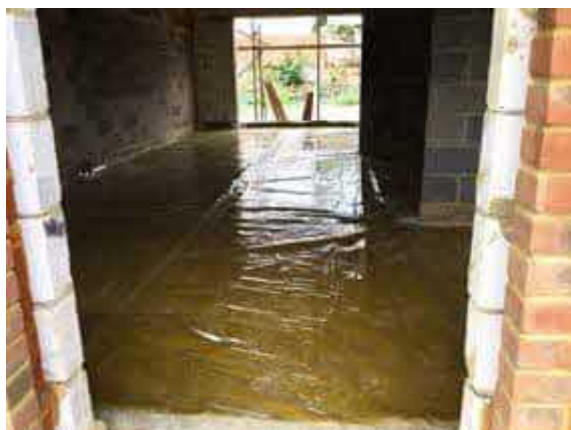
Plot 10 overview.

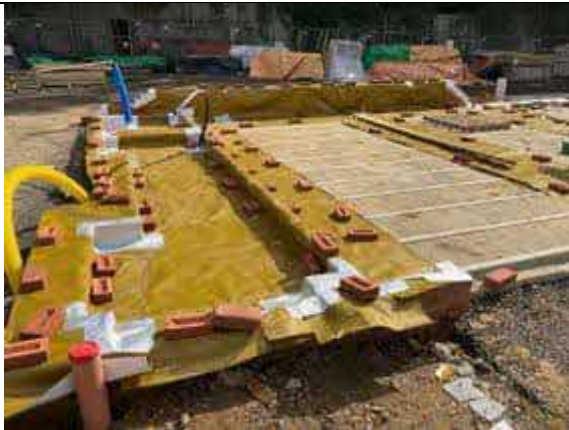
Plot 63 FOG Unit - Overview of Installation of Visqueen Ultimate HC Blok.

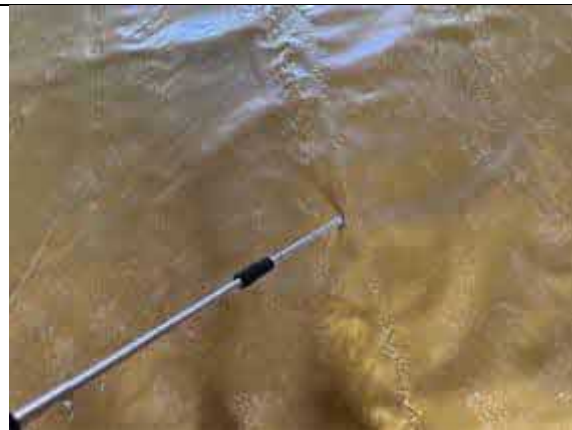
Plot 29 - Air lance integrity test upon a hand welded membrane lap joint.

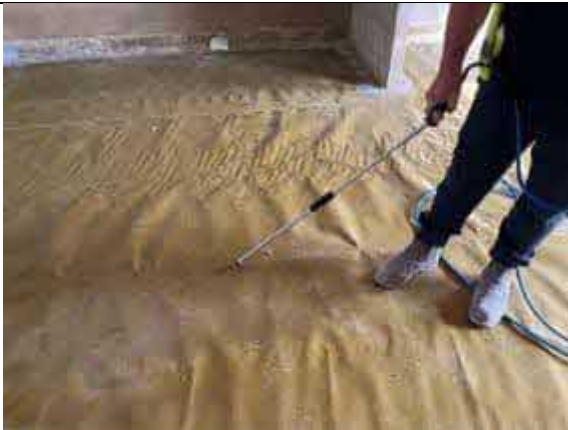
Plot 30 - Air lance test conducted upon all membrane lap joints.

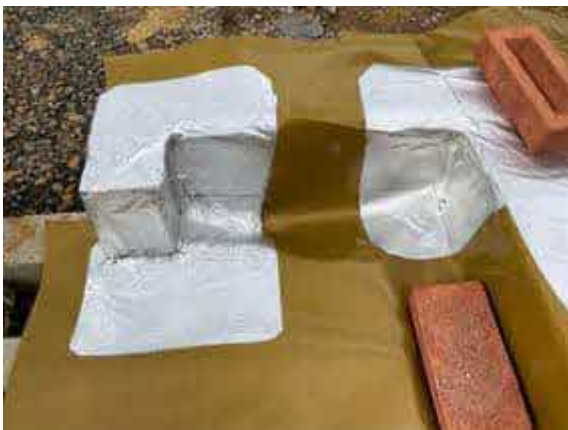
Plot 63 FOG Unit - Corner detailing sealed using SAGM.

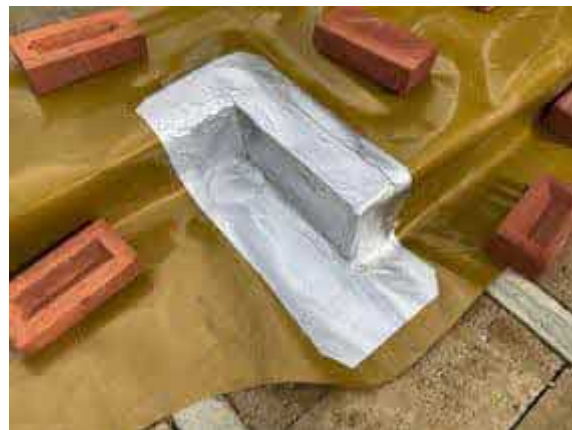
Plot 63 FOG Unit - Typical threshold detail sealed using SAGM.

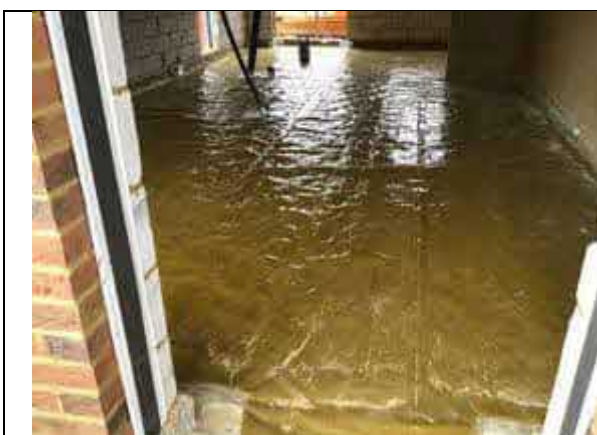
Overview of installed membrane to plot 27.

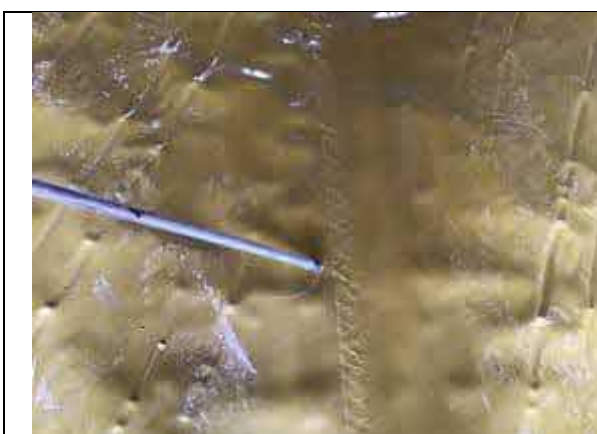
Plot 27 air lancing all weld laps.

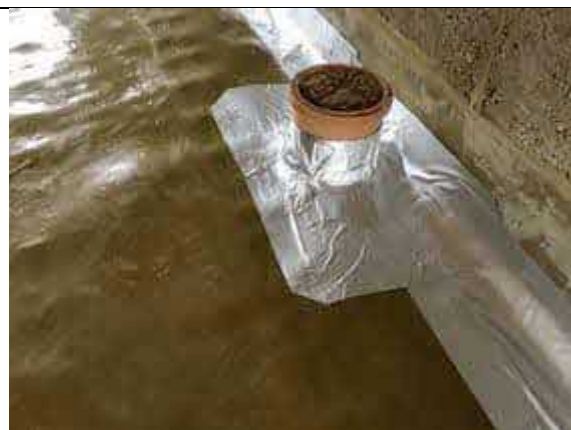
Plot 28 typical pipe penetration seal using SAGM.

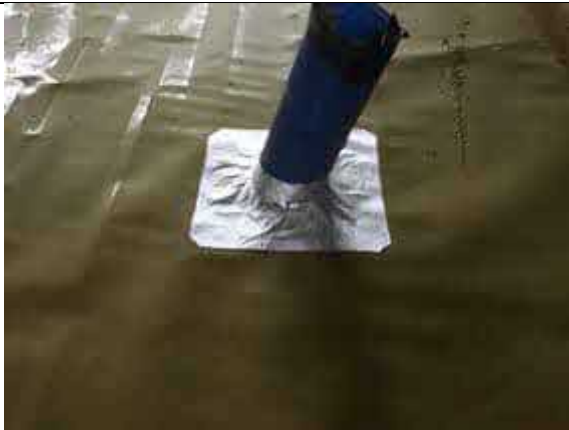
Typical pipe penetration seal using SAGM to plot 39.

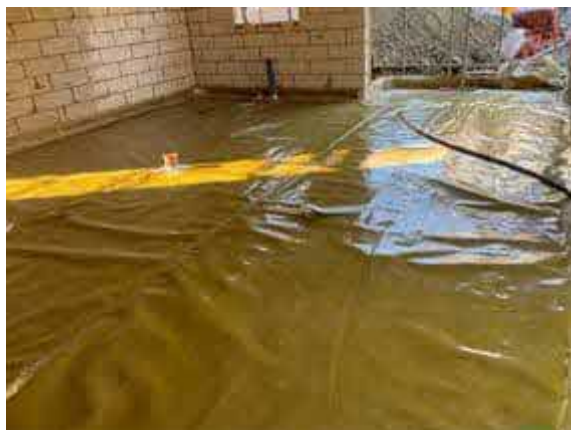
Plot 74. Overview of installation of Visqueen HC Blok gas barrier.

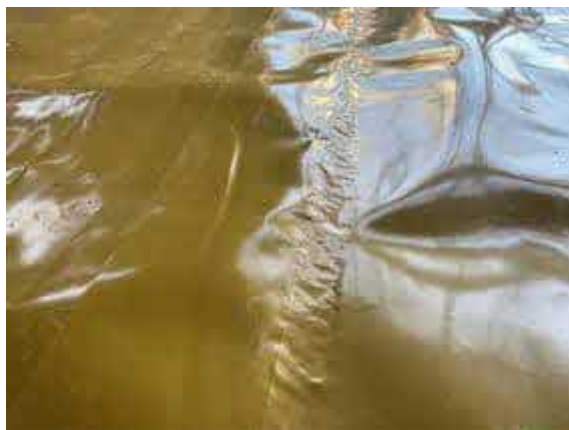
Plot 74. Hand welded membrane lap joint.

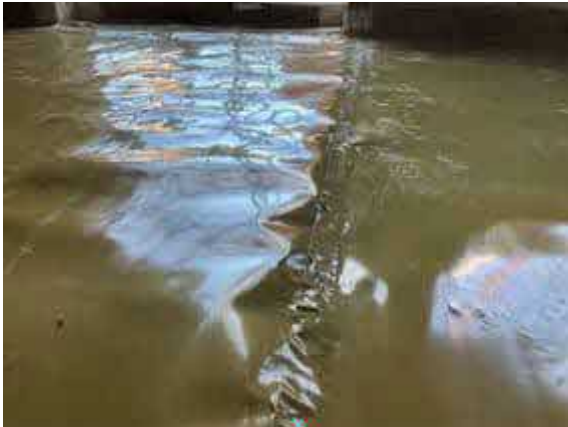
Plot 40. Hand welded membrane lap joint.

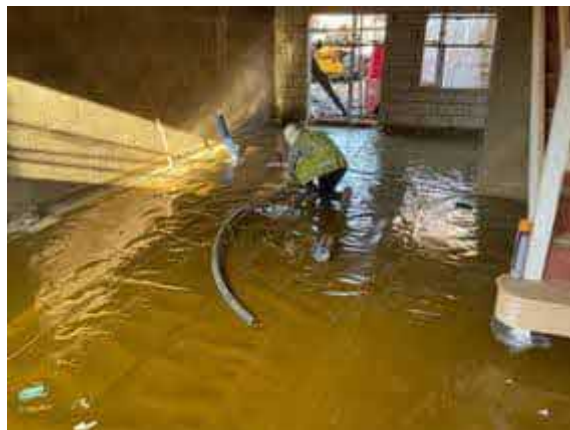
Plot 40. Overview of installation of Visqueen HC Blok gas barrier.

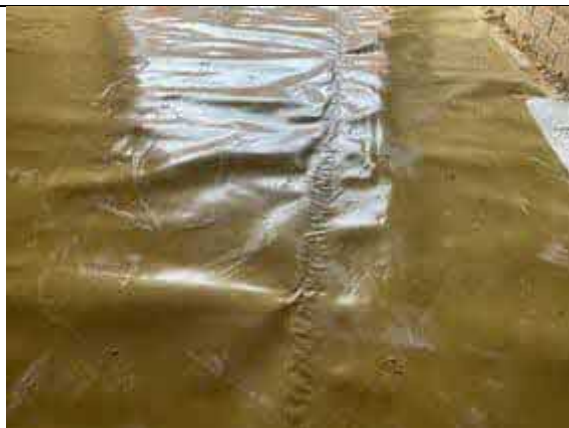
Plot 30 garage. Overview of a hand welded membrane lap joint.

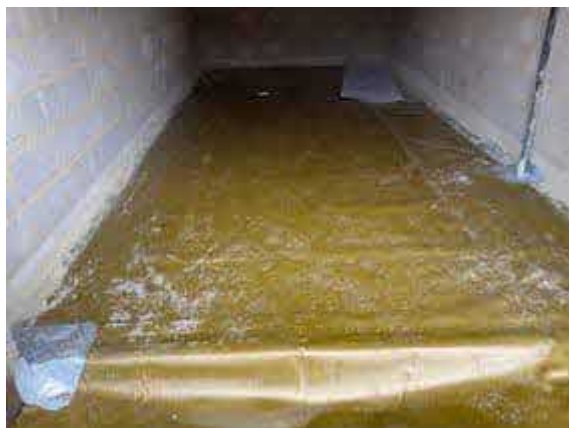
Overview of Visqueen HC Blok infill installation to Plot 32 FOG Unit Garage.

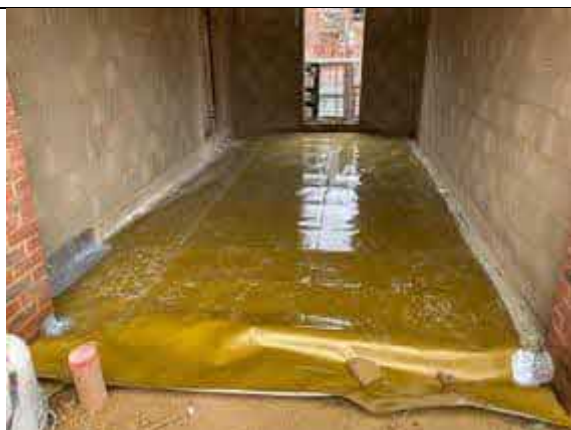
Overview of Visqueen HC Blok infill installation to Plot 35 Garage.

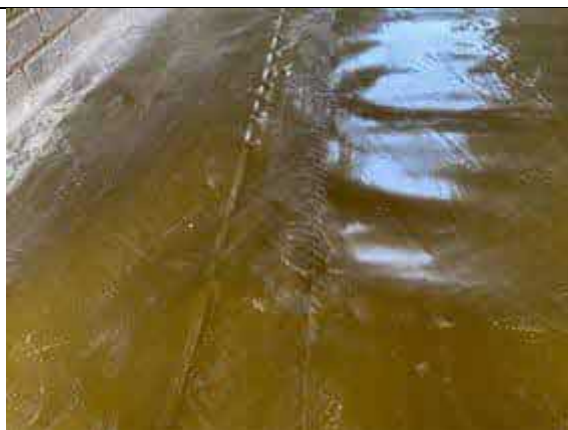
Plot 35 garage. Overview of a hand welded membrane lap joint.

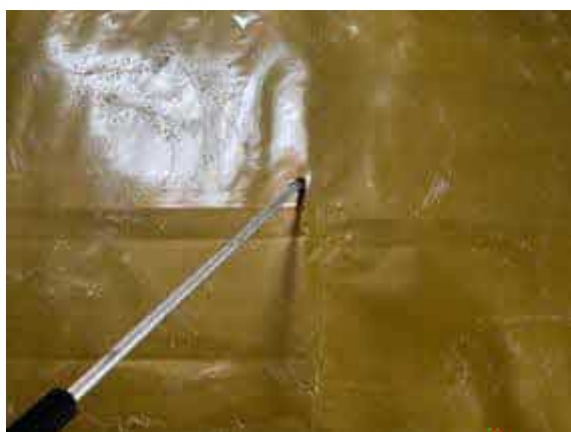
Plot 72. Air lance integrity test conducted upon hand welded lap joint.

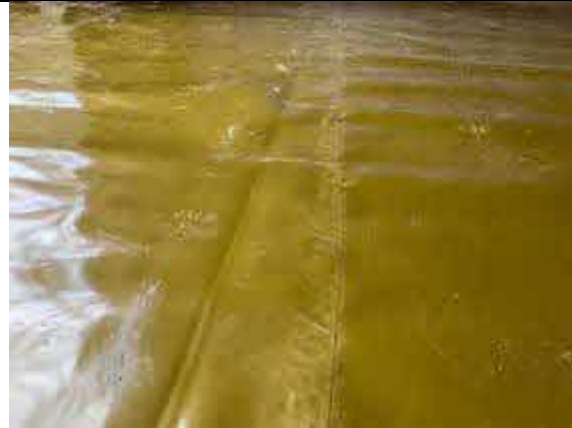
Plot 72. Overview of a hand welded membrane lap joint.

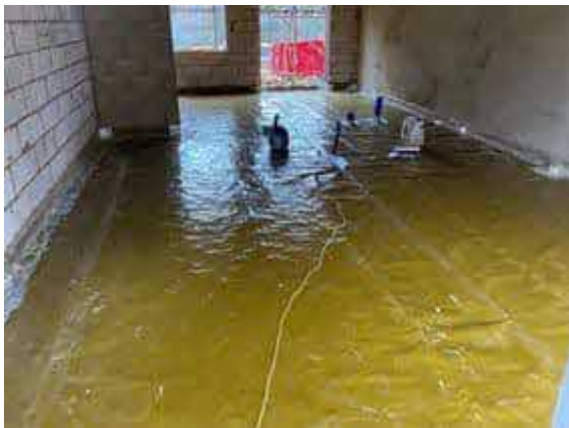
Overview of Visqueen HC Blok infill installation to Plot 70.

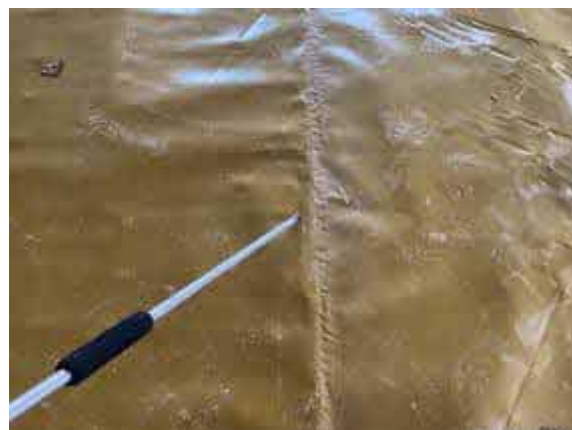
Plot 70. Air lance integrity testing along hand welded lap joint.

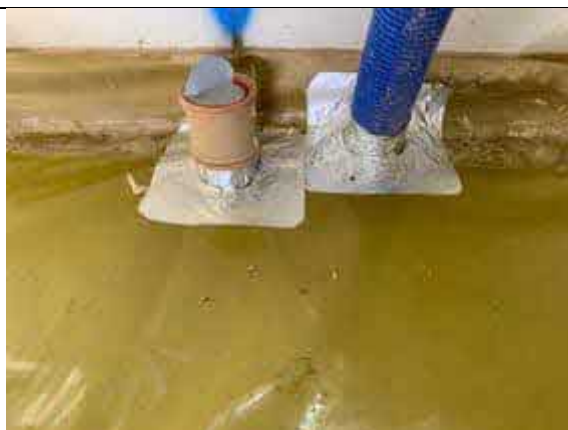
Plot 43 typical double pipe penetration seal using SAGM.

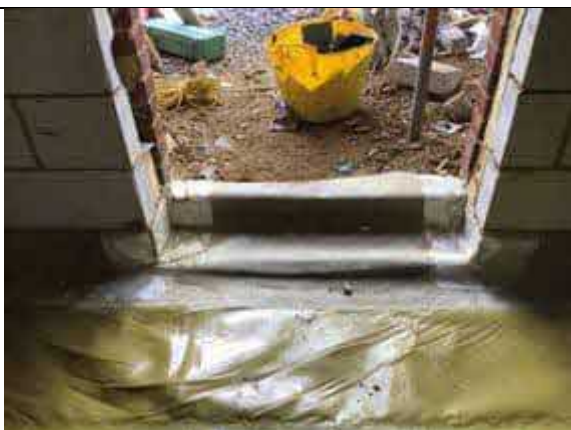
Typical door threshold seal using SAGM to plot 47.

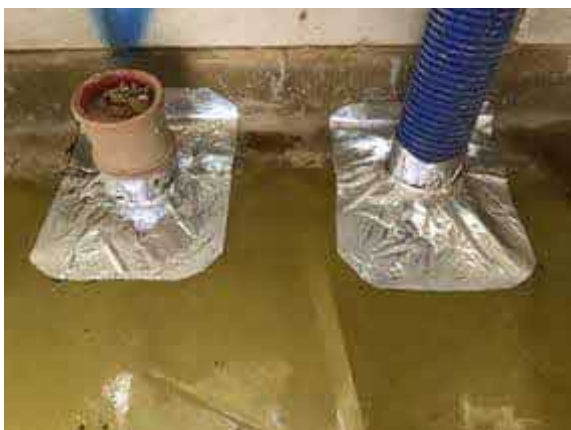
Typical double pipe penetration seal using SAGM to plot 48.

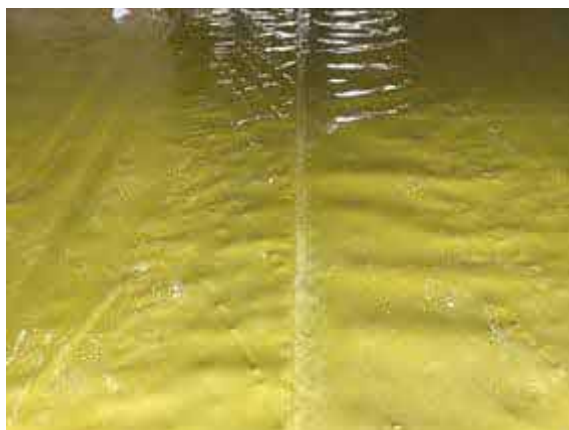
Hand welded membrane lap to plot 48.

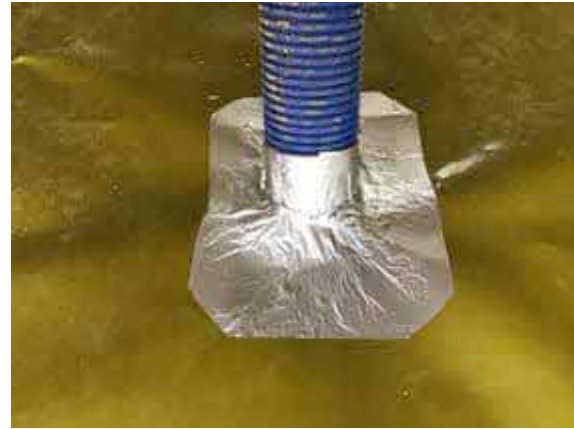
Typical pipe penetration seal using SAGM to plot 50.

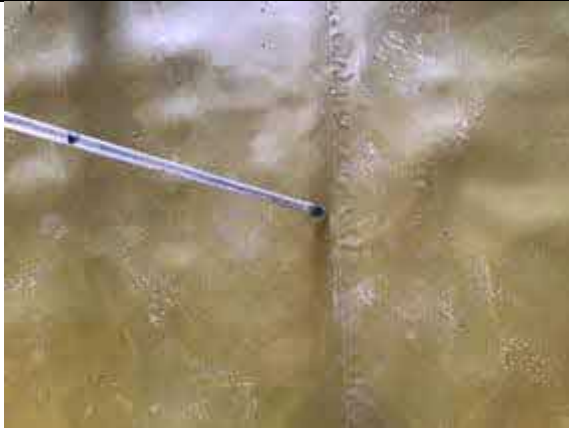
Air lancing all hand welded membrane laps to plot 66.

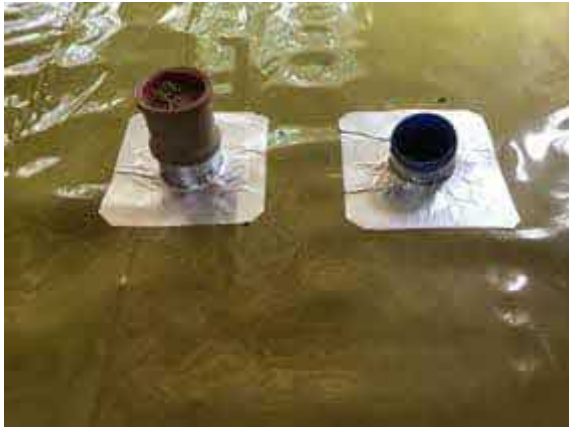
Sealed double pipe penetrations using SAGM to plot 67.

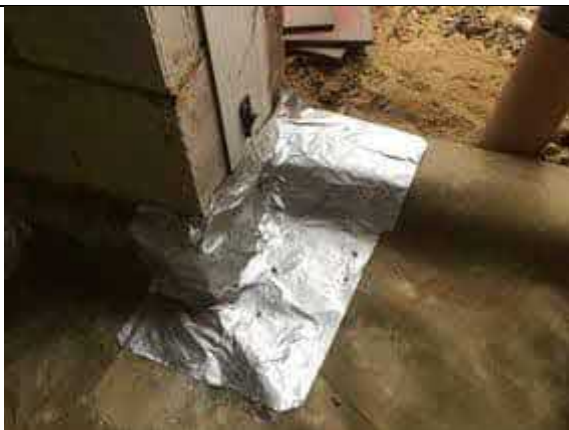
Sealed door threshold detail using SAGM to plot 64.

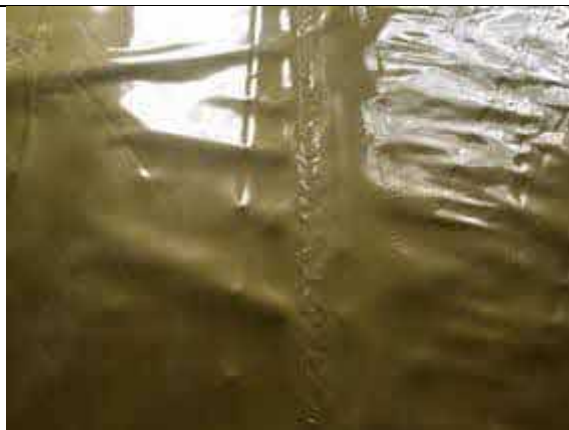
Hand welded membrane lap to plot 64.

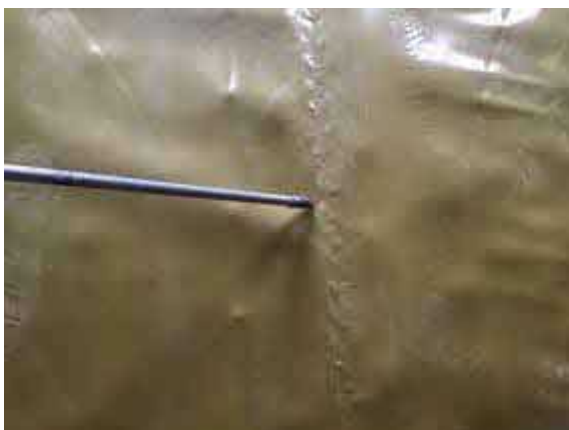
Air lancing all hand welded membrane laps to plot 64.

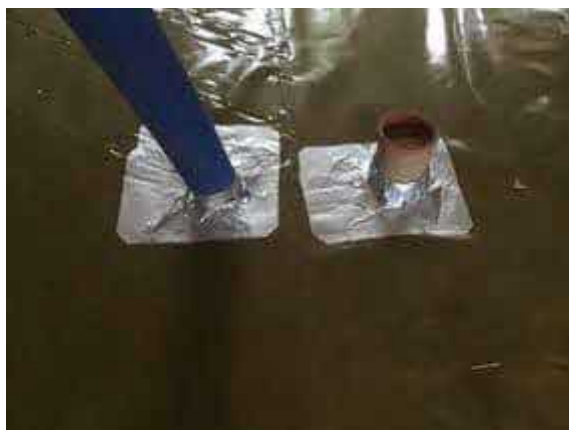
Typical double pipe penetration seal using SAGM to plot 64.

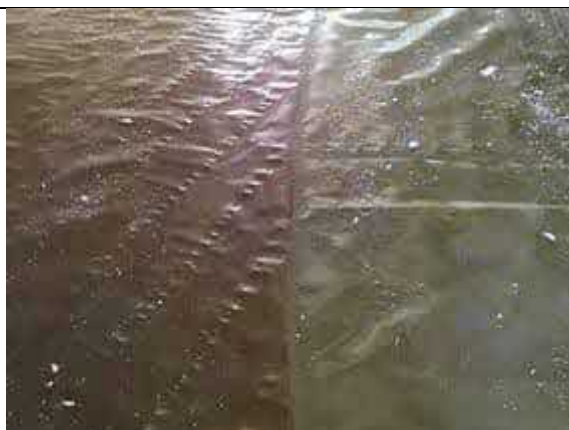
Hand welded membrane lap to plot 65.

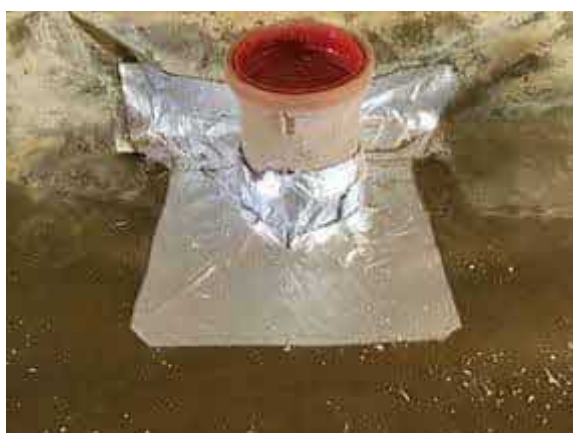
Typical pipe penetration seal using SAGM to plot 65.

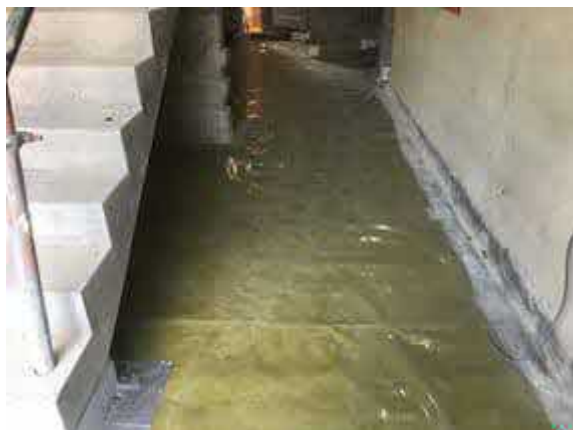
Over of installed membrane to apartment block c entrance lobby.

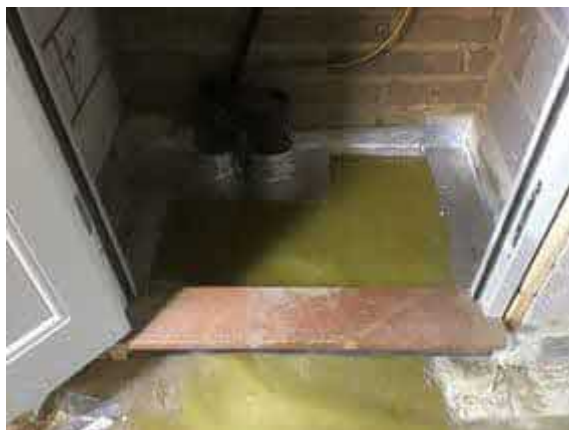
Sealed pipe penetrations in riser cupboard to apartment block c.

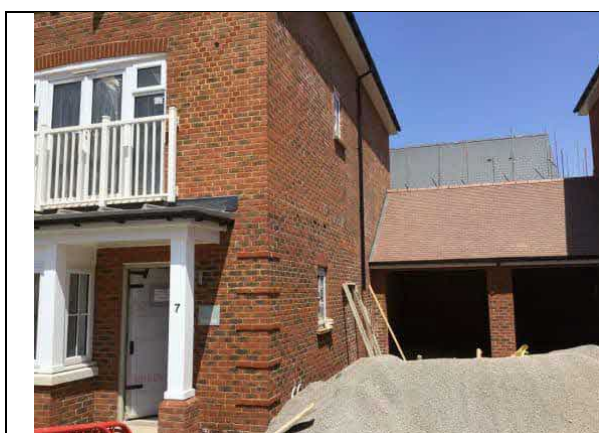
Overview of plot 40.

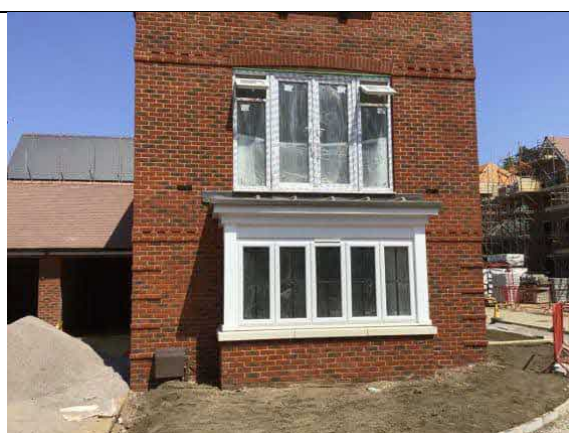
Overview of plot 41.

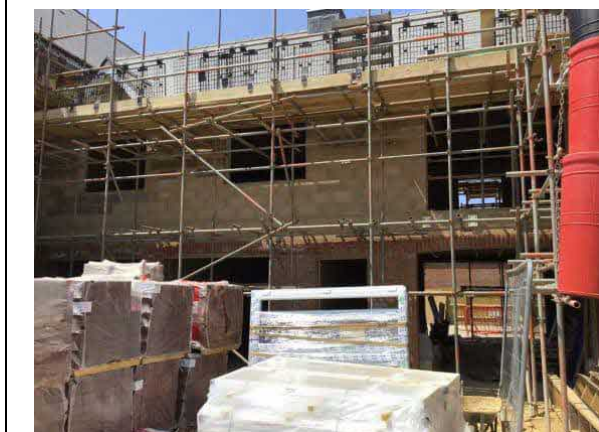
Overview of flat over garage plot 46.

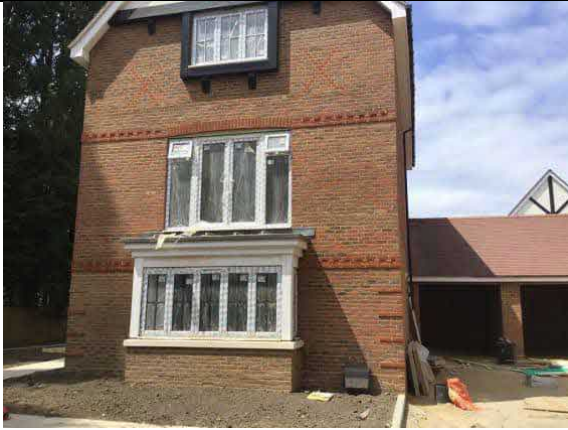
Overview of plot 73.

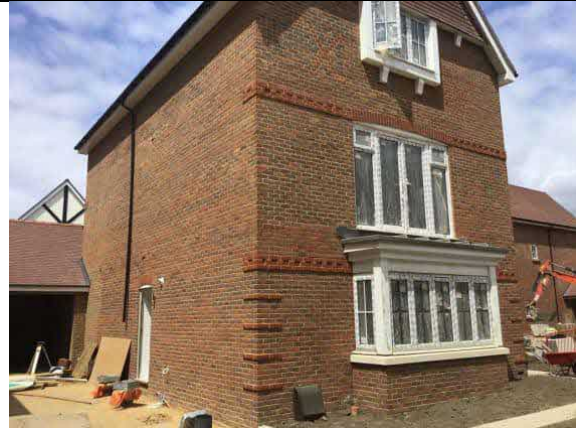
Overview of plot 74.

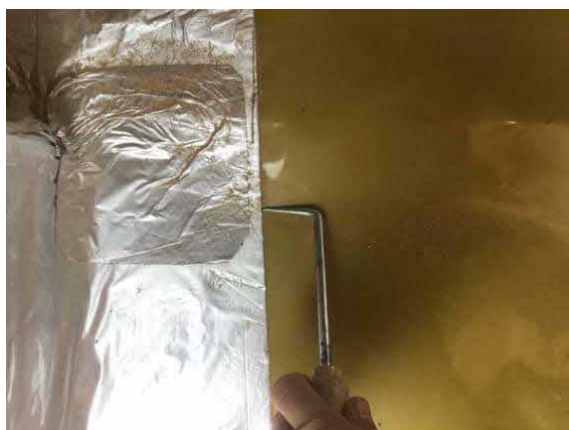
Pick testing all SAGM detailing.

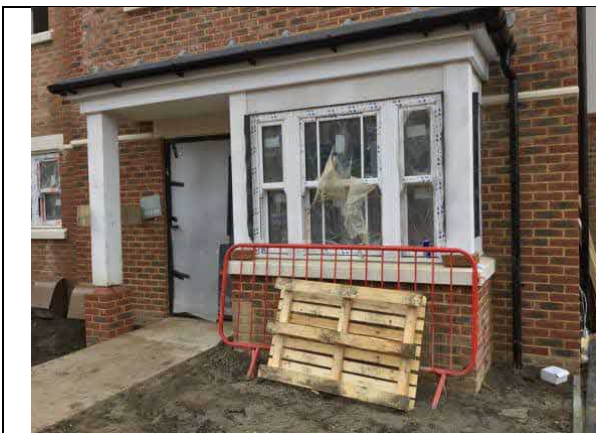
Overview of plot 45.

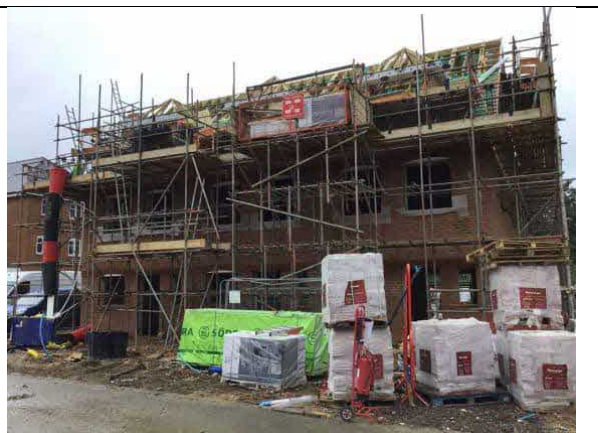
Overview of plots 51-53.

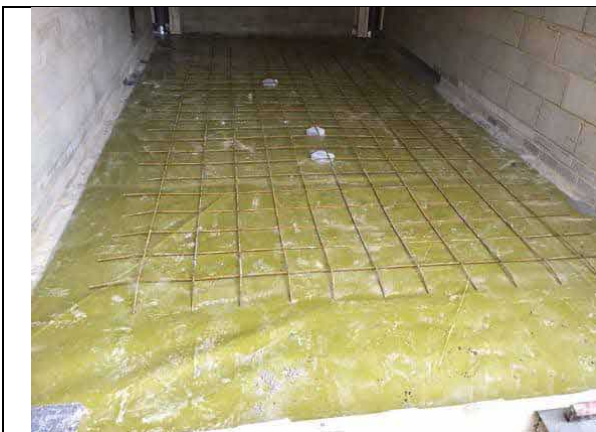
Overview of installed membrane to garage area in plot 45.

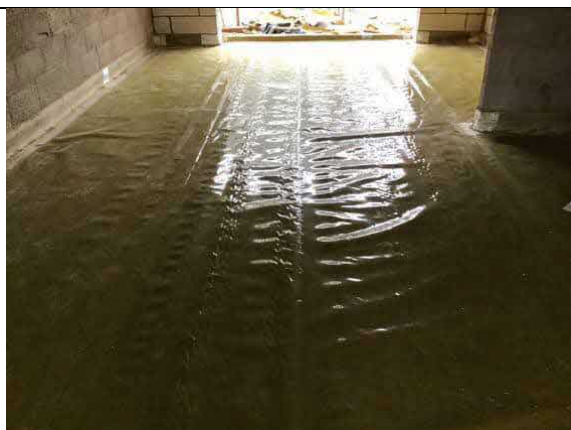
Hand welded membrane lap in plot 51.

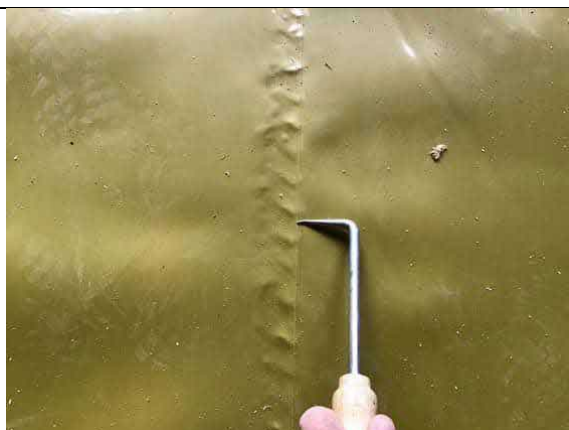
Pick testing all hand welded membrane laps in plot 51.

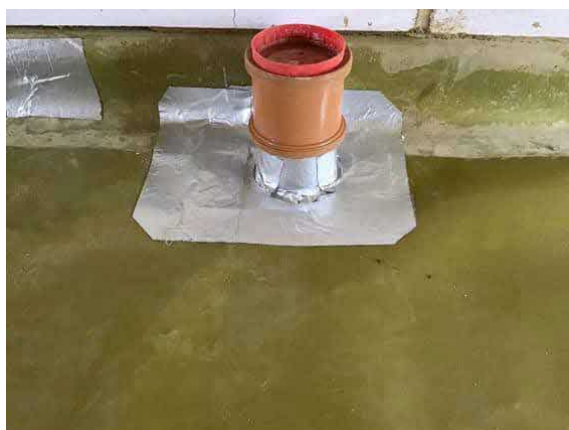
Typical pipe penetration seal using SAGM in plot 52.

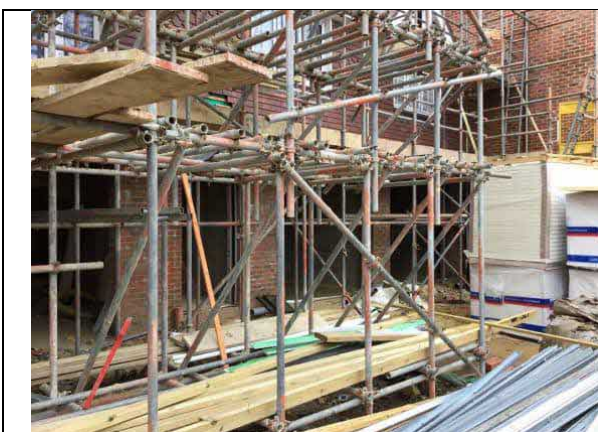
Overview of plots 63 & 64.

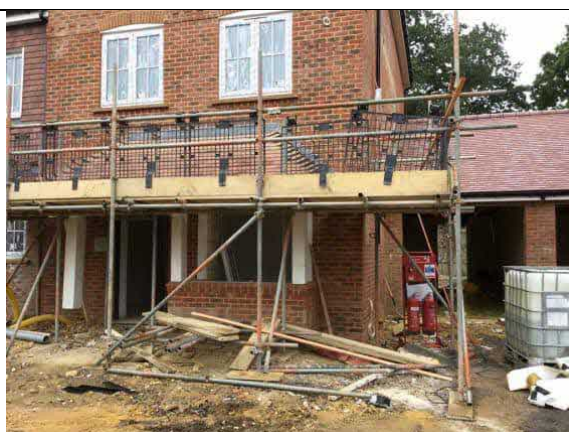
Overview of plot 67.

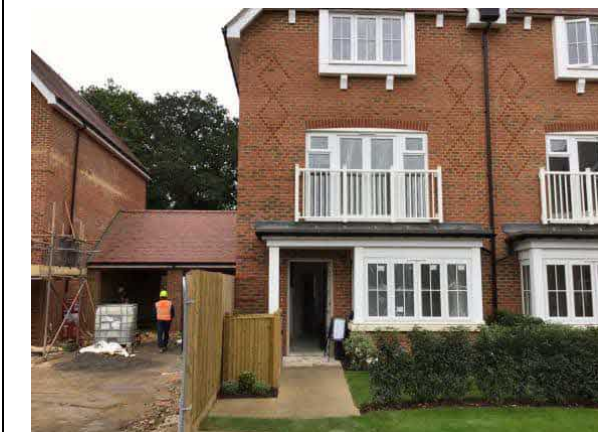
Overview of plot 68.
