Validation Letter

Our Ref: M41977-JNP-XX-XX-RP-G-0027-P01

Re: Former Sunninghill Gas Works – Validation of Capping Layer for Plots 64-67 inclusive (Block I)

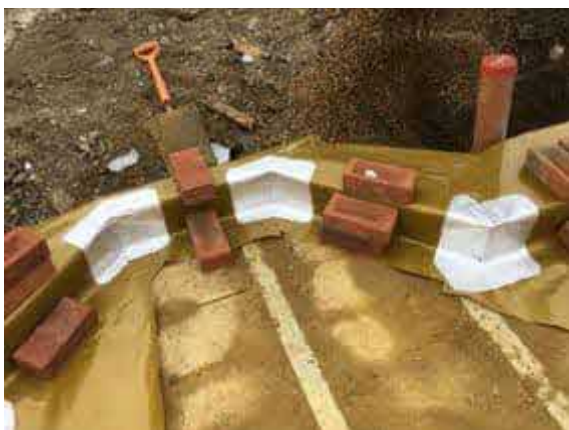
Plot 7 typical bay window corner seals using SAGM.

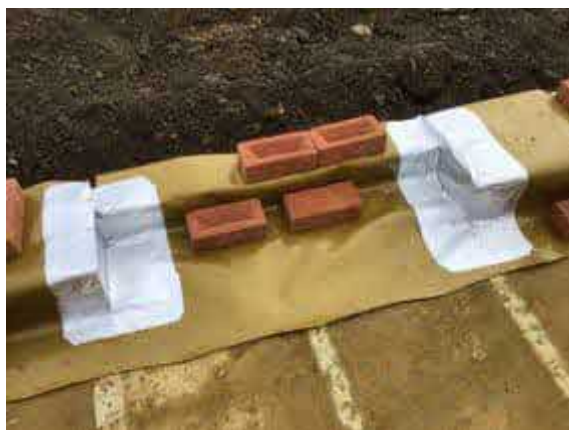
Plot 7 typical door seal using SAGM.

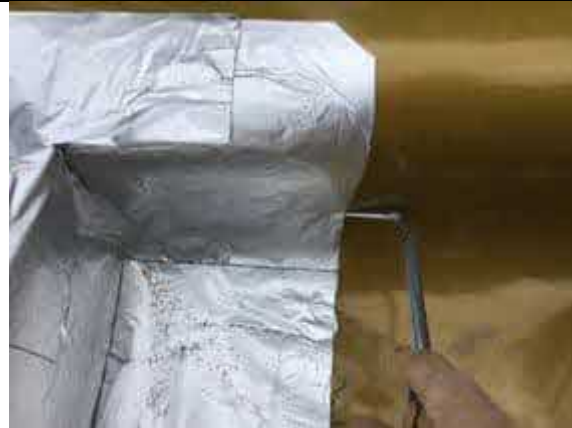
Plot 74 pick testing all SAGM detailing.

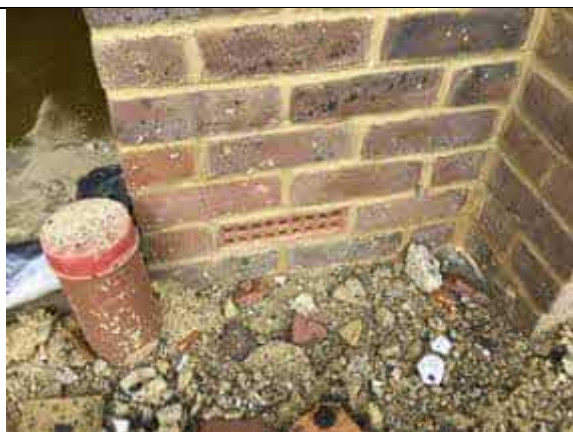
Plot 76 air brick in place at the time of our inspection.

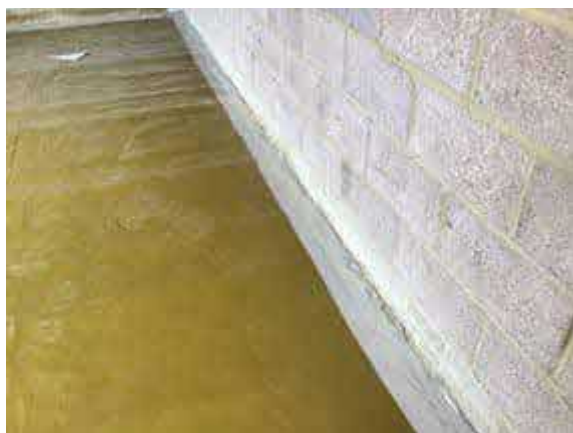
Plot 76 picture framing detail using SAGM to internal block work wall.

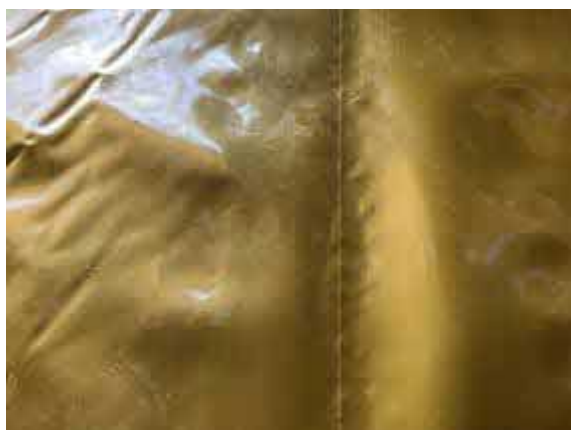
Plot 4 hand welded membrane lap.

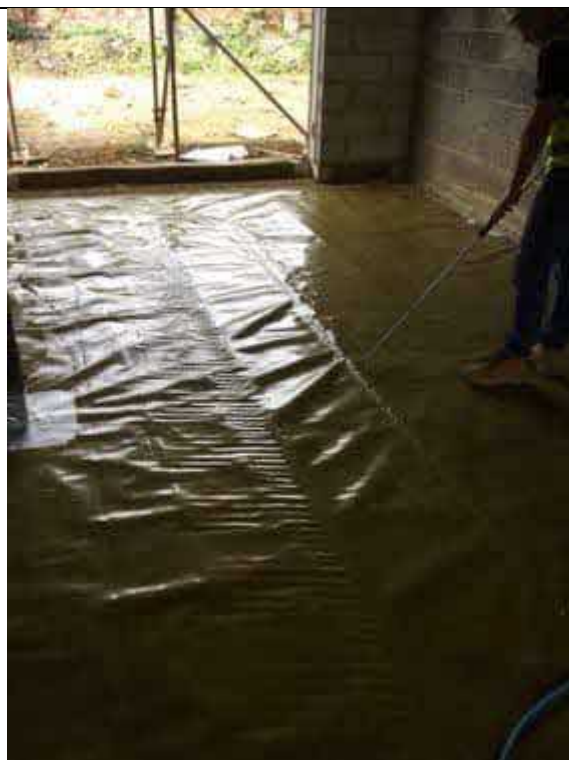
Overview to the air lance test in process to Plot 11.

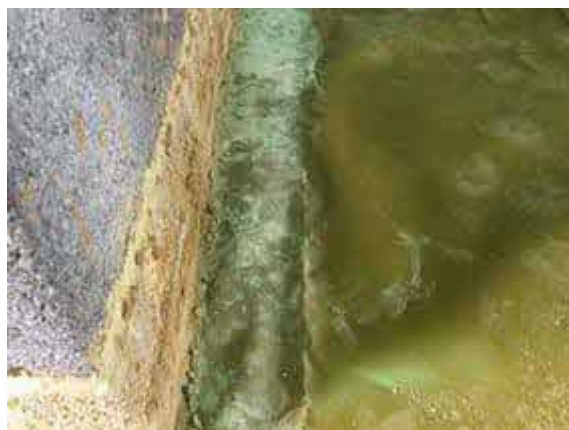
Overview to the perimeter membrane welded to the infill membrane.

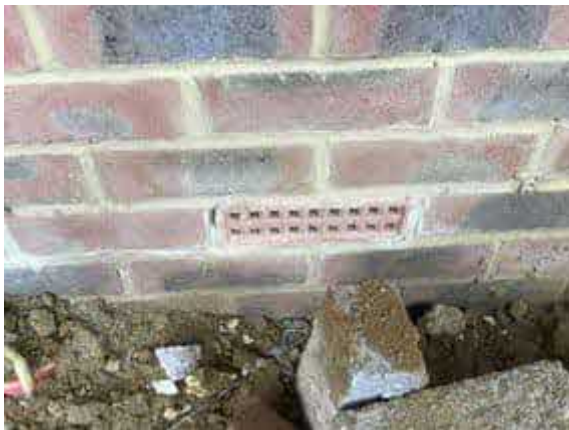
Air brick in place at the time of our inspection.

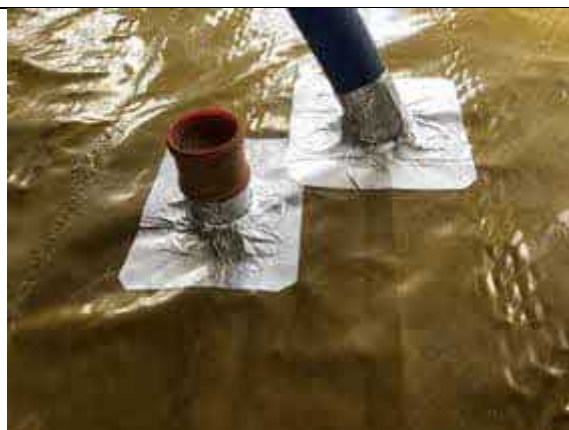
Plot 35 typical double pipe penetration seal using SAGM.

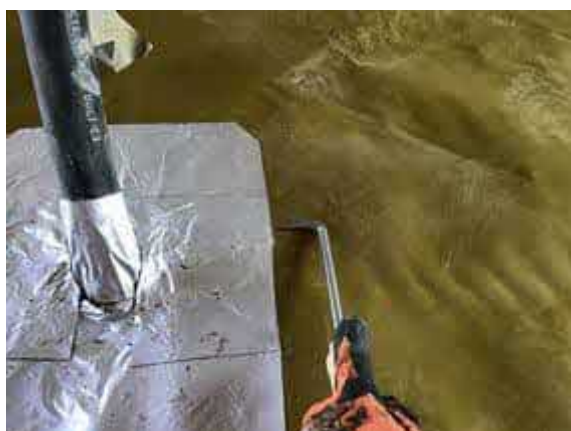
Plot 35 pick testing all SAGM detailing.

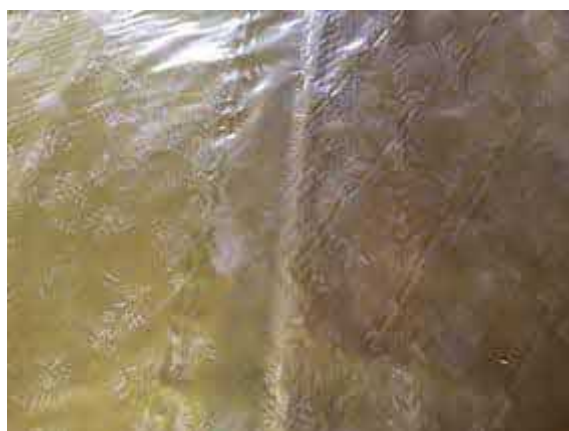
Plot 35 hand welded membrane laps.

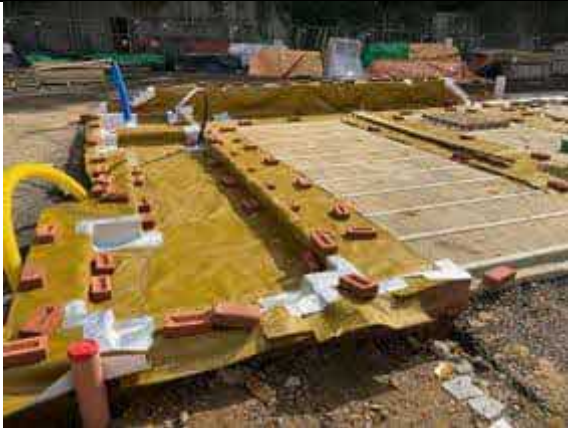
Plot 63 FOG Unit - Overview of Installation of Visqueen Ultimate HC Blok.

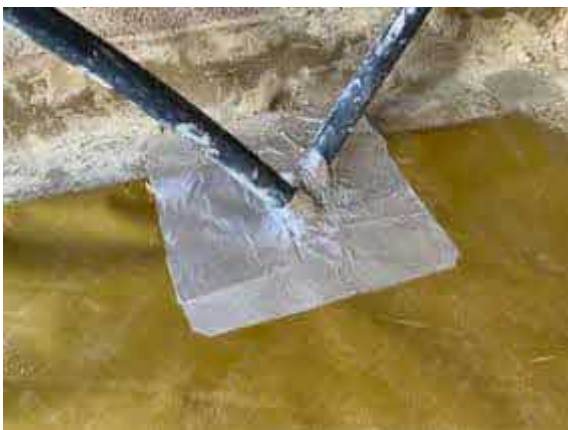
Plot 29 - Pipe penetration's sealed using SAGM.

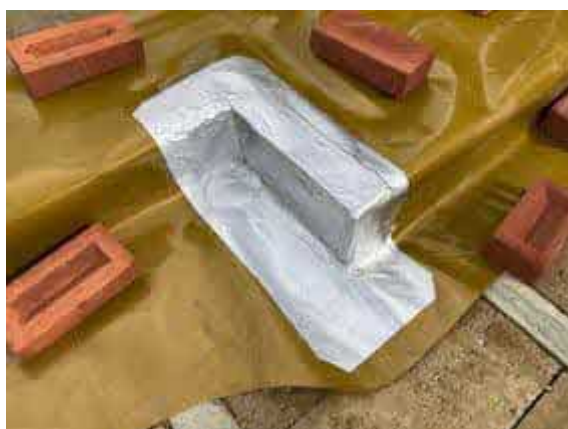
Plot 63 FOG Unit - Typical threshold detail sealed using SAGM.

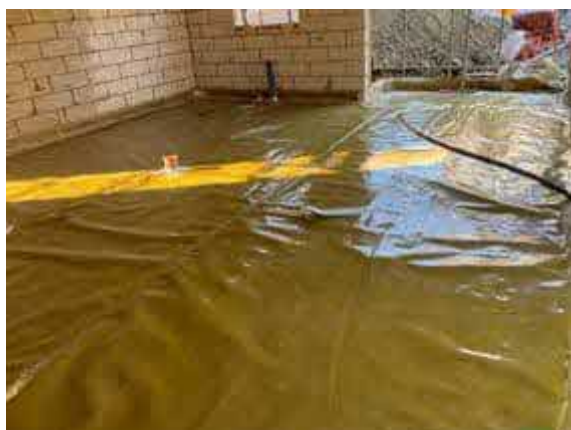
Plot 74. Overview of installation of Visqueen HC Blok gas barrier.

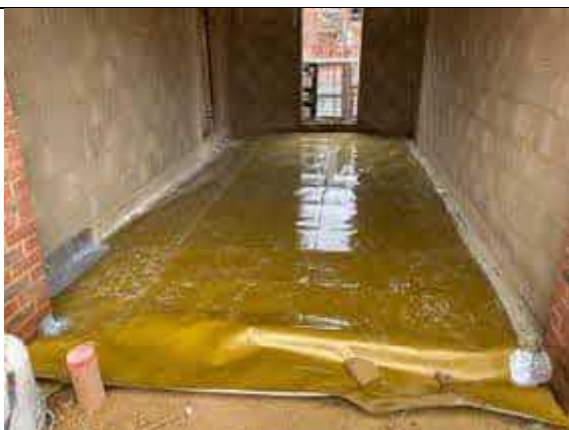
Overview of Visqueen HC Blok infill installation to Plot 35 Garage.

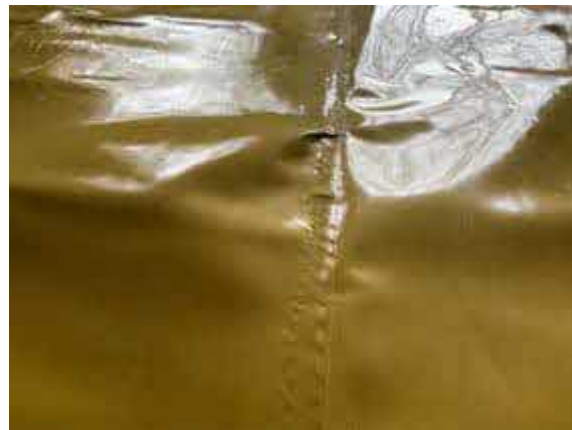
Plot 70. Overview of a hand welded membrane lap joint.

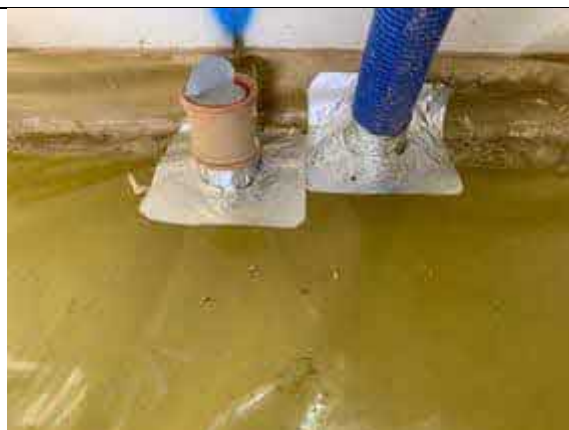
Plot 43 typical double pipe penetration seal using SAGM.

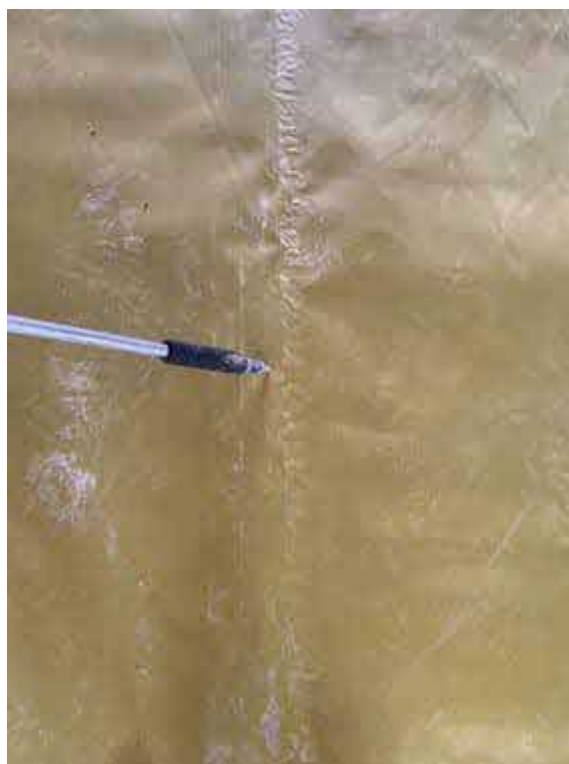
Plot 43 air lancing all hand welded membrane laps.

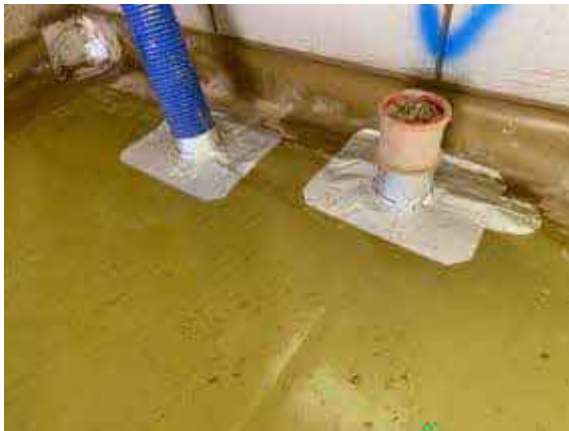
Plot 44 typical double pipe penetration seal using SAGM.

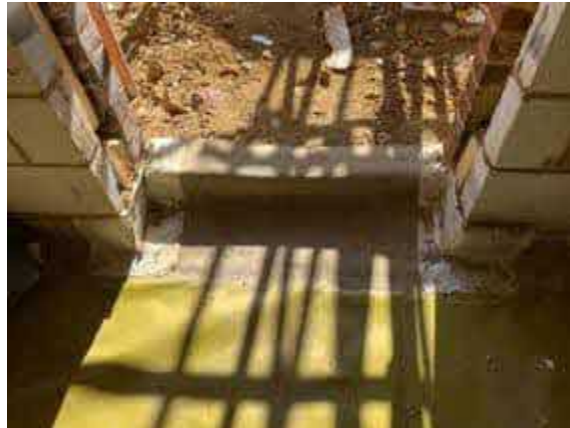
Plot 45 sealed door threshold detail using SAGM.

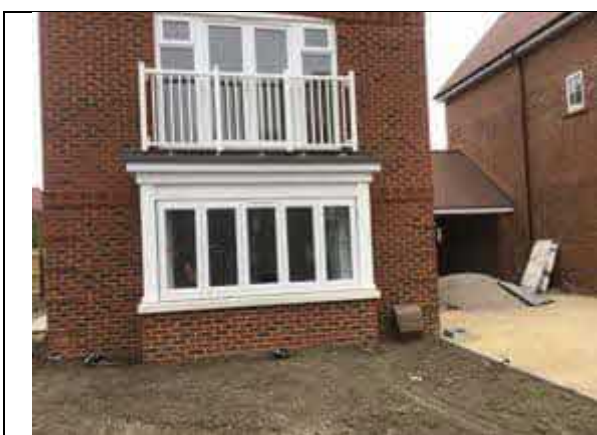
Overview of plot 36.

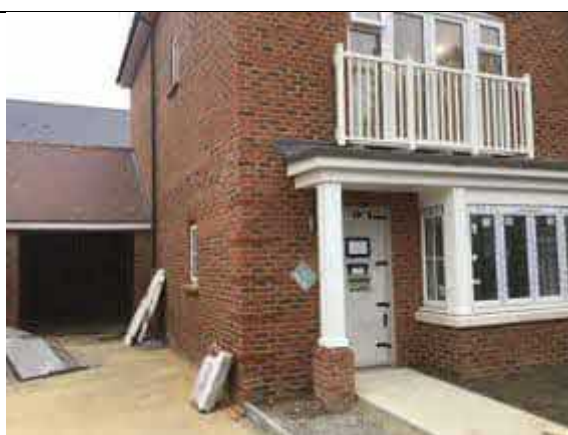
Overview of plot 37.

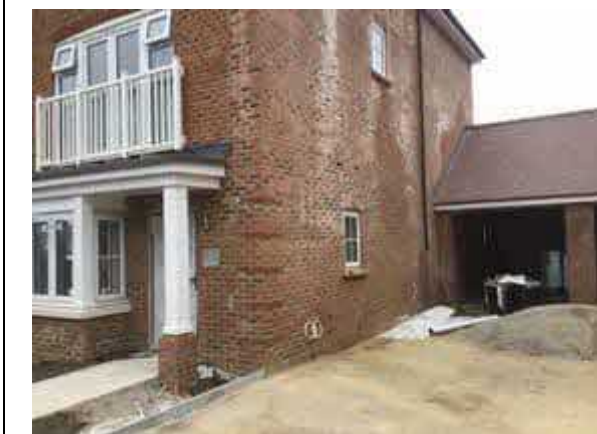
Overview of plot 38.

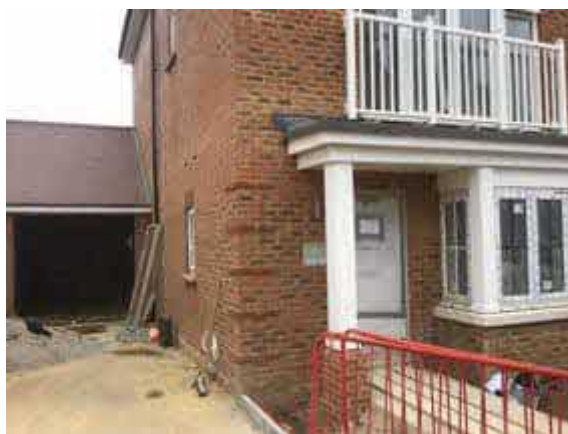
Overview of plot 39.

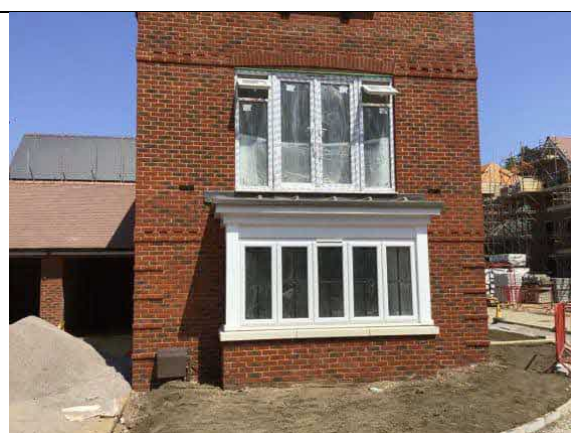
Overview of plot 41.

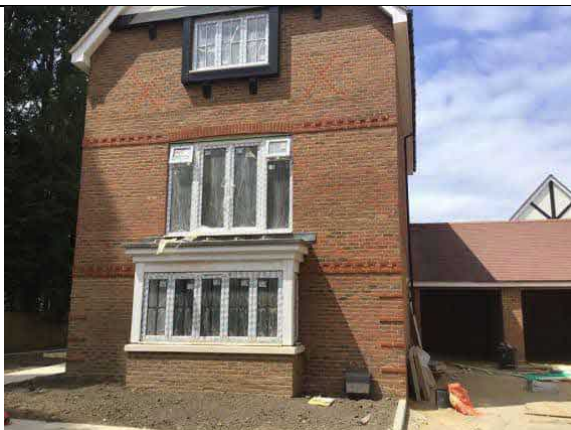
Overview of plot 73.

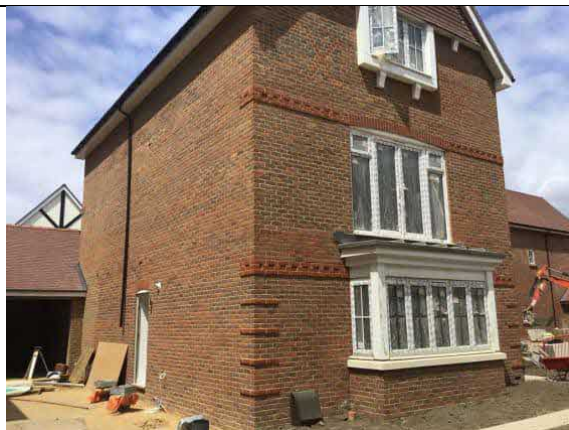
Overview of plot 74.

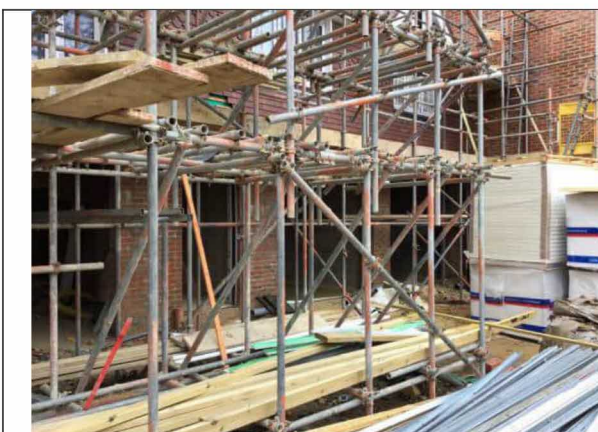
Overview of plots 63 & 64.

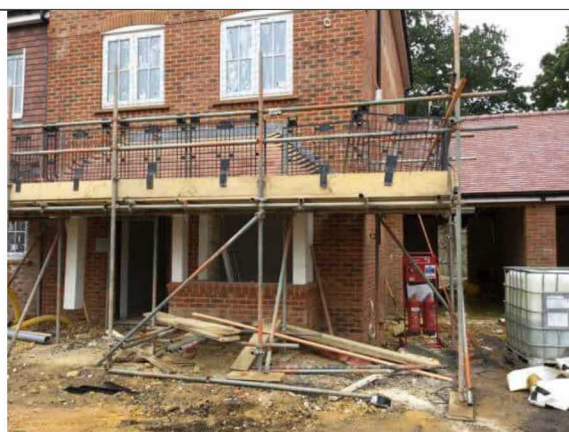
Overview of plot 67.

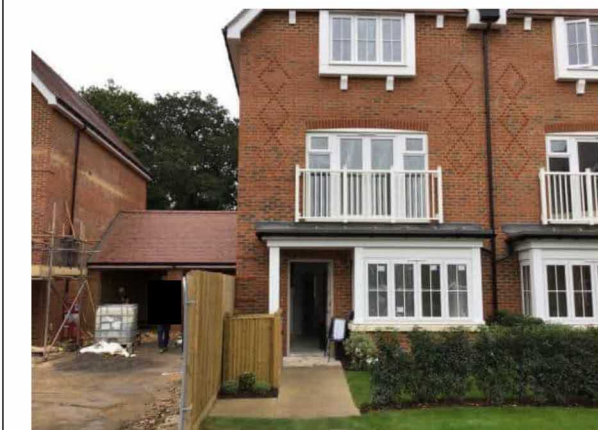
Overview of plot 68.
