# Appendix E - Additional Photographs

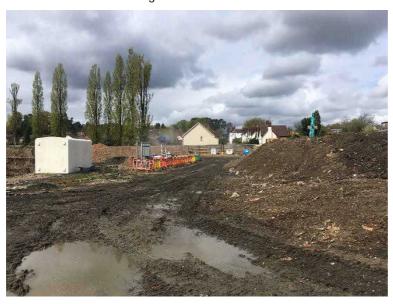
Above: Windrow Turning in South-West of the Site

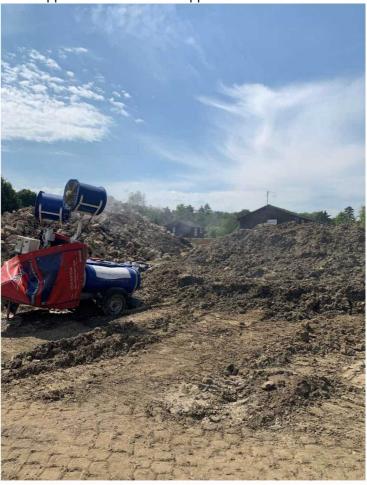
**Dust Suppression and Odour Suppression**

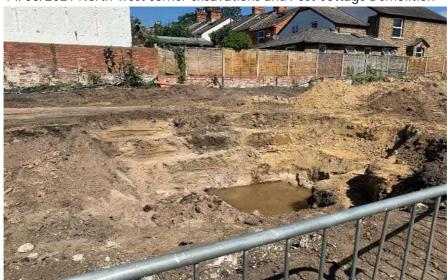
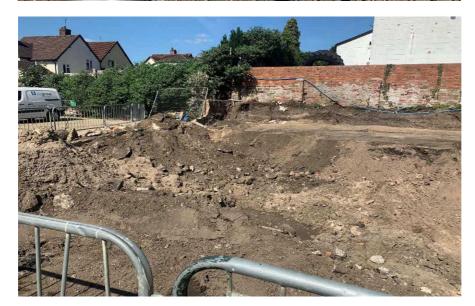
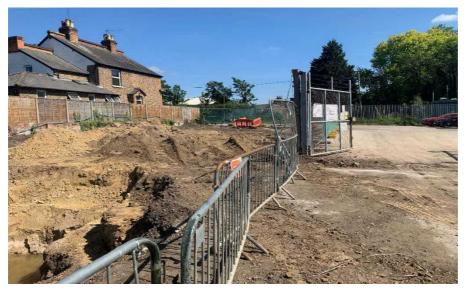
14/06/2021 North-west corner excavations and Post Cottage Demolition

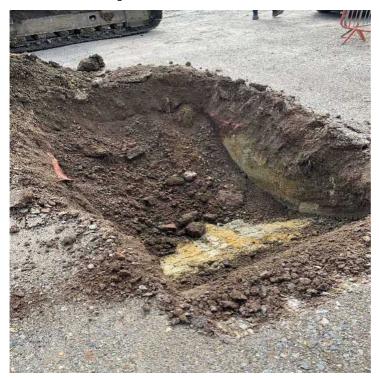
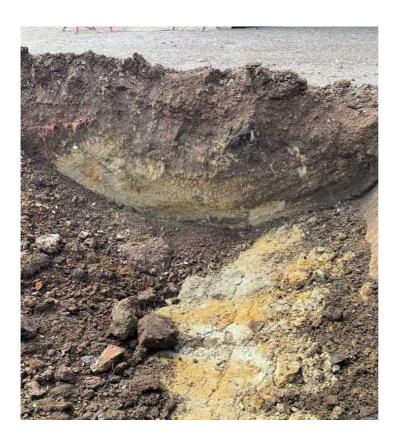
## 11/08/2021 Cottage Validation Trial Pits

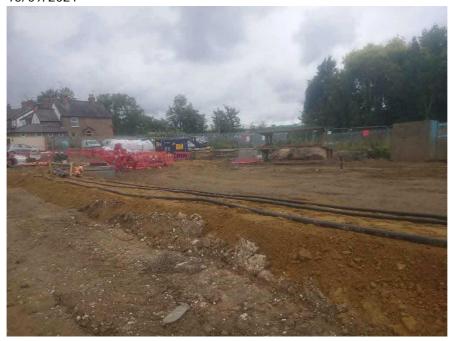
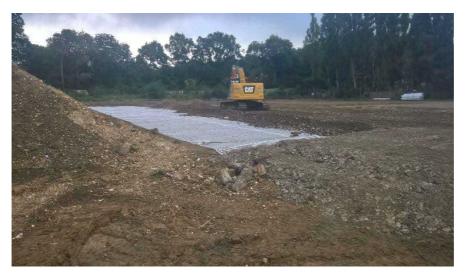
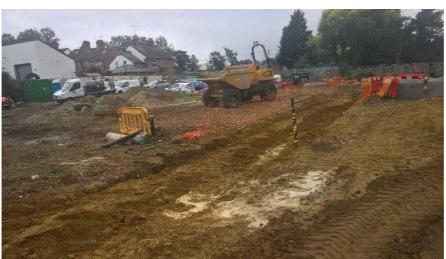
### 15/09/2021

In-situ Groundwater Treatment in North-East of the site

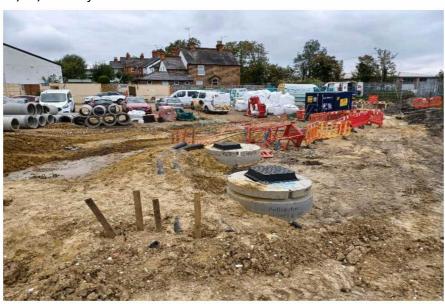
13/10/2021 Infrastructure Works
