Validation Letter

Our Ref: M41977-JNP-XX-XX-RP-G-0024-P01

Re: Former Sunninghill Gas Works – Validation of Capping Layer for Plots 42- 50 inclusive (Block F)

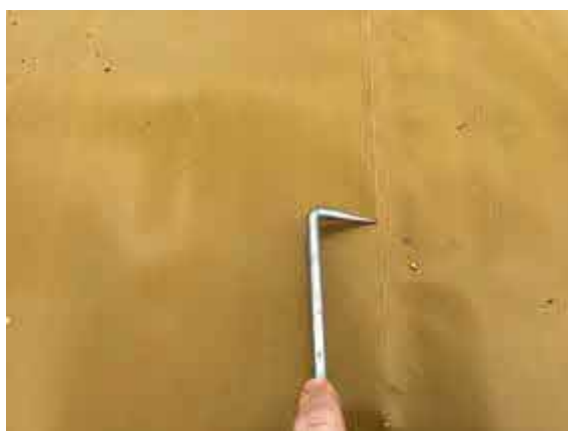
Plot 4 pick testing all weld laps.

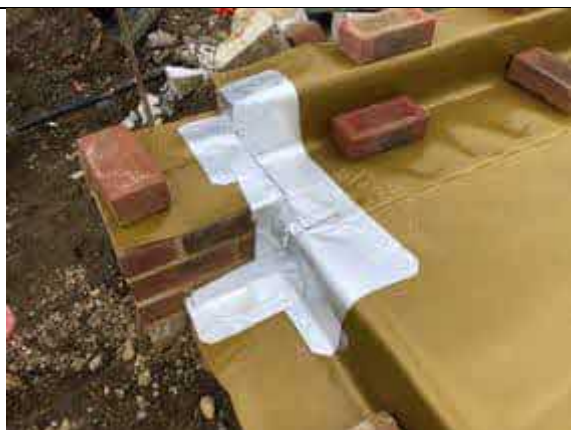
Plot 4 seal using SAGM to the front of the garage.

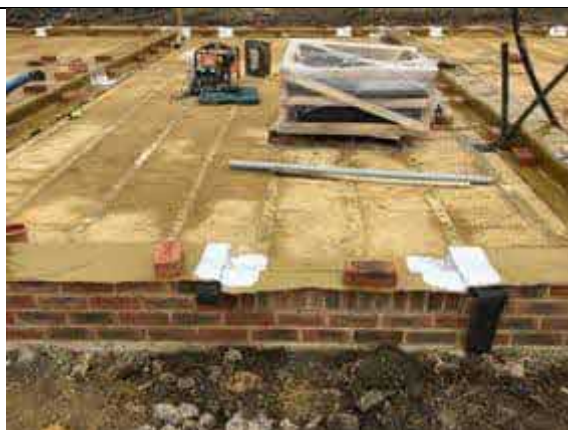
Plot 5 overview of installed membrane to the perimeter and party walls.

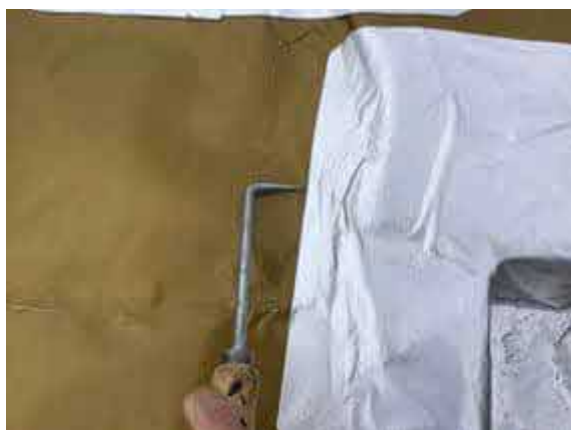
Plot 5 pick testing all SAGM detailing.

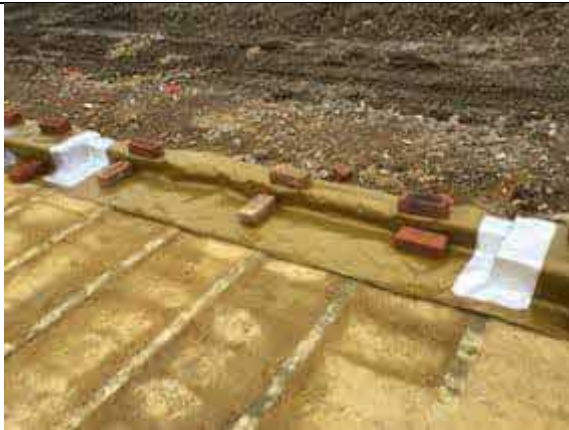
Plot 6 typical door threshold seal using SAGM.

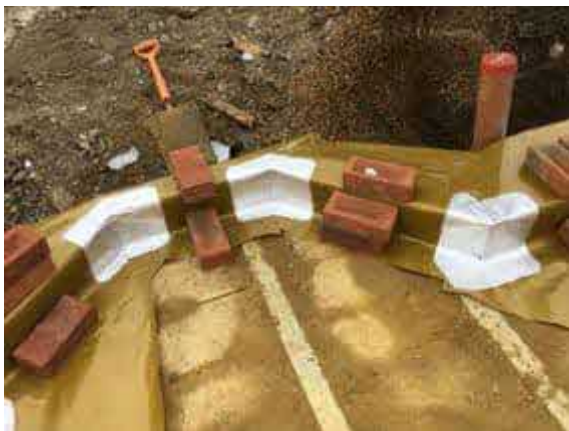
Plot 7 typical bay window corner seals using SAGM.

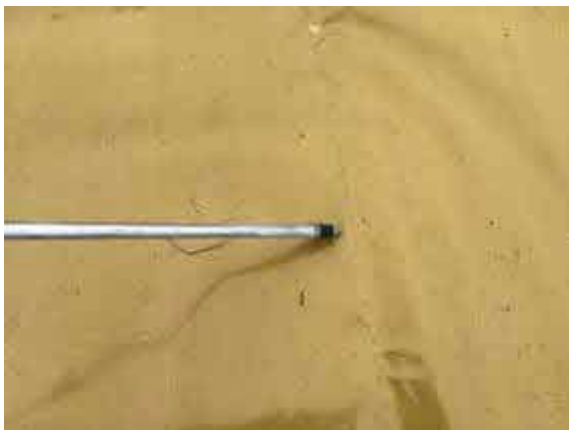
Air lancing all weld laps and SAGM detailing.

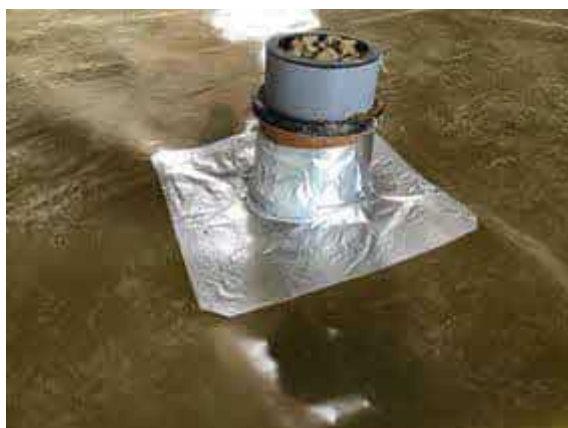
Typical pipe penetration seal using SAGM.

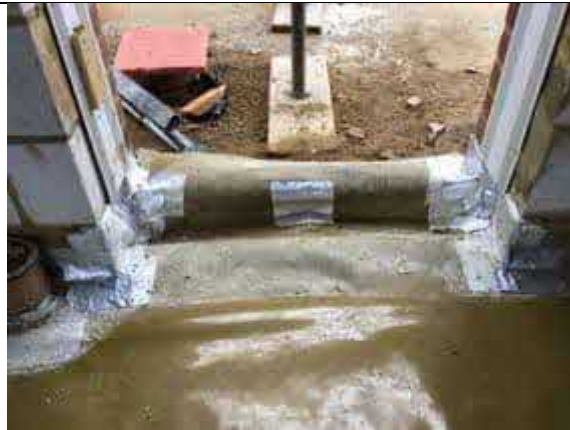
Door threshold seal using SAGM.

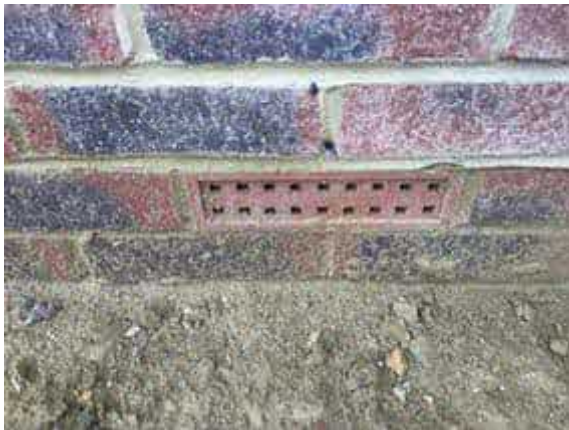
Air brick in place at the time of our inspection.

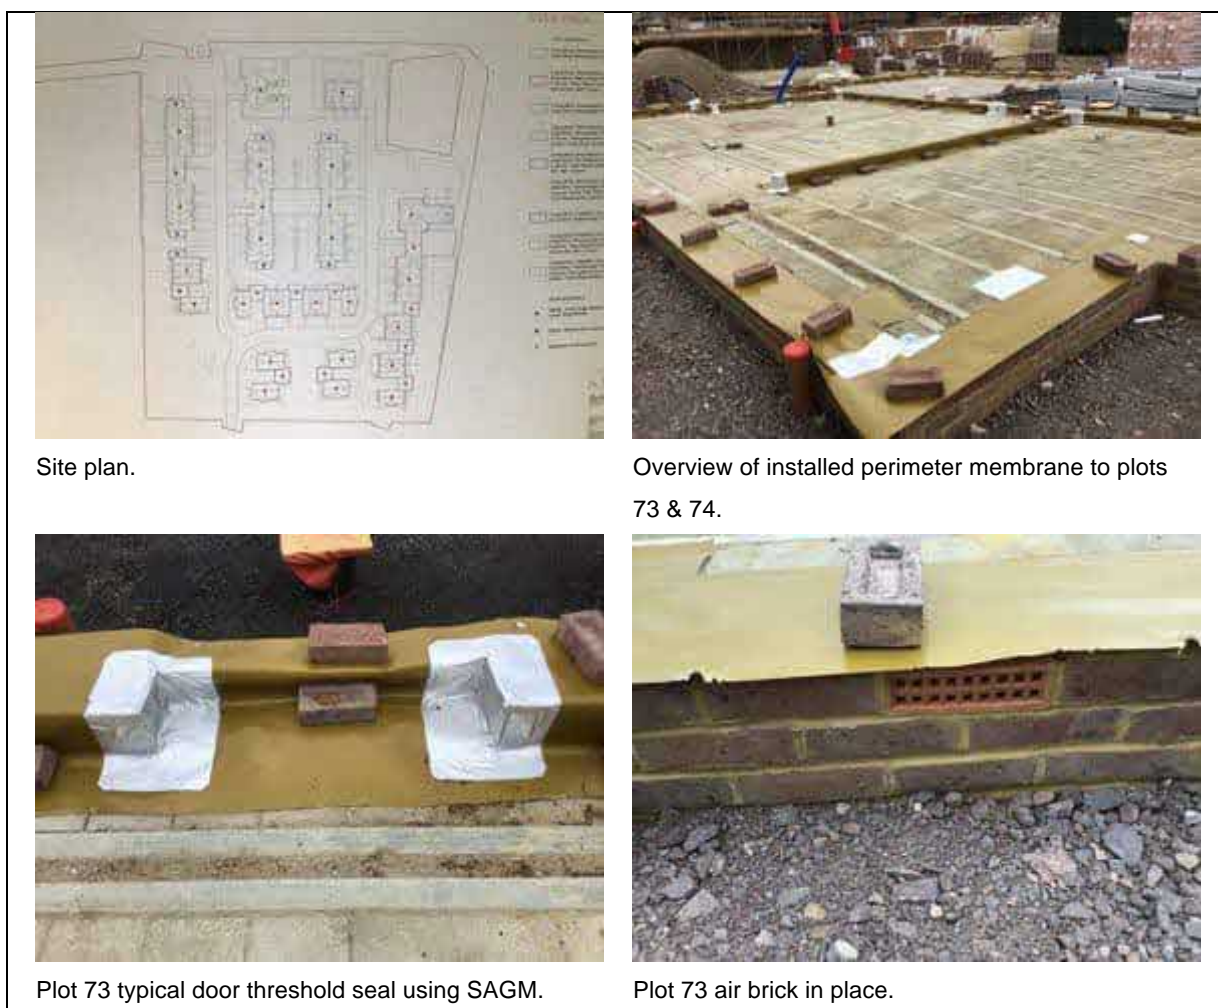
Overview of installed perimeter membrane to plots 73 & 74.

Plot 73 typical door threshold seal using SAGM.

Plot 73 air brick in place.

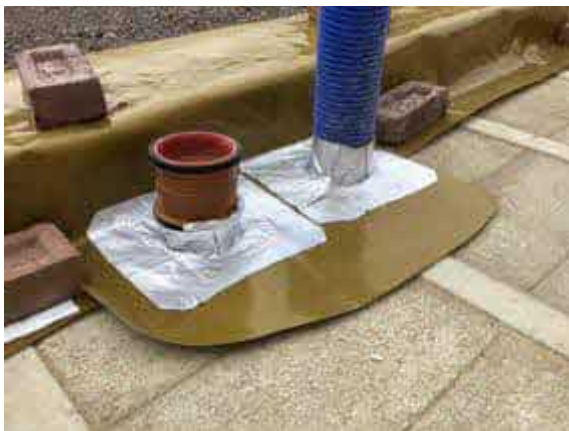
Plot 74 typical double pipe penetration seal using SAGM.

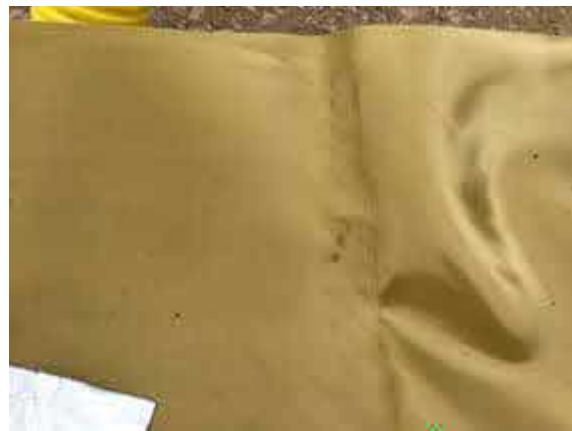
Plot 74 hand welded membrane laps over the cavity wall.

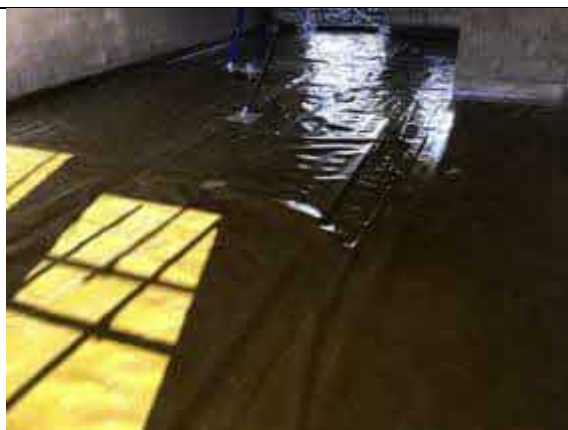
Plot 3 overview of installed membrane.

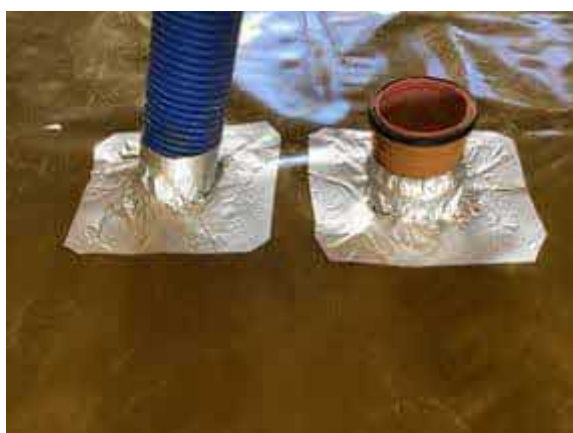
Plot 3 typical double pipe penetration seal using SAGM.

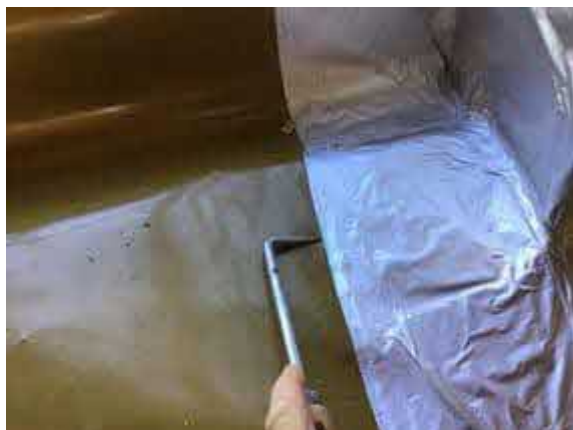
Plot 3 pick testing all SAGM detailing.

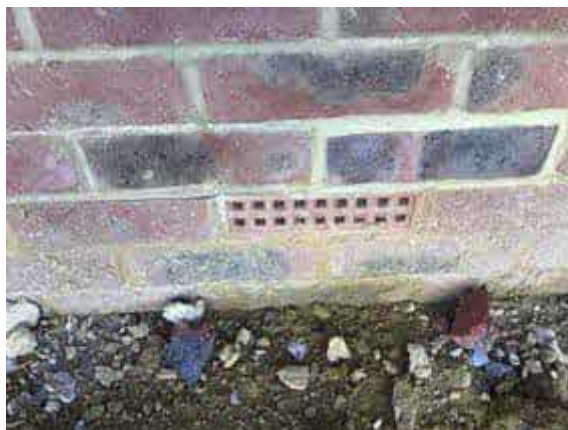
Air brick in place at the time of our inspection.

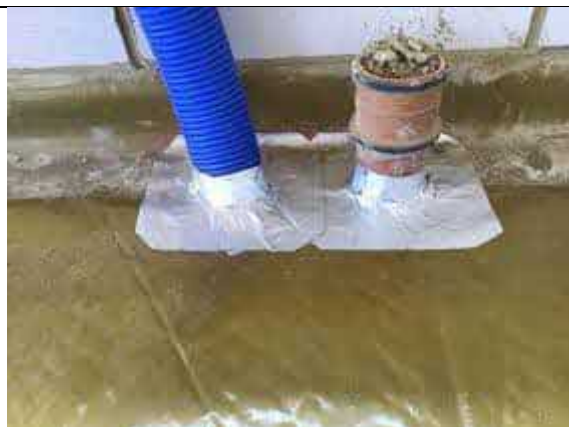
Plot 75 typical double pipe penetration seal using SAGM.

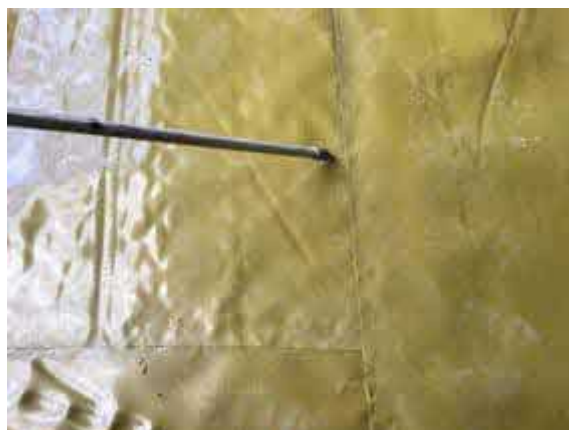
Plot 75 air lancing all weld laps and SAGM detailing.

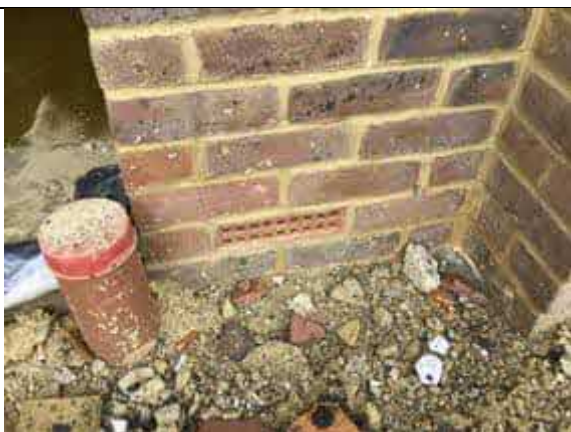
Plot 76 air brick in place at the time of our inspection.

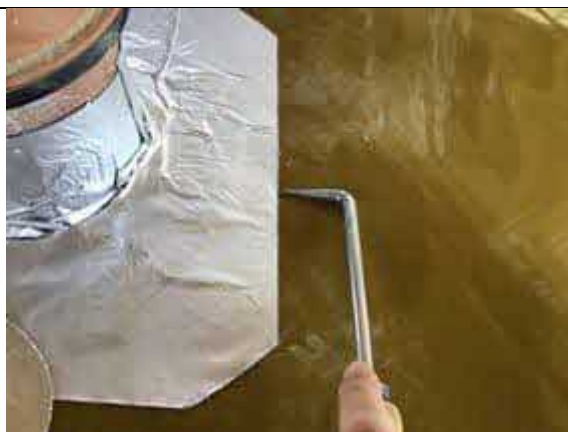
Plot 76 pick testing all SAGM detailing.

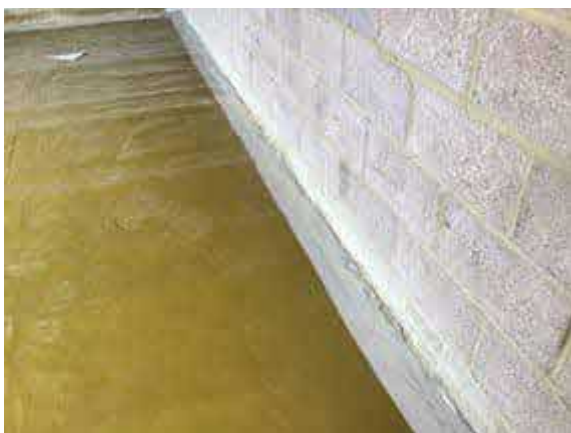
Plot 76 picture framing detail using SAGM to internal block work wall.

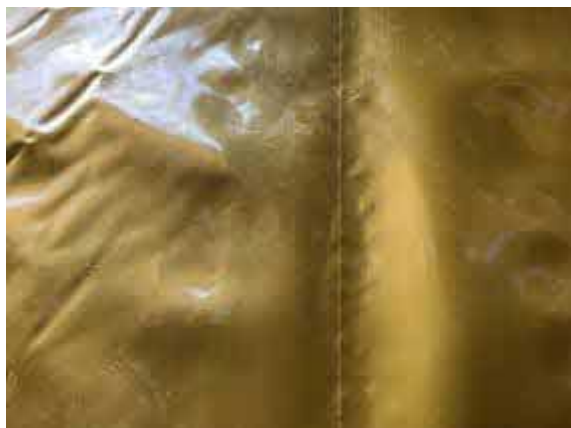
Plot 4 hand welded membrane lap.

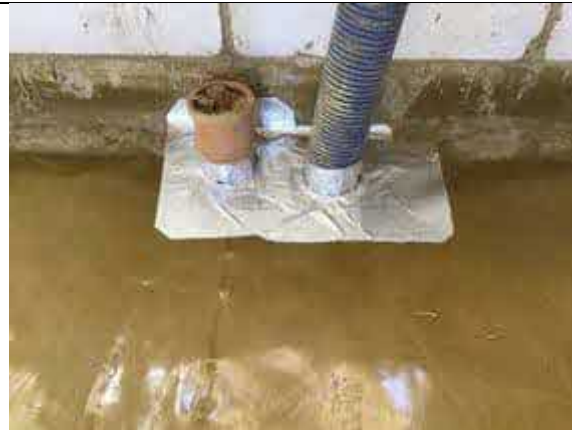
Plot 5 typical double pipe penetration seal using SAGM.

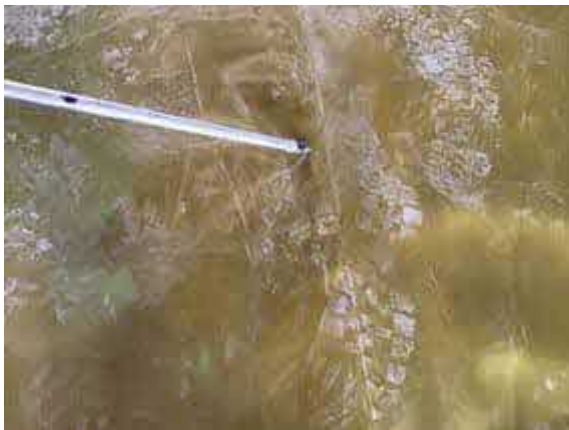
Plot 5 air lancing all SAGM detailing and welded membrane laps.

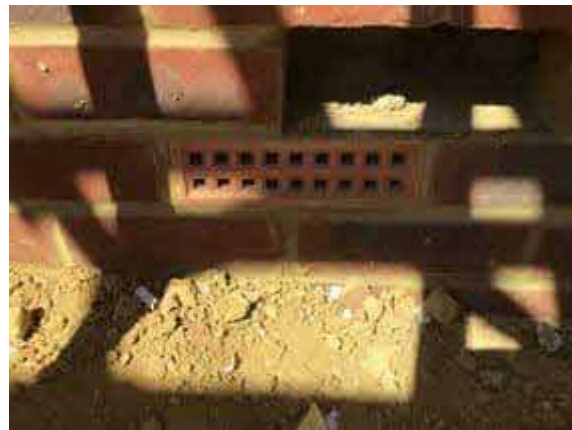
Plot 5 air brick in place at the time of our inspection.

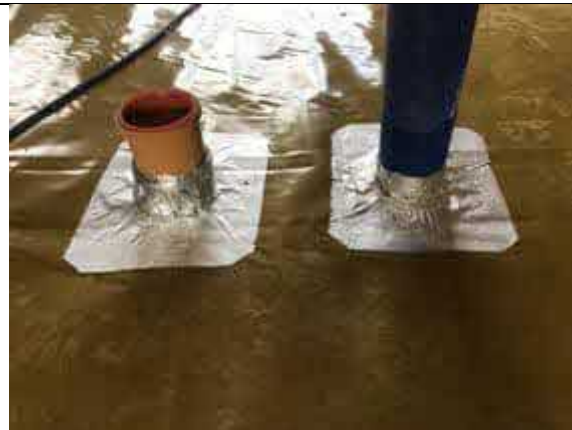
Plot 7 typical double pipe penetration seal using SAGM.

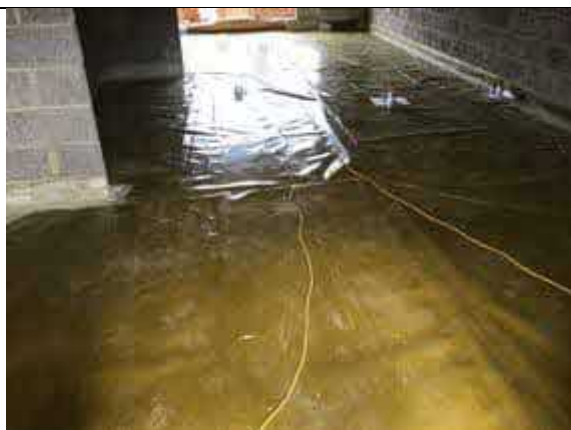
Plot 6 overview of installed membrane.

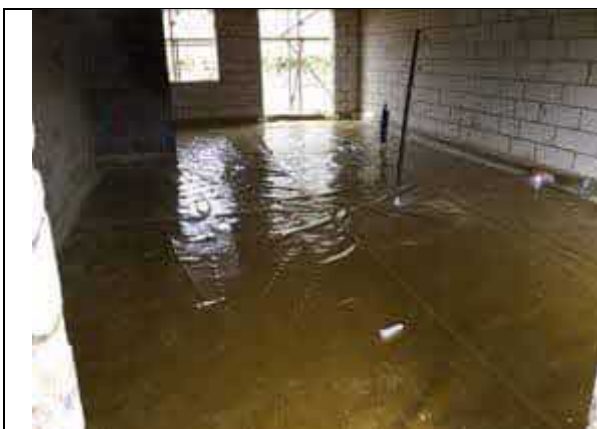
Overview to Plot 12 infill lined out using Visqueen HC Bloc.

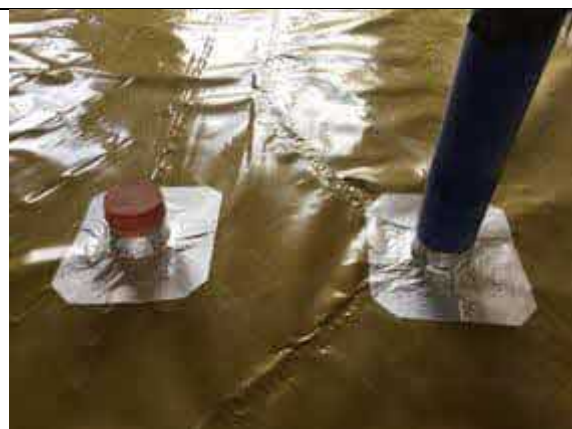
Two typical pipe details sealed with SAGM to Plot 12.

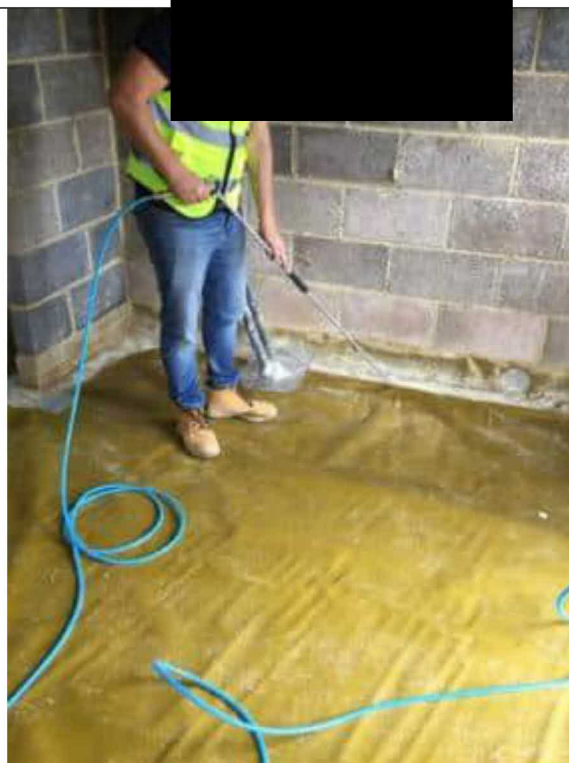
Lance testing to the perimeter hand welded lap joints.

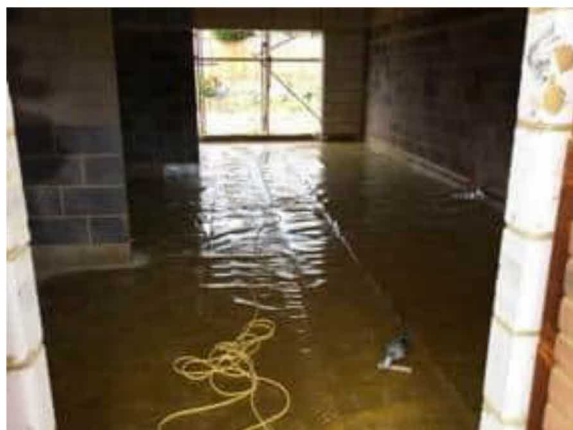
Plot 11 infill overview.

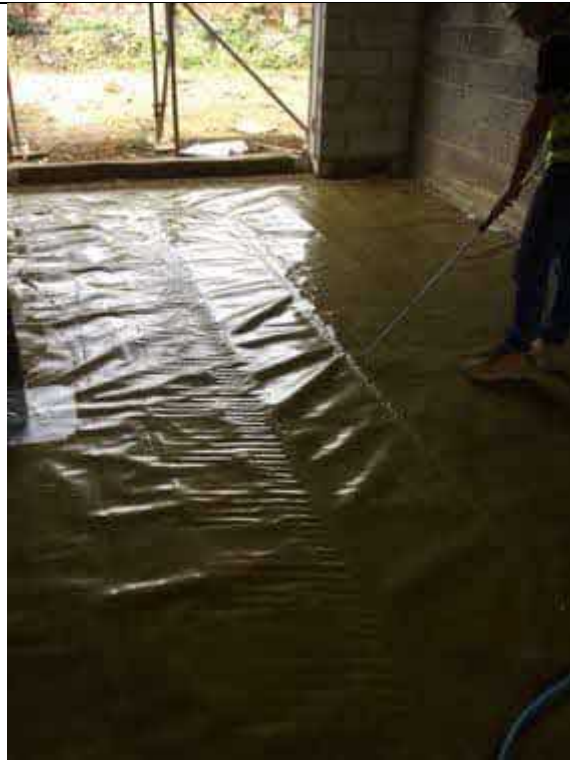
Overview to the air lance test in process to Plot 11.

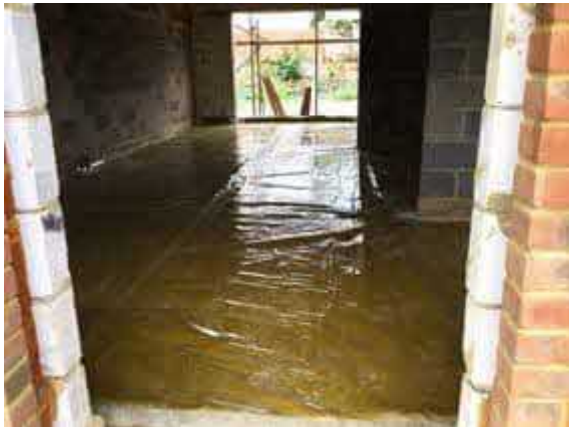
Plot 10 overview.

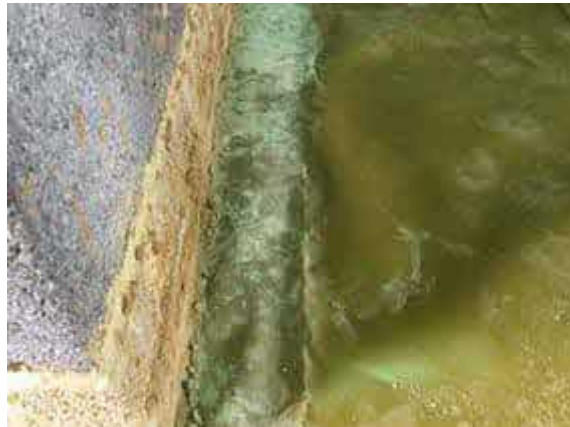
Overview to the perimeter membrane welded to the infill membrane.

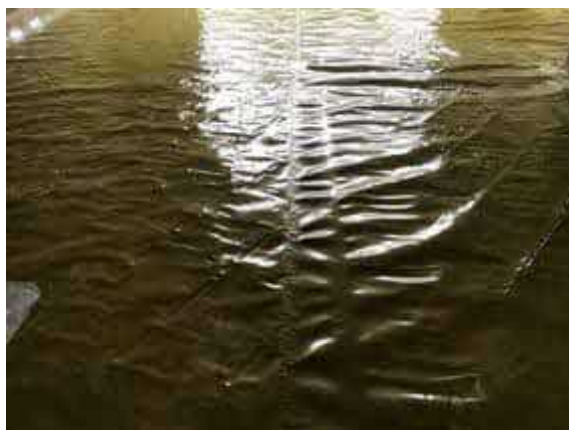
Plot 33 hand welded membrane lap.

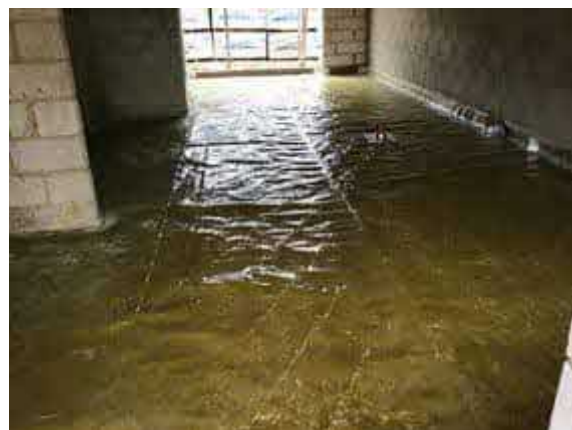
Plot 34 overview of installed Visqueen HC Blok Gas Barrier.

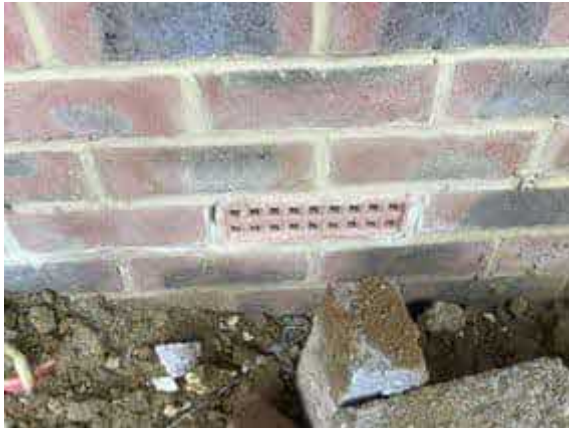
Air brick in place at the time of our inspection.

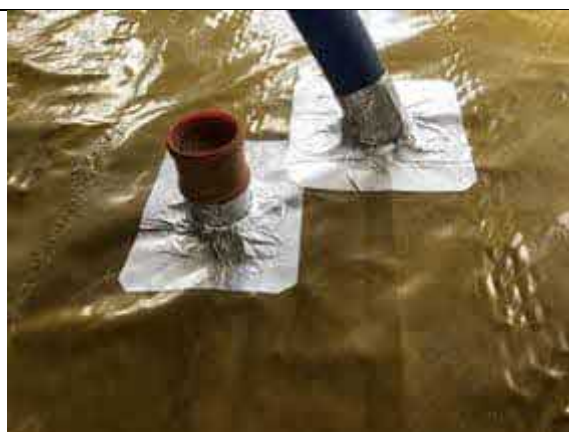
Plot 35 typical double pipe penetration seal using SAGM.

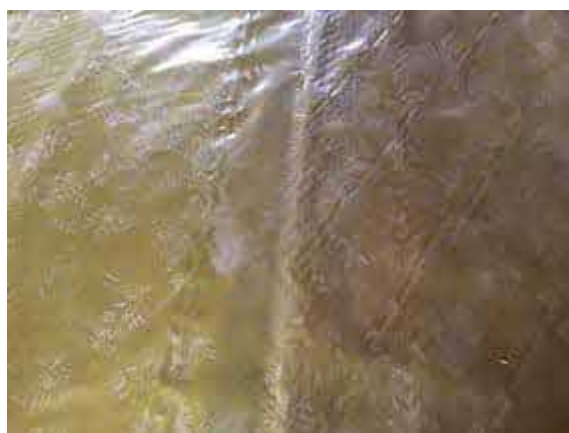
Plot 35 hand welded membrane laps.

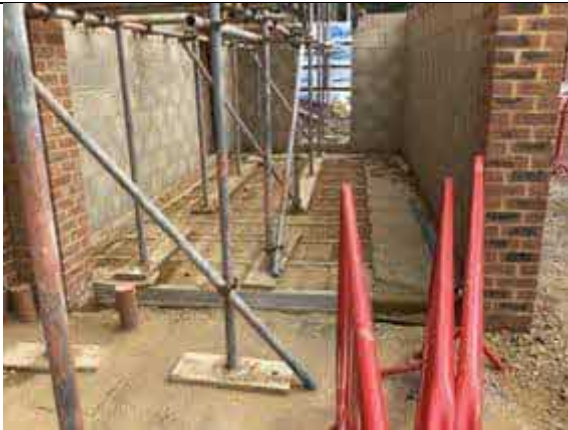
Plot 35 attached garage incomplete at the time of our inspection.

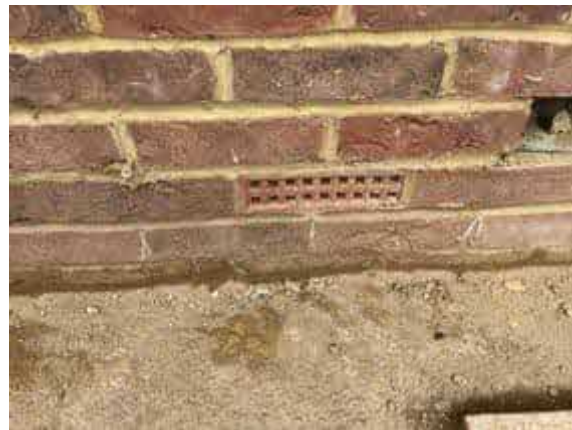
Plot 32 air brick in place at the time of our inspection.

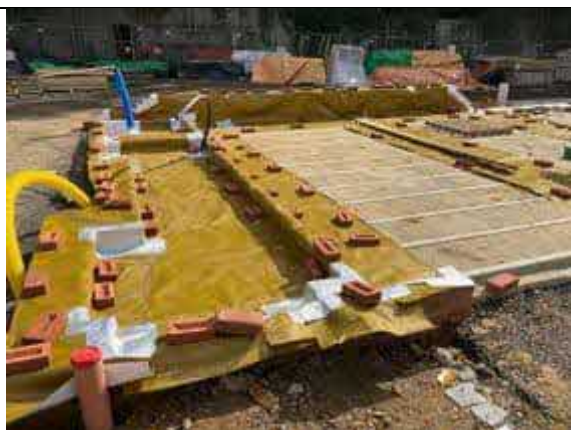
Plot 63 FOG Unit - Overview of Installation of Visqueen Ultimate HC Blok.

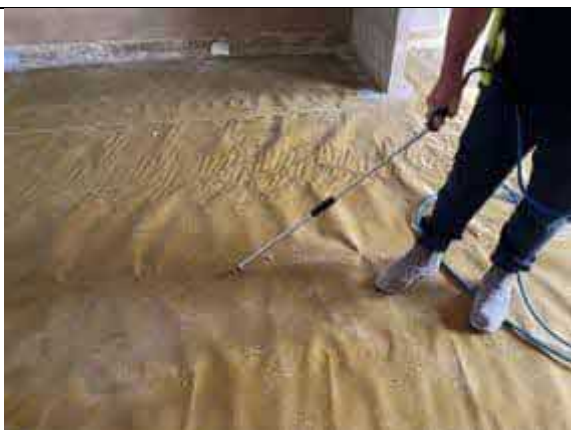
Plot 30 - Air lance test conducted upon all membrane lap joints.

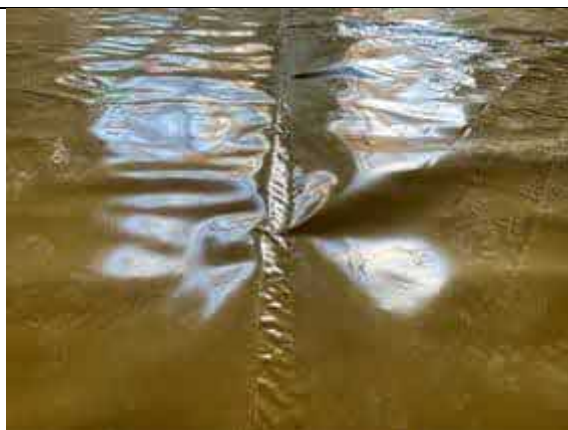
Plot 30 - Hand welded membrane lap joint.

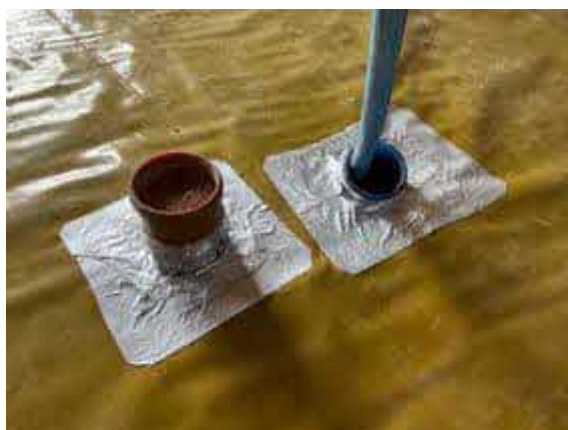
Plot 30 - Typical pipe penetration's sealed using SAGM.

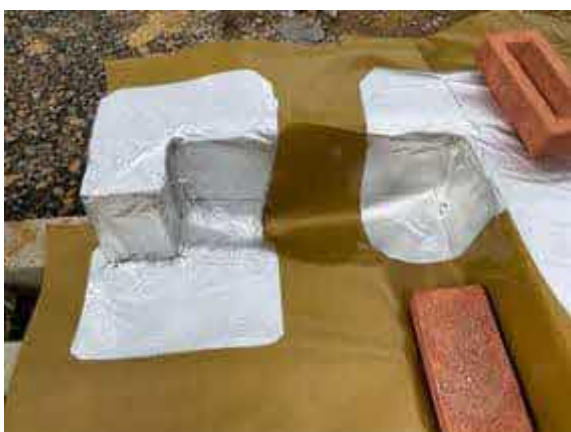
Plot 63 FOG Unit - Corner detailing sealed using SAGM.

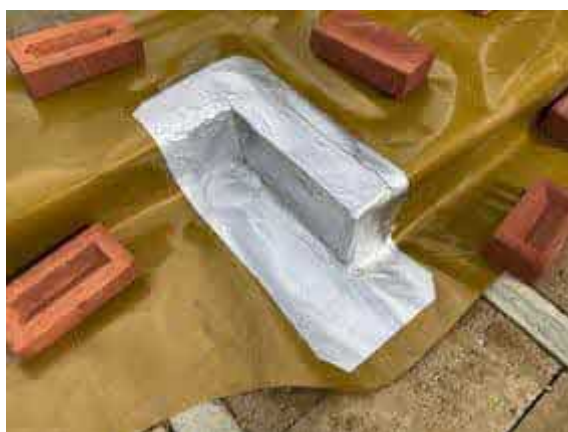
Plot 63 FOG Unit - Typical threshold detail sealed using SAGM.

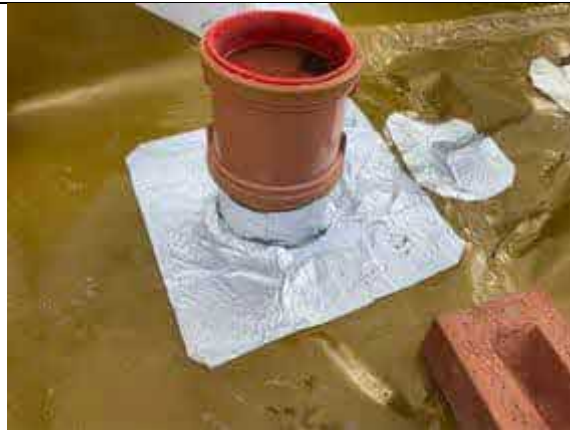
Plot 63 FOG Unit - Typical pipe penetration sealed using SAGM.

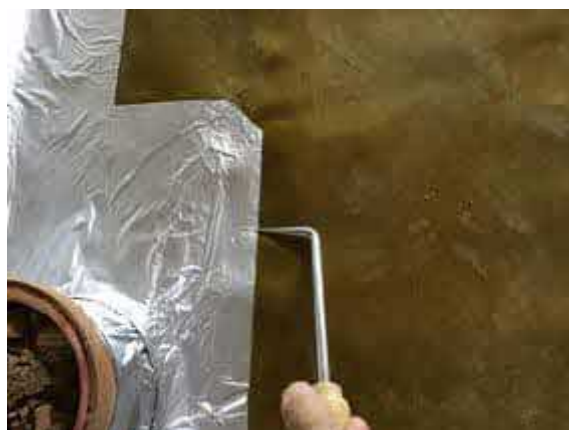
Plot 28 pick testing all SAGM detailing.

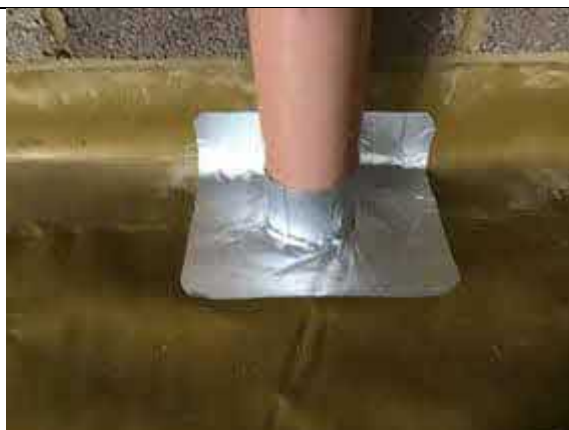
Typical pipe penetration seal using SAGM.

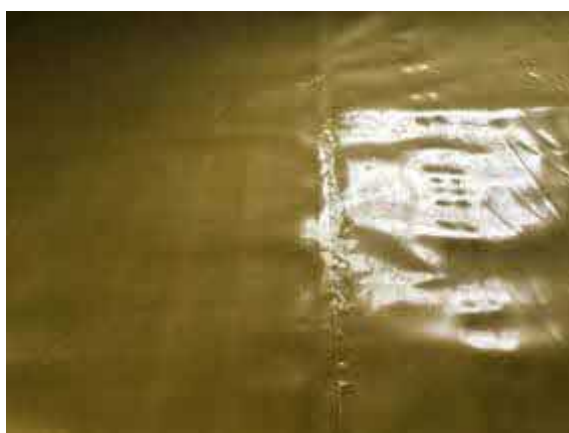
Hand welded membrane lap.

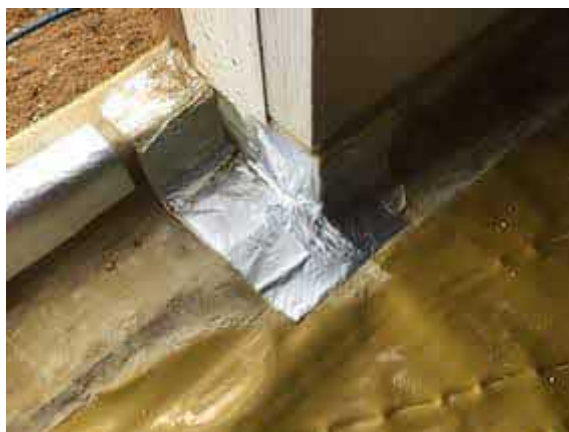
Sealed corner detail using SAGM.

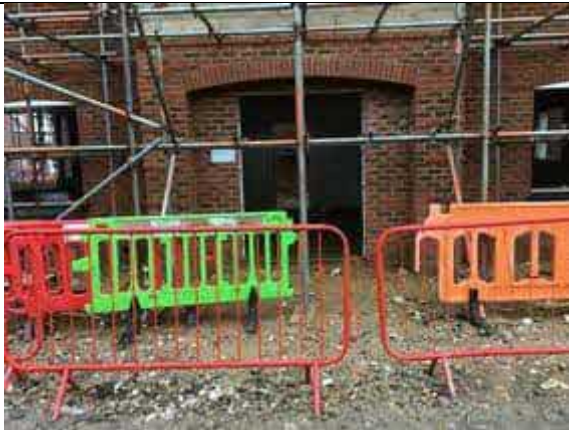
Overview of plot 41.

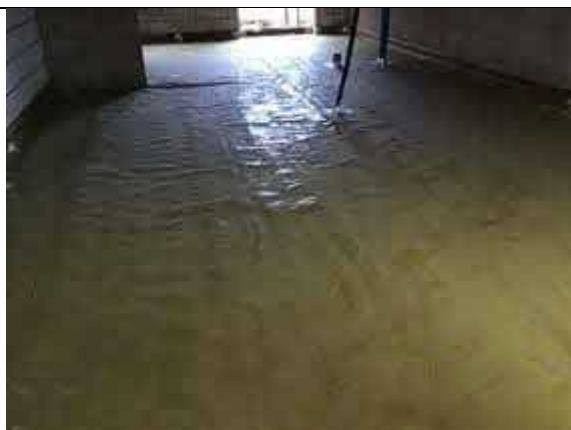
Overview of installed membrane to plot 37.

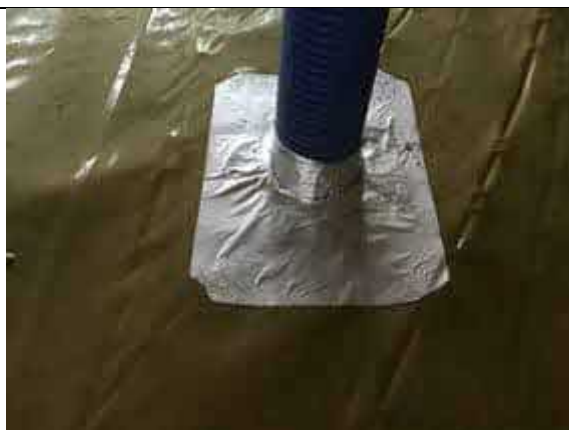
Typical pipe penetration seal using SAGM to plot 37.

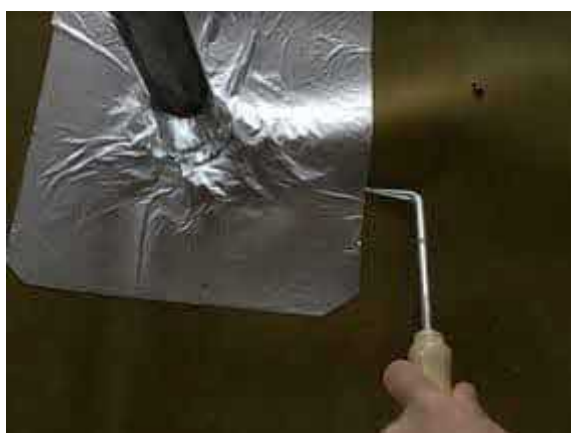
Pick testing all SAGM detailing to plot 38.

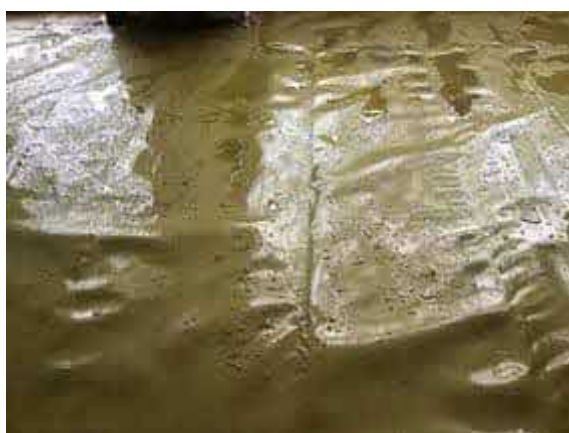
Hand welded membrane lap in plot 38.

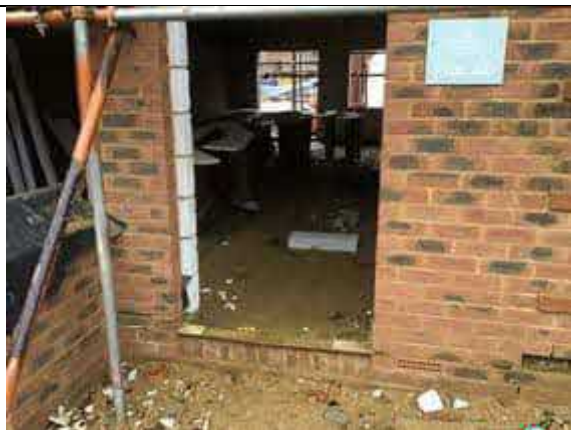
Plot 40 was incomplete at the time of our inspection due to being used as storage.

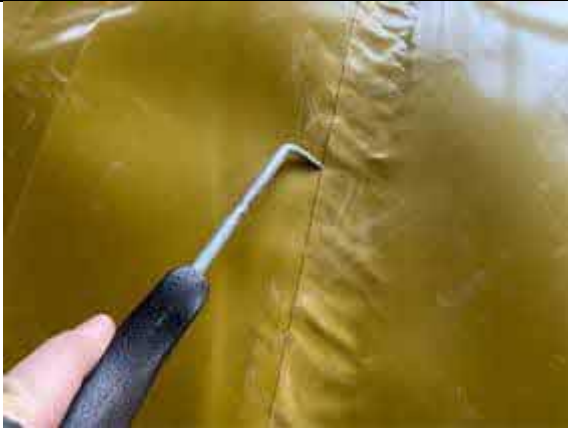
Plot 74. Pick test upon hand welded membrane lap joint.

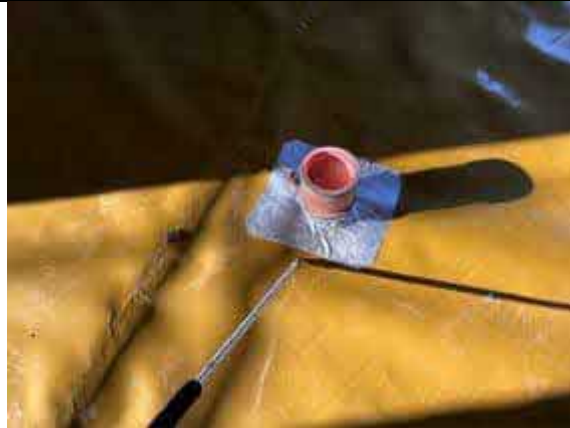
Plot 74. Air lance integrity test conducted upon sealed pipe penetration.

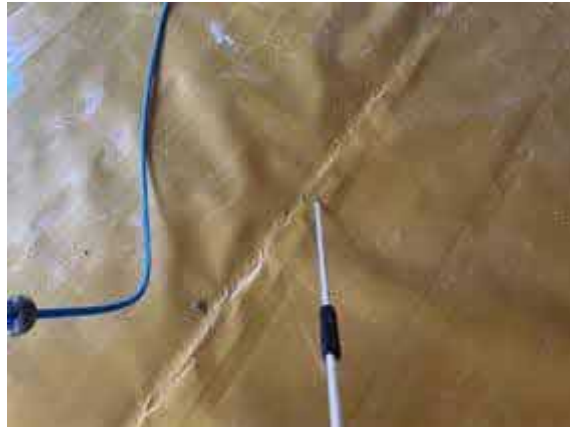
Plot 40. Air lance integrity conducted upon all welded membrane lap joints.

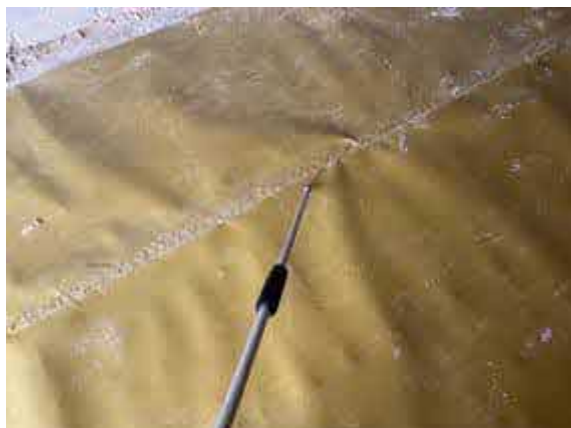
Plot 30 garage. Air lance integrity test upon welded lap joint.

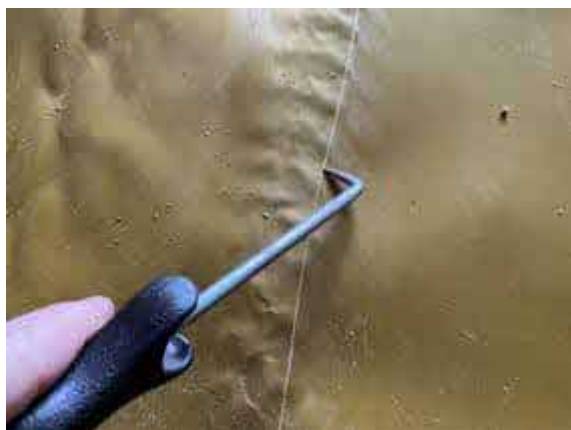
Plot 32 garage. Pick testing along hand welded lap joint.

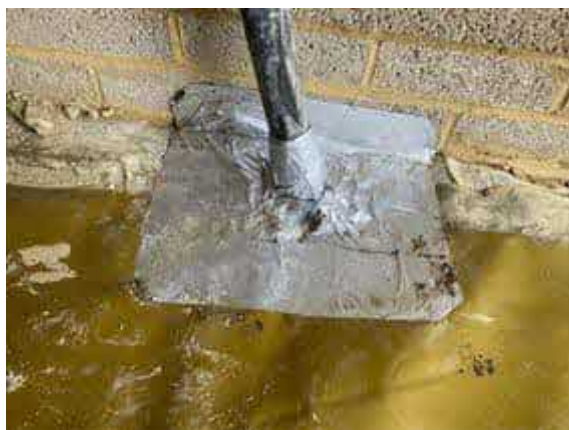
Plot 32 garage. Typical pipe penetration sealed using SAGM.

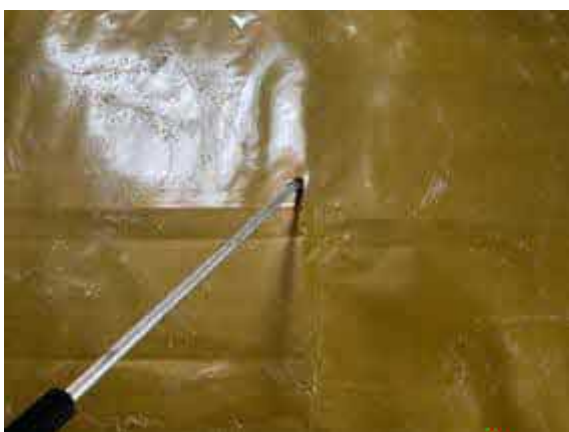
Plot 72. Air lance integrity test conducted upon hand welded lap joint.

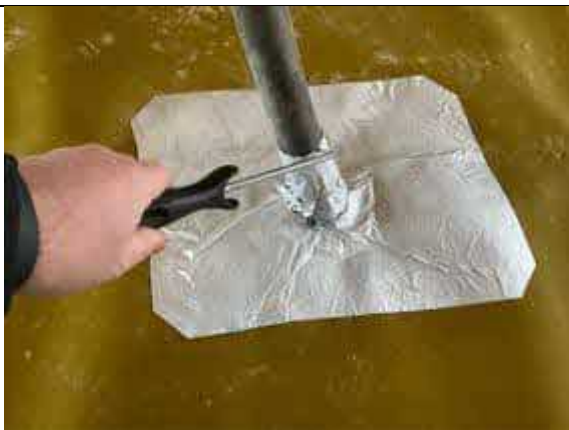
Plot 70. Pick test conducted upon sealed pipe penetration.

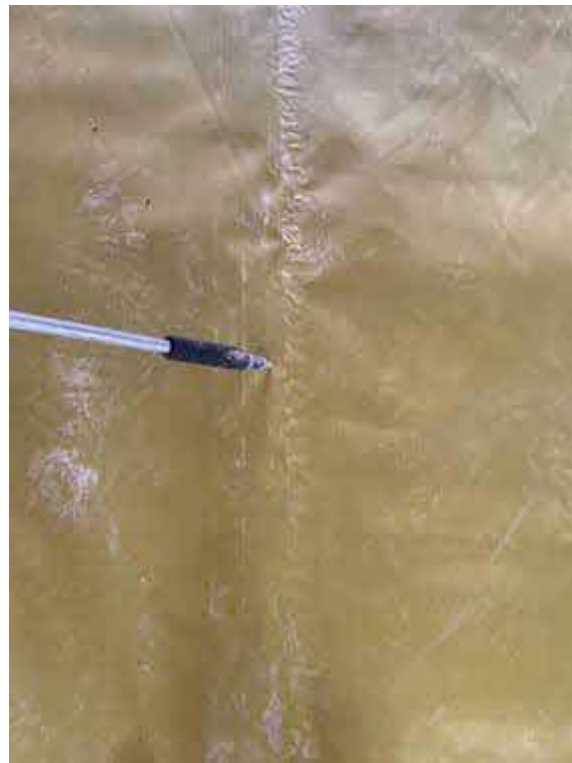
Plot 43 air lancing all hand welded membrane laps.

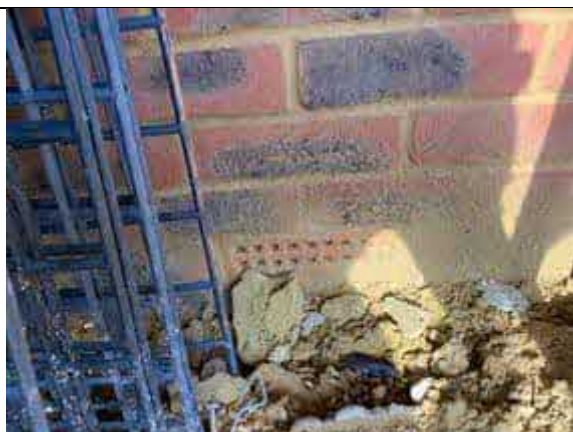
Plot 44 air brick in place at the time of our inspection.

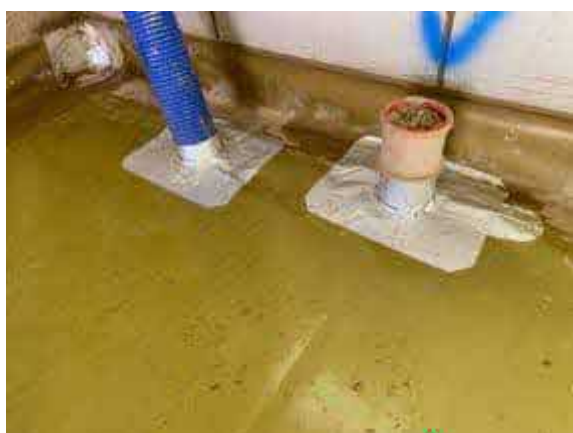
Plot 44 typical double pipe penetration seal using SAGM.

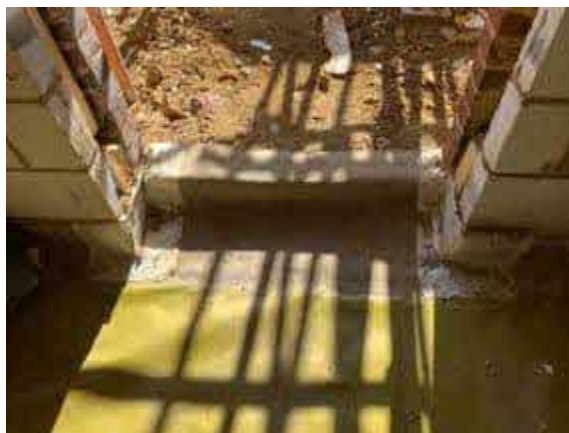
Plot 45 sealed door threshold detail using SAGM.

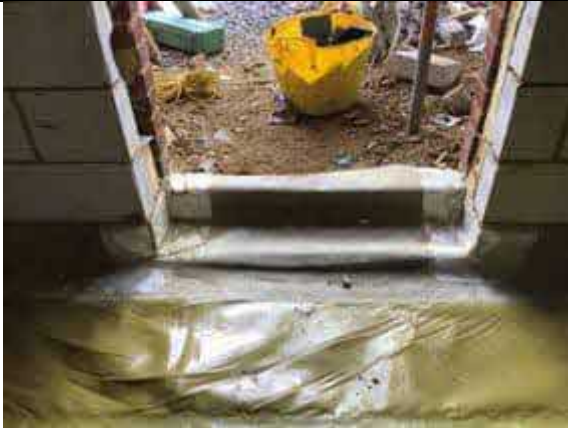
Typical door threshold seal using SAGM to plot 47.

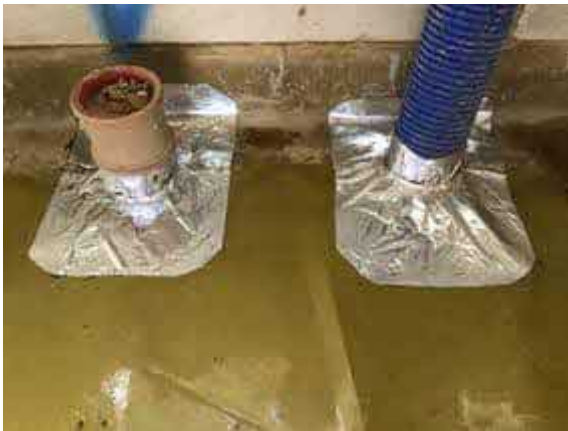
Typical double pipe penetration seal using SAGM to plot 48.

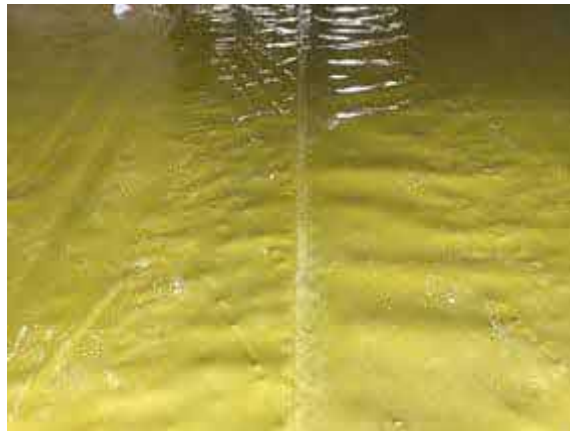
Hand welded membrane lap to plot 48.

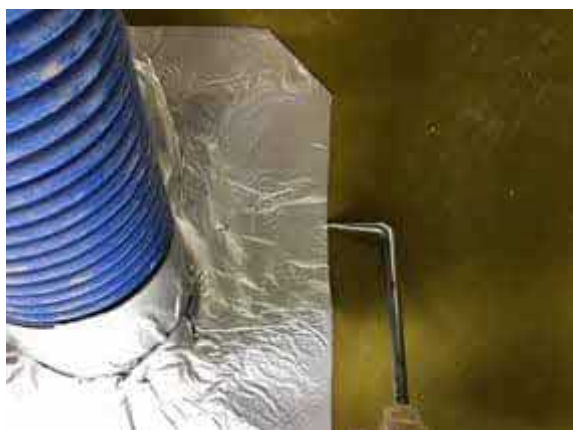
Pick testing all SAGM detailing in plot 50.

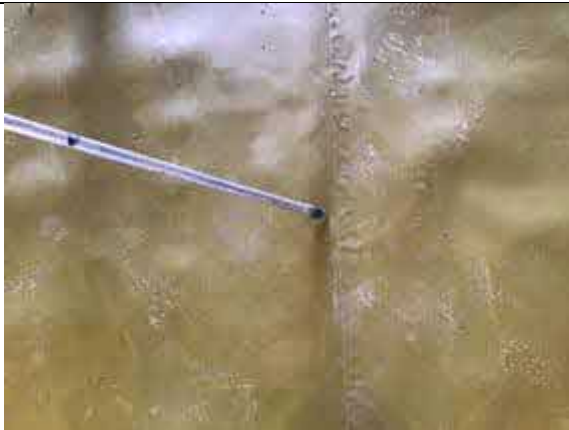
Air lancing all hand welded membrane laps to plot 66.

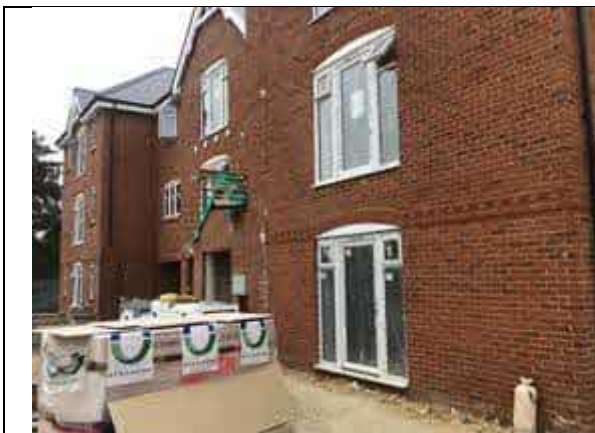
Overview of Apartment Block C.

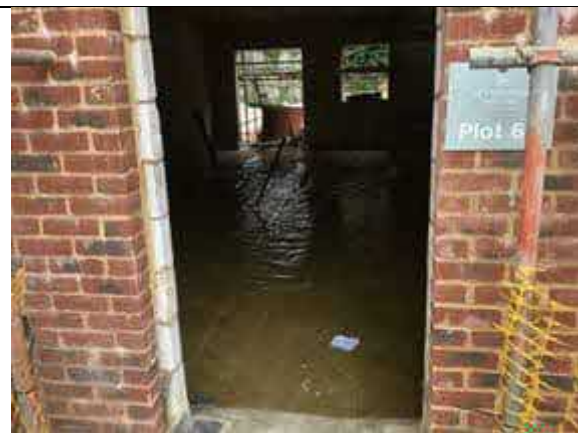
Overview of plot 64.

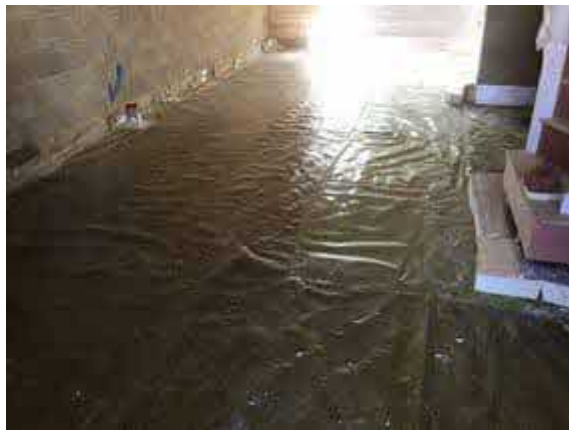
Overview of plot 65.

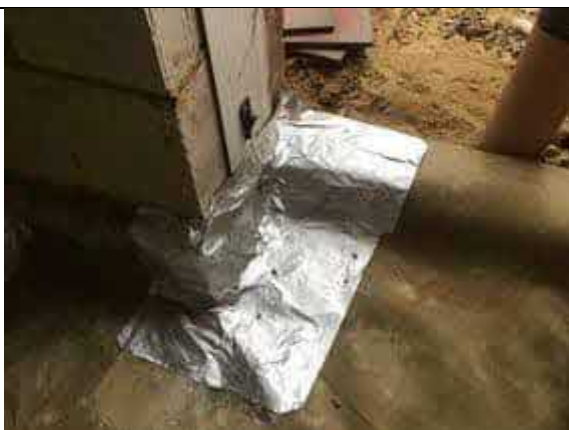
Sealed door threshold detail using SAGM to plot 64.

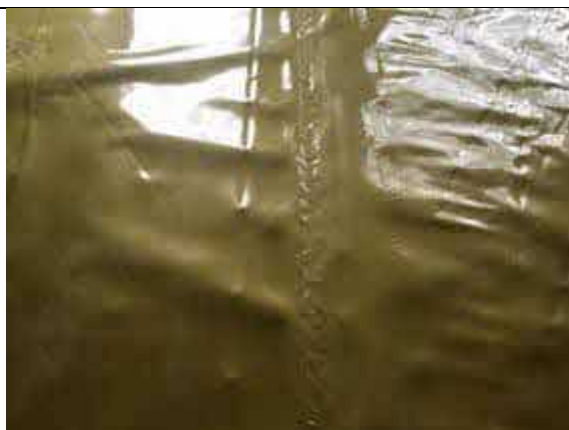
Hand welded membrane lap to plot 64.

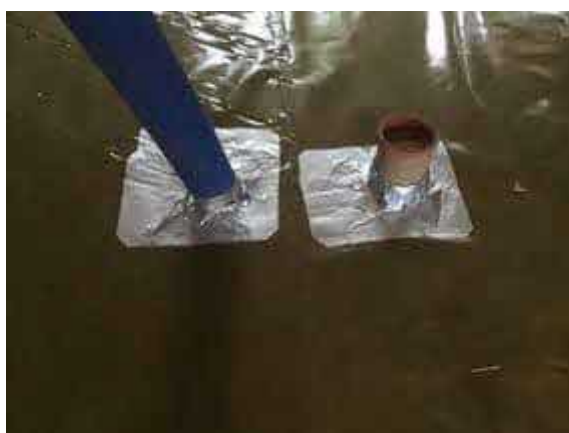
Typical double pipe penetration seal using SAGM to plot 64.

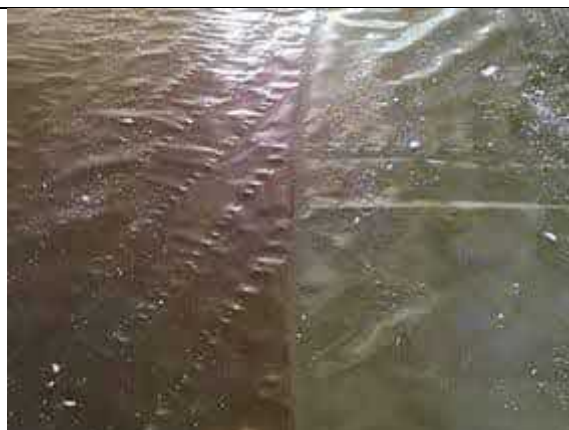
Hand welded membrane lap to plot 65.
