Validation Letter

Our Ref: M41977-JNP-XX-XX-RP-G-0024-P01

Re: Former Sunninghill Gas Works – Validation of Capping Layer for Plots 42- 50 inclusive (Block F)

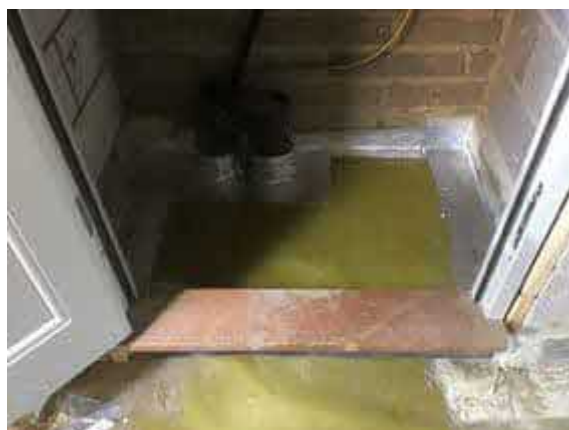
Sealed pipe penetrations in riser cupboard to apartment block c.

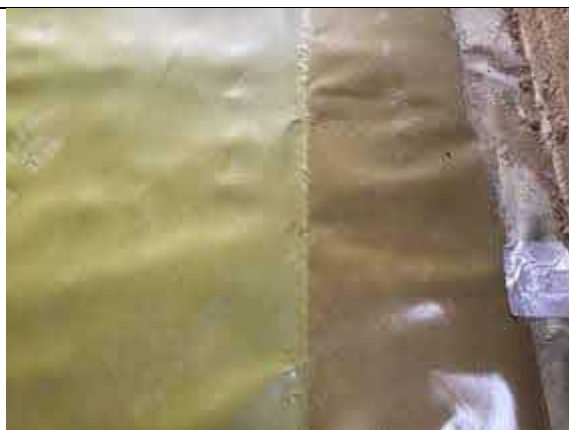
Hand welded membrane lap to plot 36.

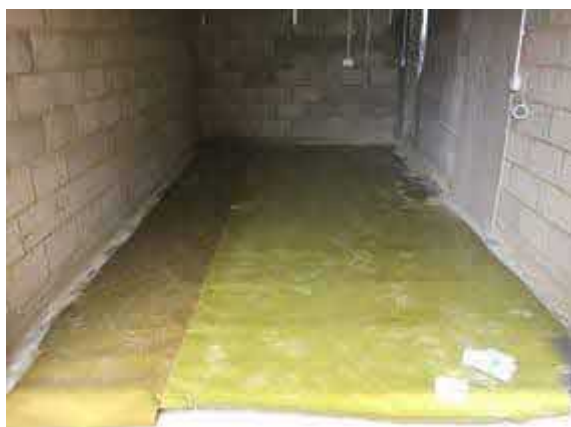
Overview of installed membrane to garage area in plot 37.

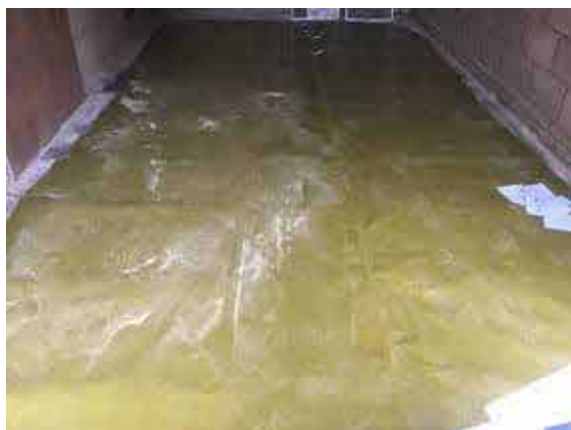
Overview of installed membrane to garage area to plot 38.

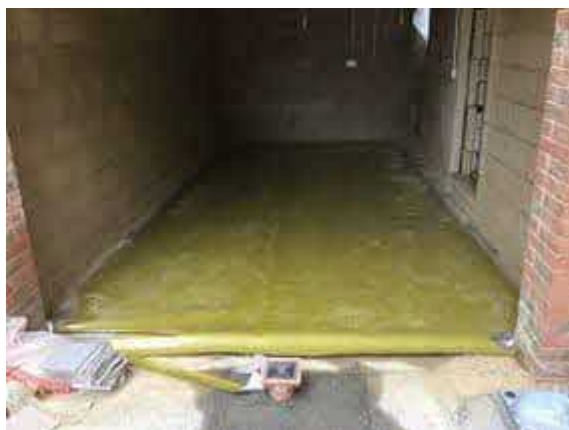
Overview of installed membrane to garage area to plot 39.

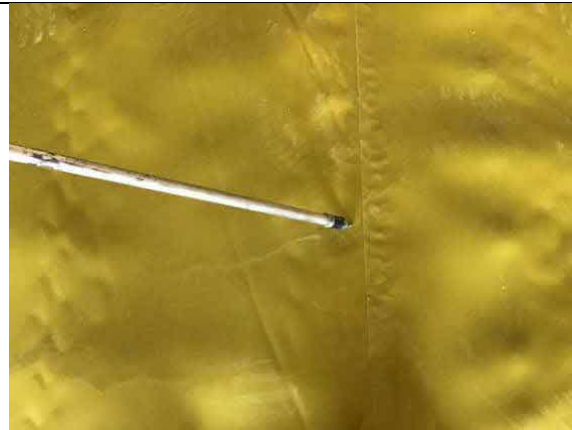
Air lancing all hand welded membrane laps in apartment block H.

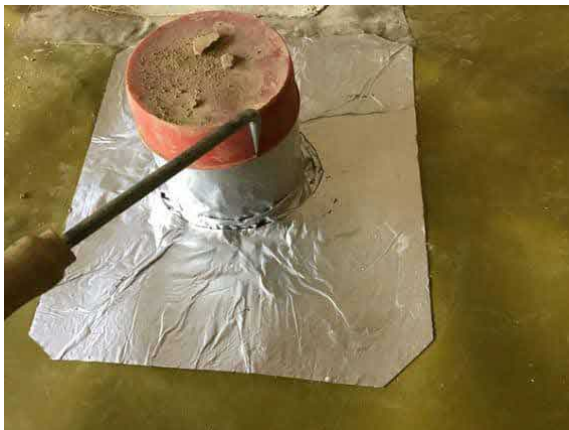
Pick testing all SAGM detailing in apartment block H.

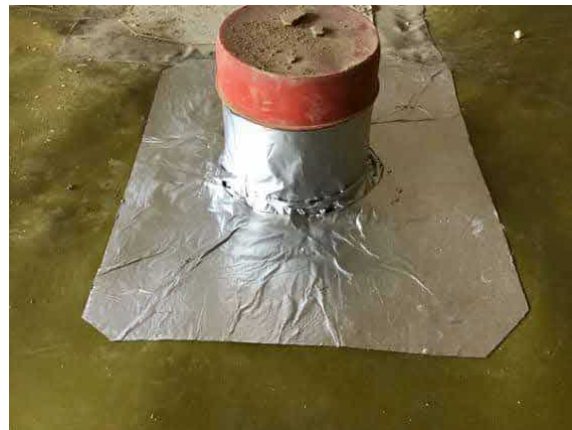
Typical pipe penetration seal using SAGM in apartment block H.

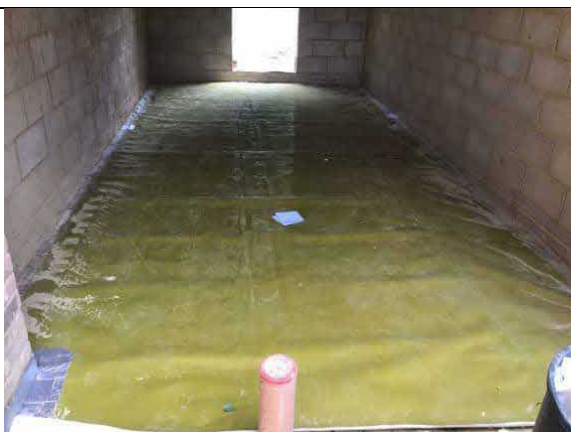
Overview of installed membrane to the garage, as an infill to plot 69.

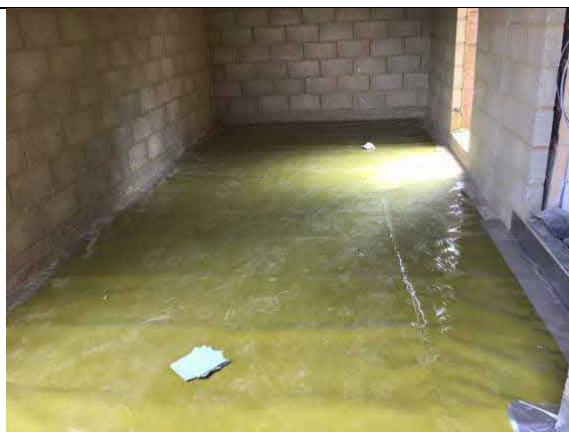
Overview of installed membrane to the garage, as an infill to plot 70.

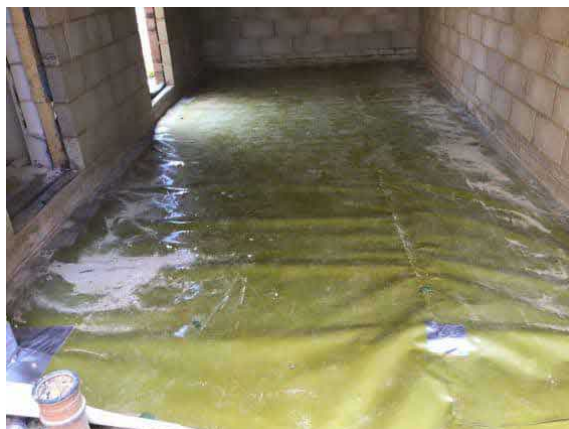
Overview of installed membrane to the garage, as an infill to plot 72.

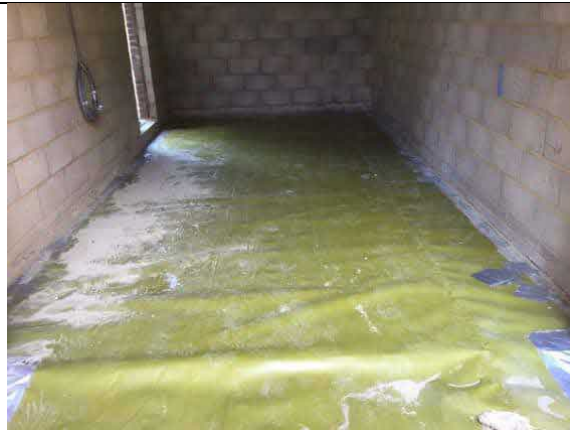
Overview of installed membrane to the garage, as an infill to plot 74.

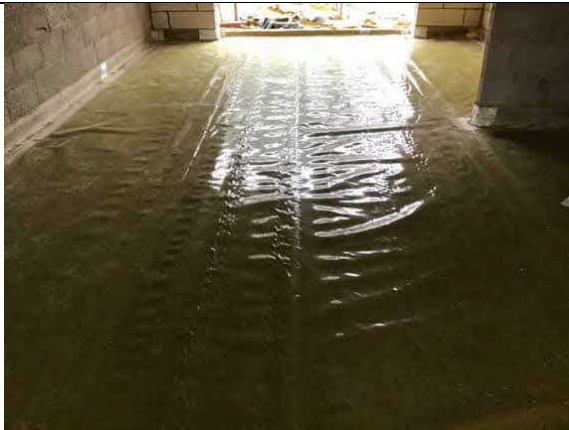
Hand welded membrane lap in plot 51.

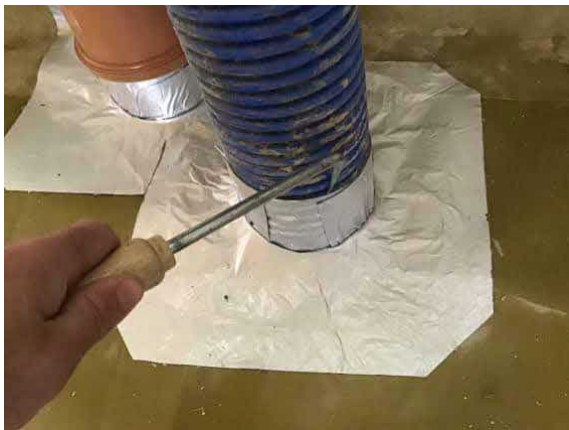
Pick testing all SAGM detailing in plot 52.

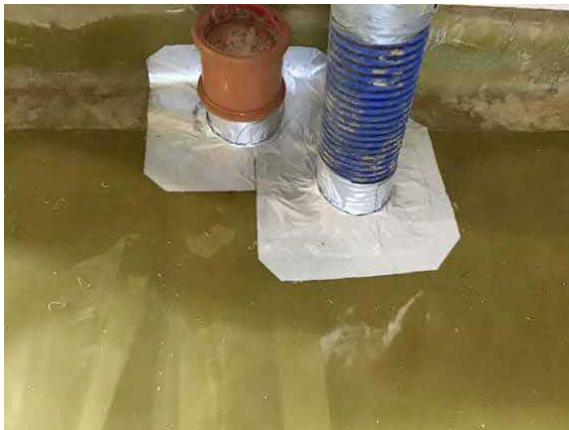
Sealed double pipe penetration using SAGM to plot 53.
