Validation Letter

Our Ref: M41977-JNP-XX-XX-RP-G-0025-P01

Re: Former Sunninghill Gas Works – Validation of Capping Layer for Plots 51- 53 inclusive (Block G)

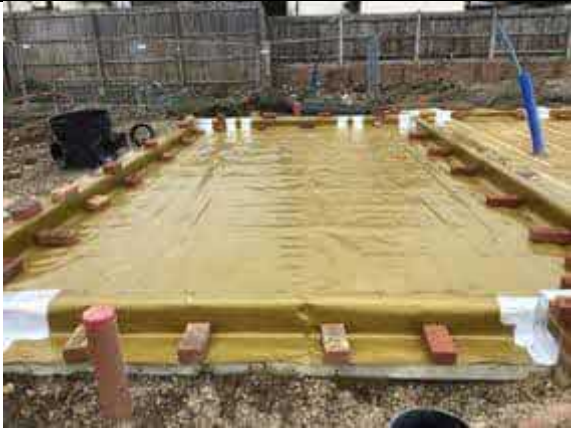
<p>Site plan.</p>	<p>Plot 4 overview of installed membrane to the garage.</p>

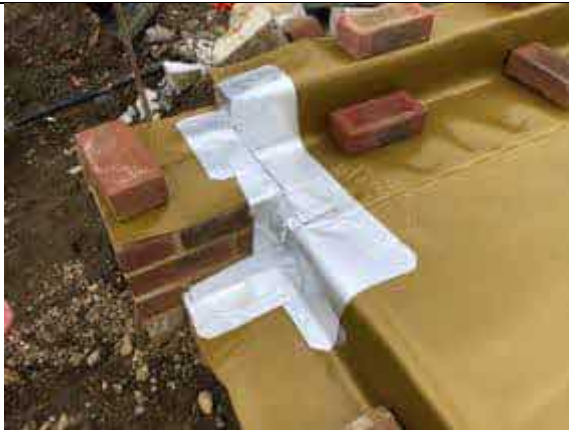
Plot 4 seal using SAGM to the front of the garage.

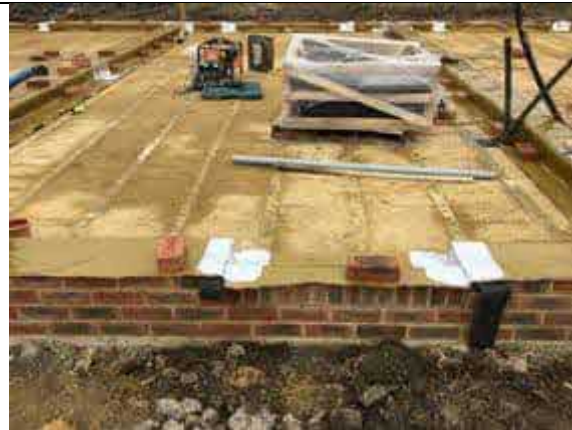
Plot 5 overview of installed membrane to the perimeter and party walls.

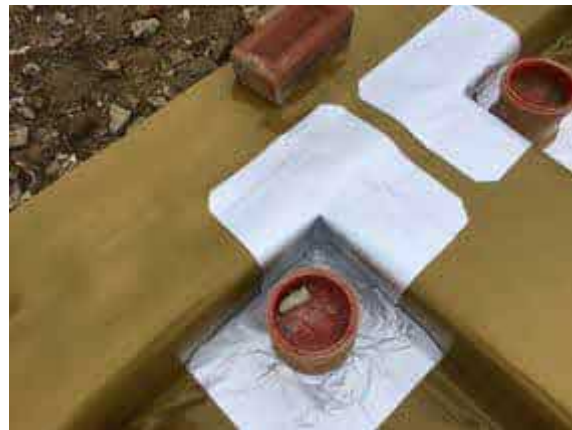
Plot 5 typical corner and pipe penetration seal using SAGM.

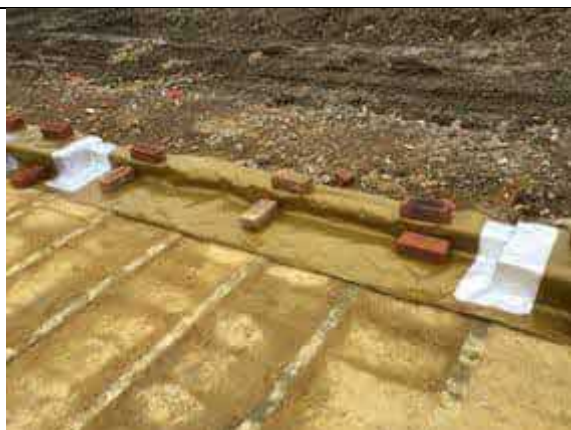
Plot 6 typical door threshold seal using SAGM.

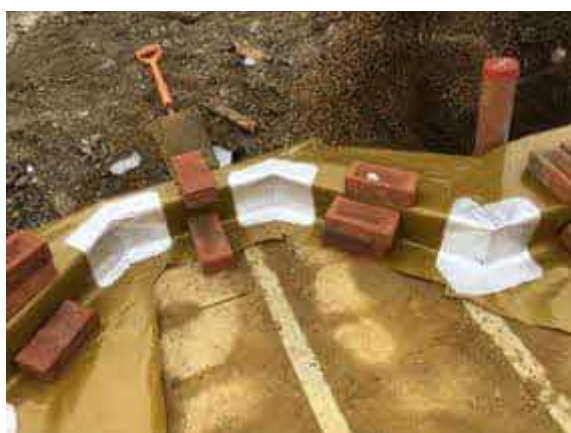
Plot 7 typical bay window corner seals using SAGM.

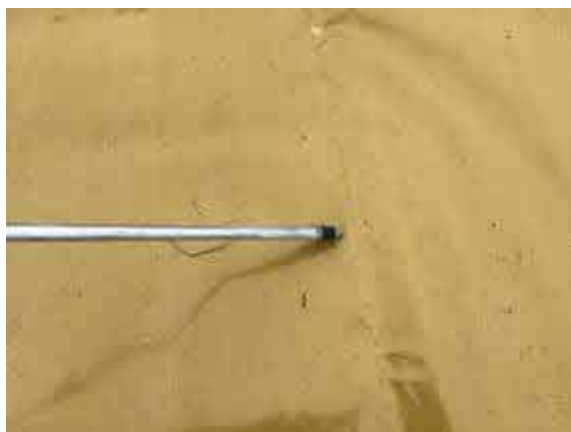
Air lancing all weld laps and SAGM detailing.

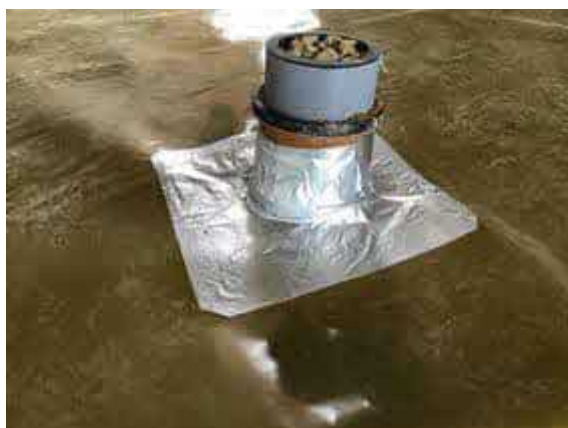
Typical pipe penetration seal using SAGM.

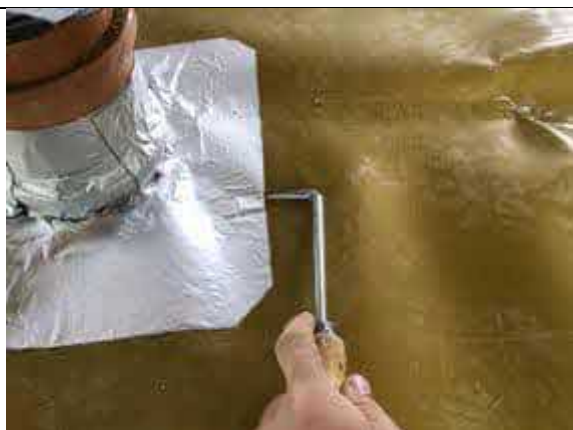
Pick testing all SAGM detailing.

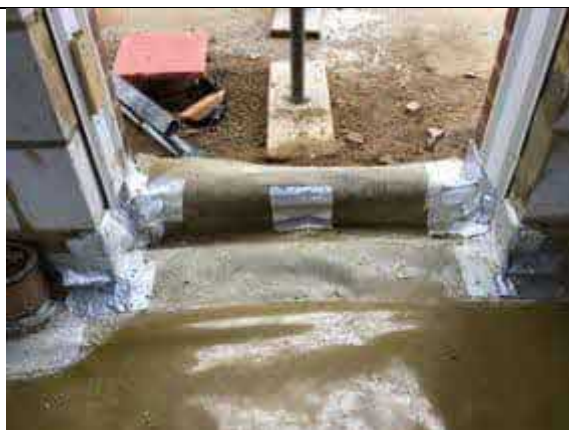
Door threshold seal using SAGM.

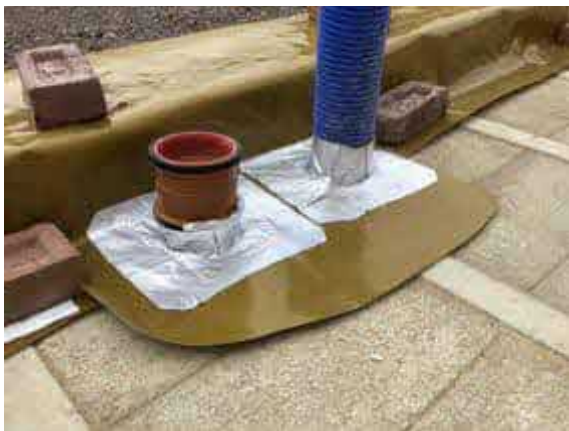
Plot 74 typical double pipe penetration seal using SAGM.

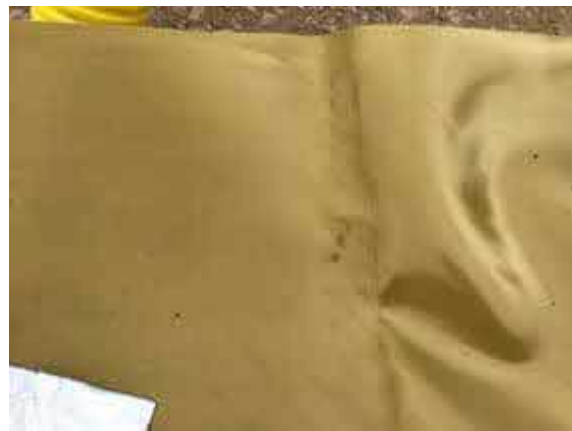
Plot 74 hand welded membrane laps over the cavity wall.

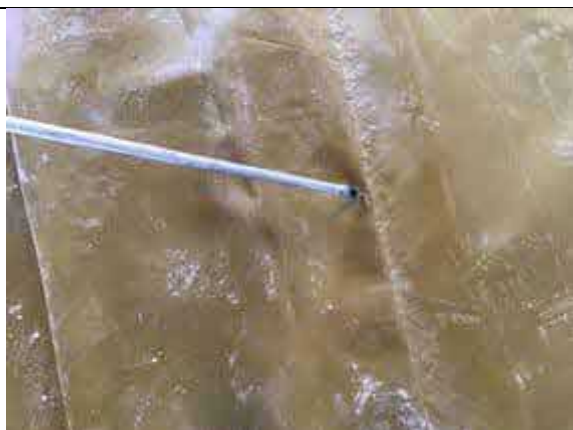
Plot 2 air lancing all weld laps and SAGM detailing.

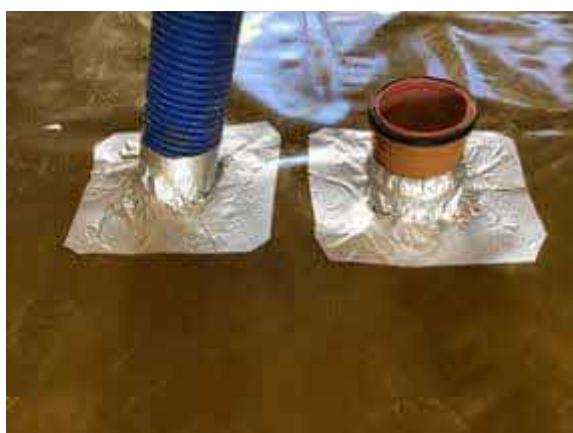
Plot 3 typical double pipe penetration seal using SAGM.

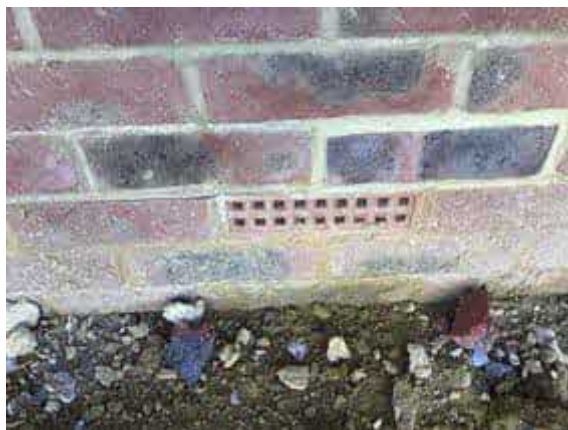
Air brick in place at the time of our inspection.

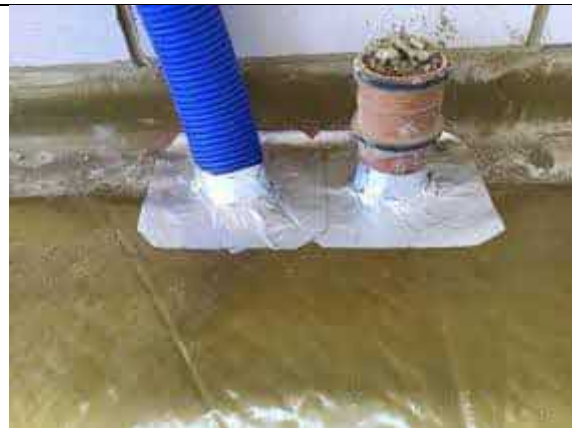
Plot 75 typical double pipe penetration seal using SAGM.

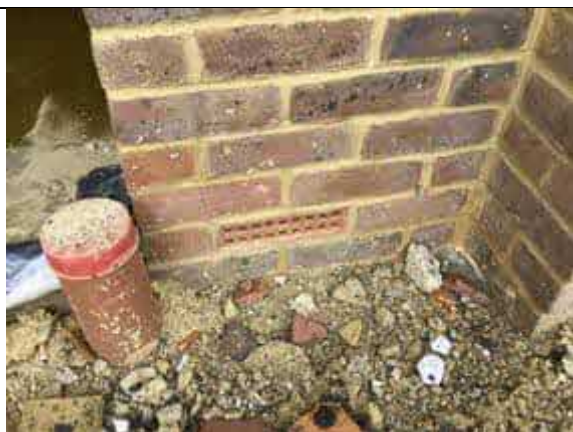
Plot 76 air brick in place at the time of our inspection.

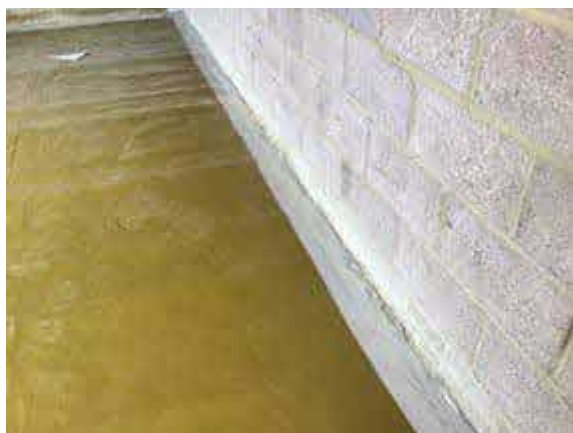
Plot 76 picture framing detail using SAGM to internal block work wall.

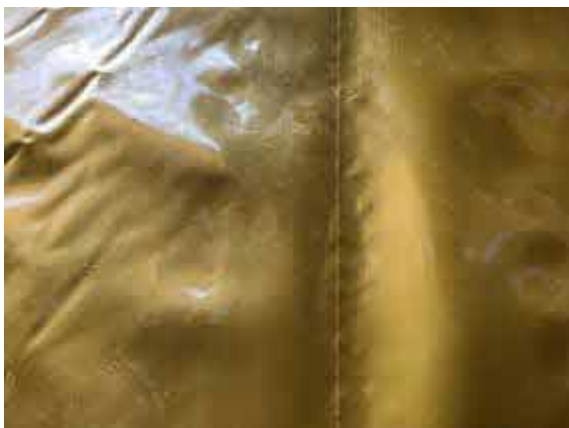
Plot 4 hand welded membrane lap.

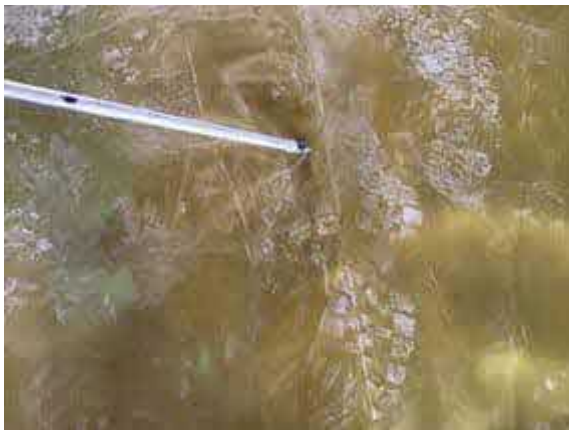
Plot 5 air lancing all SAGM detailing and welded membrane laps.

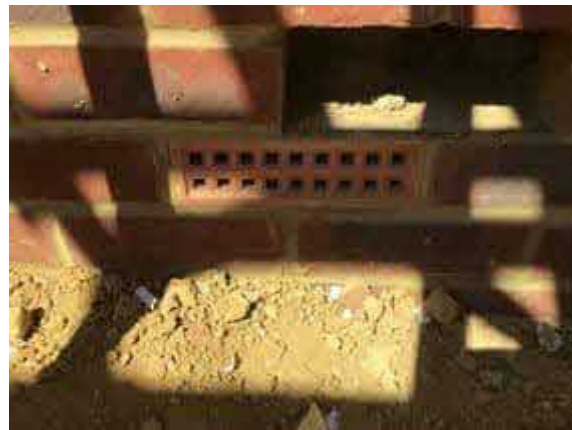
Plot 5 air brick in place at the time of our inspection.

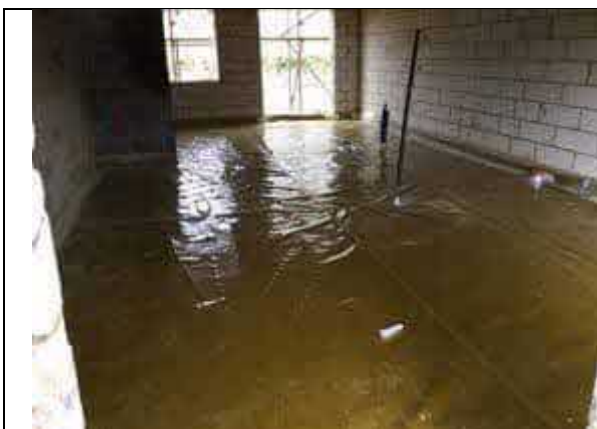
Overview to Plot 12 infill lined out using Visqueen HC Bloc.

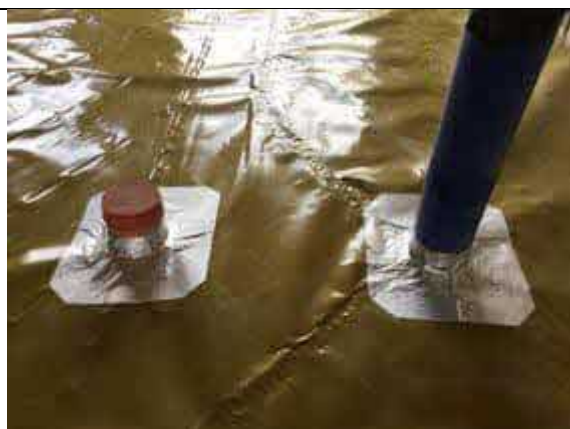
Two typical pipe details sealed with SAGM to Plot 12.

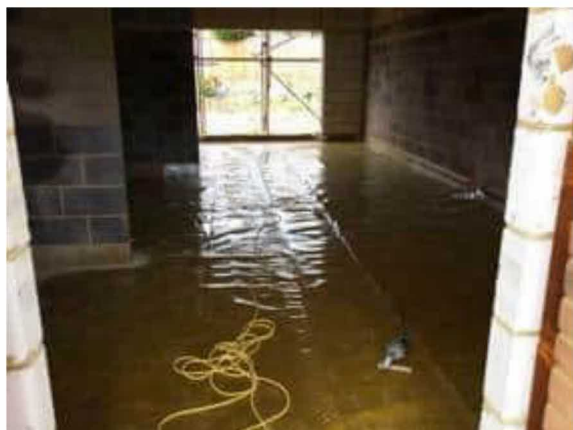
Plot 11 infill overview.

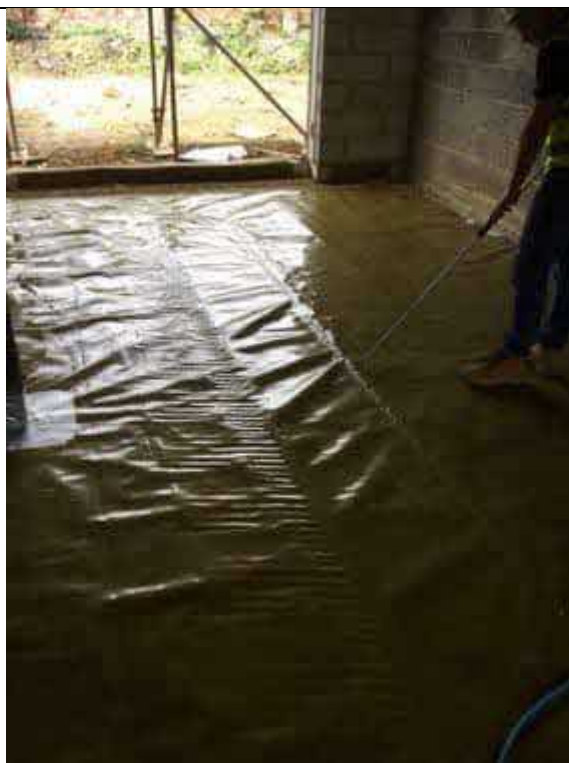
Overview to the air lance test in process to Plot 11.

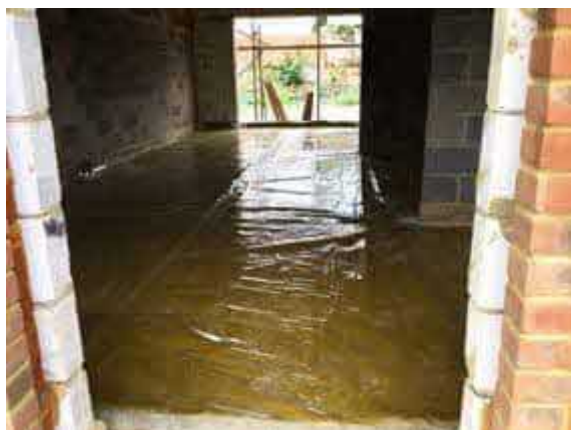
Plot 10 overview.

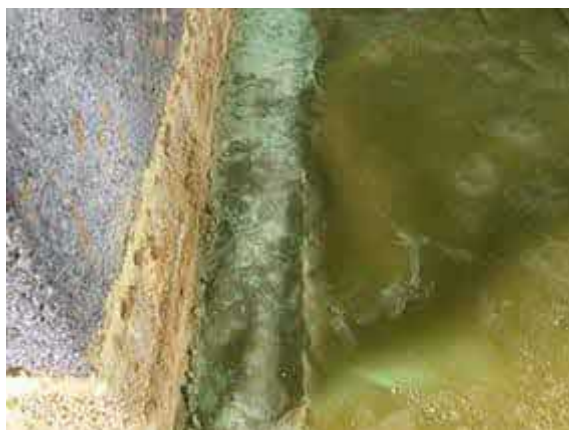
Overview to the perimeter membrane welded to the infill membrane.

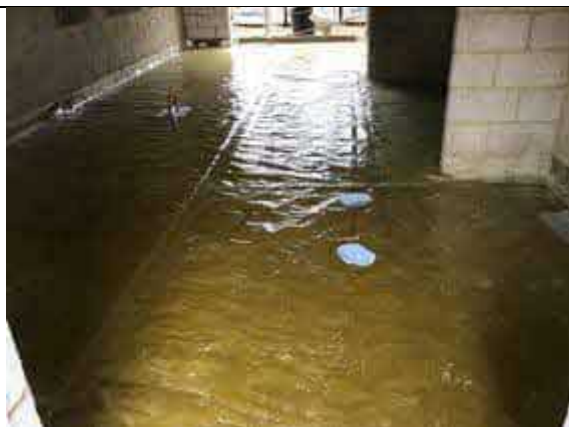
Plot 33 overview of installed Visqueen HC Blok Gas Barrier as an infill.

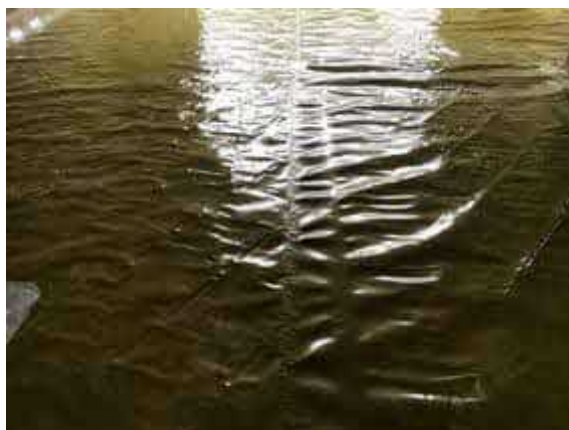
Plot 33 hand welded membrane lap.

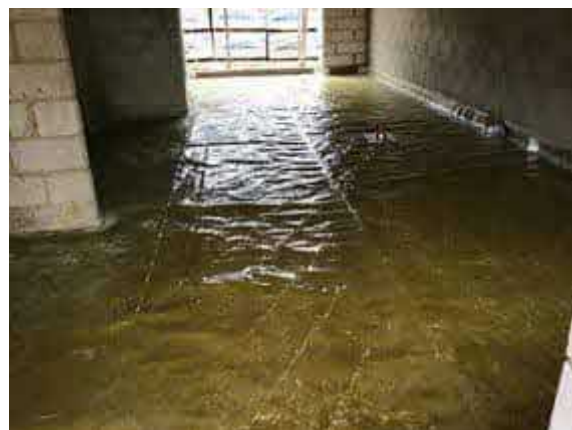
Plot 34 overview of installed Visqueen HC Blok Gas Barrier.

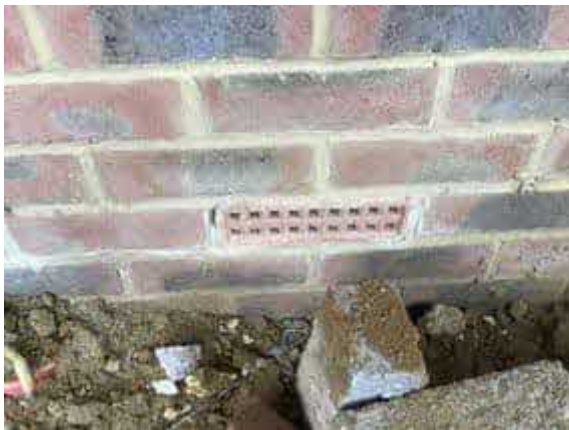
Air brick in place at the time of our inspection.

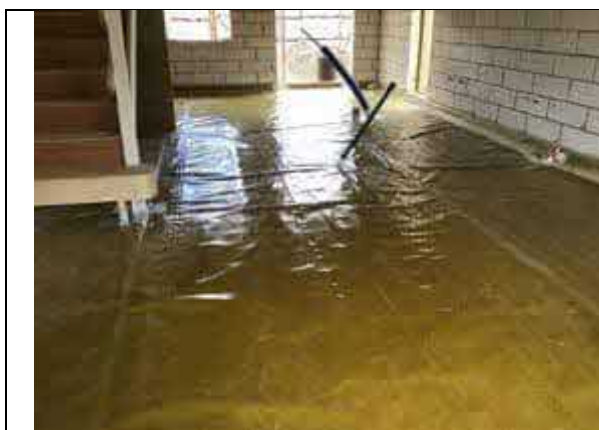
Plot 35 overview of installed Visqueen HC Blok Gas Barrier as an infill.

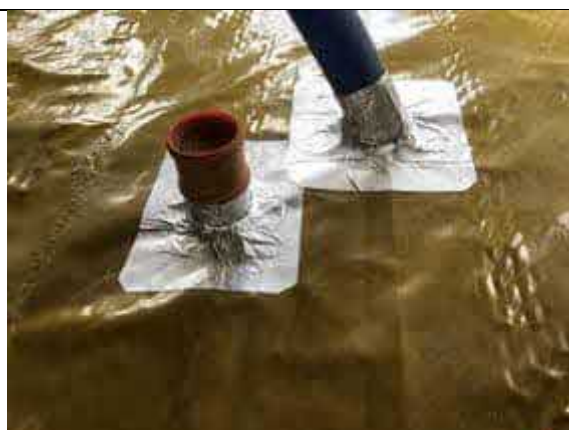
Plot 35 typical double pipe penetration seal using SAGM.

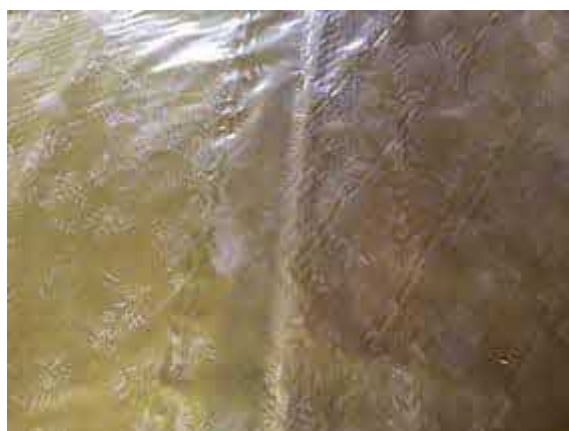
Plot 35 hand welded membrane laps.

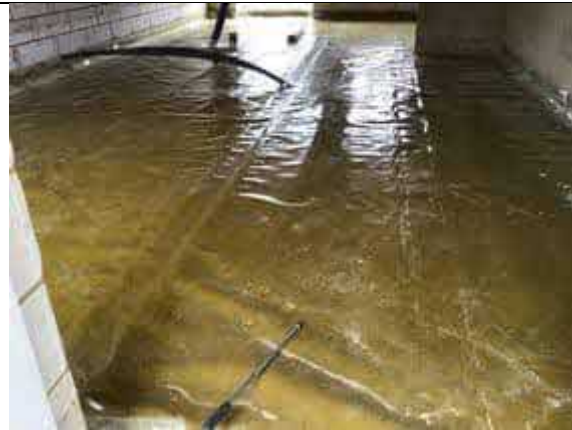
Plot 32 overview of installed Visqueen HC Blok Gas membrane.

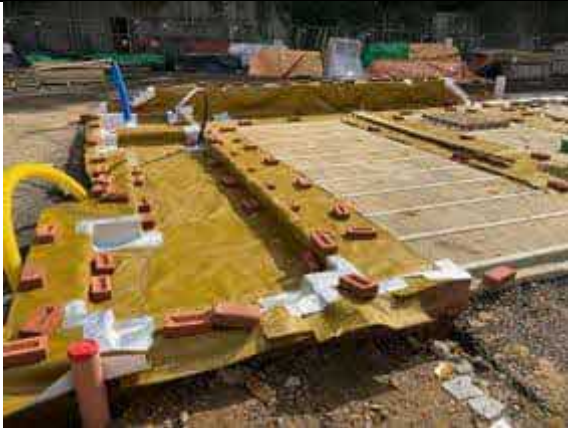
Plot 63 FOG Unit - Overview of Installation of Visqueen Ultimate HC Blok.

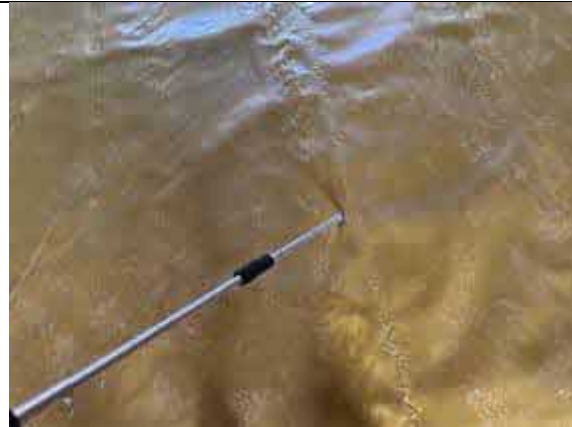
Plot 29 - Air lance integrity test upon a hand welded membrane lap joint.

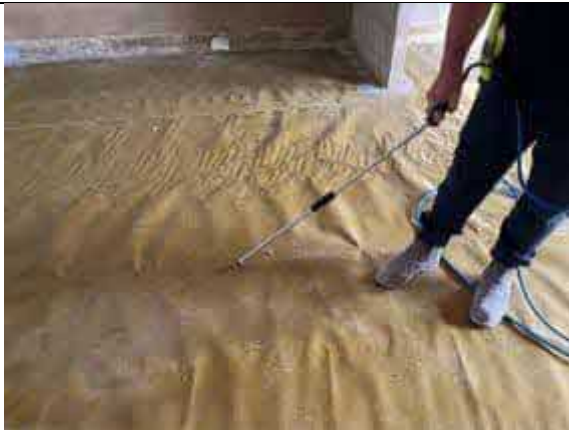
Plot 30 - Air lance test conducted upon all membrane lap joints.

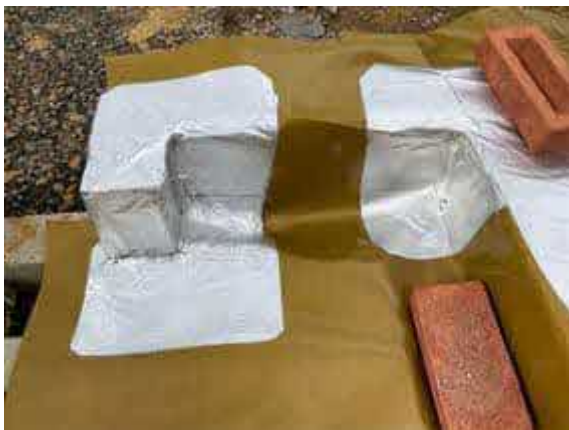
Plot 63 FOG Unit - Corner detailing sealed using SAGM.

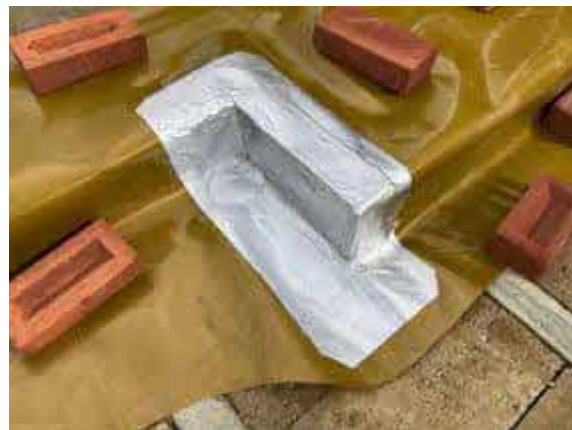
Plot 63 FOG Unit - Typical threshold detail sealed using SAGM.

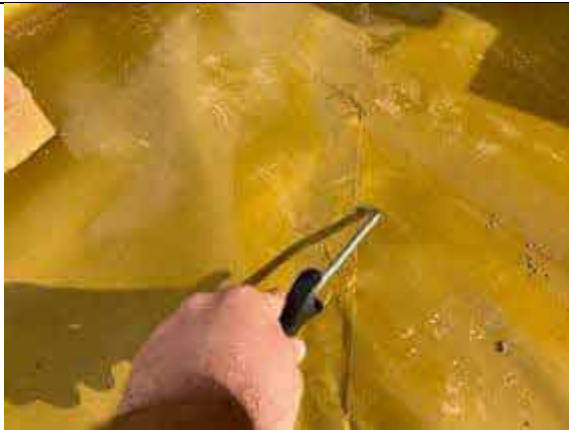
Plot 63 FOG Unit - Pick test upon a successfully hand welded lap joint.

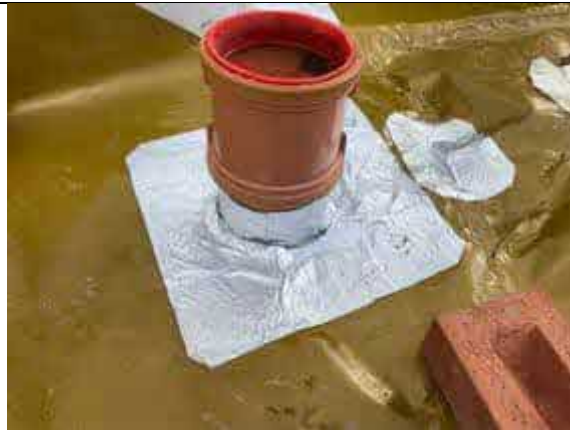
Plot 63 FOG Unit - Typical pipe penetration sealed using SAGM.

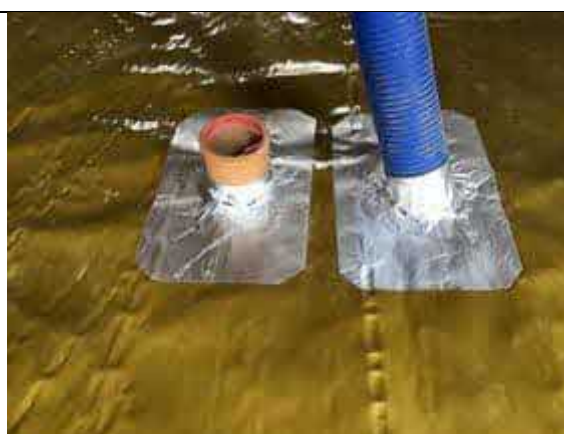
Plot 27 typical double pipe penetration seal using SAGM.

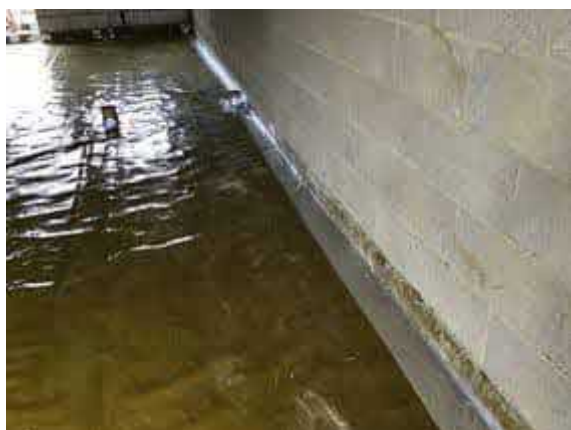
Plot 28 retro fit detail using SAGM.

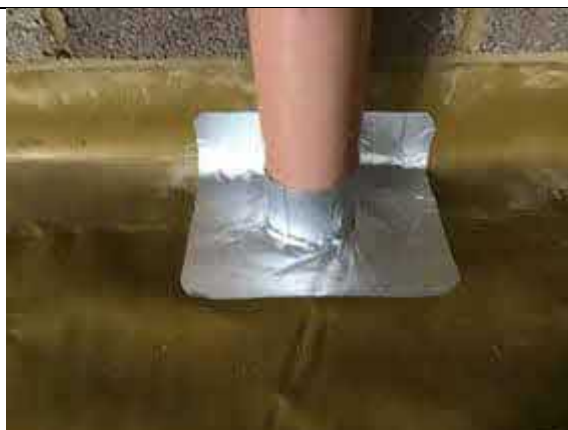
Typical pipe penetration seal using SAGM.

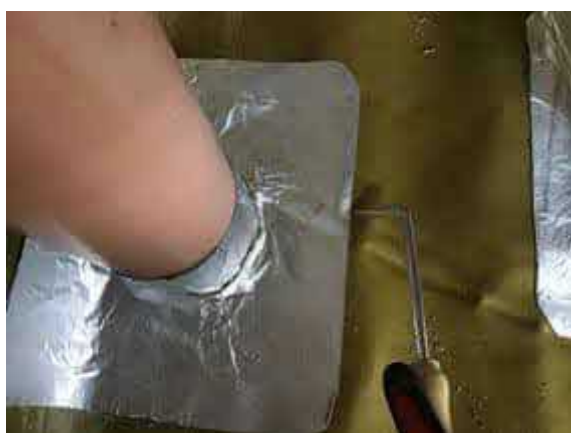
Pick testing all SAGM detailing.

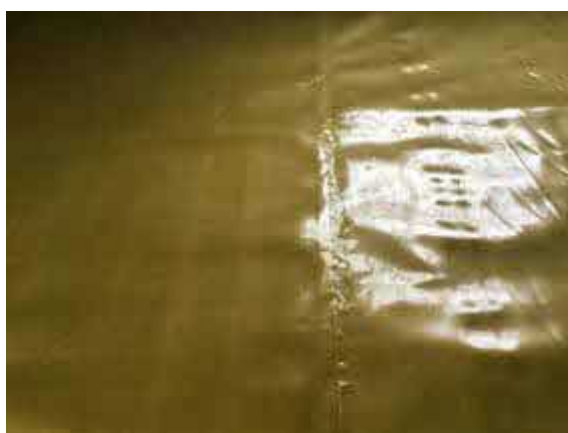
Hand welded membrane lap.

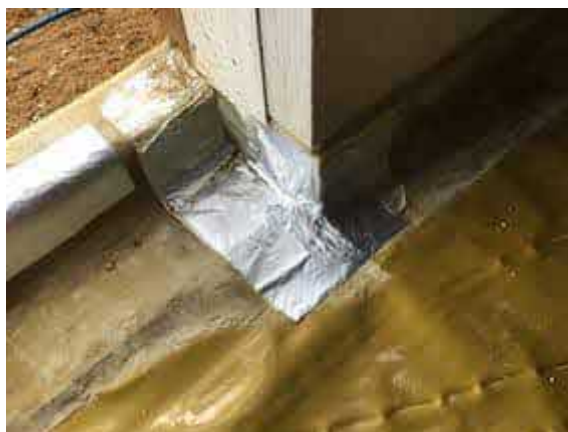
Sealed corner detail using SAGM.

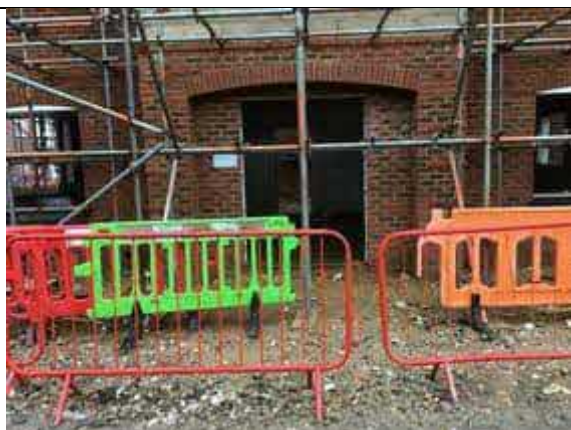
Overview of plot 41.

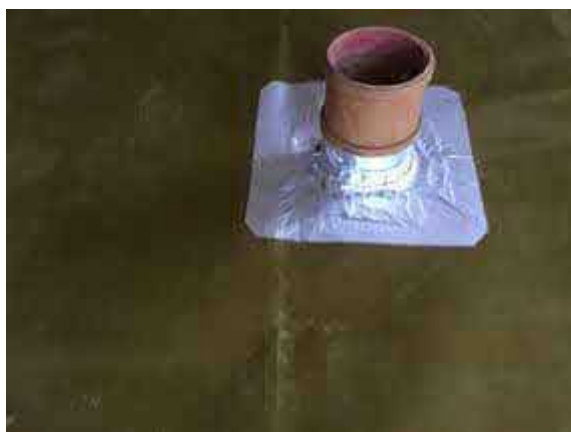
Typical pipe penetration seal using SAGM to plot 36.

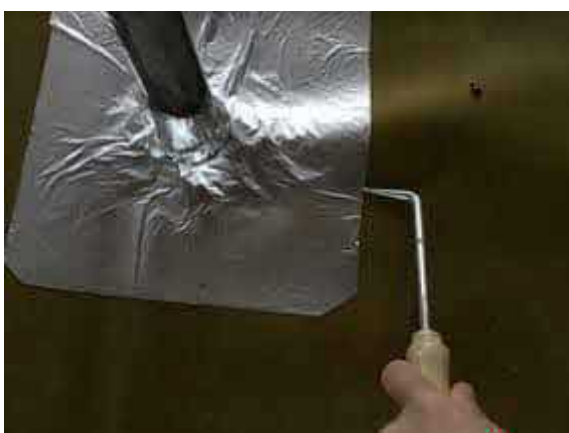
Pick testing all SAGM detailing to plot 38.

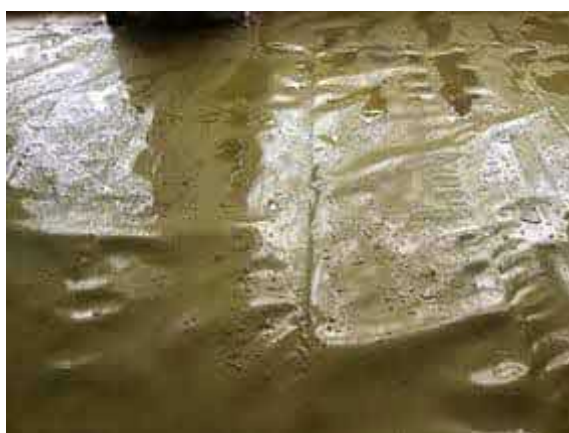
Hand welded membrane lap in plot 38.

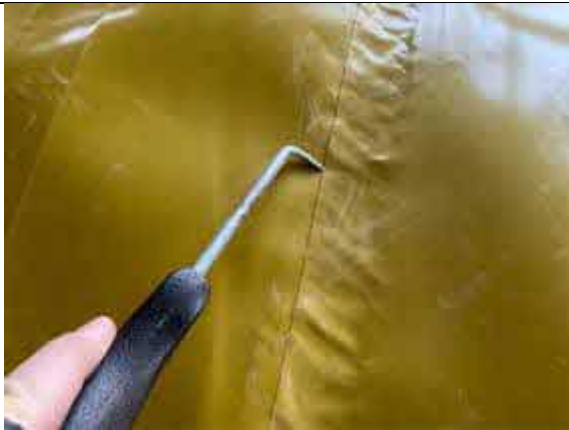
Plot 74. Air lance integrity test conducted upon sealed pipe penetration.

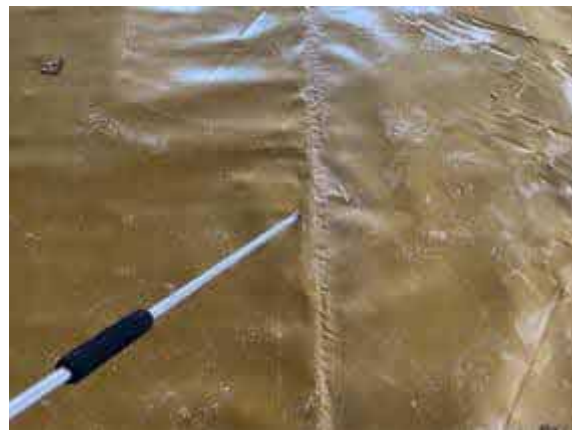
Plot 70. Pick test conducted upon sealed pipe penetration.

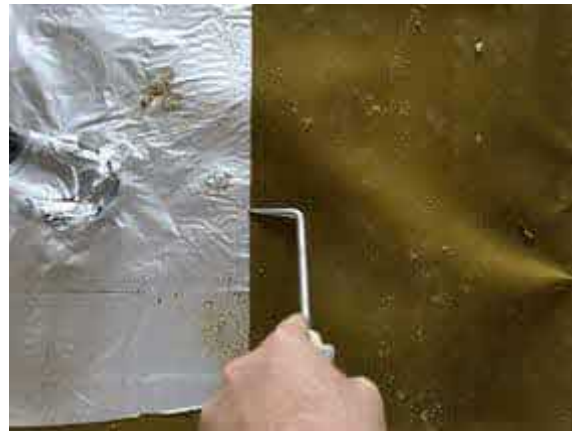
Pick testing all SAGM detailing.

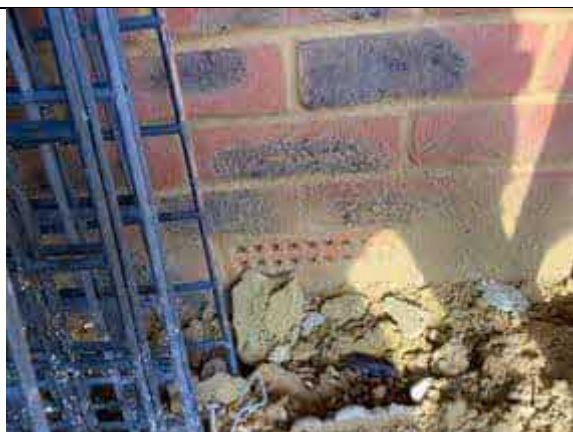
Plot 44 air brick in place at the time of our inspection.

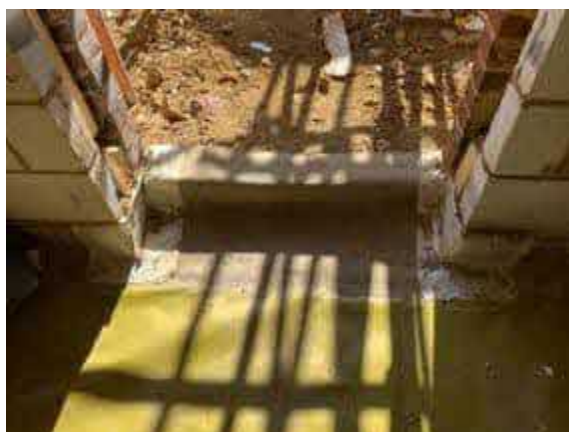
Plot 45 sealed door threshold detail using SAGM.

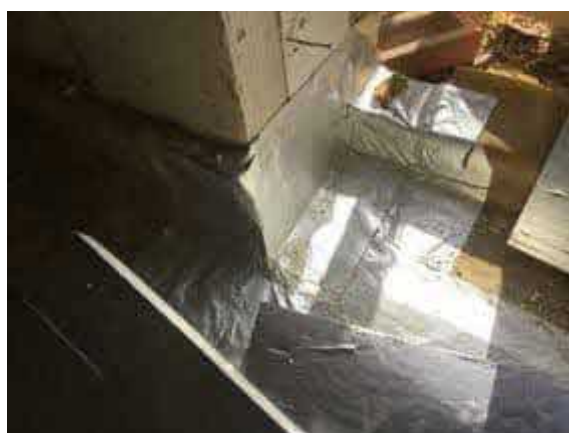
Re sealed door threshold detail using SAGM to plot 65.

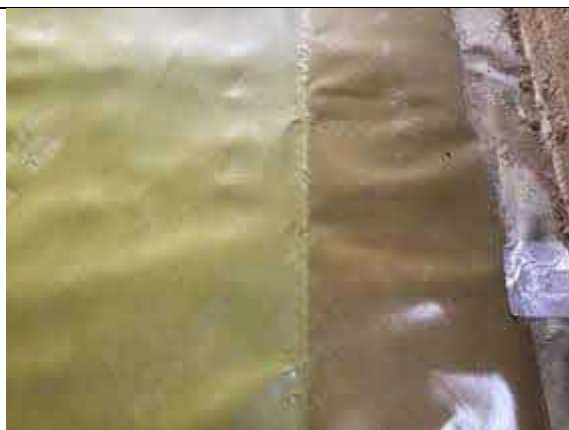
Hand welded membrane lap to plot 36.

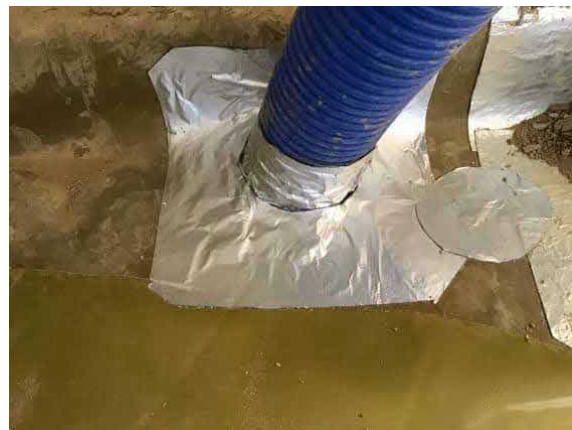
Typical pipe penetration seal using SAGM to plot 46.

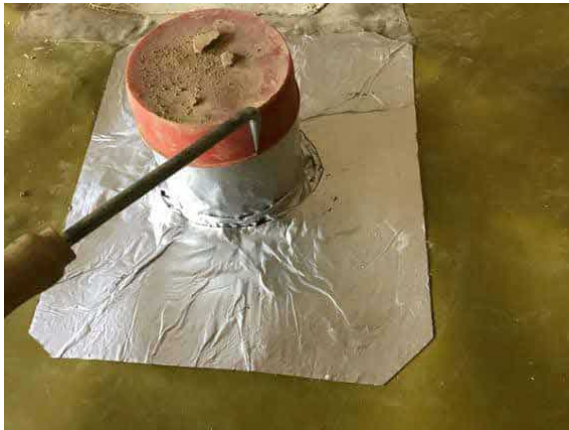
Pick testing all SAGM detailing in apartment block H.

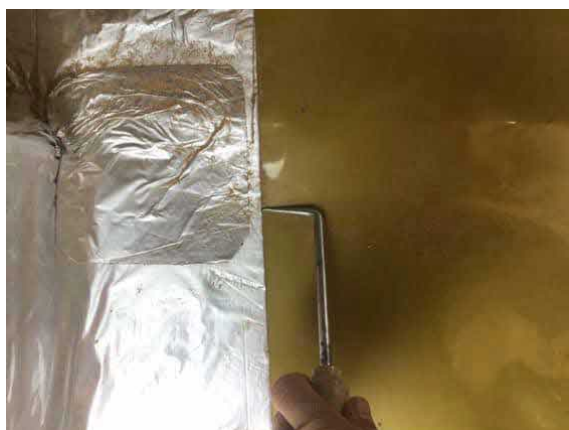
Pick testing all SAGM detailing.

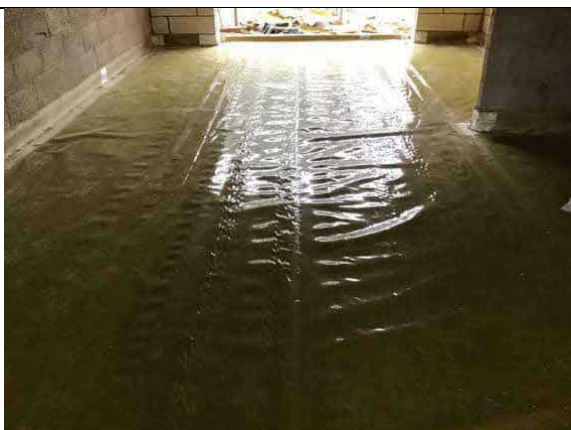
Hand welded membrane lap in plot 51.

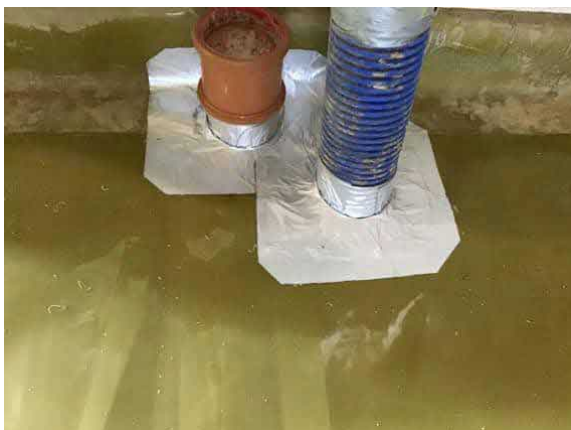
Sealed double pipe penetration using SAGM to plot 53.

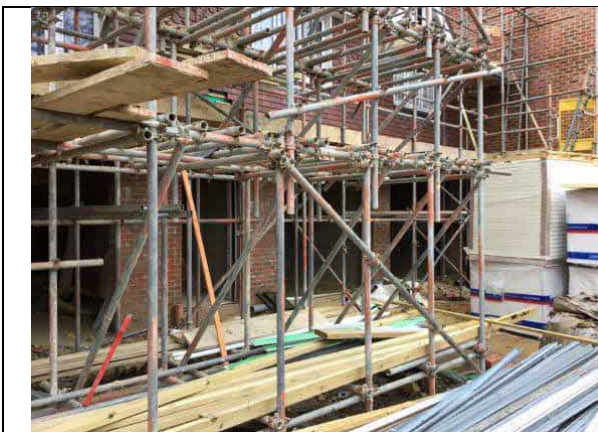
Overview of plots 63 & 64.

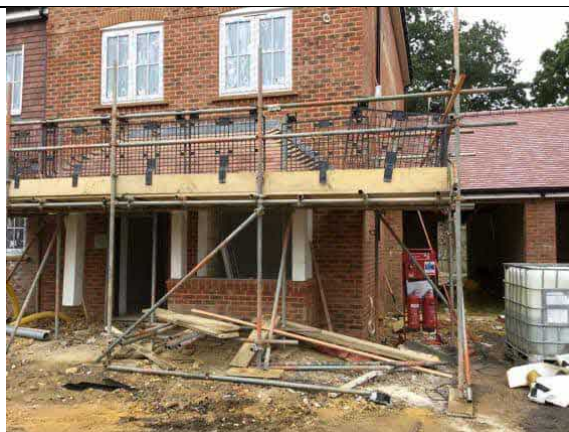
Overview of plot 67.

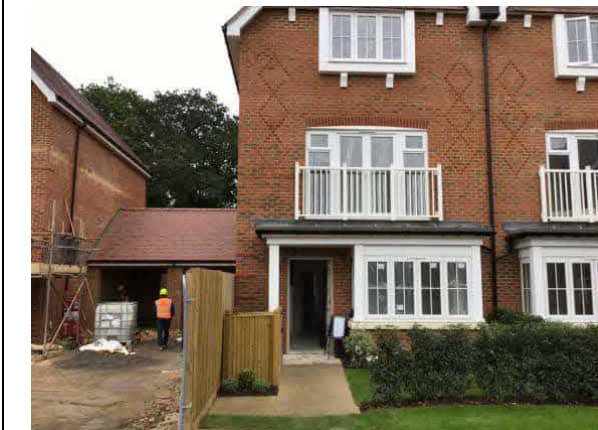
Overview of plot 68.
