STRUCTURAL CONDITION REPORT

Former Chambers Bus Garage site, Bures

Rose Builders

Project no: 62021

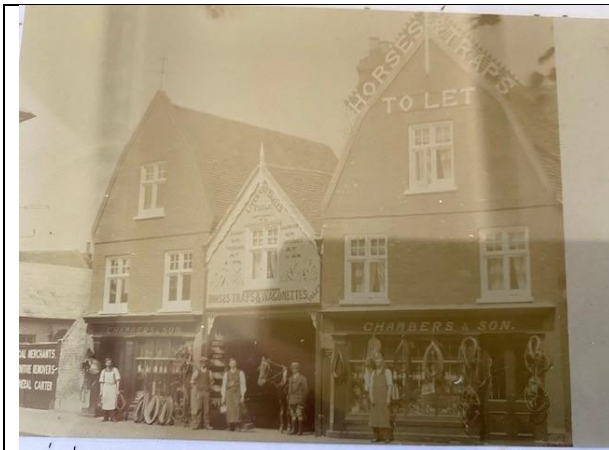
1. Historic view of street frontage

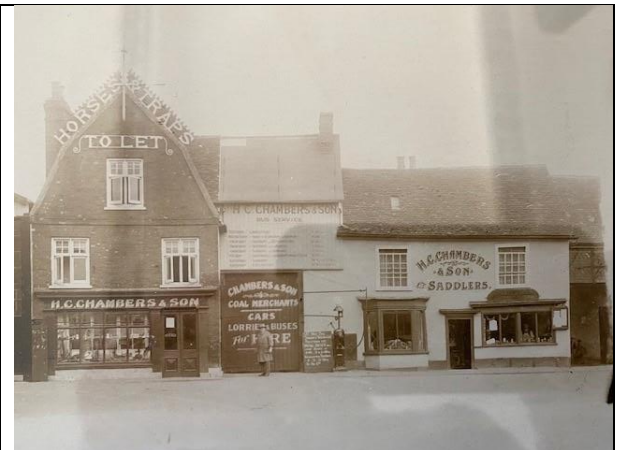
2. Another historic view

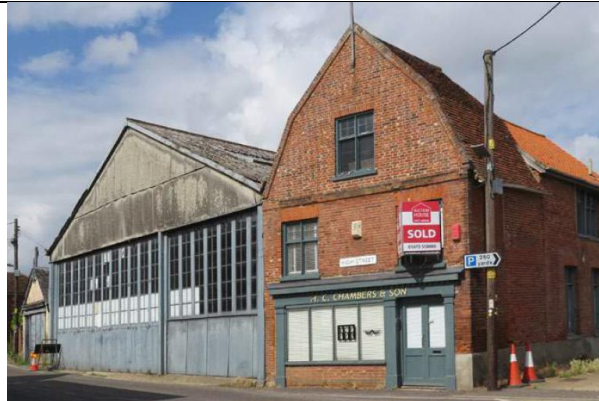
3. Current day street frontage

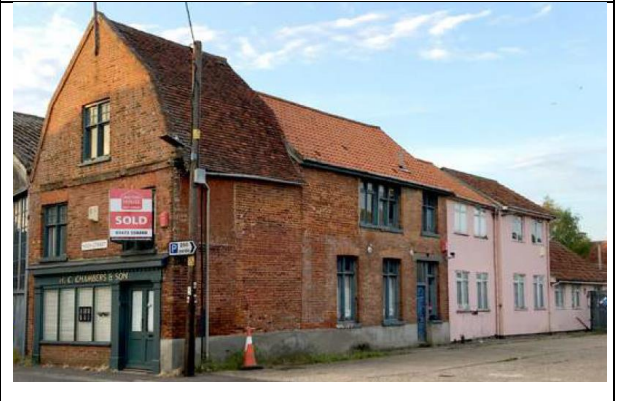
4. Current day side elevation

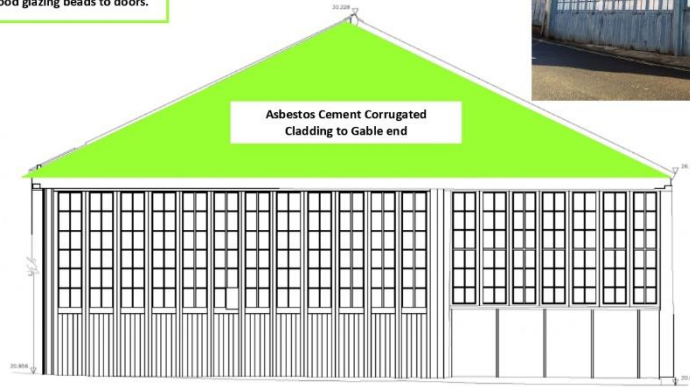
Asbestos Cement Corrugated Cladding
To Roof, Ridges, Capping pieces
Asbestos Rope In Roof Glazing bars
Asbestos cement cladding to sides
Asbestos cement Gutters & Down pipes
Wood doors wood glazing beads to doors.

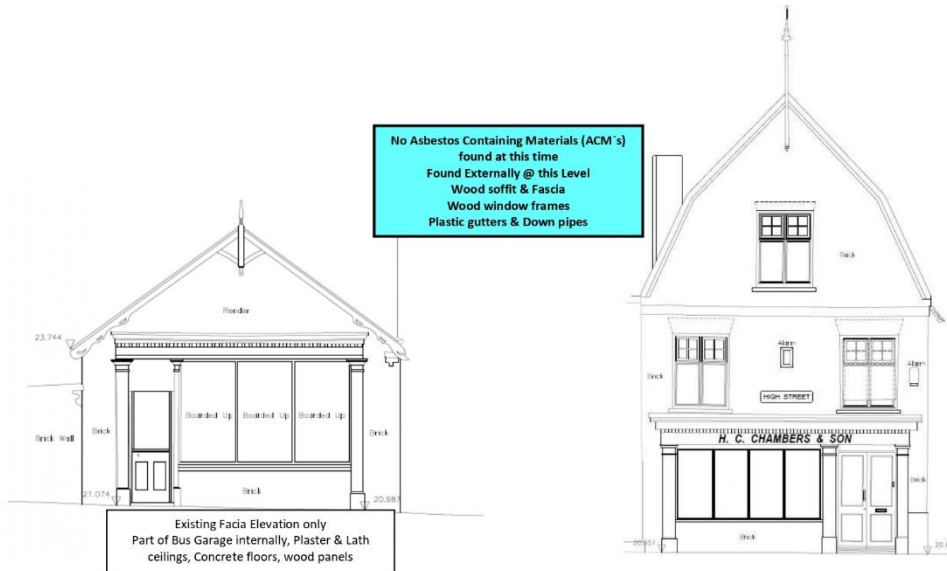
No Asbestos Containing Materials (ACM's)
found at this time
Found Externally @ this Level
Wood soffit & Fascia
Wood window frames
Plastic gutters & Down pipes
