THE OLD FORGE HOUSE

SURVEY PHOTOGRAPHS/
SCHEDULE OF WORKS.

RBD 5423

MR/MRS LU

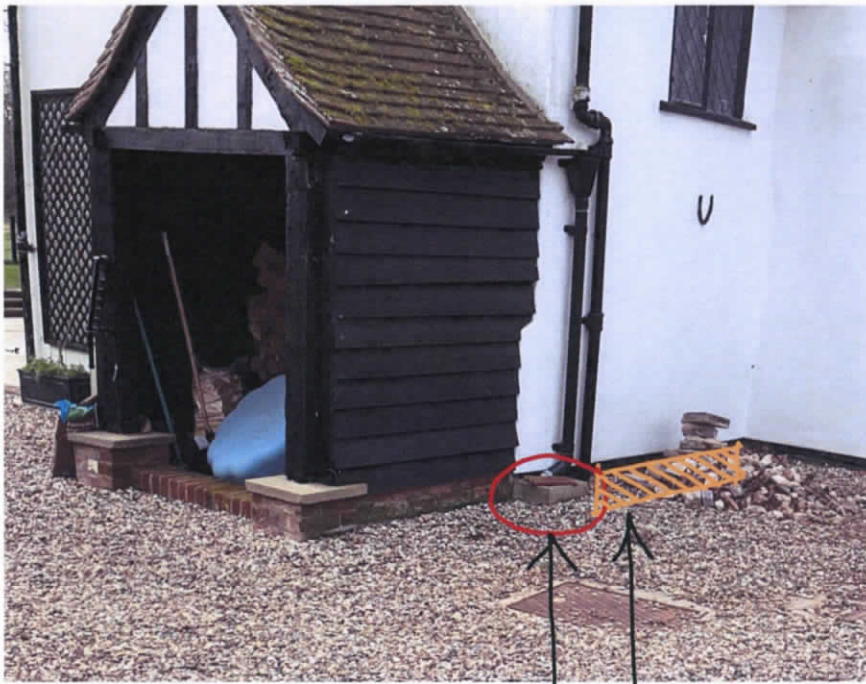
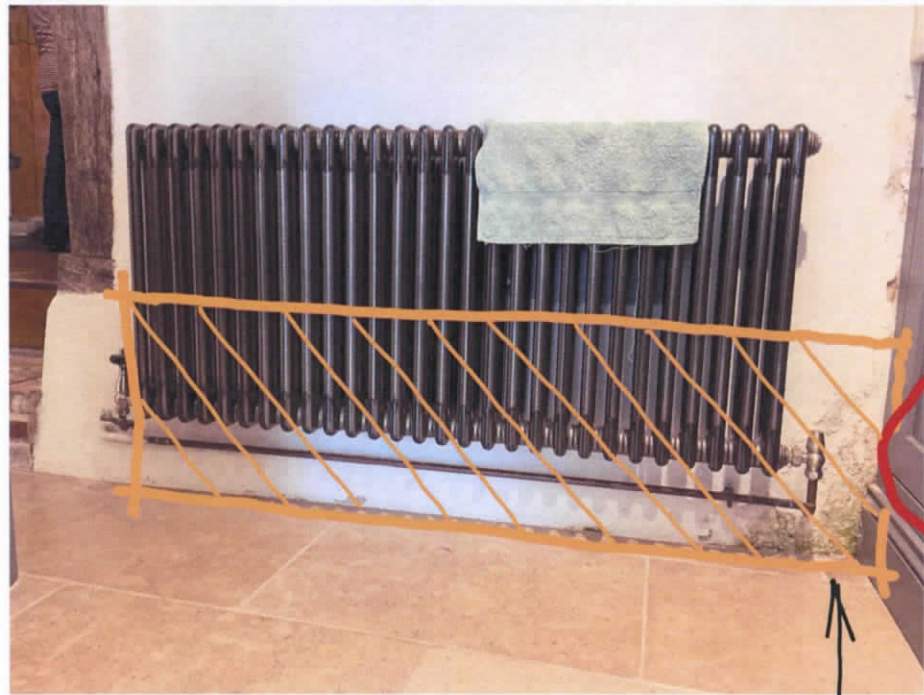
KITCHEN DAMP.

LOCATION AREA OF DAMP

LOCATION SURFACE WATER

DRAINAGE GULLY

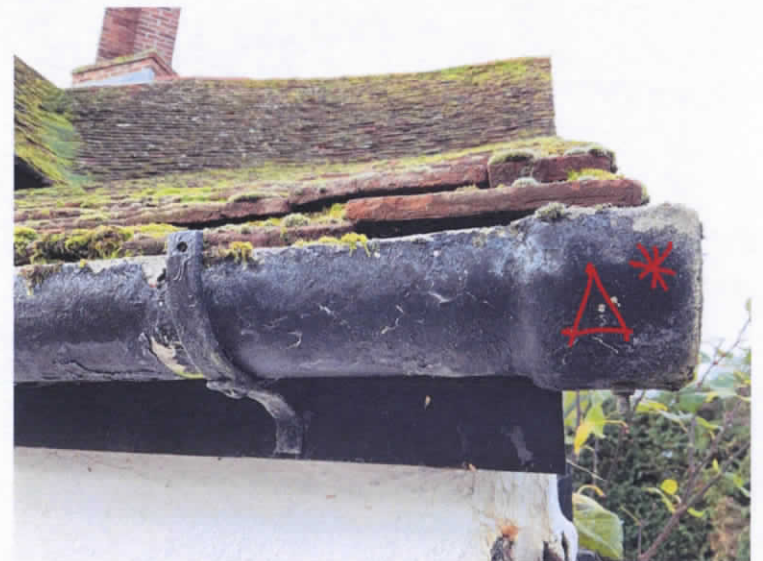
* Δ NOTE - POSSIBLE ASBESTOS GUTTER
WARNING FOR REMOVAL AND
DISPOSAL TO REGULATION

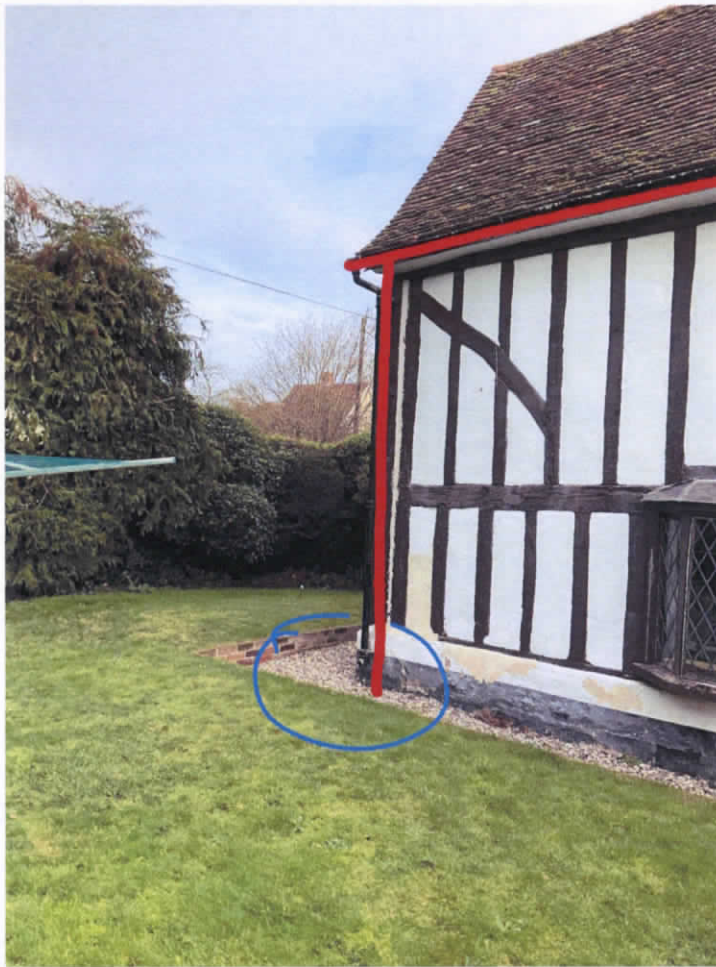
WEST ELEVATION - RAIN WATER GOODS

- SURFACE WATER GULLYS REQUIRED TO BE CONNECTED
TO EXISTING SURFACE WATER DRAINAGE OR AWAY
TO NEW SOAKAWAY.

- REPLACEMENT - GUTTERS - PROPOSED NEW DOWN PIPE
AND DOWN PIPE

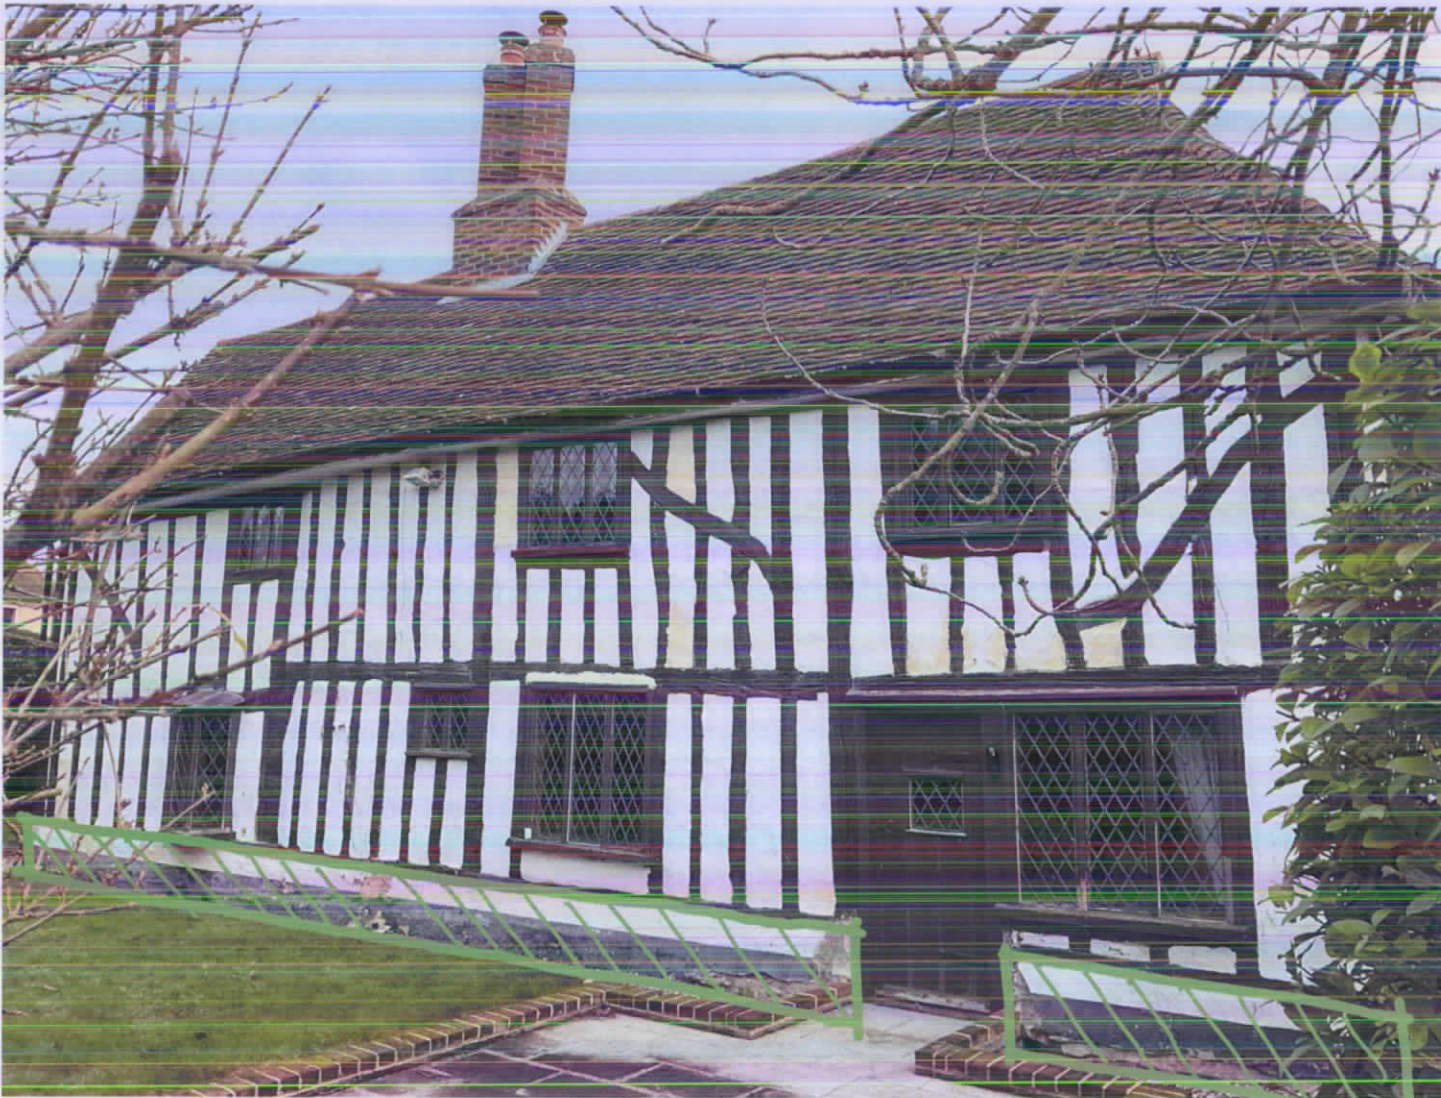
WEST ELEVATION

CEMENTIOUS RENDER
PANEL - SUBSTRATE
TO BE DETERMINED.

INAPPROPRIATE
CEMENT REPAIR

FOR THE LONG TERM BENEFIT OF THE BRICK PUNTH AND
TIMBER FRAME OVER — CONSIDER REMOVAL OF THE
CEMENTIOUS RENDER TO THE PUNTH AND REPLACEMENT
LIME BASED RENDER.

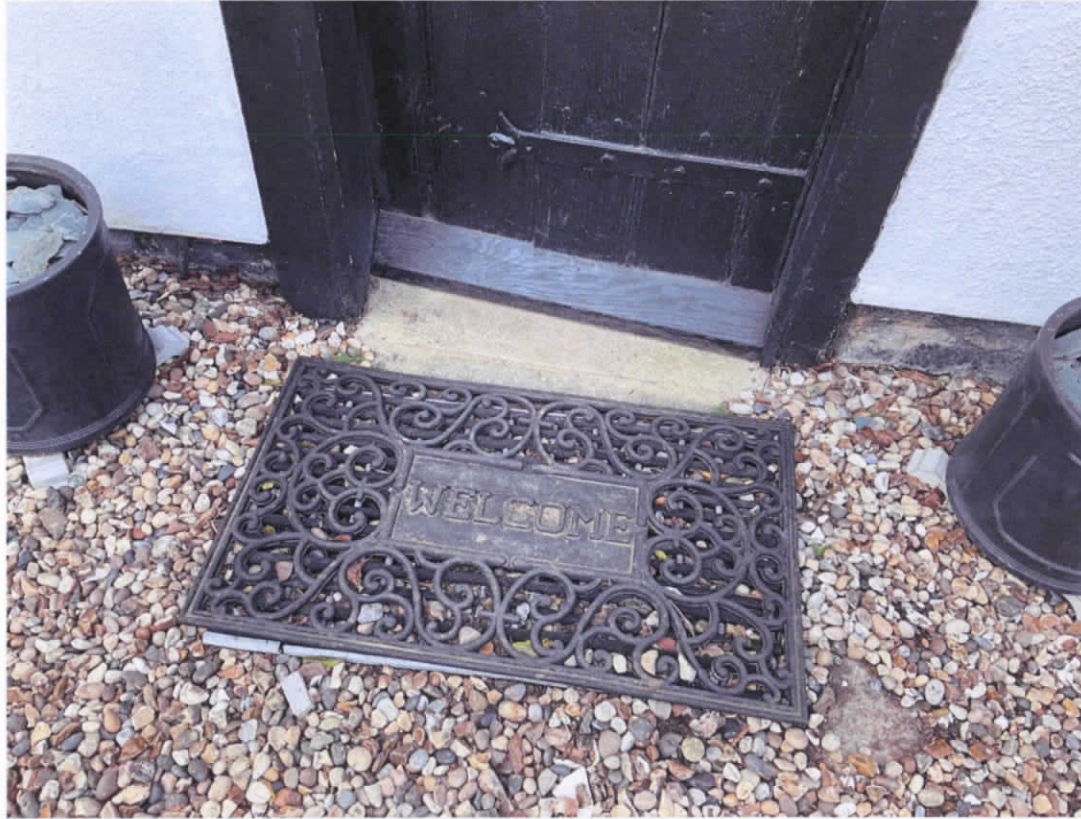
FRONT DOOR

CEMENT
THRESHOLD.

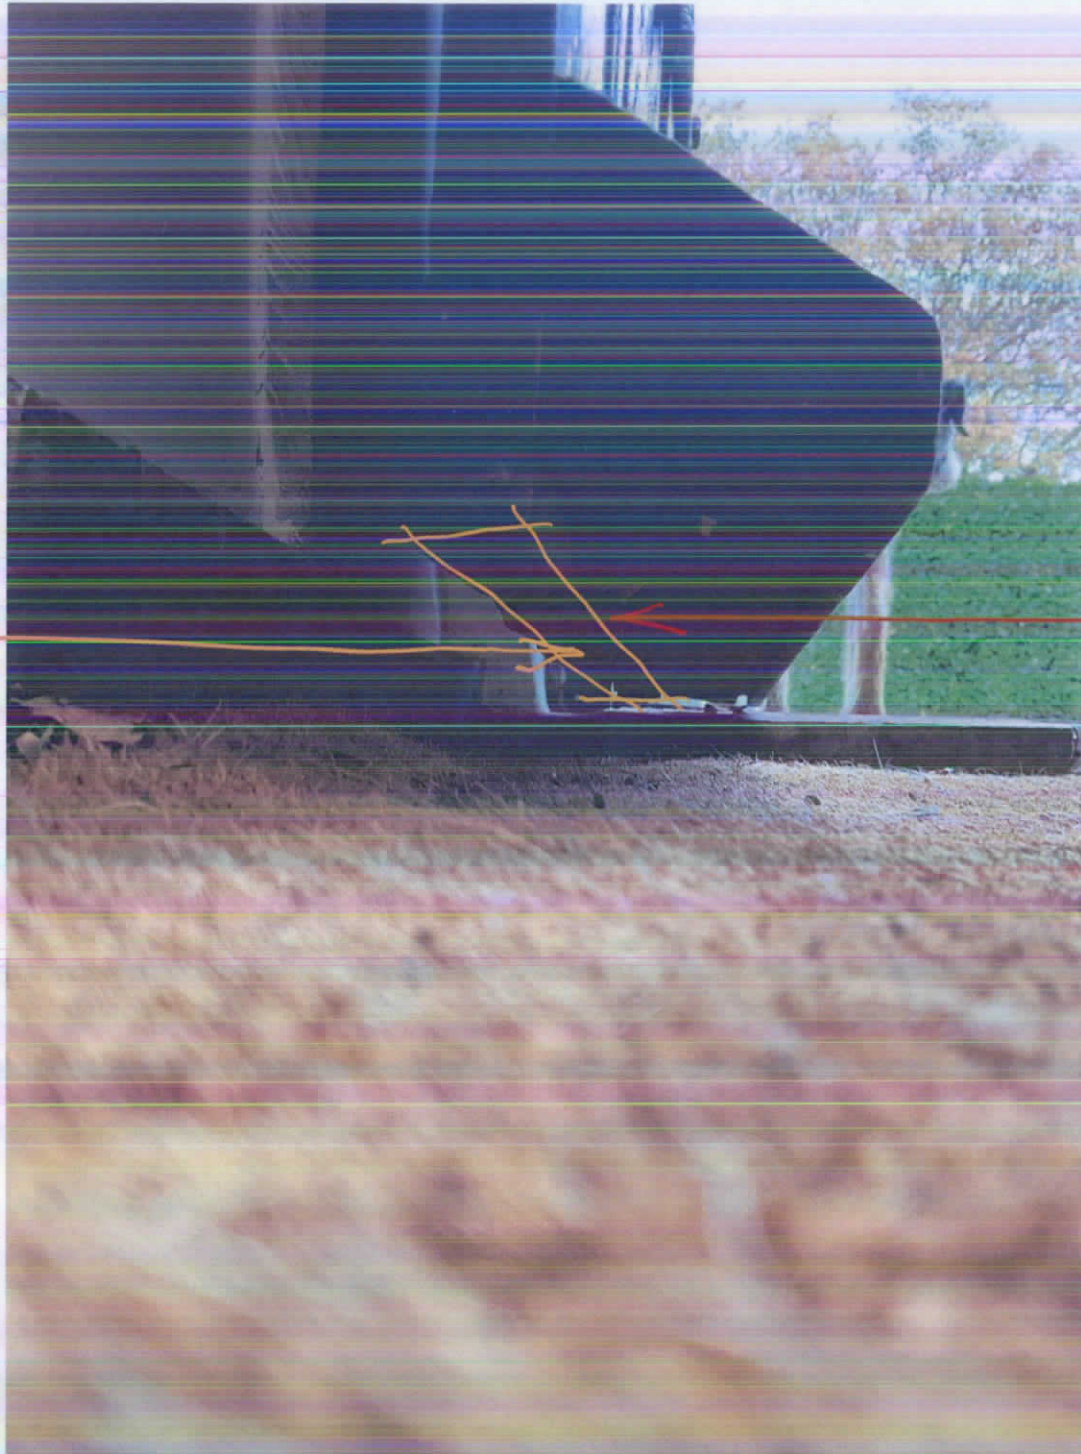
DRIVING RAIN
AGAINST
HERE
