Date: 23<sup>rd</sup> November 2023  
Ref: C8785E/8486/AS/AS

## GROUND GAS VERIFICATIONS – STEPHENSON ROAD, PETERLEE (PLOTS 23 TO 28, 31 AND 47 TO 59)

## Gas Protection Verification Photographs

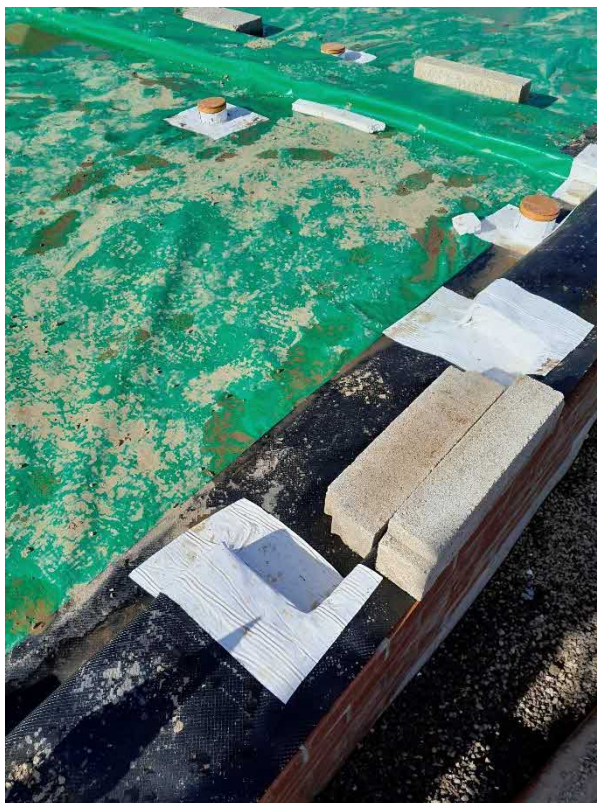
07 C8785E 07.03.23 Plot 26 Corners (client photo)

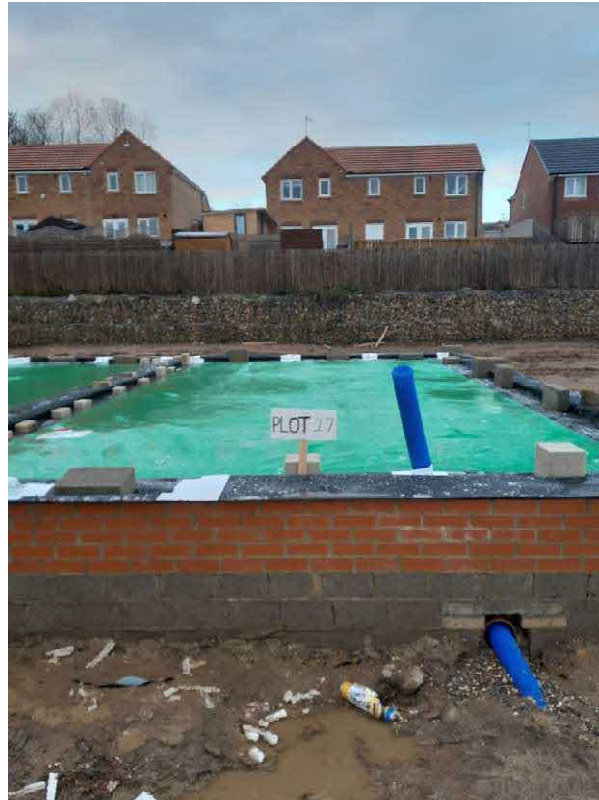
01 C8785E 07.12.22 Plot 27 Overview (Client photo)

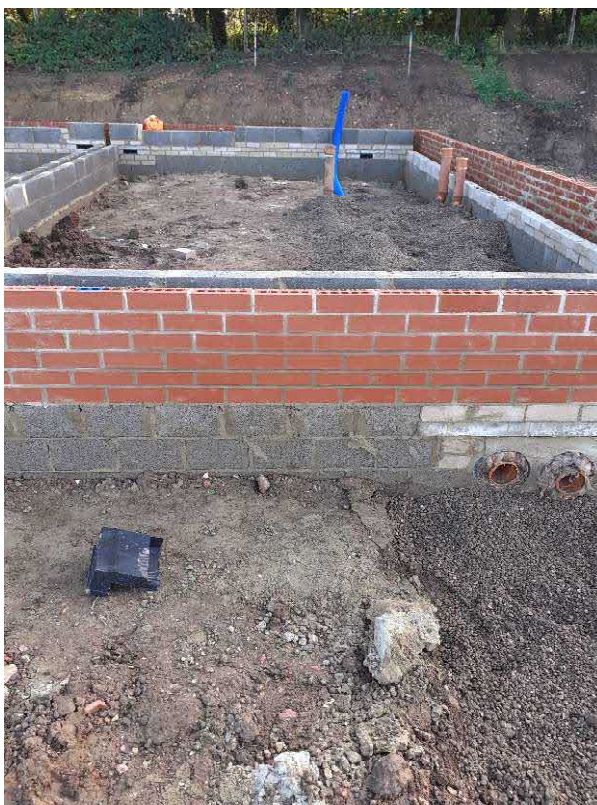
01 C8585E 29.09.22 Plot 31 Void Space

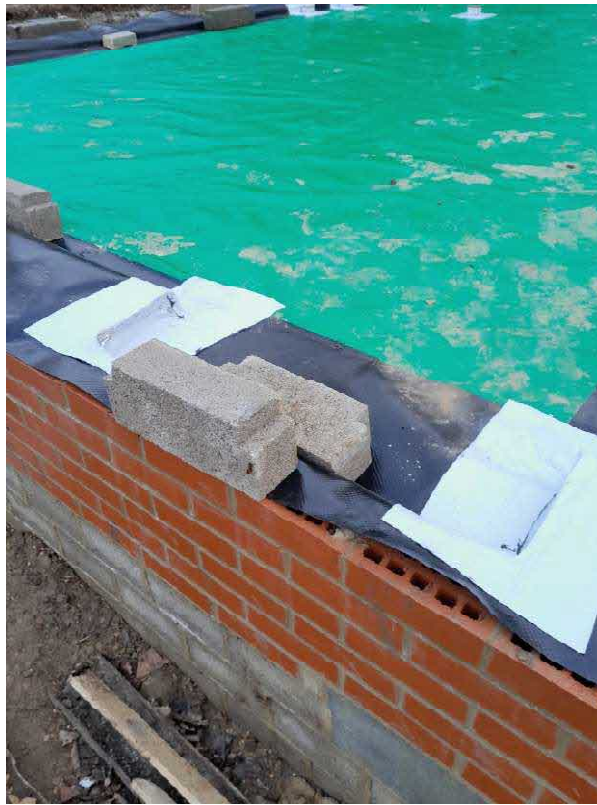
03 C8785E 23.01.23 Plot 31 Corners (client photo)

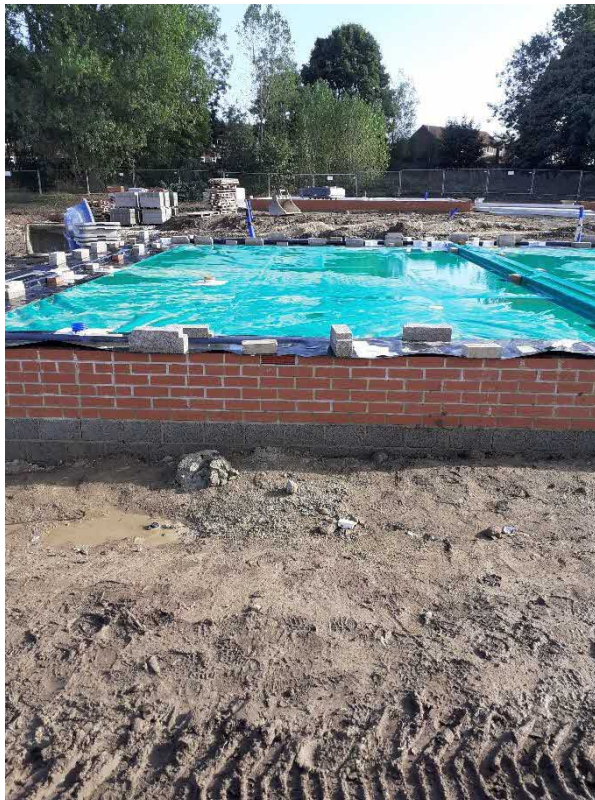
02 C8585E 29.09.22 Plot 47 Overview

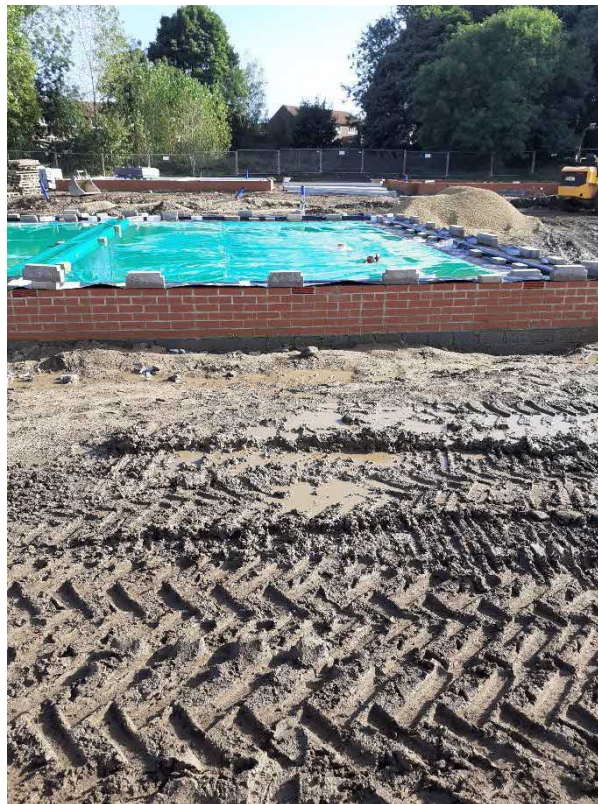
02 C8585E 29.09.22 Plot 48 Overview

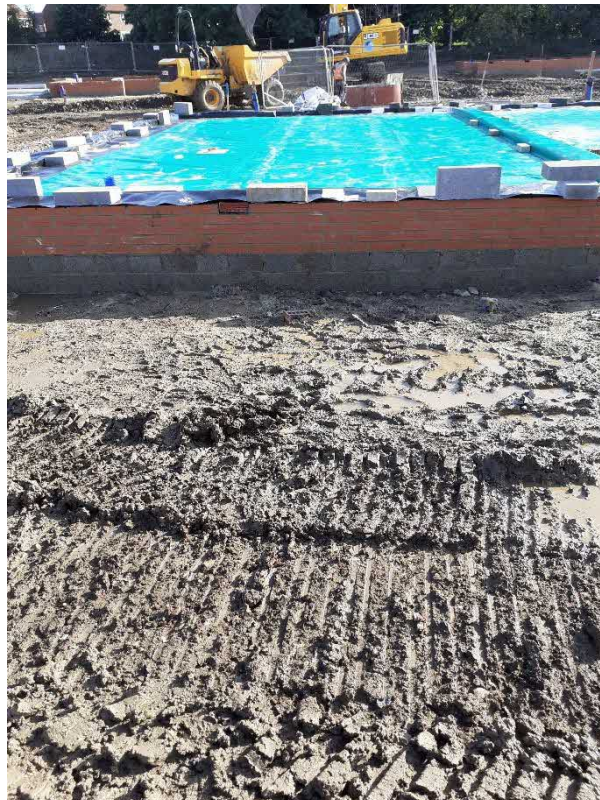
02 C8585E 29.09.22 Plot 49 Overview

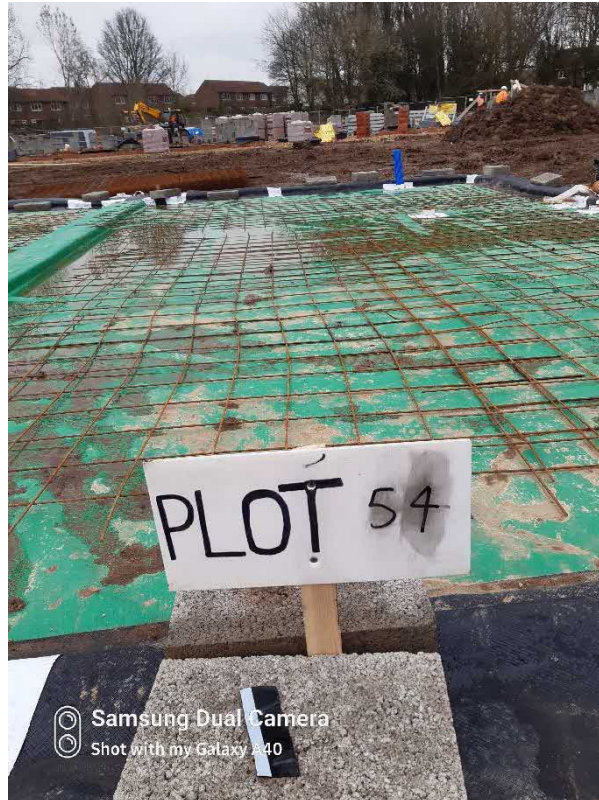
01 C8785E 29.03.23 Plot 54 Overview (client photo)

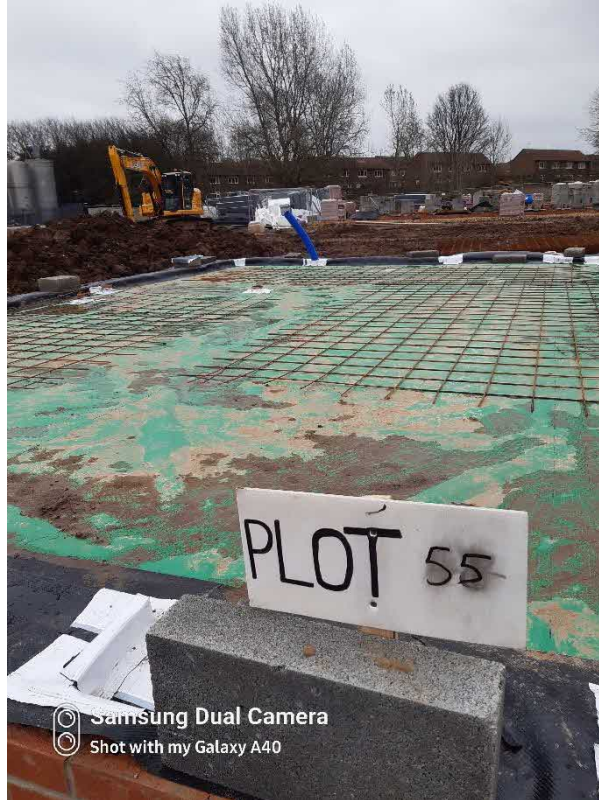
01 C8785E 29.03.23 Plot 55 Overview (client photo)

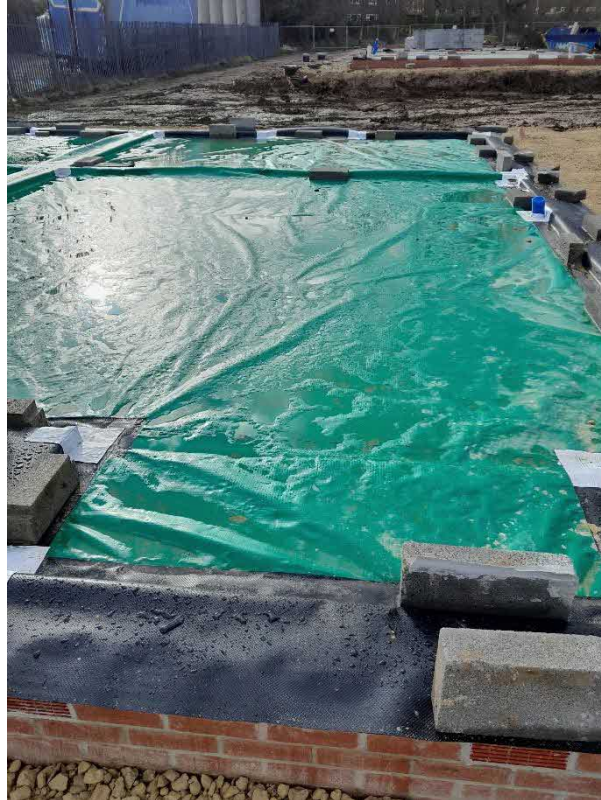
01 C8785E 24.03.23 Plot 58 Overview (client photo)

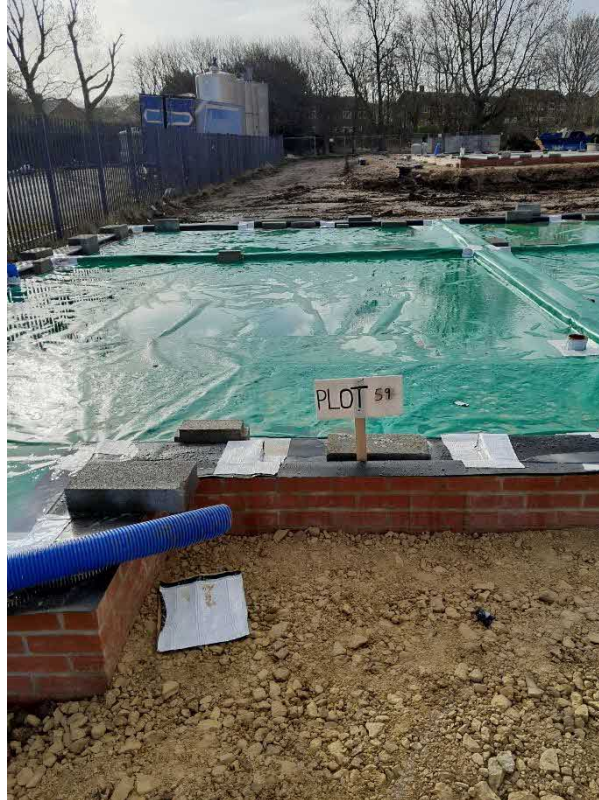
01 C8785E 24.03.23 Plot 59 Overview and Corners (client photo)

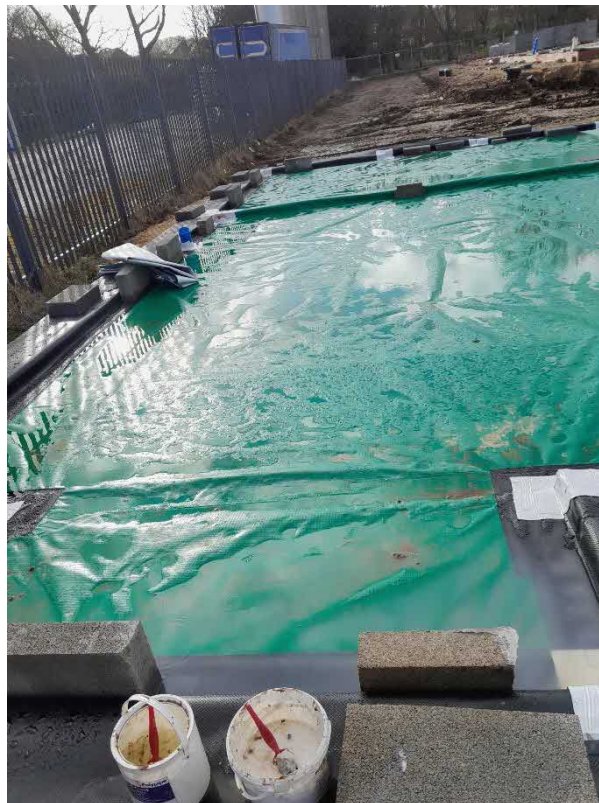
02 C8785E 24.03.23 Plot 59 Overview and Corners (client photo)
